## **QPRC HQ Development**

### Geotechnical Investigation Report

Queanbeyan-Palerang Regional Council

6 June 2019

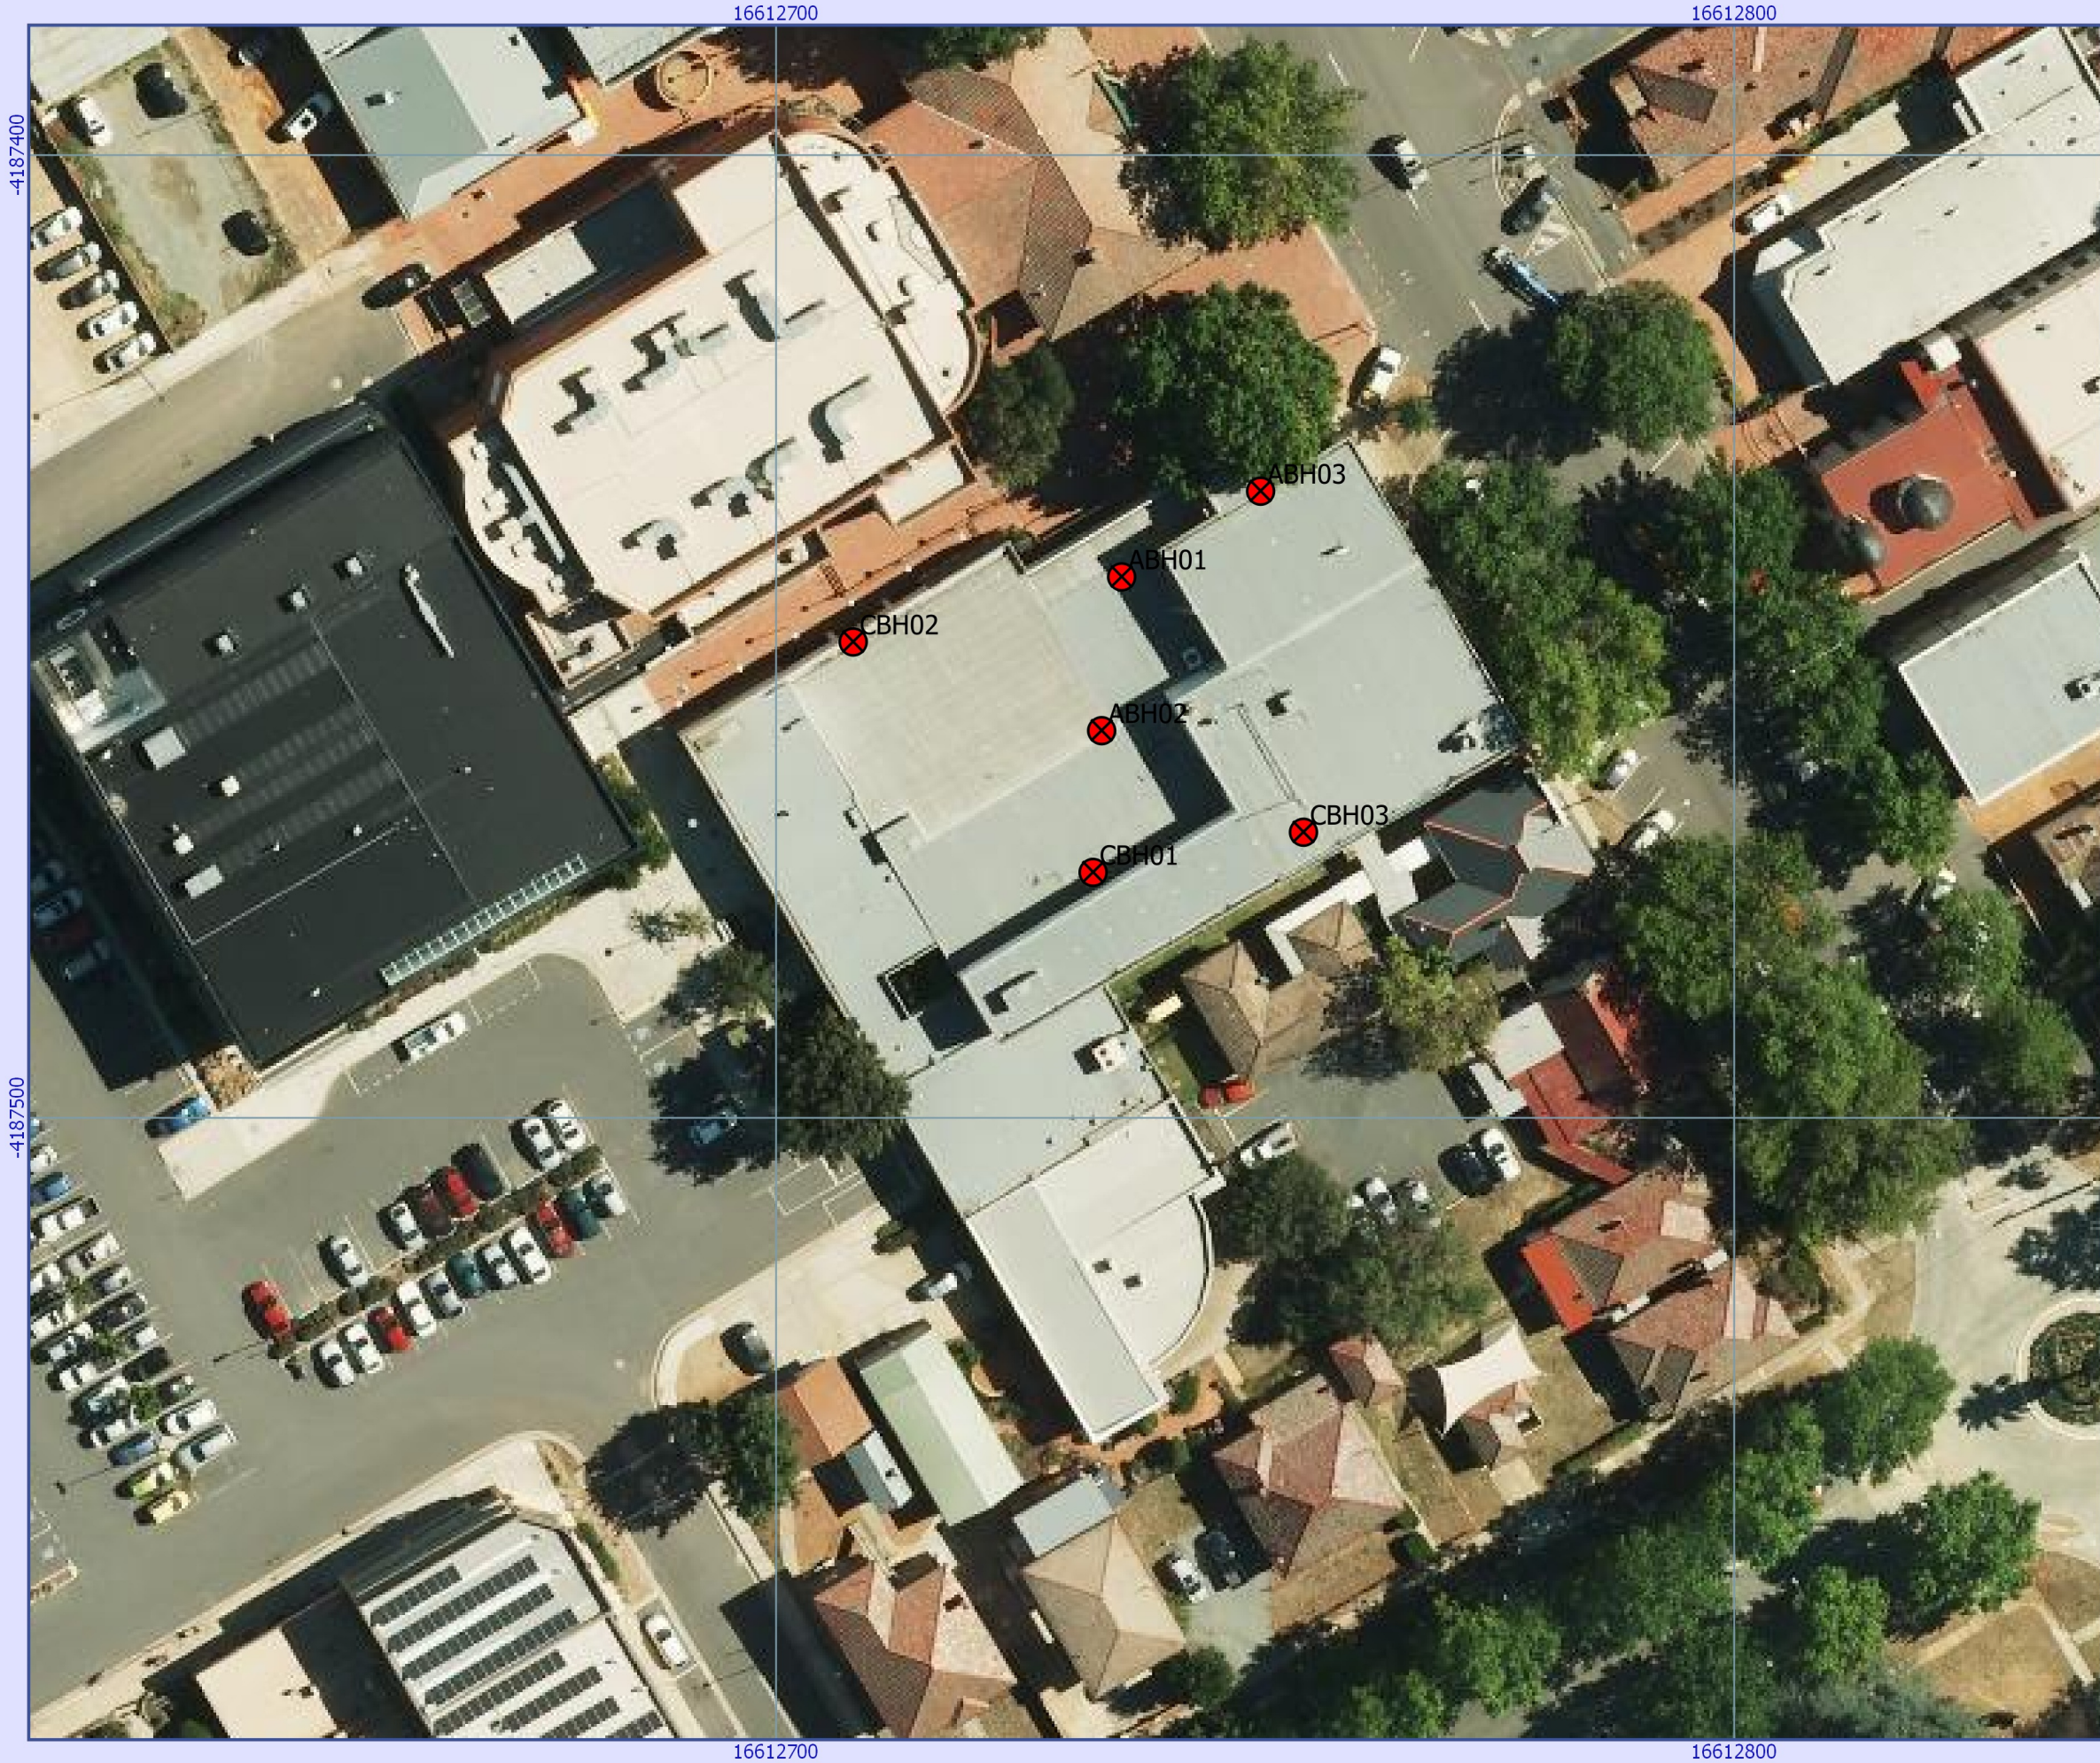
Figure 1 – Investigation Location Plan

Figure 1 shows the approximate borehole locations which were located using hand-held GPS equipment (accurate to  $\pm 3$  m) and by using measurements from existing site features.
