ABORIGINAL CULTURAL HERITAGE ASSESSMENT

Wagga Wagga Solar Farm South

Report Number: 19-088

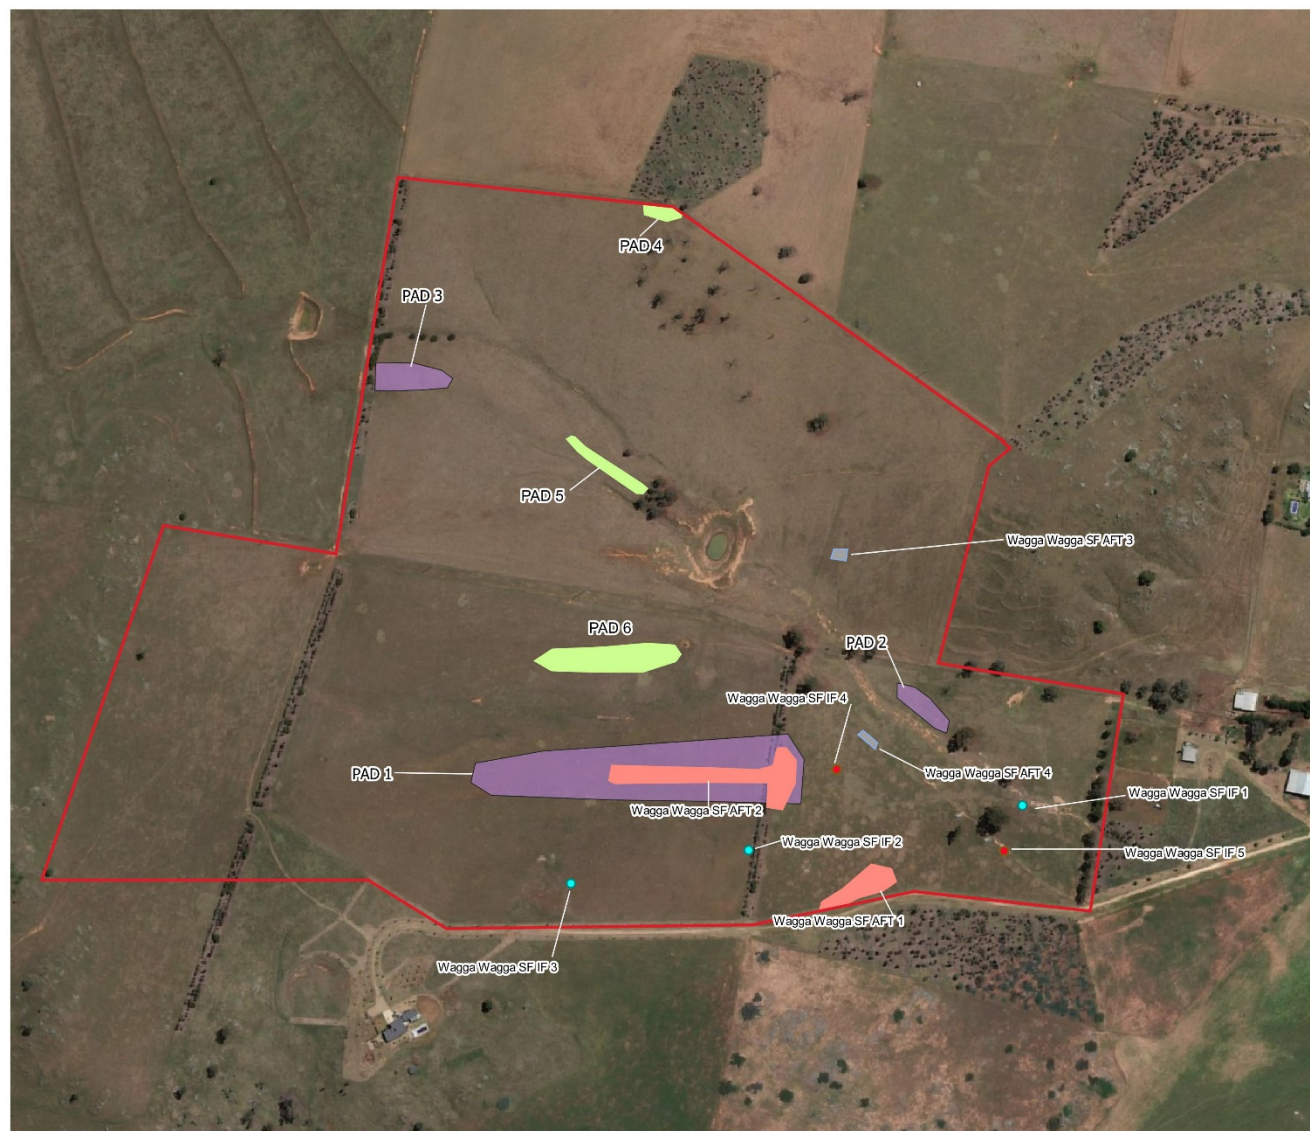
Figure 15 Results Map from the 2019 ACHA and Due Diligence Surveys.

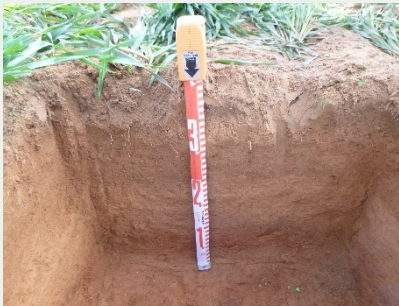
2	20-60	Friable sandy clay with minimal roots, some gravels and clay nodules.	Gravel content is increased in close proximity to the drainage lines. Sandy clay is yellowish red to reddish brown across all areas.	9 artefacts

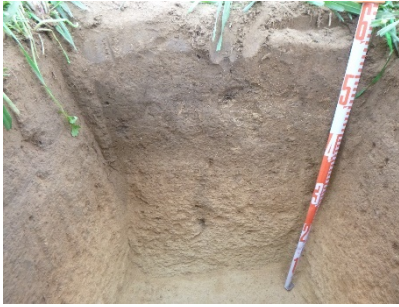
3	20-40	Compacted red, red brown yellowish red clay.	Compacted bright red clay across all landforms, except drainage lines which have a yellowish gravelly sand.	1 artefact

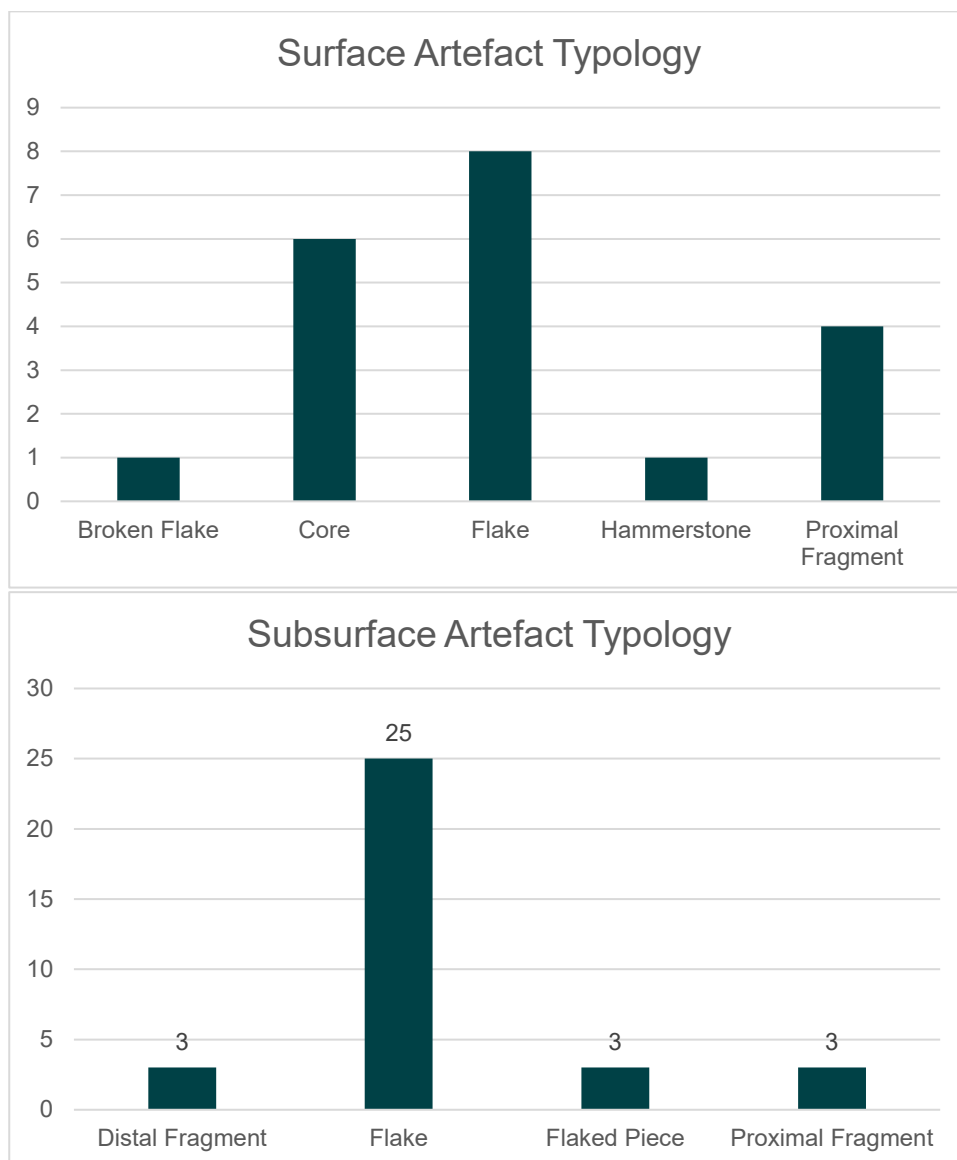
Figure 18 Surface Artefact Typologies vs Subsurface Artefact Typologies

Table 15 and Figure 18 show the typological characteristics of the artefacts recovered from the test pits. It is clear that the majority of artefacts were flakes with low numbers of broken flakes and flaked pieces also recovered. No cores were recovered from the test pits however six cores were identified on the surface. Two of the artefacts exhibited edge damage but none were retouched. One unfinished tool, a basalt hammerstone was identified as part of surface artefact scatter Wagga Wagga SF AFT 2. No formal subsurface tools were recovered from the test pits.

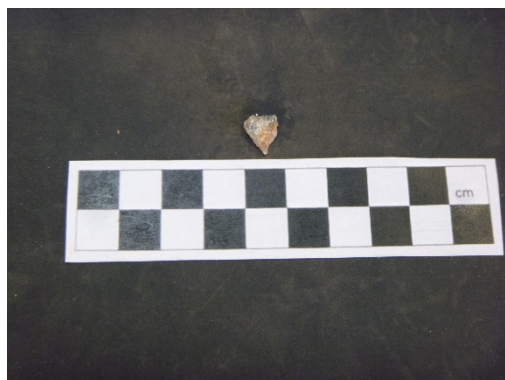
Plate 19 Crystal quartz flake from Pit 022, Spit 1 (PAD 1).

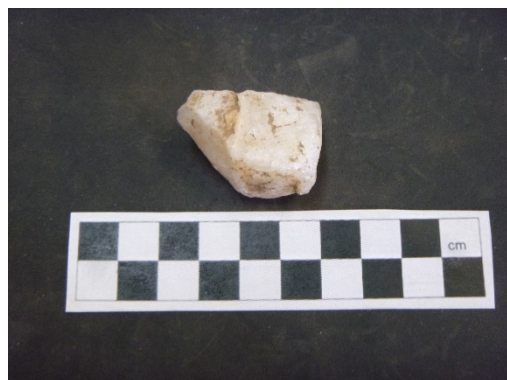
Plate 20 White quartz flake from Pit 028, Spit 1 (PAD 2).

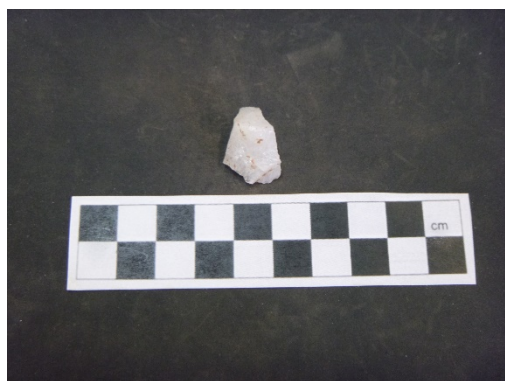
Plate 21 White quartz flake from Pit 041, Spit 2 (PAD 1).

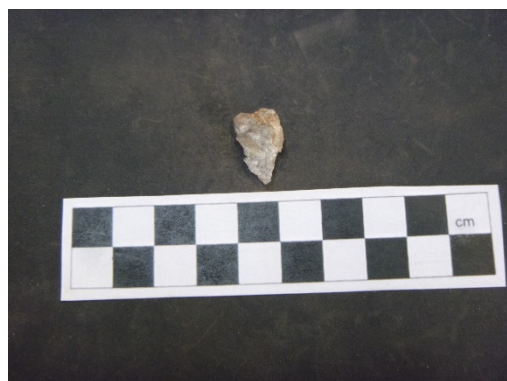
Plate 22 Crystal quartz flake from Pit 047, Spit 2 (PAD 4).

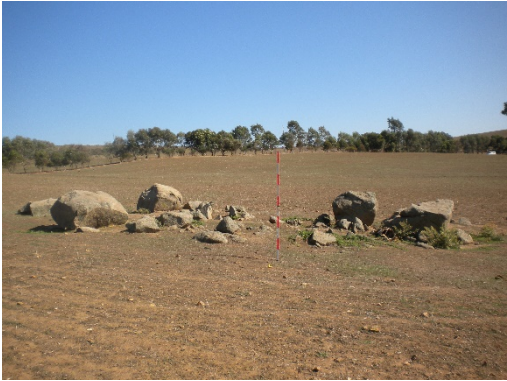
AHIMS #	Site Name	Comments	Pictures
56-1-0605	Wagga Wagga SF AFT 1	The site consisted of at least six quartz artefacts including two broken flakes, two flakes and two cores. The assemblage was identified along a northern facing slope interspersed with granite outcropping. Ground surface visibility at the site was 40% in the exposure surrounding the outcropping.

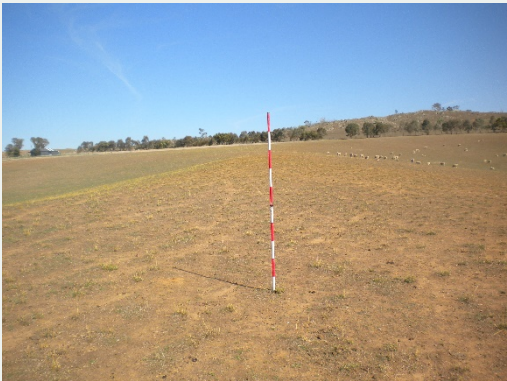
56-1-0604	Wagga Wagga SF AFT 2	The site consisted of at least five quartz artefacts and one basalt hammerstone, including one broken flake, two flakes and two cores. The assemblage was identified along an east-west running spurline that dissects the central portion of the proposal area. Ground surface visibility at the site was 40% in the exposures along the flattest and highest part of the spurline.

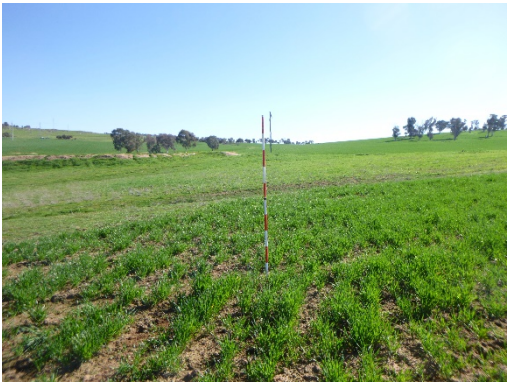
56-1-0603	Wagga Wagga SF AFT 3	The site consisted of at least two quartz artefacts, including one broken flake and one flake. The site was identified along a southerly facing slope approximately 95 m east of a man-made dam in a ploughed paddock. Ground surface visibility was 10%.

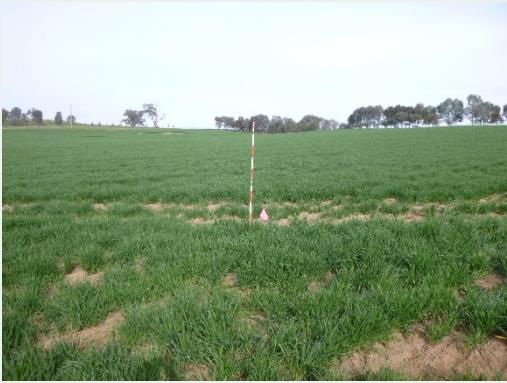
56-1-0602	Wagga Wagga SF AFT 4	The site consisted of at least two quartz artefacts, including one broken flake and one flake. The assemblage was identified along the south western edge of a vehicle access track and 50 m from the edge of an ephemeral drainage line. The ground surface visibility was 15%.

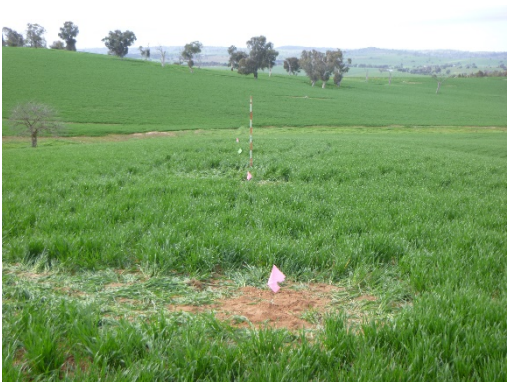
56-1-0601	Wagga Wagga SF AFT 5	The site consisted of at least six quartz subsurface artefacts, including broken flakes and flakes. The assemblage was identified during a subsurface testing program of six PADs. The artefacts were located in two of four test pits in the top two spits to a depth of 15-20cm within a reddish brown gritty sandy loam.

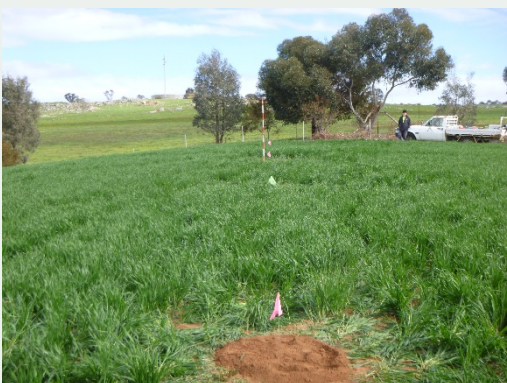
56-1-0600	Wagga Wagga SF AFT 6	The site consisted of at least nine quartz subsurface artefacts, including broken flakes, flakes and flaked pieces. The assemblage was identified during a subsurface testing program of six PADs. The artefacts were located in two of five test pits in the top two spits to a depth of 15-20cm within a reddish brown gritty sandy loam.

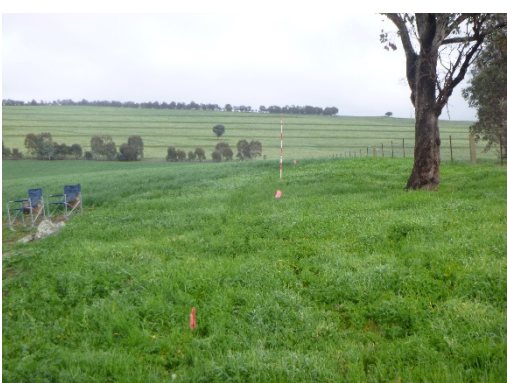
56-1-0599	Wagga Wagga SF AFT 7	The site consisted of at least four quartz subsurface artefacts, including broken flakes and flakes. The assemblage was identified during a subsurface testing program of six PADs. The artefacts were located in three of four test pits in the top two spits to a depth of 15-20cm within a reddish brown gritty sandy loam.

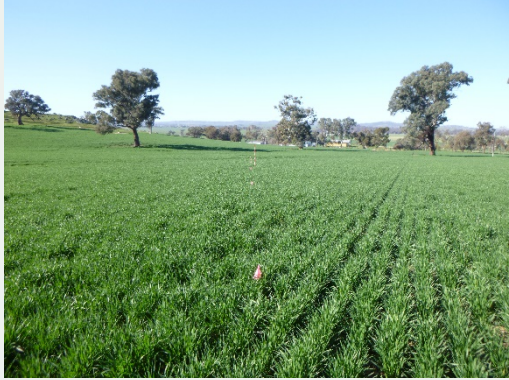
56-1-0598	Wagga Wagga SF AFT 8	The site consisted of at least five quartz subsurface artefacts, including broken flakes and flakes. The assemblage was identified during a subsurface testing program of six PADs. The artefacts were located in five of 12 test pits in the top two spits to a depth of 15-20cm within a reddish brown gritty sandy loam.

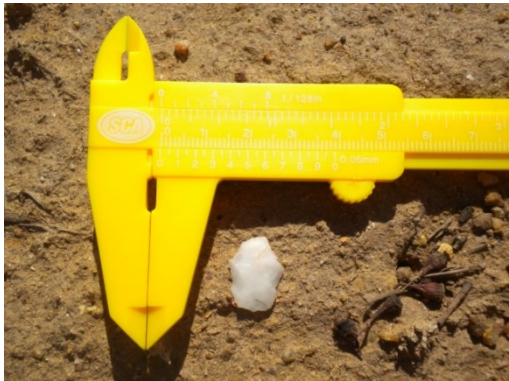
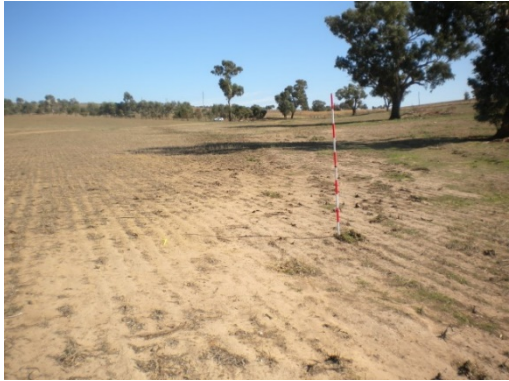
AHIMS #	Site Name	Comments	Pictures
56-1-0597	Wagga Wagga SF IF 1	The site contains a white quartz flake, measuring 16 x 12 x 3 mm and at the tertiary stage of reduction. The flake was identified on the eastern edge of a north west to south east running drainage line in an area of 75% ground surface visibility.

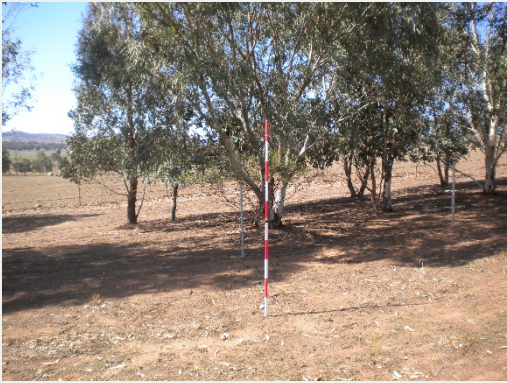
56-1-0596	Wagga Wagga SF IF 2	The site contains a white quartz core, measuring 50 x 52 x 32 mm and at the secondary stage of reduction, with 10% vein cortex, two platforms, 2 negative flakes scars. The flake was identified on the western side of a north to south running fenceline in an area of 45% ground surface visibility.

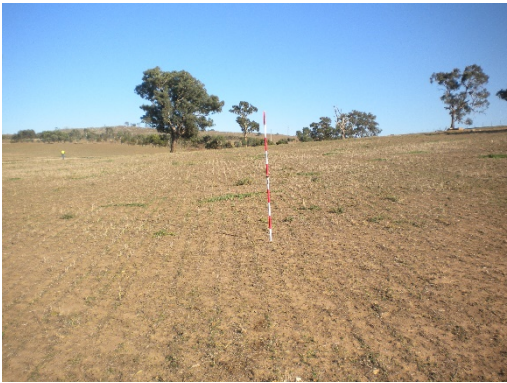
56-1-0595	Wagga Wagga SF IF 3	The site contains a white quartz flake, measuring 12 x 10 x 5 mm and at the tertiary stage of reduction. The flake was identified on the southerly facing slope surrounded by areas of granite outcropping. The ground surface visibility was 30%.

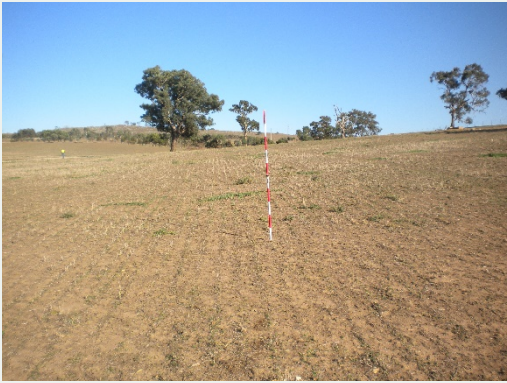
56-1-0594	Wagga Wagga SF IF 4	The site contains a white quartz broken flake, measuring 18 x 27 x 10 mm and at the secondary stage of reduction, with 10% pebble cortex. The broken flake was identified on the southerly facing slope in between two ephemeral drainage lines. The ground surface visibility was 5%.

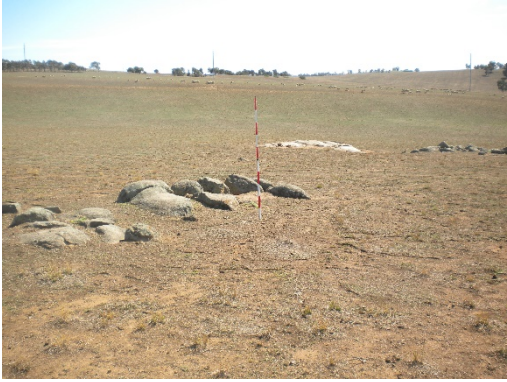
56-1-0593	Wagga Wagga SF IF 5	The site contains a white quartz core, measuring 30 x 25 x 23 mm and at the secondary stage of reduction, with 40% pebble cortex, 3 platforms and 4 negative flake scars. The core was identified on the main vehicle access track in the southernmost paddocks. The ground surface visibility was 85% along the track.

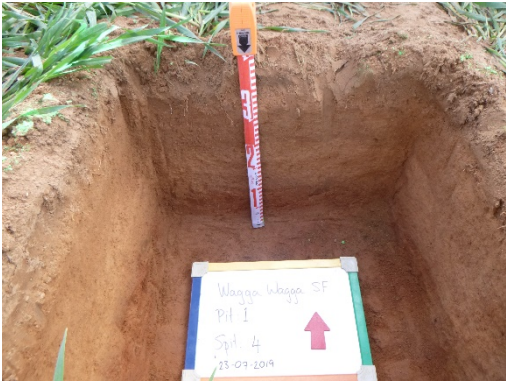
<p>Pit 1 Spit 4</p>

Pit no	Grid Reference	Spit number	Depth (cm)	Soil Description	Artefacts
1	539333	1	1-5	Reddish brown gritty sandy loam with roots. Low compaction due to recent ploughing. pH = 5	
	6118540	2	5-15	Reddish brown gritty sandy loam with few roots and no gravel inclusions. pH= 5	
		3	15-25	Reddish brown gritty sandy loam with clay content starting at base of spit and compaction increasing with depth. pH = 5	1
		4	25-35	Deep reddish brown gritty clayey loam becomes a compact reddish clay at 30 cm. pH=5.5	
2	539342	1	1-10	Brown silty loam topsoil with root and small gravel inclusions. PH=5.5	2
	6118544	2	10-20	Brown silty loam with small quartz gravel inclusions. Very moist and lots of root inclusions. pH= 5	3
		3	20-28	Friable red clay increasing in compaction with depth. Bright red sticky clay at base. pH=5.5

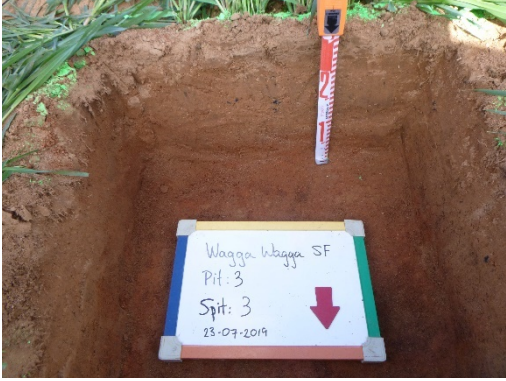
<p>Pit 3 Spit 3</p>

<p>Pit 2 Spit 3</p>	
3	539352	1	0-10	Reddish brown gritty sandy loam with grass roots and low compaction to 5 cm and compaction increasing with depth. Some isolated charcoal smears. pH= 5

6118547	2	10-20	Reddish brown gritty sandy loam with clay content and compaction increasing with depth. Very compact at base of spit with clay appearing. pH=5	
		3	20-25	Dark reddish brown very compacted clay. pH=5.5

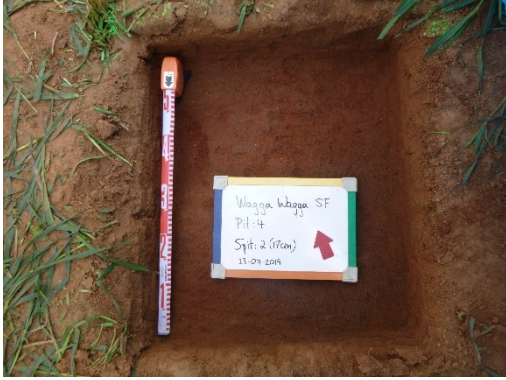
4	539361	1	0-10	Reddish brown gritty sandy loam with grass root and small quartz gravel inclusions. Compacted clay appearing at 8cm depth. pH= 5.5	
	6118551	2	10-17	Friable dark reddish-brown clay to 12 cm depth. Compact red clay 12-17 cm depth. pH= 6

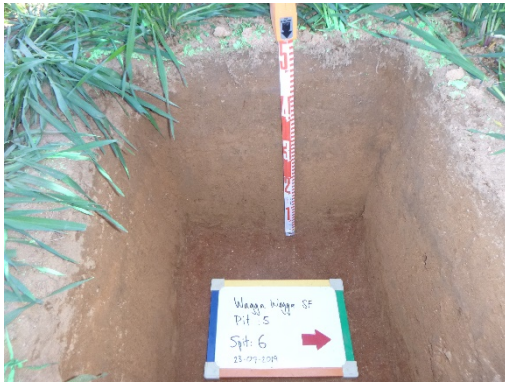
Pit 5 Spits 5 & 6

<p>Pit 4 Spit 2</p>	
5	539522	1	0-5	Reddish brown gritty sandy clay loam with grass root inclusions. pH= 5	
	6118486	2	5-15	Reddish brown gritty sandy clay loam with grass root inclusions, compaction increasing with depth. pH= 5	
		3	15-25	Reddish brown gritty sandy clay loam with grass root inclusions, compaction increasing with depth. pH= 5	
		4	25-35	Reddish brown gritty sandy clay loam with grass root inclusions, compaction increasing with depth. pH= 5	
		5	35-45	Reddish brown gritty sandy clay loam with grass root inclusions, compaction increasing with depth. pH= 5	
		6	45-50	Deep reddish brown gritty compacted clay. pH= 5

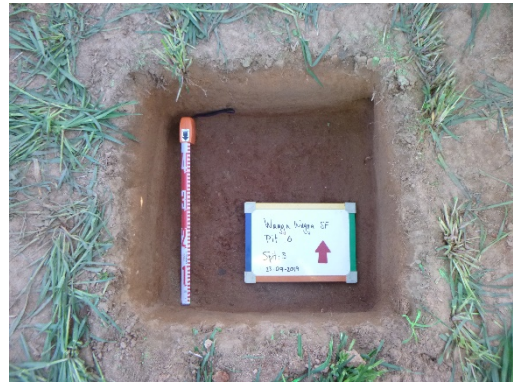
Pit 6 Spit 3

6	539537	1	1-10	Reddish brown gritty sandy clay loam with grass root and high-density gravel inclusions. pH= 5.5	8
	6118474	2	10-20	Gritty sandy yellowish red loam to 20 cm depth. Clay appearing at base of spit with lots of quartz gravel inclusions. pH= 6	
		3	20-30	Friable clay loam to 28cm. Compact reddish-brown clay to 30 cm. pH= 5.5

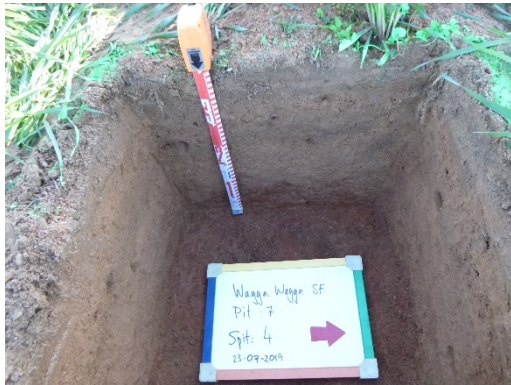
Pit 7 Spit 4

7	539556	1	0-10	Reddish brown gritty sandy clay loam with grass root inclusions and gravels present up to 1 cm. pH= 5	
	6118463	2	10-20	Light reddish brown gritty sandy clay loam with grass root inclusions decreasing. Compaction and clay content increasing with depth pH= 5	
		3	20-30	Light reddish brown gritty sandy clay loam with grass root inclusions decreasing. Compaction and clay content increasing with depth pH= 5	
		4	30-35	Reddish brown gritty sandy clay loam that becomes a dark reddish-brown gritty clay at 33 cm. pH= 5	
8	539572	1	1-10	Reddish brown moist gritty sandy clay loam with grass root inclusions and gravels. pH=5	
	6118452	2	10-20	Dark reddish brown moist gritty sandy clay loam with less grass root inclusions, but gravel density increasing. pH= 6.5	
		3	20-28	Friable dark reddish-brown clay loam at 27cm. pH= 6.5	
		4	30-40	Compact dark reddish-brown clay at 38cm. pH= 6.5	
		5	40-42	Compact dark reddish-brown clay. pH= 6

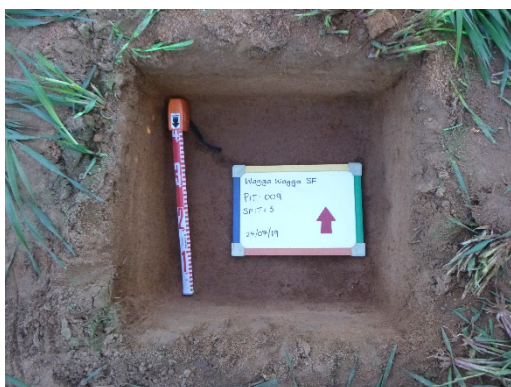
Pit 9 Spit 3

9	539589	1	0-10	Reddish brown moist gritty sandy clay loam with grass root inclusions and gravels. pH= 6	1
	6118442	2	10-20	Dark reddish brown moist gritty sandy clay loam with fewer grass root inclusions, but gravels increasing in size and density. Compaction increasing with depth. pH= 5.5	
		3	20-30	Reddish brown gritty sandy loam with less gravels and no roots, becomes friable clay loam at 24cm. Compact red clay at 30cm. pH= 5.5	
10	539608	1	0-5	Dark brown silty loam with small gravels and lots of root inclusions. Moist but loose compaction with some clay nodules present. pH= 6	
	6118260	2	5-15	Yellowish red gritty sandy loam with clay nodules density increasing and less root inclusions. pH = 6	
		3	15-25	Yellowish red gritty sandy loam with clay nodules to 25cm. Reddish brown clay appearing at base of spit. pH = 6	
		4	25-30	Reddish brown compact clay with less clay nodules. pH= 6

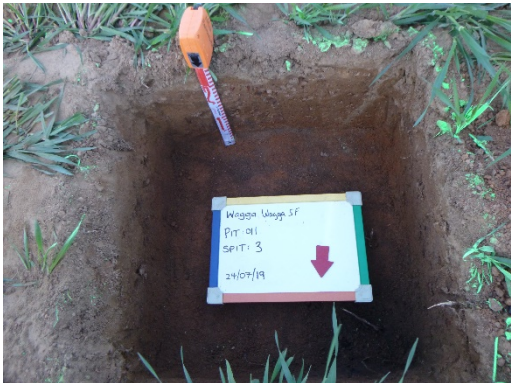
Pit 11 Spit 3

11	539588	1	0-10	Reddish brown moist gritty sandy clay loam with grass root, gravel and some clay nodule inclusions. pH= 5.5	
	6118260	2	10-20	Reddish brown clayey loam with large gravels and clay nodules. Large tree roots throughout spit. Compaction and clay content increasing with depth. pH= 5.5	
		3	20-25	Reddish brown clayey loam with scattered charcoal throughout becoming a reddish-brown compact clay at base of spit. pH= 5.5	
12	539568	1	0-10	Fine reddish-brown sandy loam with few gravel and grass root inclusions. pH= 5.5	
	6118261	2	10-20	Fine reddish-brown sandy loam with few gravel and grass root inclusions. Compaction and clay content increasing with depth. pH= 5.5	
		3	20-30	Fine reddish-brown sandy loam with few gravel and grass root inclusions. Compaction and clay content increasing with depth. pH= 5.5	
		4	30-34	Compact reddish-brown clay at 32cm. pH= 5.5

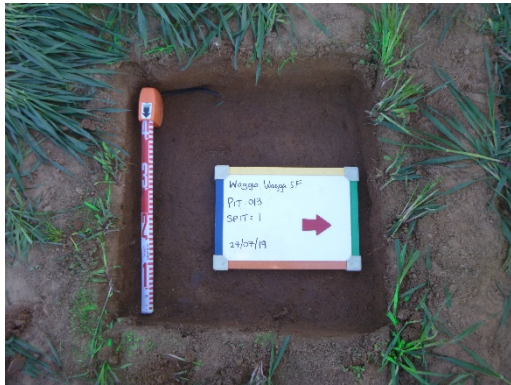
Pit 13 Spit 1

13	539547	1	0-10	Dark reddish-brown sandy loam with root inclusions becoming a friable clay at 5 cm. Compact dark reddish-brown clay at base of spit. pH= 5.5	
	6118261				
14	539528	1	0-10	Reddish brown sandy loam with lots of root inclusions. Friable clay at 5 cm. pH = 5.5	
	6118261	2	10-20	Dark reddish-brown clay becoming more compacted with depth. No inclusions. pH= 6

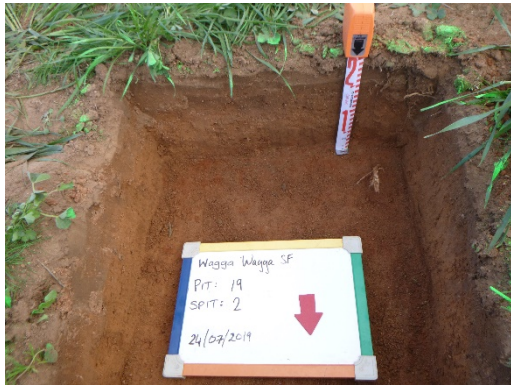
Pit 19 Spit 2

Pit 17 Spit 3				Pit 18 Spit 2	
19	539649	1	0-10	Reddish brown sandy loam with some roots that becomes clayey loam at <5cm. Compaction and clay content increasing with depth. pH= 5.5	
	6118144	2	10-20	Reddish brown clayey loam that becomes a dark reddish-brown compact clay at 19 cm. pH= 5.5	
20	539631	1	0-10	Brown moist sandy loam with loose compaction and lots of root inclusions. Minimal quartz gravels present. pH = 6	
	6118145	2	10-20	Reddish brown gritty sandy clay compacted in ground but friable in sieve. Small gravel inclusions. pH = 5.5

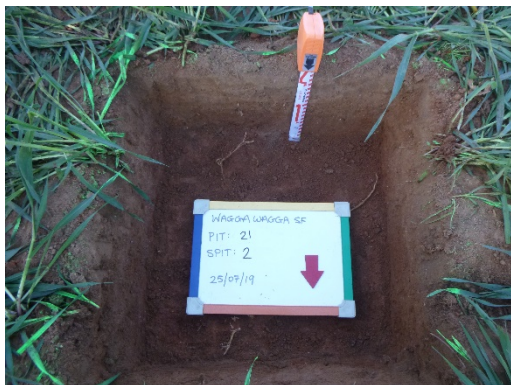
Pit 21 Spit 2

21	539611	1	0-10	Reddish brown sandy loam with some small gravel and root inclusions. pH= 5.5	
	6118145	2	10-18	Very compact reddish-brown clayey loam with roots and few gravels. Becomes very compact clay at 18cm and unable to excavate further by hand. pH= 5.5	
22	539592	1	0-10	Reddish brown moist gritty sandy loam with roots and clay nodules throughout. Loos compaction pH = 6	1
	6118143	2	10-20	Reddish brown partially cemented loamy sand with medium-density quartz gravels and less root matter. pH= 5.5	
		3	20-30	Reddish brown friable clayey sand with clay content increasing with depth. Gravel inclusions. Clay appearing at 30 cm. pH+ 5.5	
		4	30-33	Reddish brown sandy clay with some clay nodules. Compacted red clay at 32cm. pH= 5

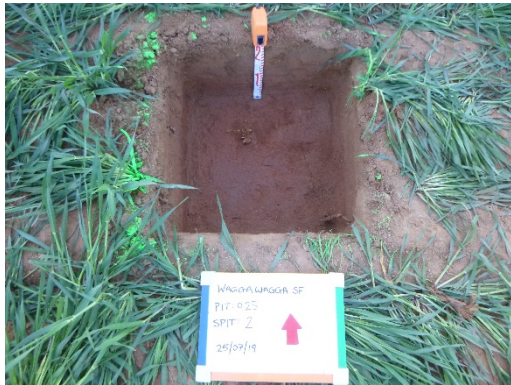
Pit 25 Spits 1 & 2

Pit 23 Spit 3				Pit 24 Spit 2	
25	539531	1	0-10	Reddish brown sandy loam with root and gravel inclusions. Becomes more compacted and more clay content at 5 cm. pH= 5.5	
	6118144	2	10-20	Reddish brown clayey loam with some root and gravel inclusions and a large tree root in the north west corner. Compacted clay reached at 19 cm. pH= 5.5	
26	539510	1	0-10	Reddish brown loosely compacted gritty sandy loam with low-density quartz gravels and root matter throughout. pH = 6	
	6118142	2	10-20	Reddish brown gritty sand becoming more cemented with depth. Less root matter, but quartz gravels increasing in size. pH = 5.5

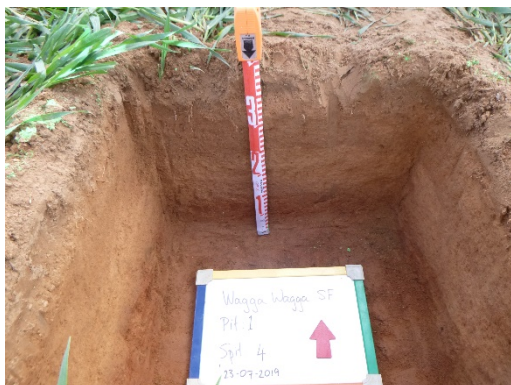
Pit 27 Spits 1 & 2

27	539850	1	0-5	Fine greyish brown silty loam with few grass roots. pH = 6	
	6118176	2	5-15	Dark reddish brown very fine silty clayey loam with few roots and gravels. pH = 7	
		3	15-25	Dark reddish brown very fine silty clayey loam with few roots and gravels. pH = 7	
		4	25-35	Very fine dark reddish brown silty clayey loam with few root inclusions. pH = 7	
		5	35-45	Gritty greyish brown compact clay at 42 cm. pH = 7	
28	539866	1	0-10	Very dusky red very fine silty loam with lots of root matter and minimal very small gravels. pH = 5	1
	6118163	2	10-20	Dark reddish-brown silty loam with clay content increasing with depth. Compacted clay reached at 15 cm. pH = 5

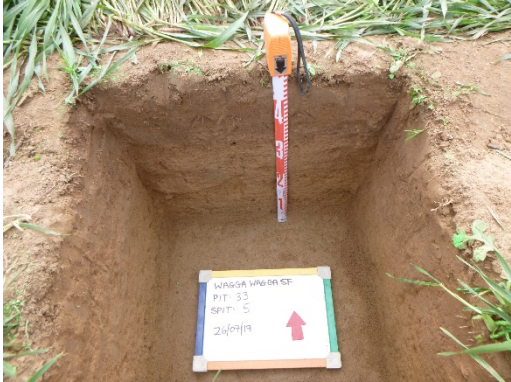
<p>Pit 33 Spit 5</p>

Pit 31 Spit 5				Pit 32 Spit 3	
33	539886	1	0-10	Very fine reddish-brown silty clay loam with few root and gravel inclusions. pH 5.5	
	6118134	2	10-20	Very fine reddish-brown silty clay loam with few root and gravel inclusions. Becoming a gritty sandy clayey loam at base of spit. pH = 5.5	
		3	20-30	Yellowish red gritty sandy clayey loam with some gravels. pH = 5.5	
		4	30-40	Yellowish red gritty sandy clayey loam with some gravels. Compaction increasing with depth pH = 5.5	
		5	40-45	Very compacted gritty sandy clay at 43 cm. Unable to manually excavate further. pH = 5.5	
34	539877	1	0-10	Reddish brown fine silty clayey loam with root matter and minimal gravels. Loose compaction. pH = 6.5	1

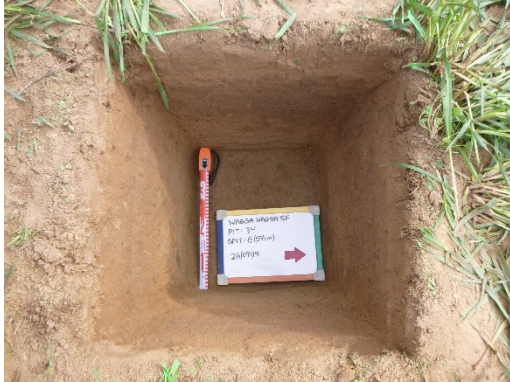
<p>Pit 34 Spit 6</p>	
35	539867	1	0-10	Very fine reddish brown silty clayey loam with root and gravel inclusions. Compaction increasing with depth. pH = 5.5	1
	6118129	2	10-20	Very compacted reddish brown very fine silty clayey loam with root and gravel inclusions becoming a yellowish red gritty sandy clayey loam at base of spit. pH = 5.5	
		3	20-30	Yellowish red gritty sandy clayey loam with gravels. Loose compaction pH = 5.5	
		4	30-40	Yellowish red gritty sandy clayey loam with gravels. Clay content and compaction increasing with depth. pH = 5.5	
		5	40-50	Yellowish red gritty sandy clayey loam with gravels. Clay content and compaction increasing with depth. Some leaching resulting in lighter very compacted soils. pH = 5.5	
		6	50-58	Very compacted strong brown gritty sandy clayey loam. Unable to manually excavate further. pH = 5.5

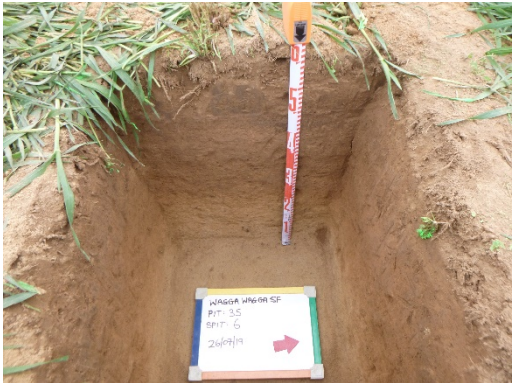
<p>Pit 35 Spite 6</p>

36	539857	1	0-10	Fine dark reddish brown silty clayey loam with some root and gravel inclusions. Loose compaction. pH = 6	
	6118126	2	10-20	Fine dark reddish brown silty clayey loam with some root and gravel inclusions. Loose compaction and sand content increasing with depth. pH = 6	
		3	20-30	Reddish brown gritty clayey sand with clay nodules and compaction increasing with depth. pH = 6.5	
		4	30-40	Yellowish brown gritty clayey sand with clay nodules and compaction increasing with depth. pH = 6.5

5	40-50	Yellowish brown gritty clayey sand with clay nodules and compaction increasing with depth. pH = 6.5	
		6	50-60	Very cemented strong brown fine sand with lots of small singular gravels and clay nodules. pH = 7	
		7	60-65	Continued excavation until unable to manually excavate further. Increase in angular gravel inclusions. pH = 7

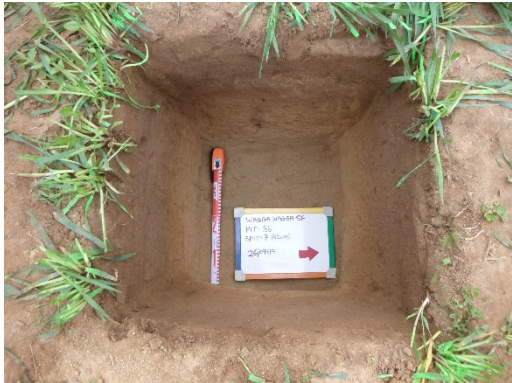
<p>Pit 36 Spite 7</p>	
37	539846	1	0-10	Very fine compacted reddish brown silty clayey loam with roots and insect activity. pH = 5.5	
	6118124	2	10-20	Gritty yellowish red less compacted sandy clayey loam at 19-20 cm. pH = 5.5	
		3	20-30	Fine gritty yellowish red loosely compacted sandy clayey loam with small gravels. pH = 6	
		4	30-40	Yellowish red cemented sand at 35-38 cm with high density angular gravel inclusions. pH = 6	
		5	40-47	Yellowish red cemented sand with high density angular gravel inclusions. Gravels and cementation increasing with depth. pH = 6

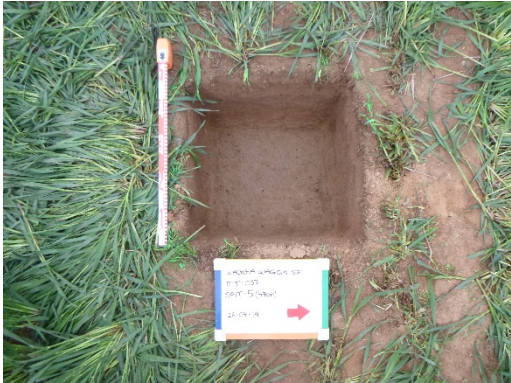
<p>Pit 37 Spit 5</p>

38	539837	1	0-10	Fine dark reddish brown silty clayey loam with lots of root matter and small gravels. Loose compaction. pH = 6	
	6118120	2	10-20	Less root matter and gravels, but clay content increasing. Yellowish red sand appearing at base of spit. pH = 6.5	
		3	20-30	Fine reddish brown silty sandy with no roots and minimal gravels. Some clay content. Compaction increasing with depth. pH = 6.5	
		4	30-40	Loosely compacted brown gritty sand with no inclusions. pH = 6.5	
		5	40-50	Angular gravel inclusions appearing at 48 cm and compaction increasing. pH = 6.5

6	50-55	Angular gravels increasing in compacted sand. Minimal quartz gravels. pH = 6.5

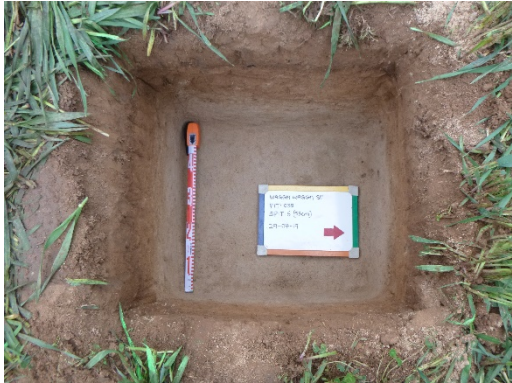
<p>Pit 38 Spit 6</p>	
39	539731	1	0-10	Fine dark reddish-brown silty loam with some clay content. Minimal gravel inclusions and lots of root matter. Red compact clay appearing at base of spit. pH = 5.5	
	6118102	2	10-13	Red compacted clay with minimal quartz gravels. pH = 6	
40	539732	1	0-10	Fine dark reddish-brown silty loam with root matter and minimal gravels. pH = 5.5	1
	6118113	2	10-20	Compact red clay at 11-13 cm. No inclusions. Possible yellow ochre in centre of test pit at base of spit. pH = 6

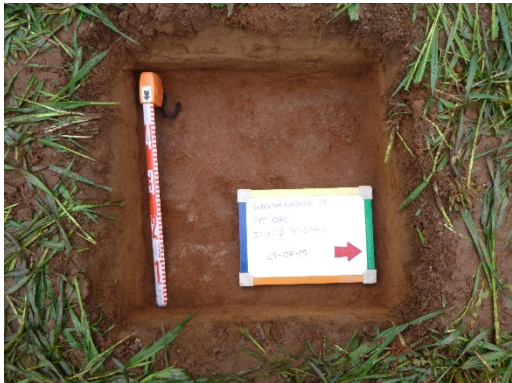
<p>Pit 40 Spit 2</p>	
41	539734	1	0-10	Reddish brown sandy silty loam with some gravels and roots. Damp from recent rain activity. pH = 5.5	
	6118123	2	10-20	Reddish brown sandy silty loam with clay content increasing with depth. Compact clay appearing at base of spit. pH = 5.5	1

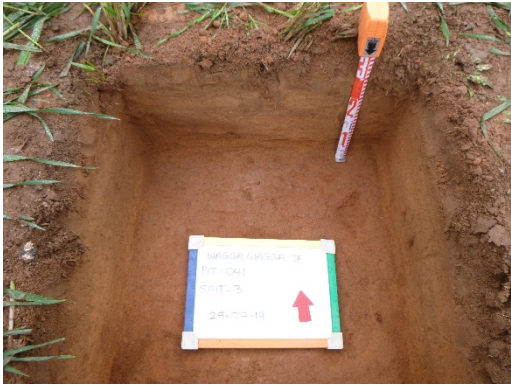
Pit 41 Spit 3

42	539735	1	0-5	Fine dark reddish brown friable sandy loam with root matter and minimal small gravels. Moist but loose compaction. pH = 5.5	
	6118133	2	5-15	Fine dark reddish-brown sandy loam becoming gritty sand with some quartz gravels and root matter at 15 cm. pH = 5.5	
		3	15-25	Yellowish red gritty sand with less root matter and gravel inclusions. pH = 5.5	
		4	25-35	Compacted red clay appearing at 35 cm with no inclusions. pH = 6	
		5	35-40	Compacted red clay across entire base. pH = 6

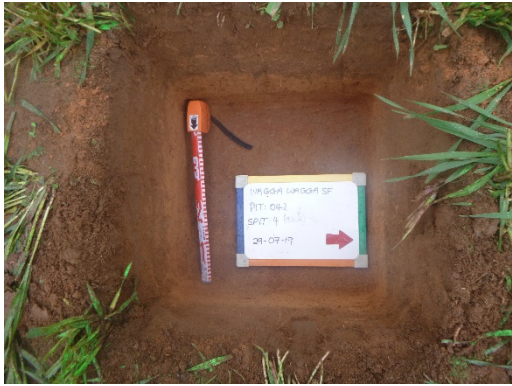
Pit 42 Spit 5	
43	539739	1	0-10	Reddish brown sandy silty clayey loam with root and gravel inclusions. Clay content and compaction increasing with depth from 6 cm. pH = 5.5	1
	6118141	2	10-20	Compacted red silty clay at 18 cm. Unable to manually excavate further due to compaction. pH = 5.5	
44	539740	1	0-10	Fine dark reddish brown silty sandy loam with root matter and minimal gravels. Loose compaction. pH = 5.5

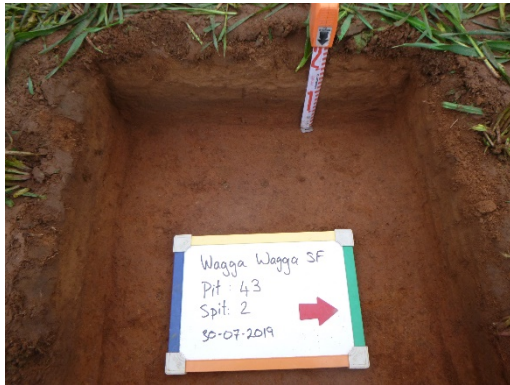
Pit 43 Spit 2

6118151	2	10-16	Red clayey sand with no roots and minimal quartz gravels and pebbles. Compacted red clay at 14 cm-16 cm. pH = 6	1

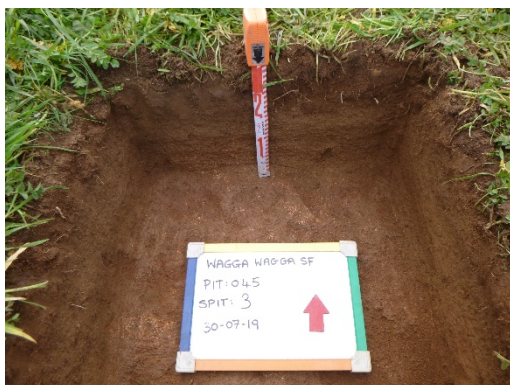
Pit 45 Spit 3

45	539742	1	0-5	Reddish brown silty loam with some gravels and roots. pH = 6.5	2
	611816	2	5-15	Reddish brown silty clayey loam with gravels and some roots. pH = 6.5	2
		3	15-25	Dark red compacted clay at 24 cm. pH = 6.5	
46	53962	1	0-10	Fine dark reddish-brown silty loam with root matter and some small gravels and pebbles. pH = 6.5	1
	6118717	2	10-20	Reddish brown gritty loamy sand with high density pebbles and gravels. Large boulder in the southern baulk. Loose compaction. pH = 6.5	
		3	20-30	Reddish brown gritty loamy sand with high density pebbles and gravels. Large boulder in the southern baulk. Loose compaction. pH = 6.5	
		4	30-36	Bedrock appearing at 30 cm, continued excavation until all exposed. Very gravelly content. pH = 6.5

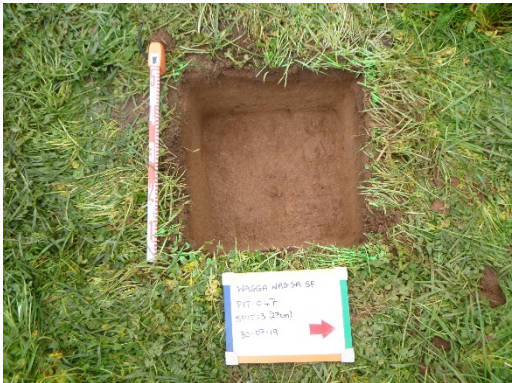
<p>Pit 47 Spit 3</p>

47	539619	1	0-10	Fine dark reddish-brown silty loam with root matter and gravels. Loose compaction. pH = 6.5	
	6118720	2	10-20	Fine reddish brown gritty loamy sand with moderate density gravels and pebbles and compaction increasing with depth. pH = 6.5	1
		3	20-27	Friable reddish-brown clay appearing at 25 cm. Compact clay with small gravels across base of spit by 27cm. pH = 6.5	
48	539610	1	0-10	Reddish brown silty loam with grass roots and gravel inclusions. pH = 6.5	2
	6118721	2	10-20	Reddish brown silty clayey loam with angular gravels and roots. pH = 6.5	
		3	20-25	Reddish brown silty clayey loam with angular gravels and clay content increasing. Dark red compacted clay at 23 cm. pH = 7

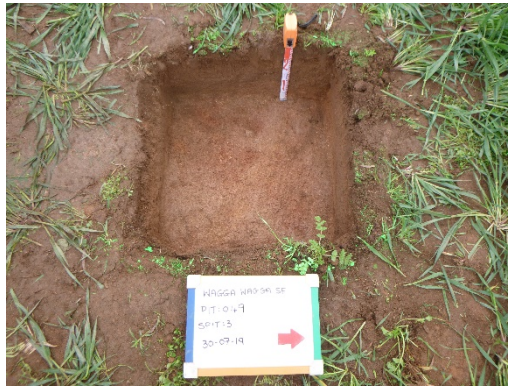
Pit 49 Spit 3

<p>Pit 48 Spit 3</p>	
49	539600	1	0-10	Reddish brown silty loam with grass roots and gravel inclusions. pH = 6.5	
	6118723	2	10-20	Reddish brown silty clayey loam with angular gravels and roots. pH = 6.5

3	20-25	Reddish brown silty clayey loam with angular gravels and clay content increasing. Dark red compacted clay at 23 cm. pH = 7
