Environmental Site Assessment

80-82 Murray Street and 185 Morgan Street,
Wagga Wagga, NSW

Project No.	CH1440	Document No.	D230125
Title	Detailed Site Investigation		
Site Address	80-82 Murray Street and 185 Morgan Street, Wagga Wagga. NSW		
Prepared For	Demasa Pty Ltd		
File Name	CH1440_D230125_Detailed Site Investigation

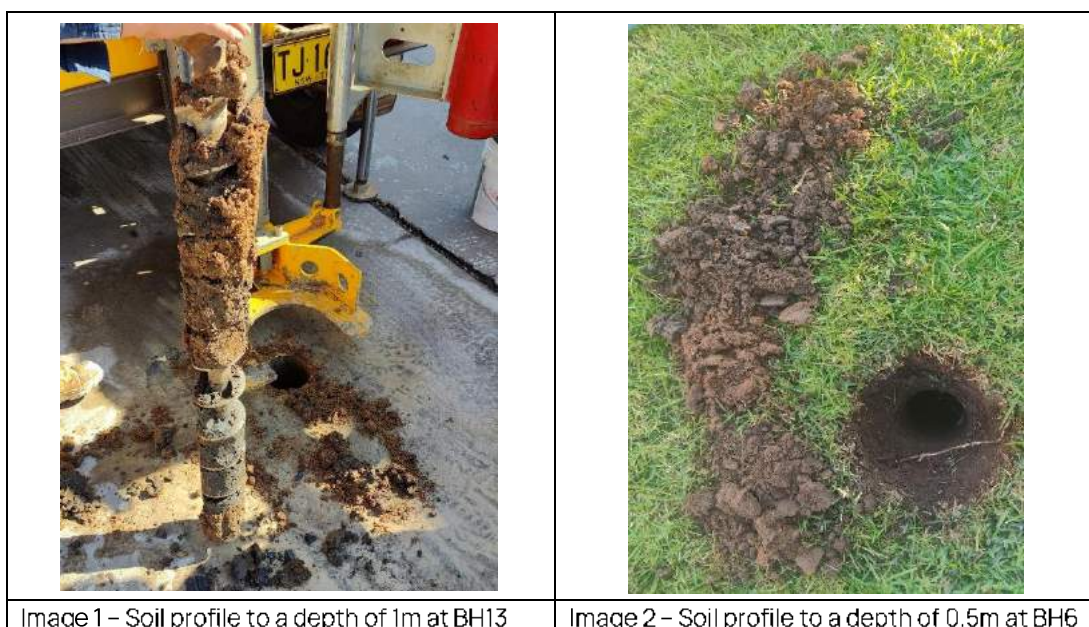
The southern carpark area was underlain with sand beneath the concrete slab, which extended down to brown clay and gravelly clay, and included significant asphalt inclusions at BH-12 to a depth of 1.3m. No ACM was identified in any of the 10L sieve samples. No odours were noted at any sample locations and no staining was observed.

Image 1 – Soil profile to a depth of 1m at BH13

Image 2 – Soil profile to a depth of 0.5m at BH6

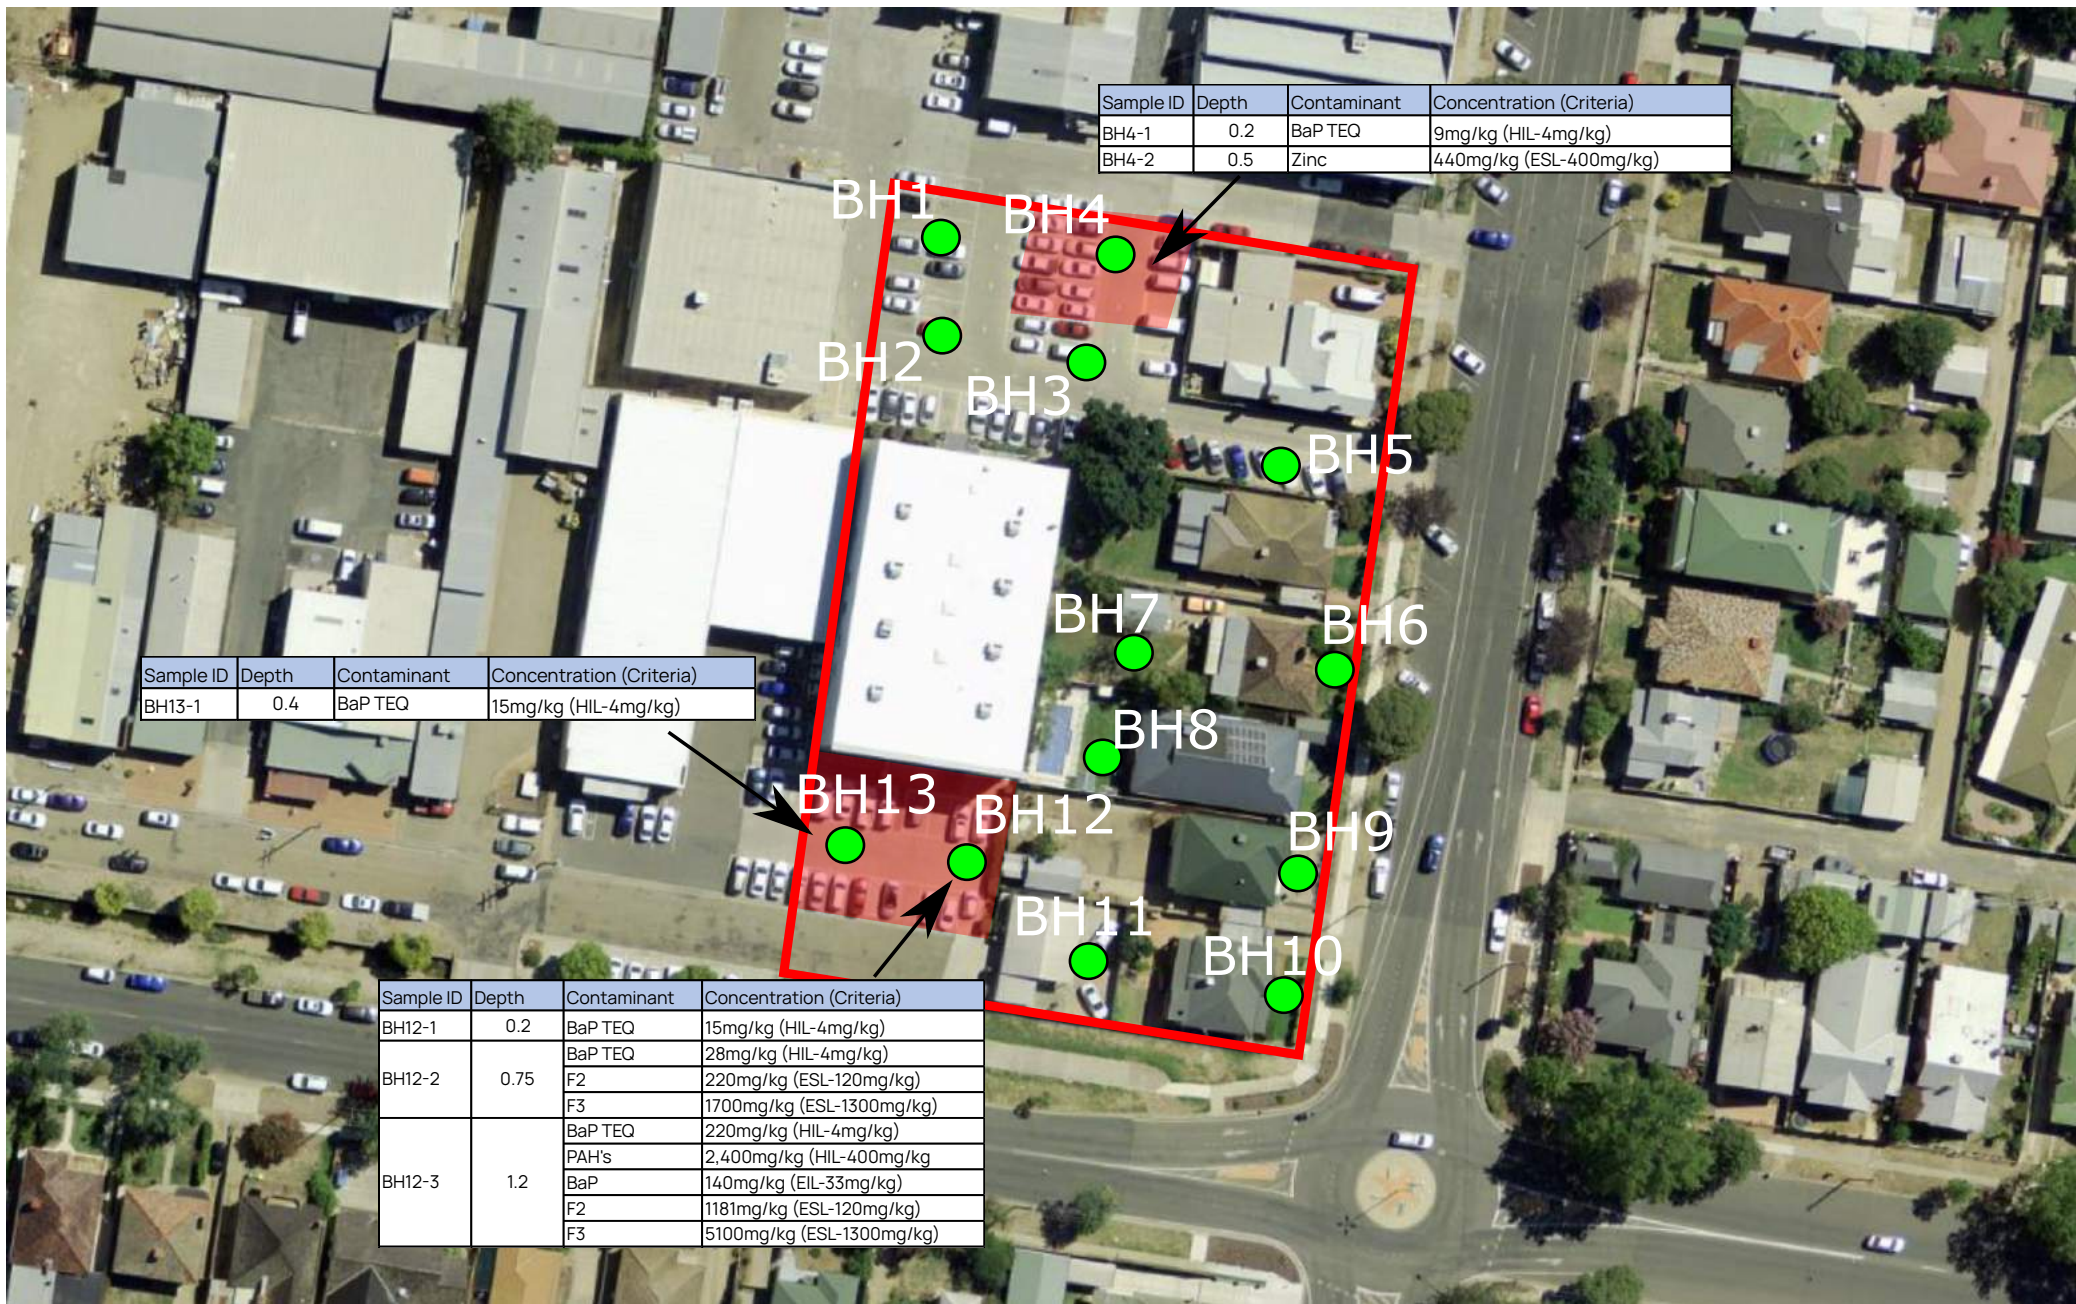
Figure 2 – Site Sampling Layout

Sample ID	Depth	Contaminant	Concentration (Criteria)
BH4-1	0.2	BaP TEQ	9mg/kg (HIL-4mg/kg)
BH4-2	0.5	Zinc	440mg/kg (ESL-400mg/kg)

Sample ID	Depth	Contaminant	Concentration (Criteria)
BH13-1	0.4	BaP TEQ	15mg/kg (HIL-4mg/kg)
