CH1440-D230311

Re: Addendum to DSI – 66-82 Murray Street and 185 Morgan Street, Wagga Wagga, NSW

1.0 Introduction

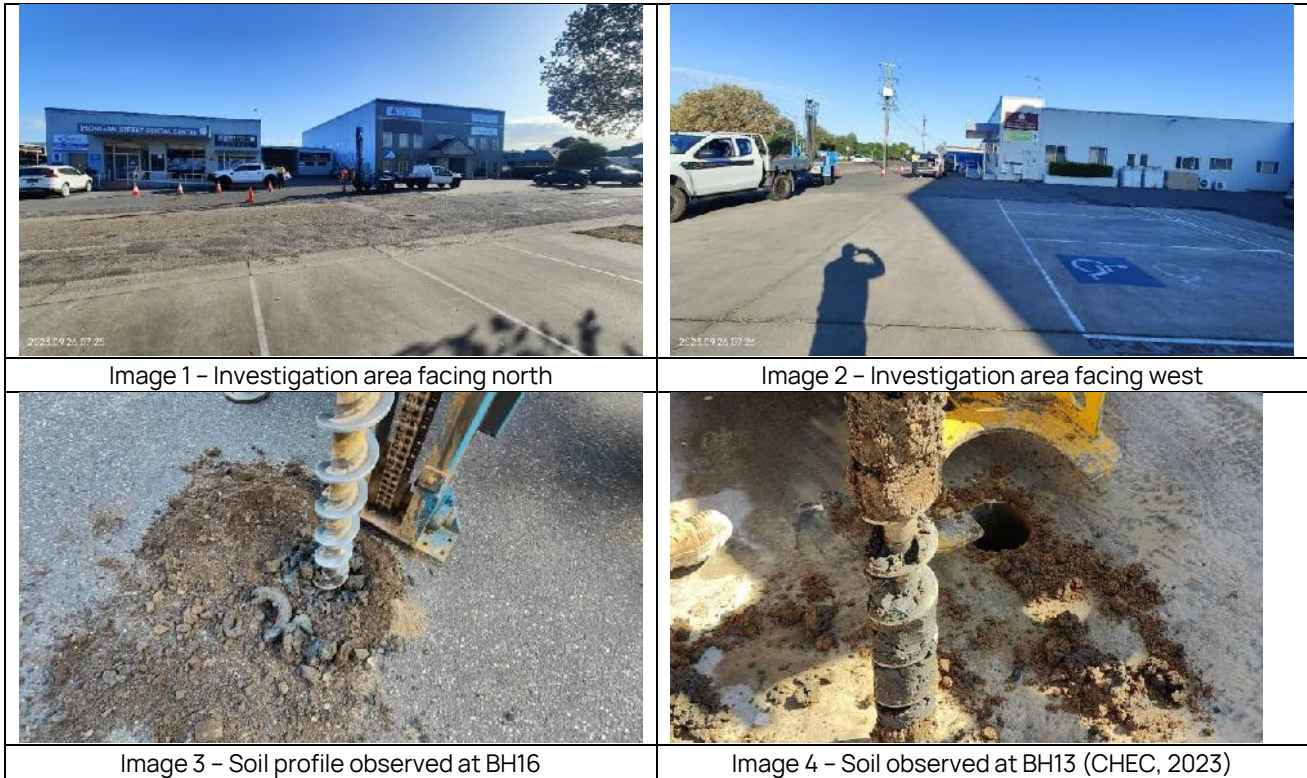
The observed soil profile consisted of a dark brown silty sandy clay fill to a depth ranging between 0.7-1.2m. A thin layer of brick was encountered at a depth of 0.9-1.0m in BH14. BH16 contained minor inclusions of crushed pipe overlying natural clays at a depth of 1.0-1.2m. A natural black organic / grey silty clay was noted to underlay the fill at all locations, which was consistent with the previous investigation in the adjacent area. No observed soils exhibited any sign of gross contamination such as odours or staining.

A 10L soil sample was passed through a 7mm sieve at each location, with material retained in the sieve thoroughly inspected for the presence of ACM. Aside from the inclusions of brick and tile, other materials to be retained on the sieve included rounded to sub-angular gravels. No ACM or material suspected as ACM was identified.

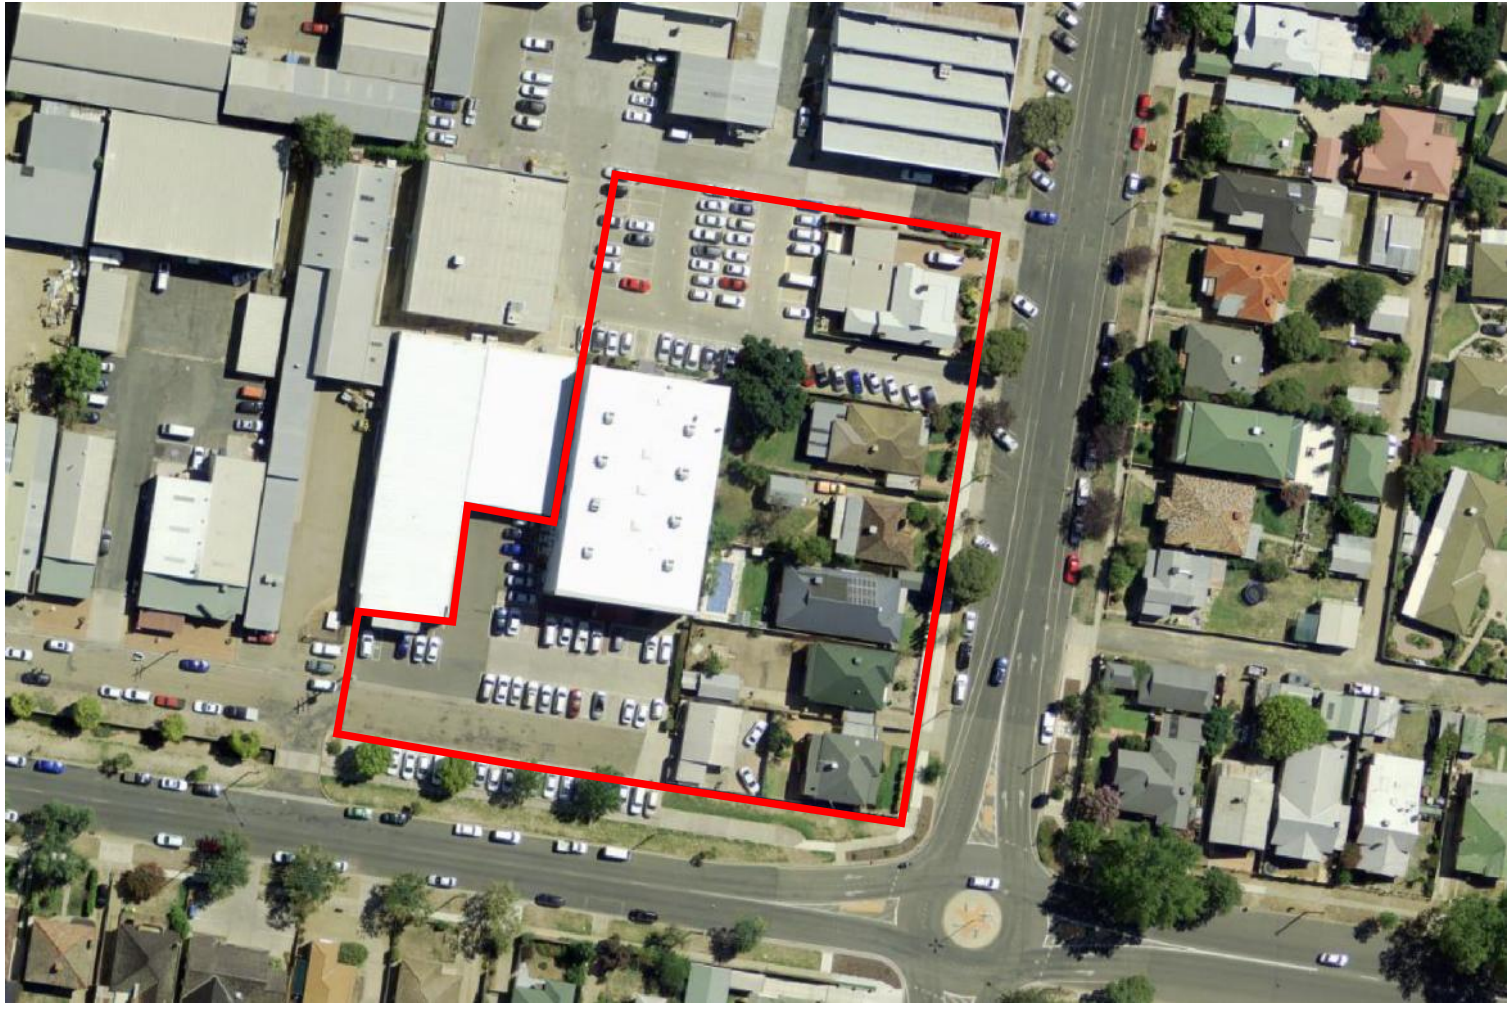
Figure 2 - Sampling Layout

The investigation covered an additional area of approximately 1,000m² and is identified in **Figure 2** – Sampling Layout. The area consisted of concrete covered car park to the west of the previous instigation of the southern car park area.
