# Nowra Build to Rent

Geotechnical Investigation Report

29 February 2024

304001019-GI-R001

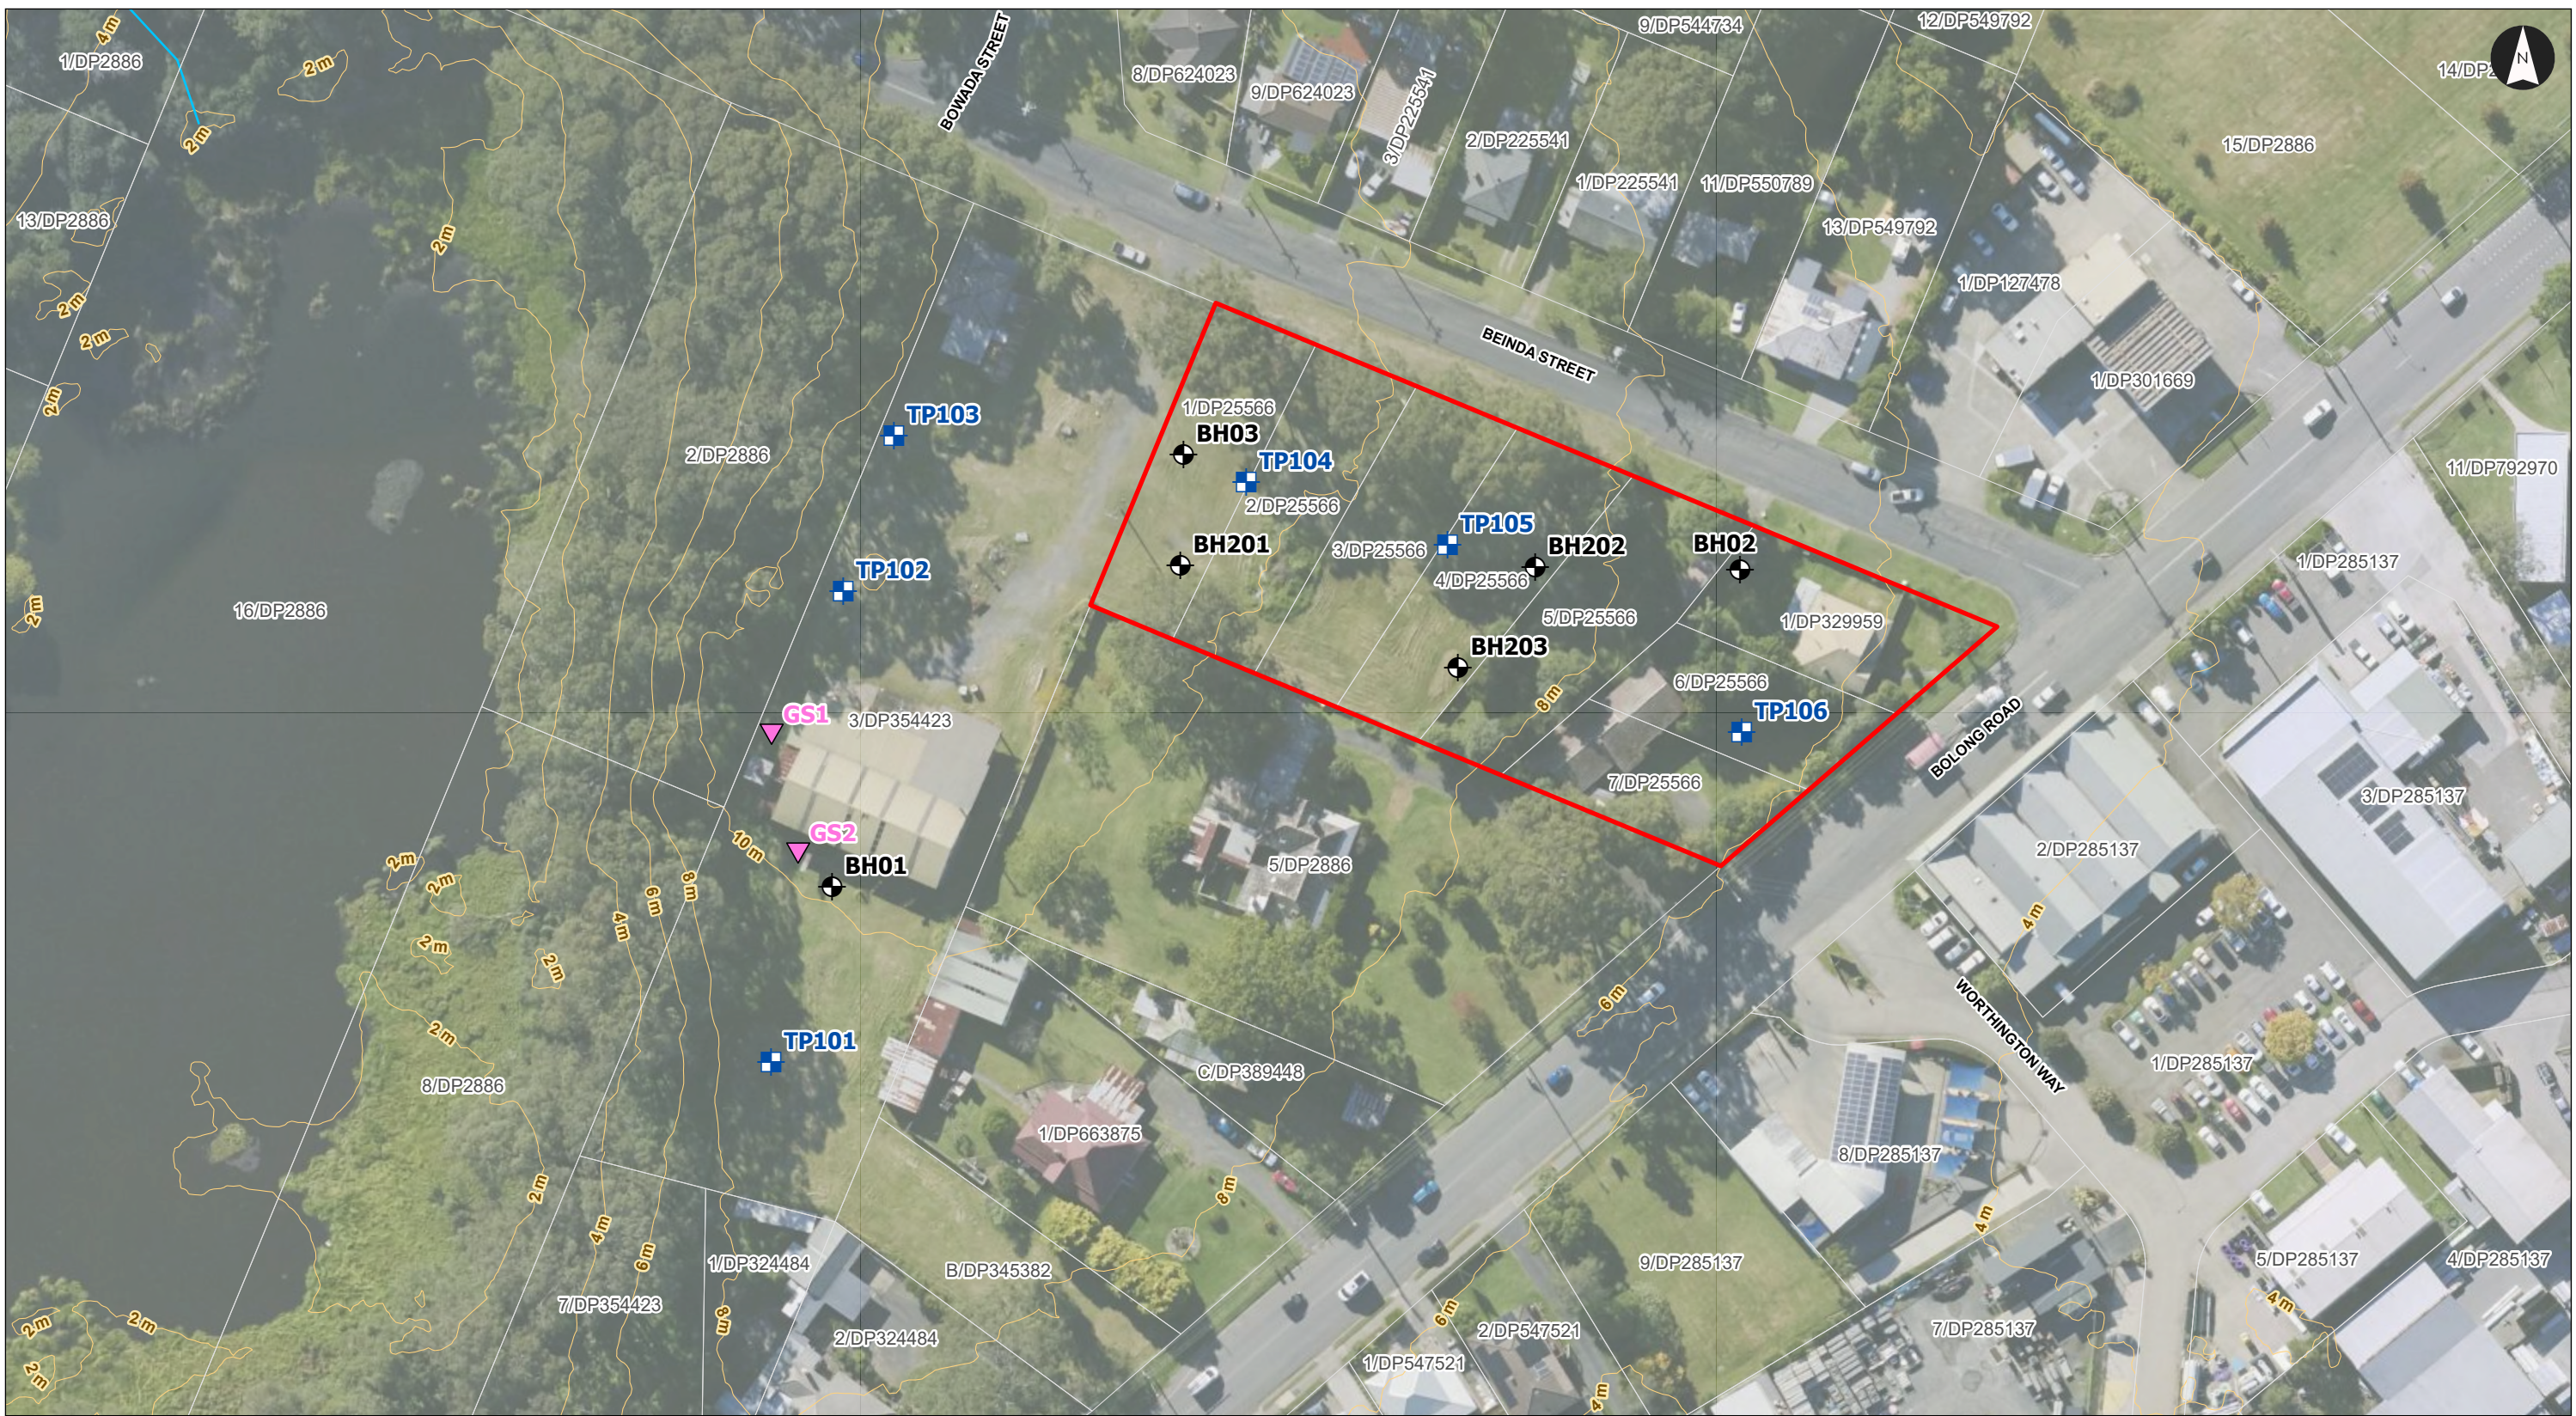
Site Plan

Build to Rent (BtR), South Coast  
Bomaderry, NSW

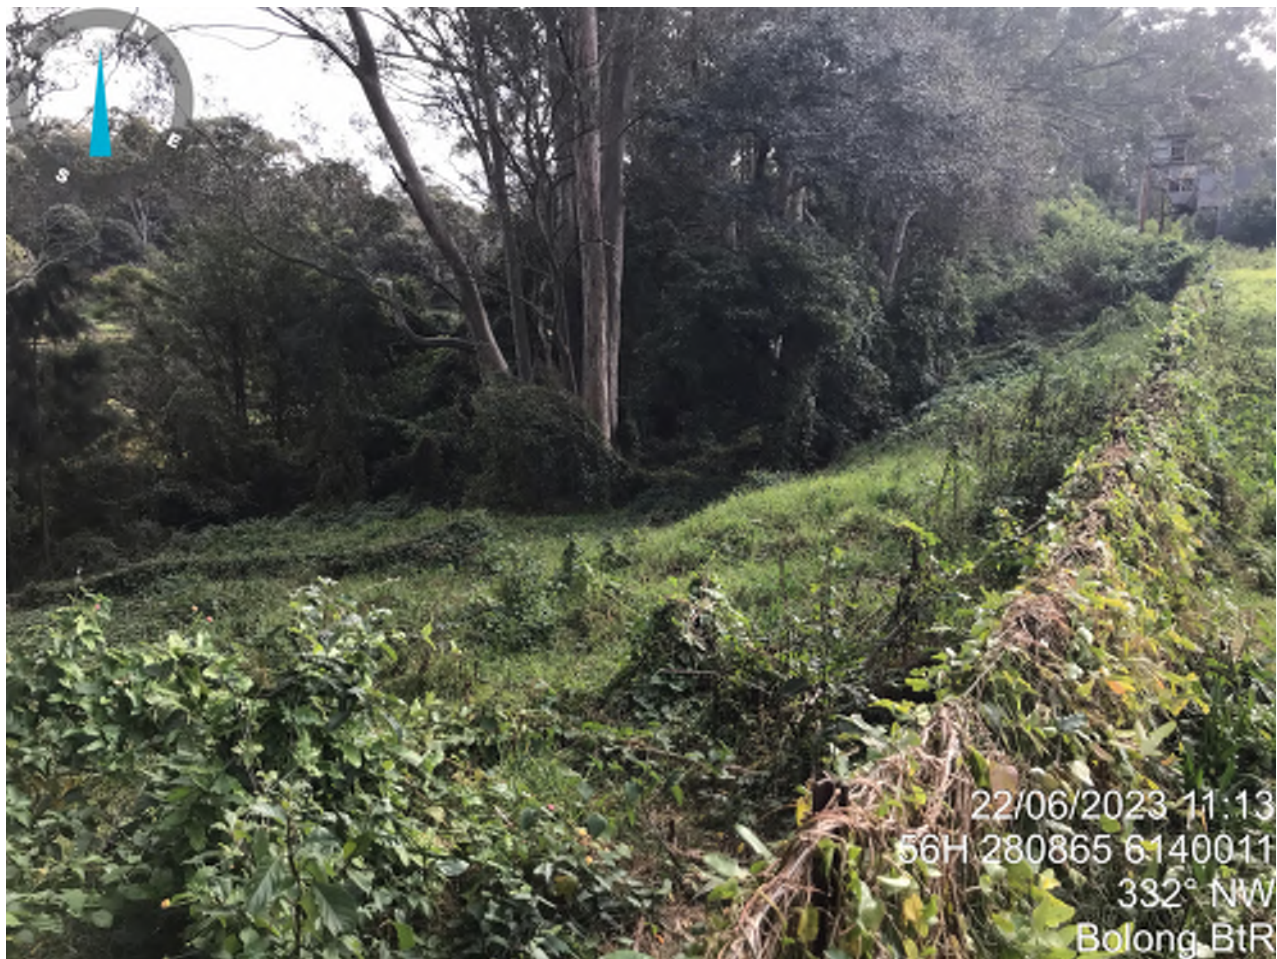
PHOTO P1 - WESTERN SLOPE BANK SLOPING AT ~20 DEGREES

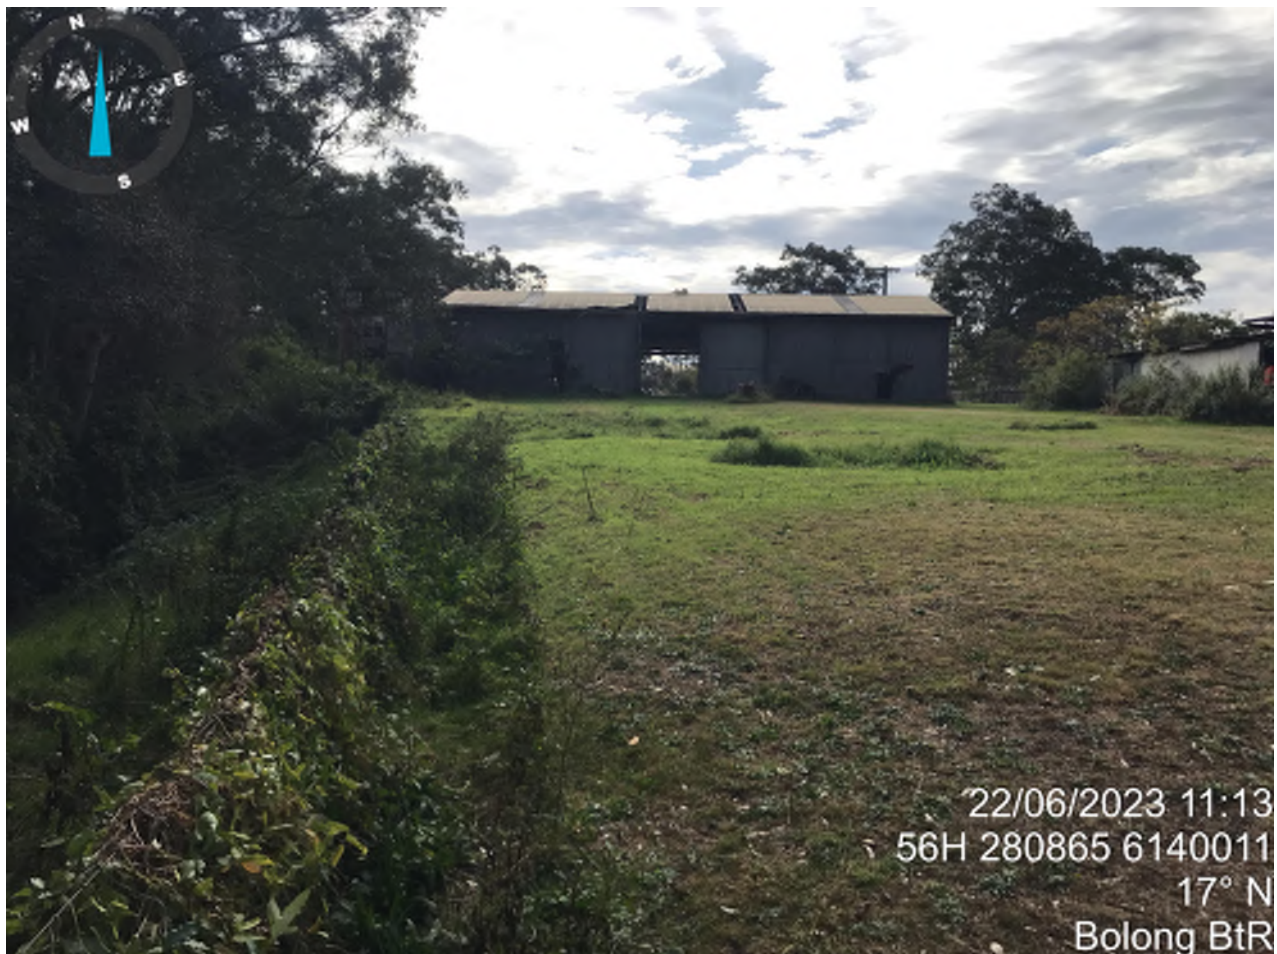
PHOTO P2 - IRREGULAR HUMMOCKY SURFACE INDICATING PRESENCE OF FILL

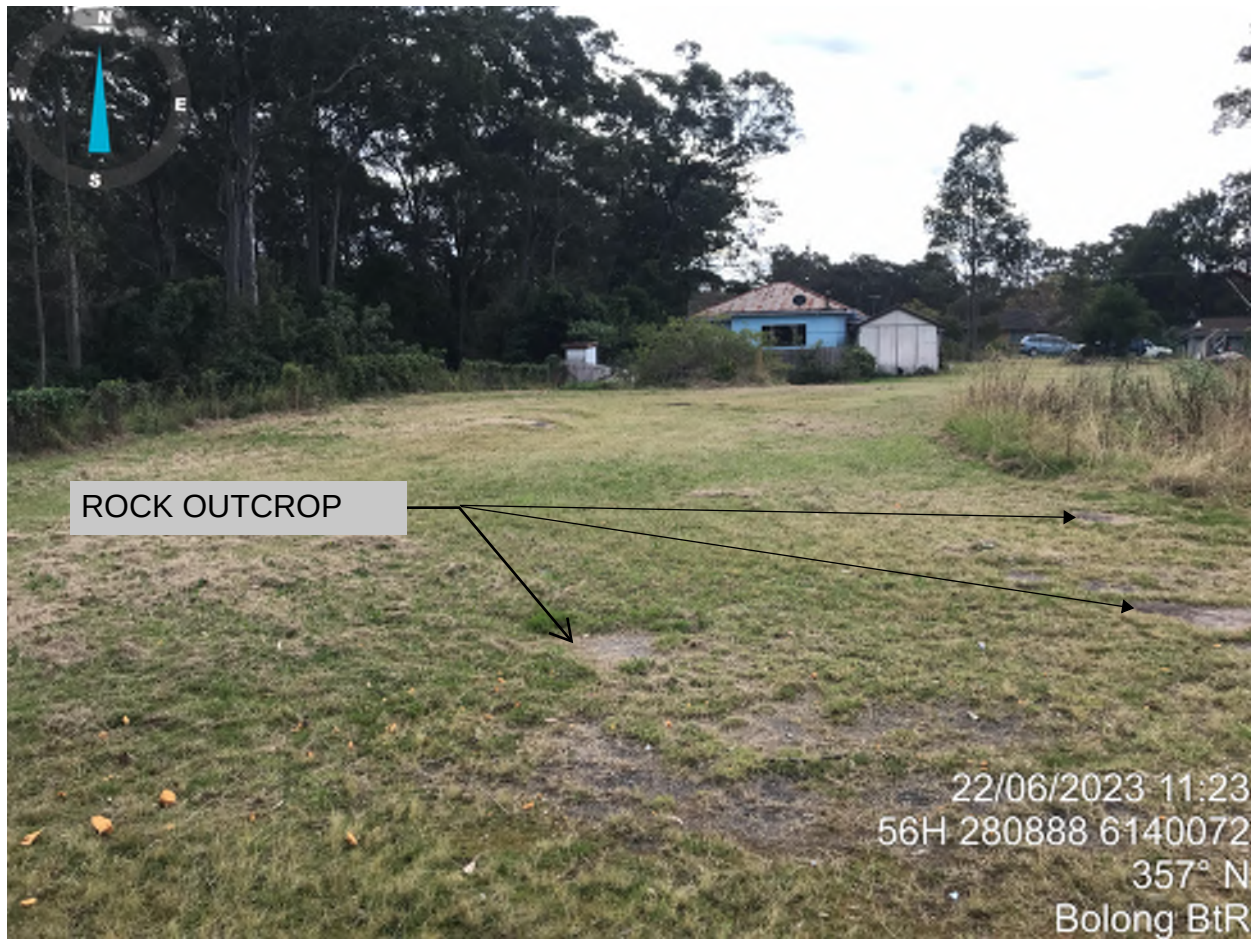
PHOTO P3 - WESTERN BOUNDARY LOOKING NORTH WITH ROCK OUTCROP

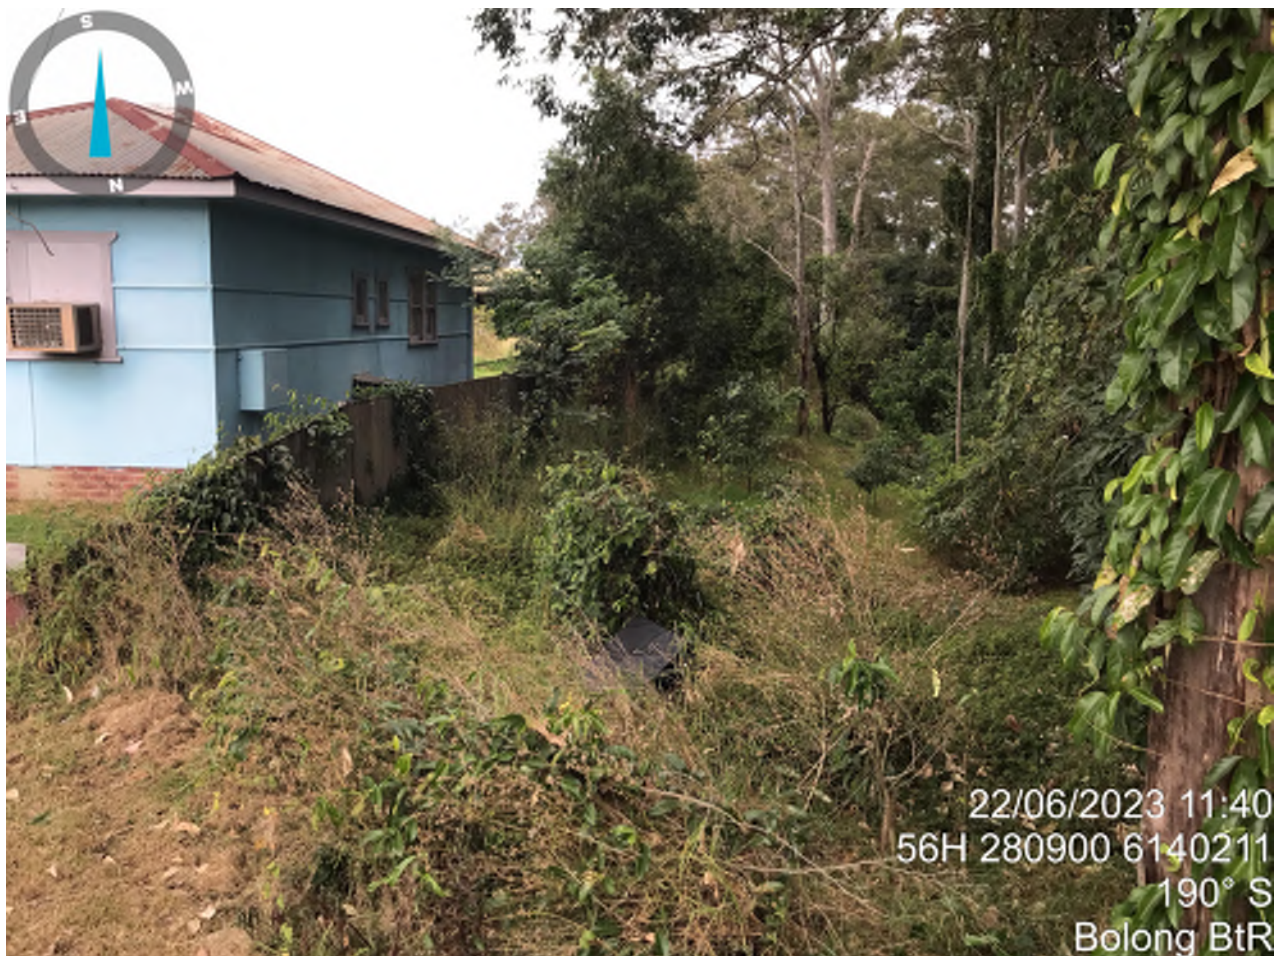
PHOTO P4 - WESTERN BOUNDARY BANK SLOPING AT ~10 DEGREES

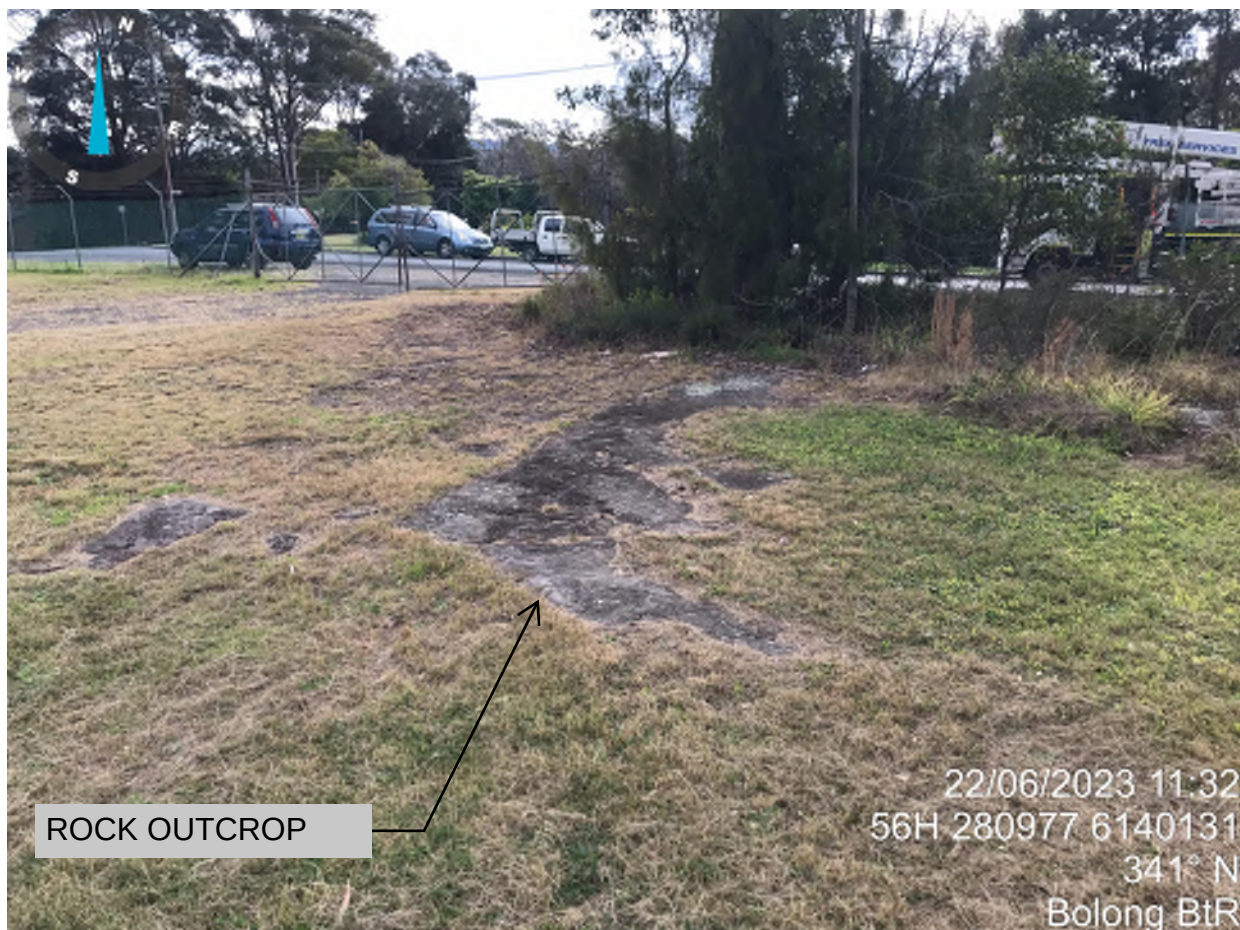
PHOTO P7 - ROCK OUTCROP ALONG NORTHERN BOUNDARY ADJACENT TO BEINDA STREET ENTRANCE

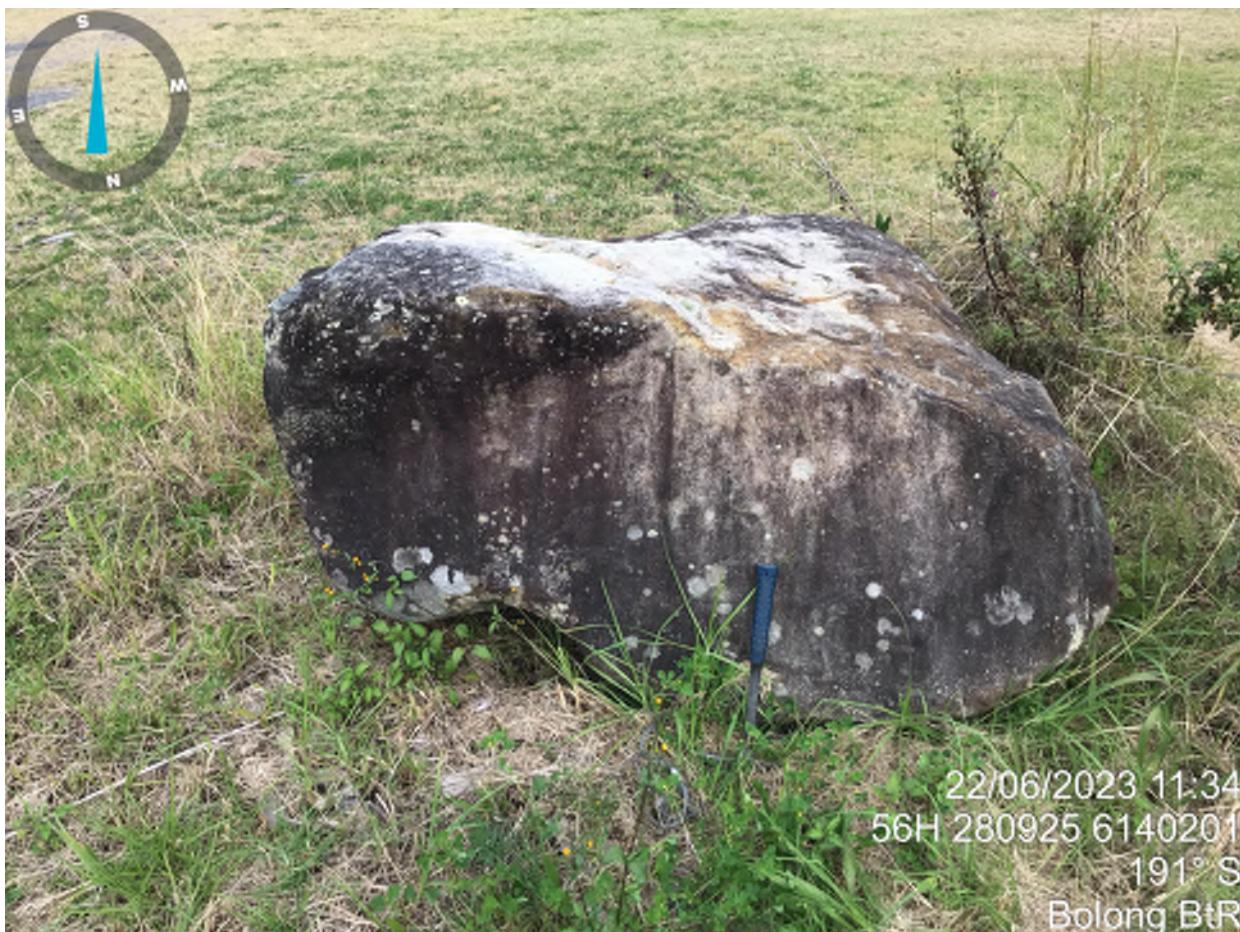
PHOTO P8 - ROCK FILL FLOATER OF HIGHLY TO MODERATLY WEATHERED SANDSTONE MEDIUM TO HIGH STRENGTH

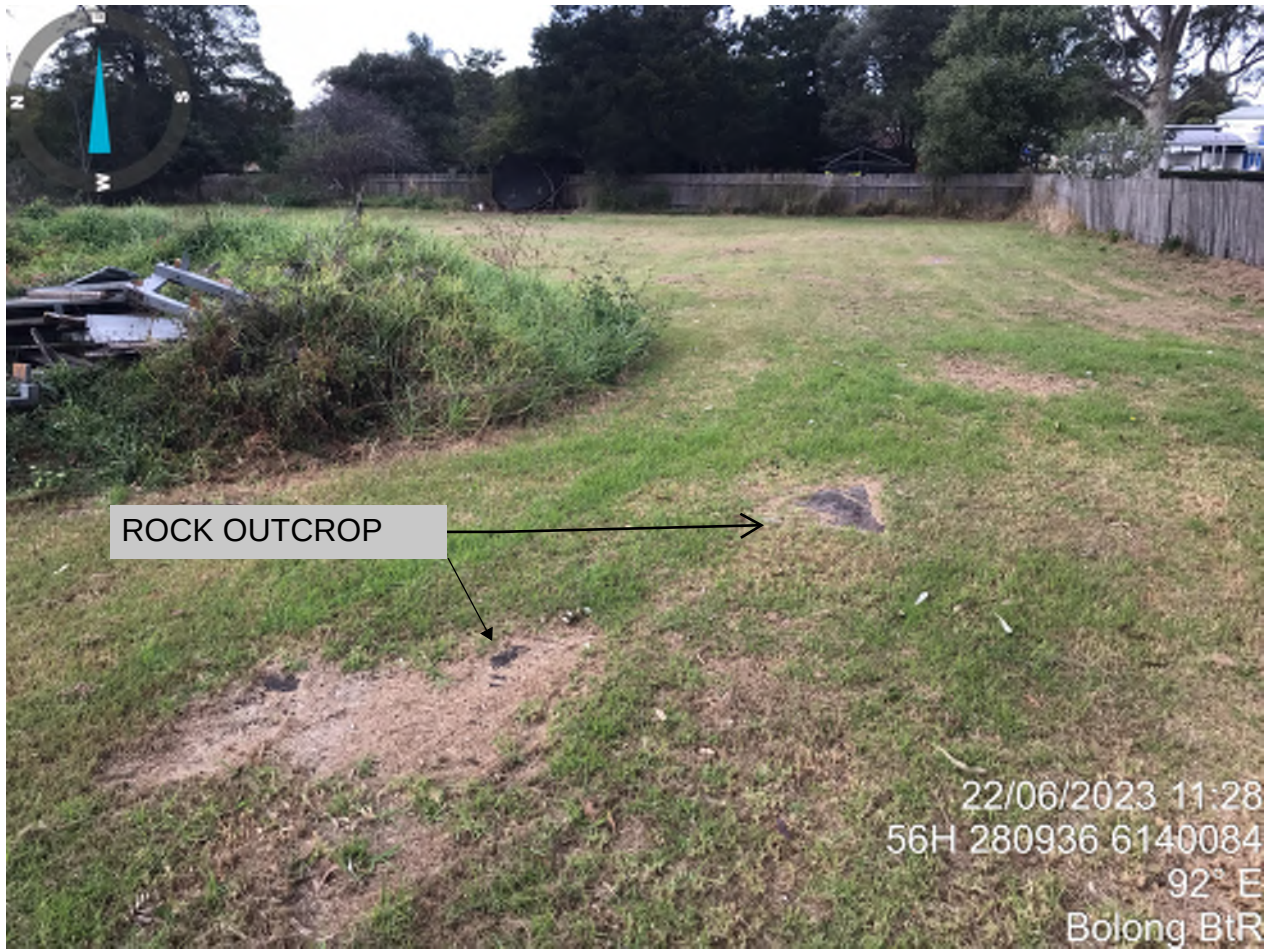
PHOTO P9 - ALONG INTERNAL BOUNDARY LOOKING EAST TOWARDS BELINDA WITH ROCK OUTCROP

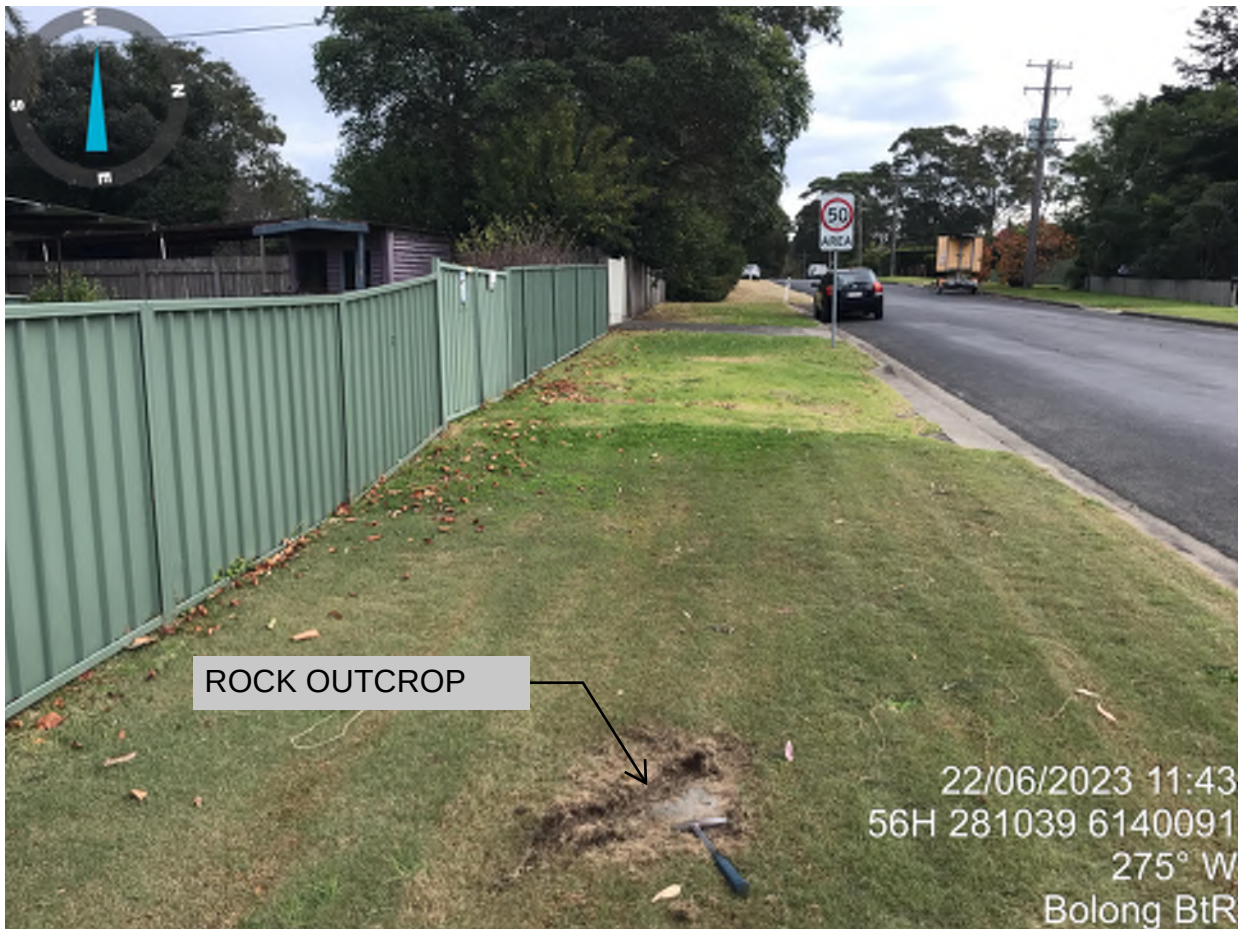
PHOTO P10 - ROCK OUTCROP IN NATURE STRIP ADJACENT TO CORNER INTERSECTION WITH BELINDA STREET

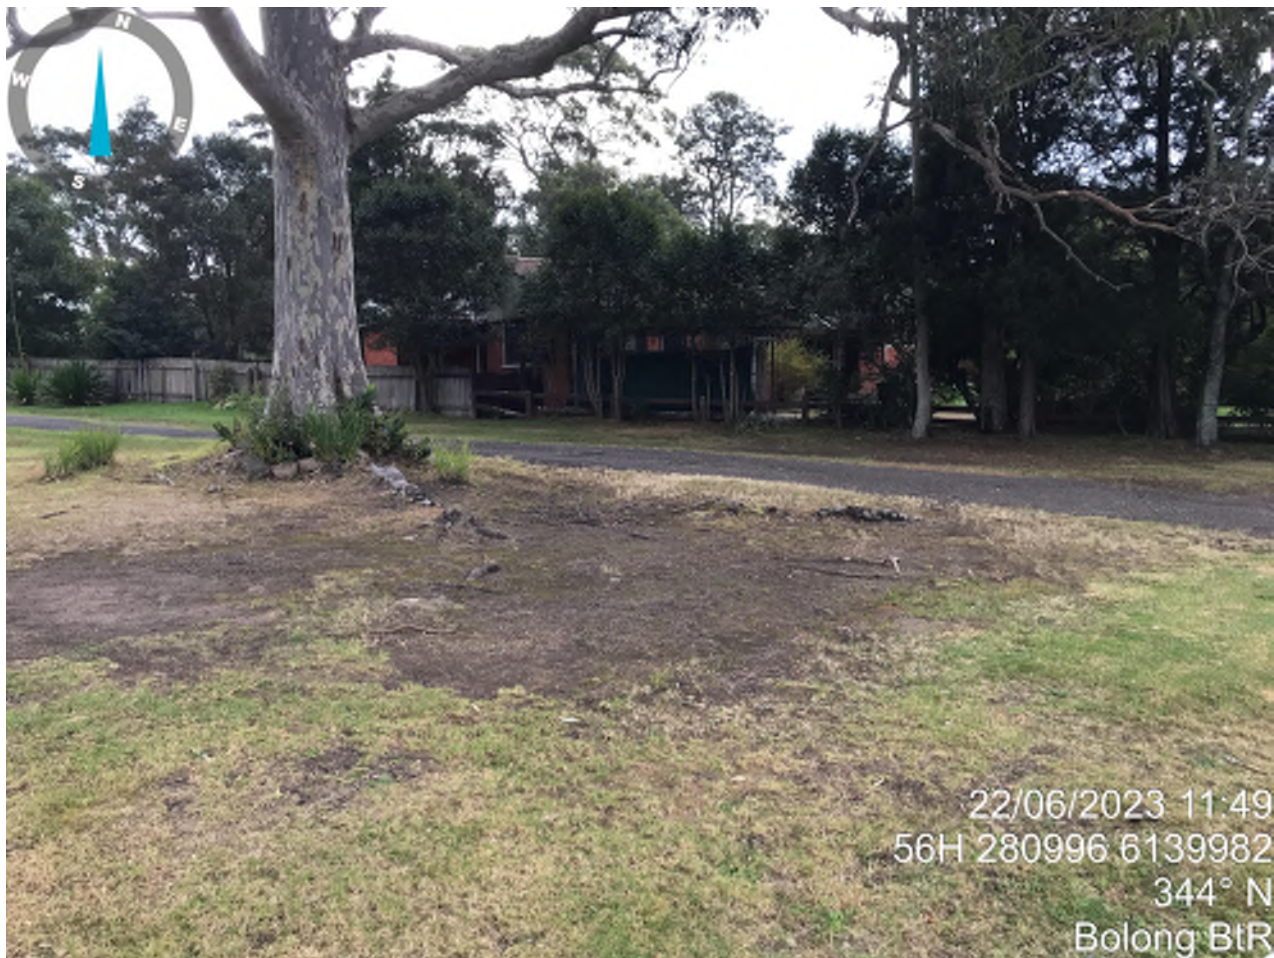
PHOTO P11 - LOOKING TOWARDS INTERNAL BOUNDARY FROM BELINDA STREET WITH INFERRED ROCK OUTCROP

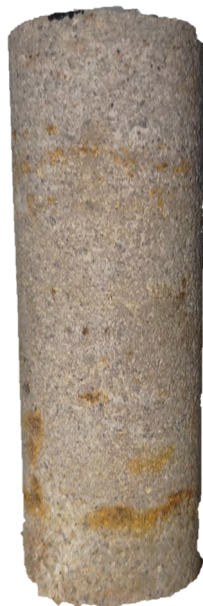
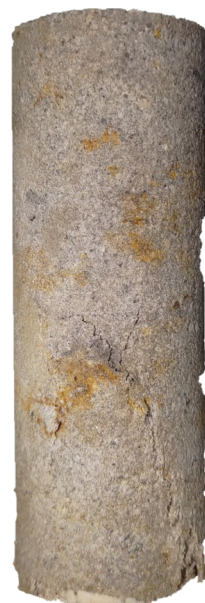
| <b>UCS (Mpa)</b> | <b>31</b> | Moisture Content (%) | 2.9 |

Specimen - Before Testing

Specimen - After Testing

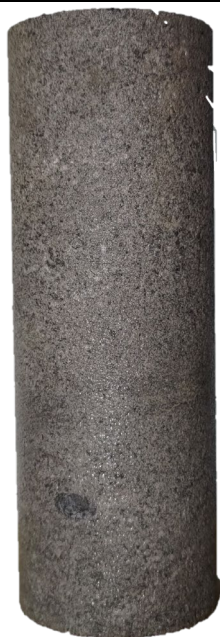
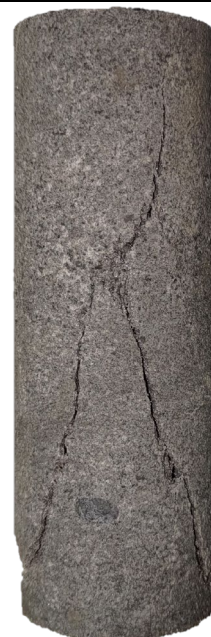
| <b>UCS (Mpa)</b> | <b>54.1</b> | Moisture Content (%) | 3.8 |

Specimen - Before Testing

Specimen - After Testing

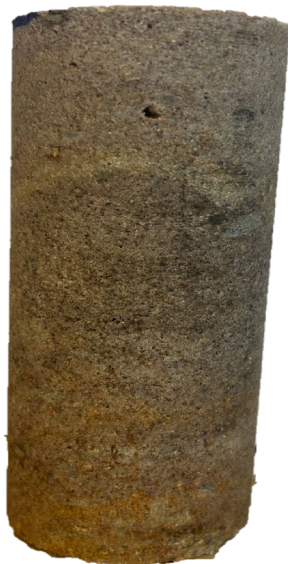
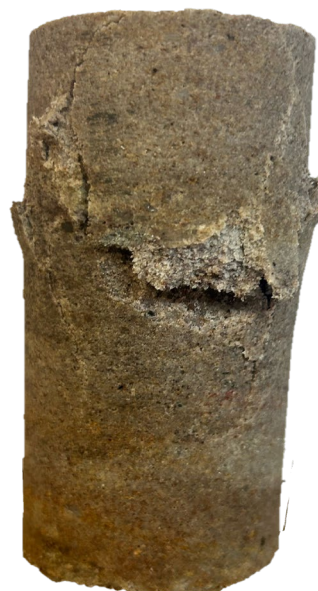
| UCS (Mpa) | <b>34</b> | Moisture Content (%) | 2.9 |

Specimen - Before Testing

Specimen - After Testing

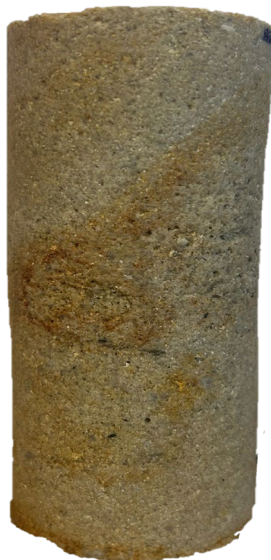
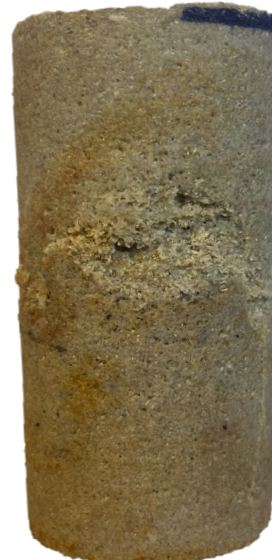
| UCS (Mpa) | <b>20</b> | | |

Specimen - Before Testing

Specimen - After Testing

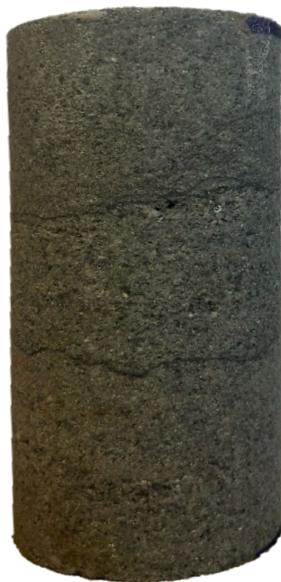
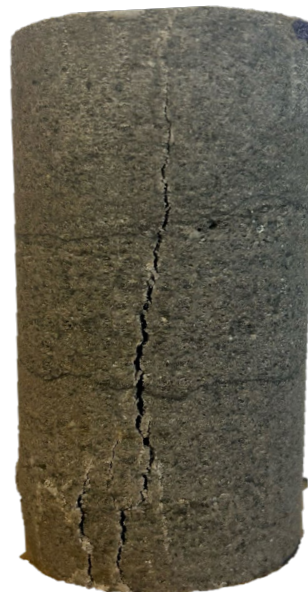
| UCS (Mpa) | <b>42</b> | Moisture Content (%) | 3.7 |

Specimen - Before Testing

Specimen - After Testing
