## Geotechnical Investigation

2 Colo Street, Mittagong NSW

**Report Title:** Geotechnical Investigation, 2 Colo Street, Mittagong NSW  
**Report No:** E25829.G03\_Rev1

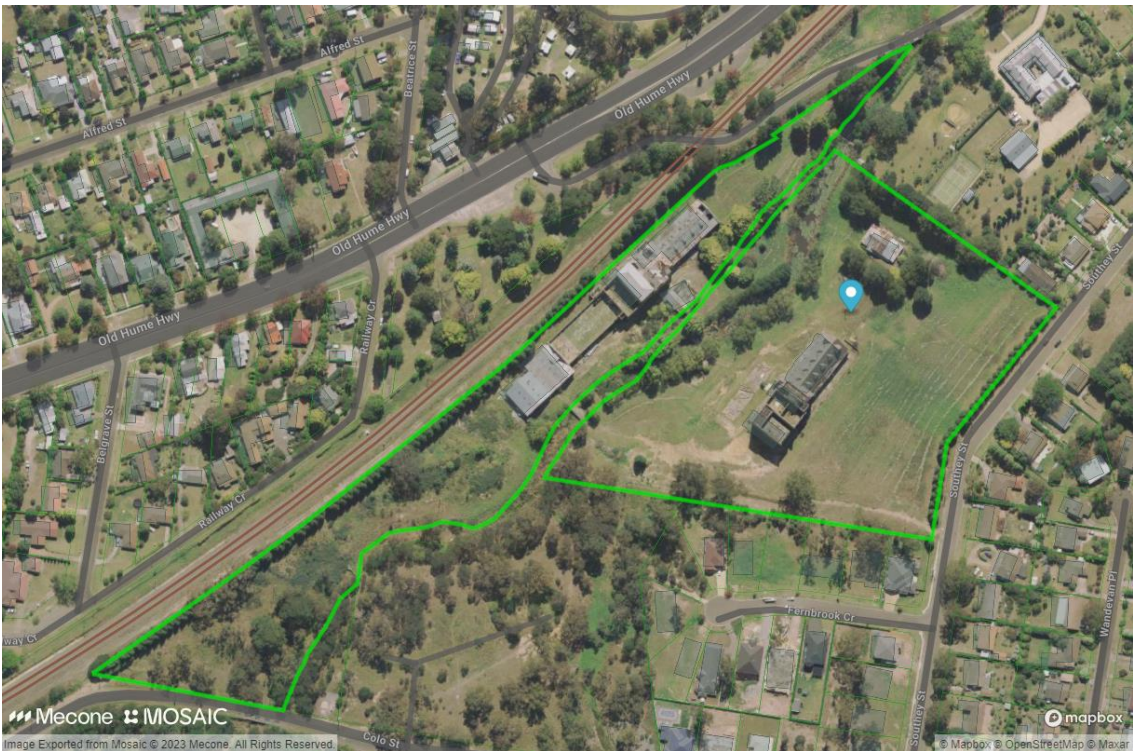
**Plate 1:** Aerial photograph of the site.

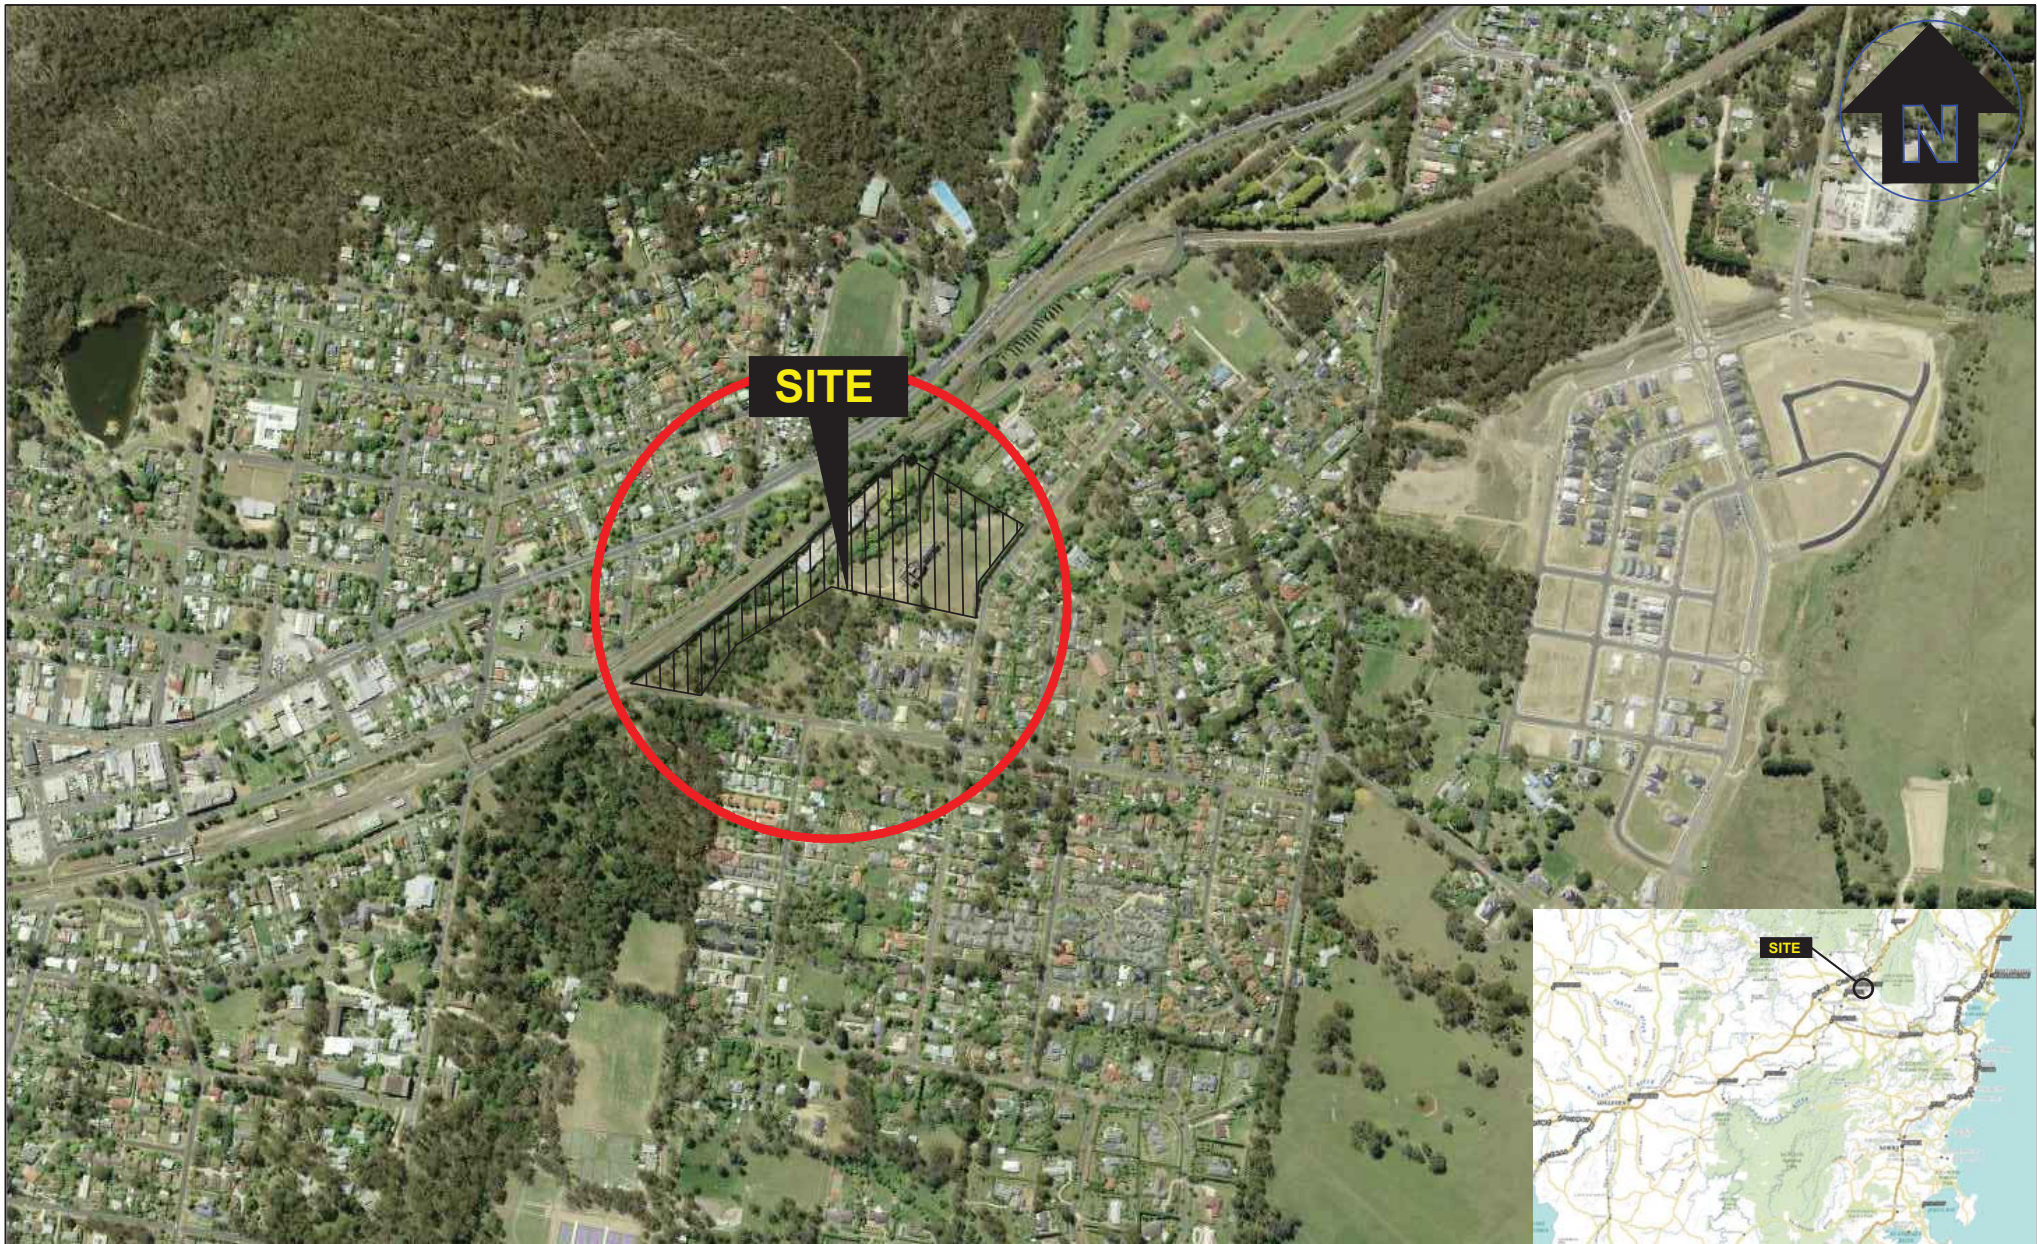
| Figure 2 | Borehole Location Plan |

- The approximate surface levels shown on the borehole and test pit logs were measured using a hand-held GPS. Approximate borehole and test pit locations are shown on **Figure 2**;

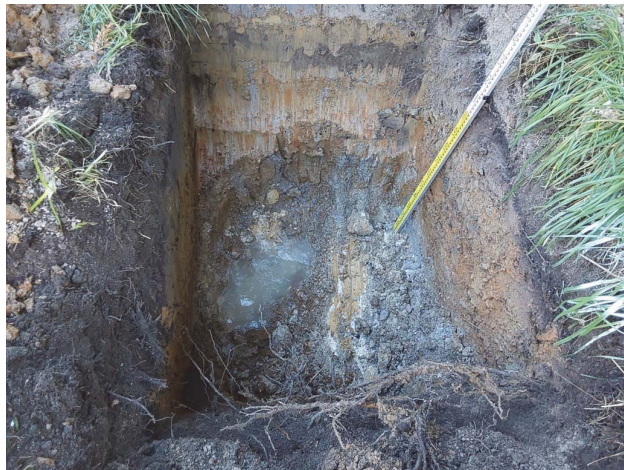
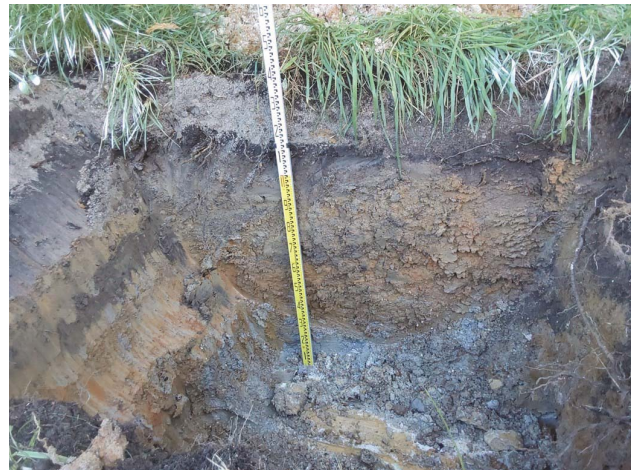
TP ID: TP1

## Photographs

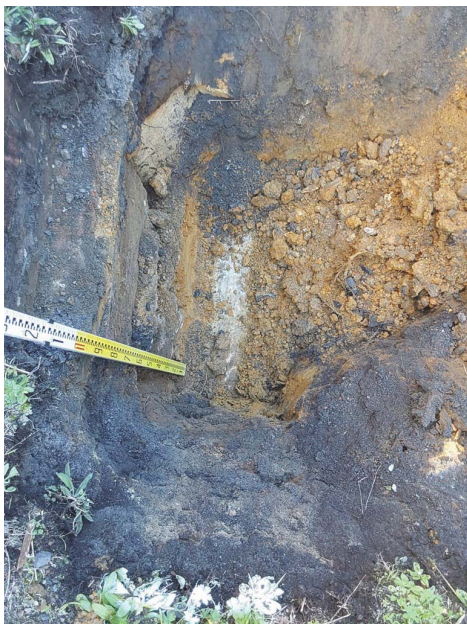
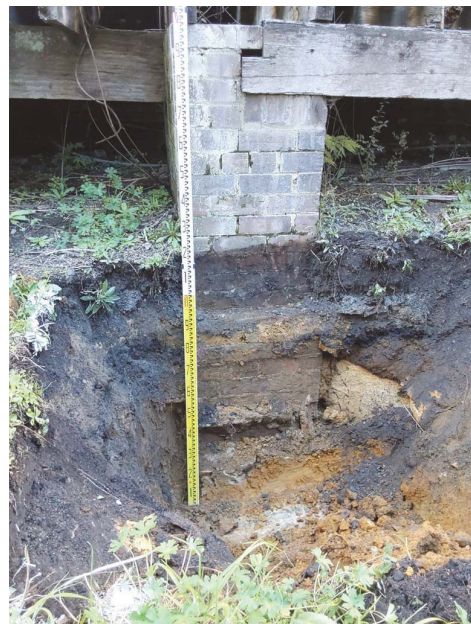
TP ID: TP3

## Photographs

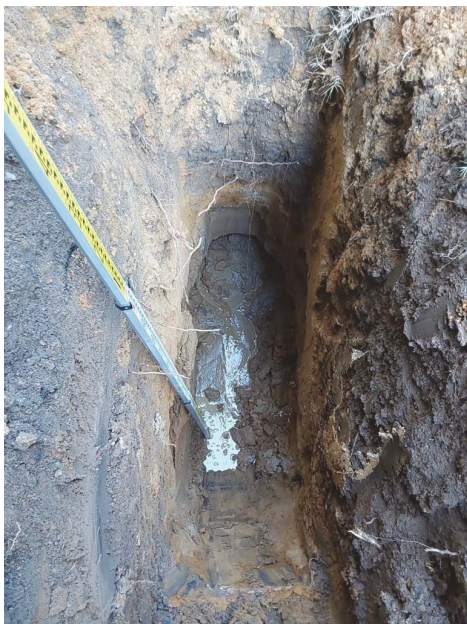
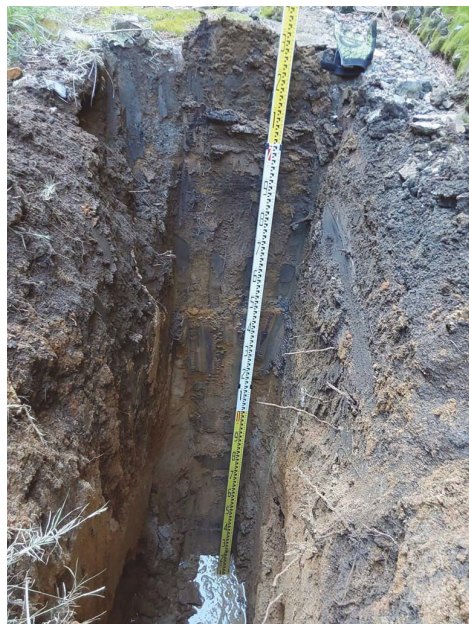
TP ID: TP4

## Photographs

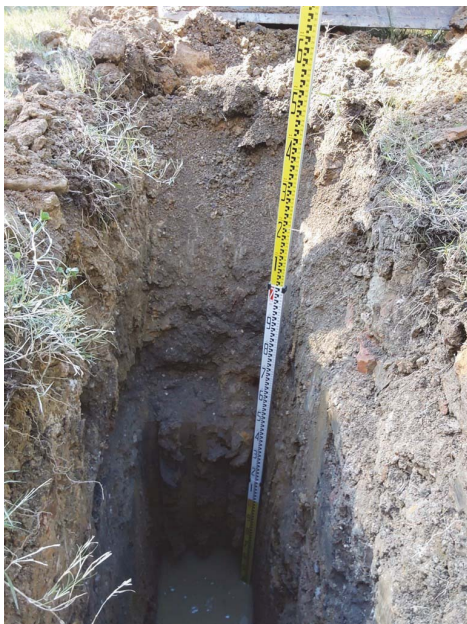
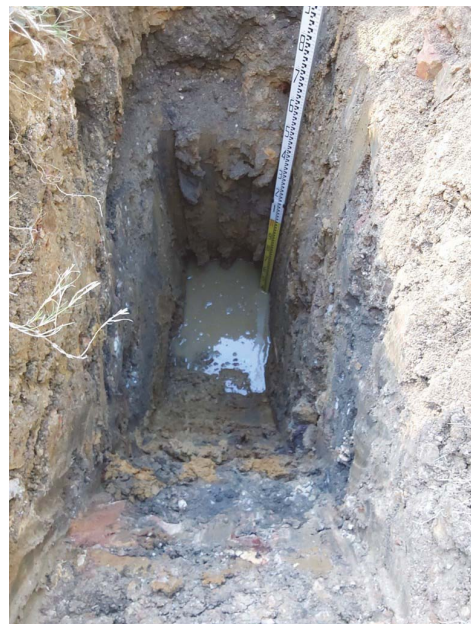
TP ID: TP5

| METHOD | GROUND WATER LEVELS | SAMPLES & FIELD TESTS | SAMPLE RECOVERY | DEPTH (m) | GRAPHIC LOG | RL (m AHD) | MATERIAL DESCRIPTION | MOISTURE CONDITION | CONSISTENCY / REL. DENSITY | DCP BLOWS | MATERIAL ORIGIN & OBSERVATIONS |
|---|---|---|---|---|---|---|---|---|---|---|---|
| | | | | 3.00 | | 621.40 | Terminated at 3.10m. Refusal on bedrock. | | | 15 | |

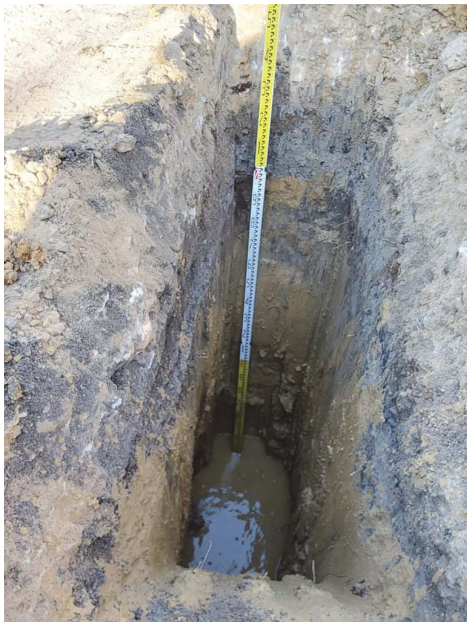
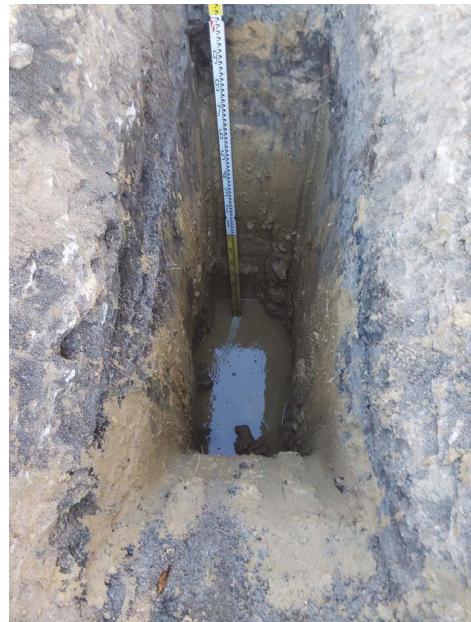
TP ID: TP8

| METHOD | GROUND WATER LEVELS | SAMPLES & FIELD TESTS | SAMPLE RECOVERY | DEPTH (m) | GRAPHIC LOG | RL (m AHD) | MATERIAL DESCRIPTION | MOISTURE CONDITION | CONSISTENCY / REL. DENSITY | DCP BLOWS | MATERIAL ORIGIN & OBSERVATIONS |
|---|---|---|---|---|---|---|---|---|---|---|---|
| | | | | 3.00 | | 623.65 | Terminated at 3.05m. Refusal on bedrock. | | | | |

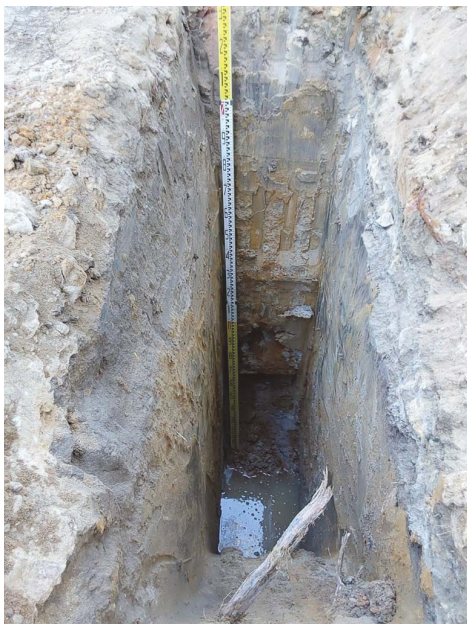
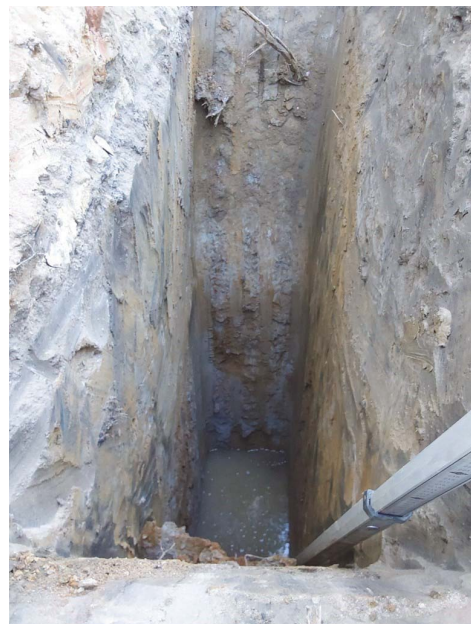
TP ID: TP10

| METHOD | GROUND WATER LEVELS | SAMPLES & FIELD TESTS | SAMPLE RECOVERY | DEPTH (m) | GRAPHIC LOG | RL (m AHD) | MATERIAL DESCRIPTION | MOISTURE CONDITION | CONSISTENCY / REL. DENSITY | DCP BLOWS | MATERIAL ORIGIN & OBSERVATIONS |
|---|---|---|---|---|---|---|---|---|---|---|---|
| | | TP 10_2.50-2.60 | | 3.00 | | 623.77 | Terminated at 3.13m. Target depth reached. | | | 15/30mm | |

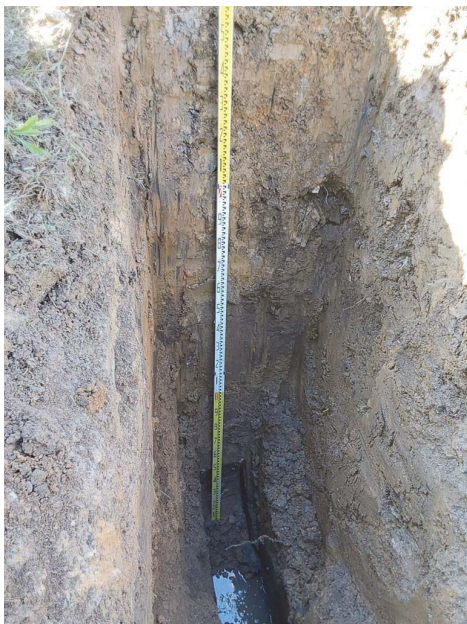
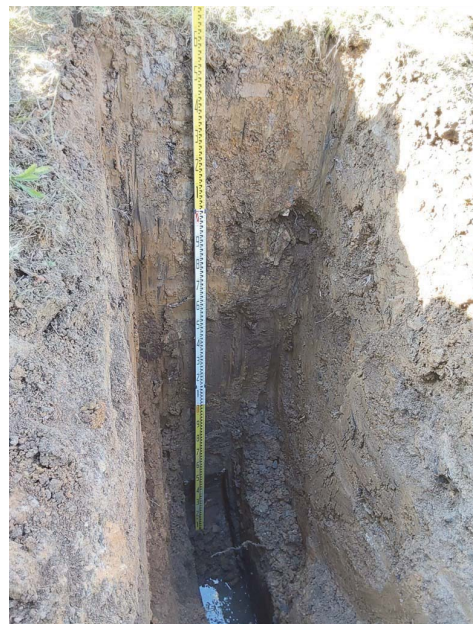
TP ID: TP17

| METHOD | GROUND WATER LEVELS | SAMPLES & FIELD TESTS | SAMPLE RECOVERY | DEPTH (m) | GRAPHIC LOG | RL (m AHD) | MATERIAL DESCRIPTION | MOISTURE CONDITION | CONSISTENCY / REL. DENSITY | DCP BLOWS | MATERIAL ORIGIN & OBSERVATIONS |
|---|---|---|---|---|---|---|---|---|---|---|---|
| | | TP 17_2.50-2.60 | | 3.43 | | 621.57 | Terminated at 3.43m. Refusal on bedrock. | M > PL | F | | |

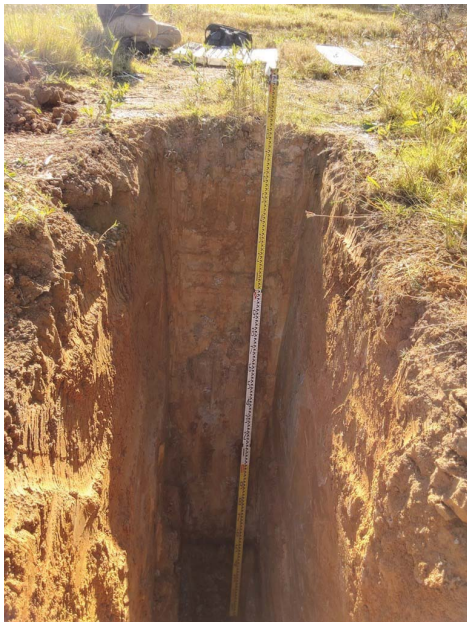
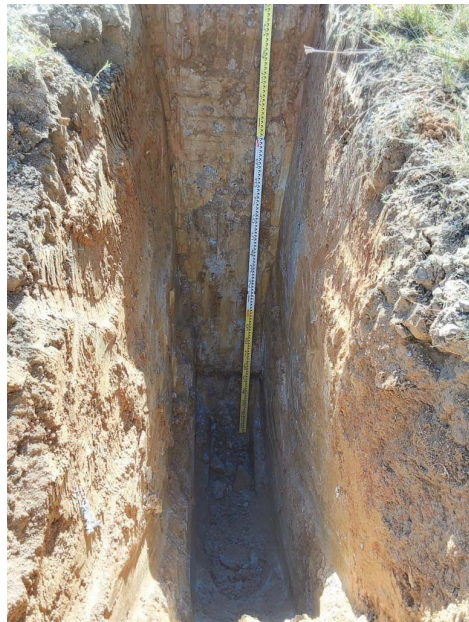
TP ID: TP18

| METHOD | GROUND WATER LEVELS | SAMPLES & FIELD TESTS | SAMPLE RECOVERY | DEPTH (m) | GRAPHIC LOG | RL (m AHD) | MATERIAL DESCRIPTION | MOISTURE CONDITION | CONSISTENCY / REL. DENSITY | DCP BLOWS | MATERIAL ORIGIN & OBSERVATIONS |
|---|---|---|---|---|---|---|---|---|---|---|---|
| | | | | 8.00 | | 621.90 | Terminated at 3.10m. Refusal on bedrock. | | | 22 | |
