**PROPOSED RESIDENCE
217A BEACH ROAD, DENHAMS BEACH, NSW**

PRELIMINARY ENVIRONMENTAL ASSESSMENT REPORT

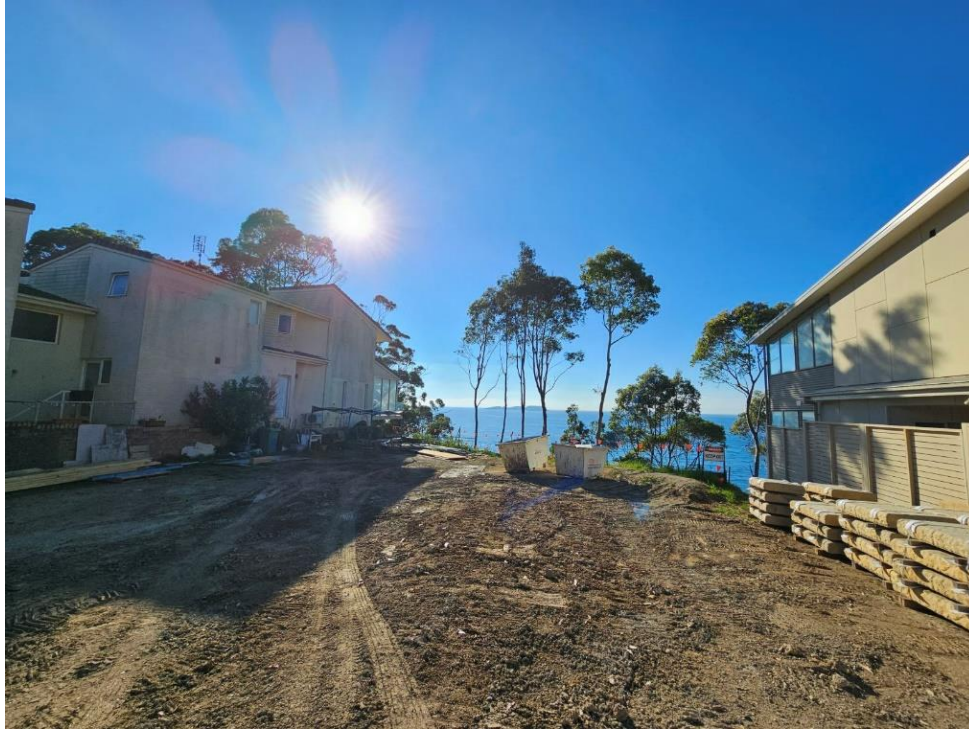
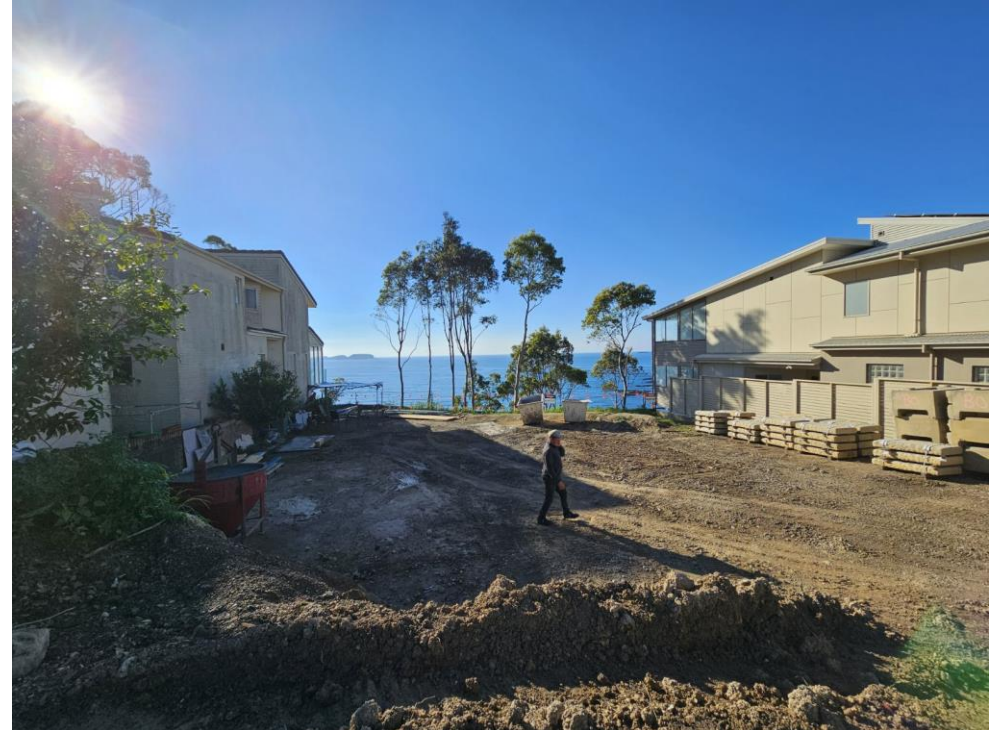
ADHAMI PENDER ARCHITECTURE
PROPOSED RESIDENCE – 217A BEACH ROAD, DENHAMS BEACH, NSW
SITE PHOTOGRAPHS FROM RE-INSPECTION ON 25 MARCH 2024

- The development site is vacant, and is no longer being used as storage for construction equipment/materials or as machinery access.
- The site had been stripped of all loose topsoil/fill material and any construction rubble, exposing the bare, natural soil below.
- No signs of gross contamination were present.

Upon re-inspection on 25 March 2024, all topsoil/fill and construction rubble had been stripped from the site and no signs of any gross contaminants were noted. No construction equipment was being stored on site. See attached site photos.
