Attn Katrena Fuller  
Re: DA0095/24 – 217A Beach Road Denhams Beach

I refer to our 7<sup>th</sup> August meeting with the Southern Regional Planning panel regarding the proposed dual occupancy at the above address and the request from the panel for additional information to be provided with respect to the works carried out on site to date. As we understand it, the panel has sought specific additional information as reproduced below:

**217 Beach Rd, Denhams Beach  
Cliff Stabilisation**

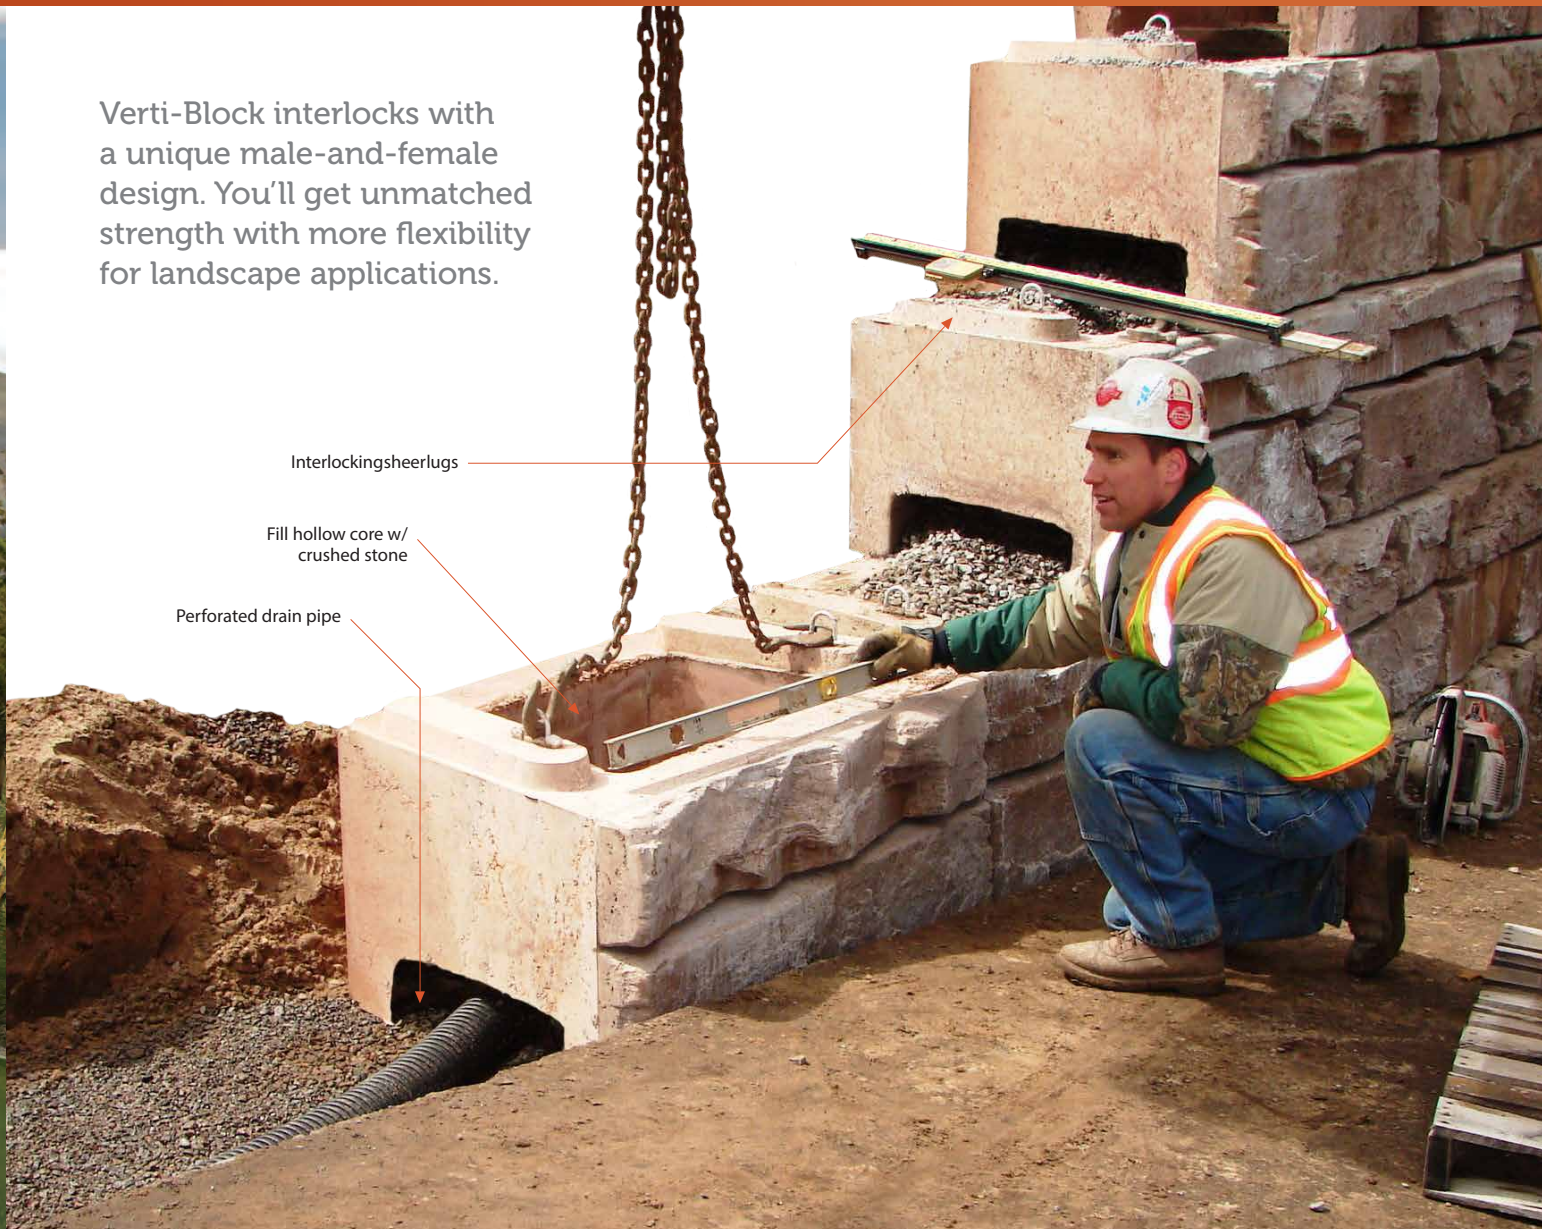
# Interlocking Verti-Blocks

Verti-Block interlocks with a unique male-and-female design. You'll get unmatched strength with more flexibility for landscape applications.

Even more appealing, Verti-Block is incredibly strong and versatile thanks to its interlocking design. Featuring a male-and-female style connection, Verti-Block units ensure you'll get a secure fit that guarantees the correct amount of setback on every installation. Verti-Block's hollow design saves money by using less concrete and lowering transportation costs. It also ensures the right amount of crushed stone backfill. Experienced installers know that too much crushed stone wastes money—too little can build hydrostatic pressure and cause the retaining wall to fail.

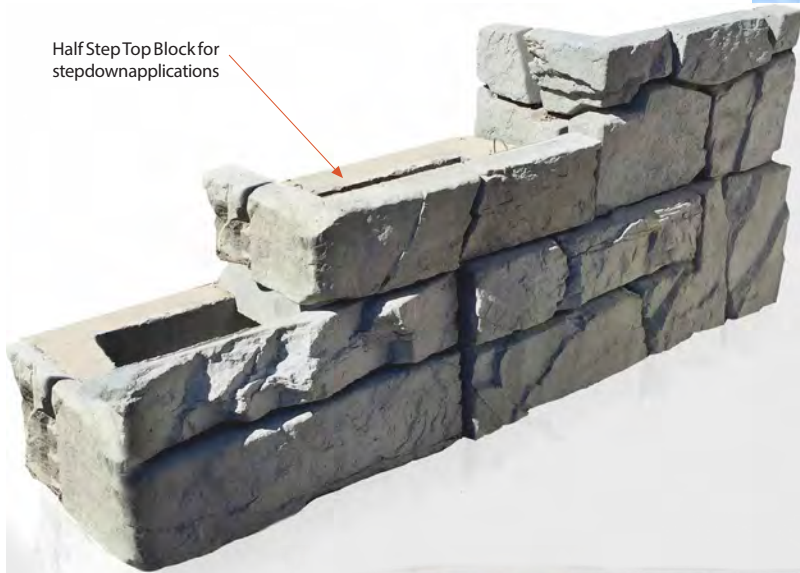
Half Step Top Block for  
stepdown applications

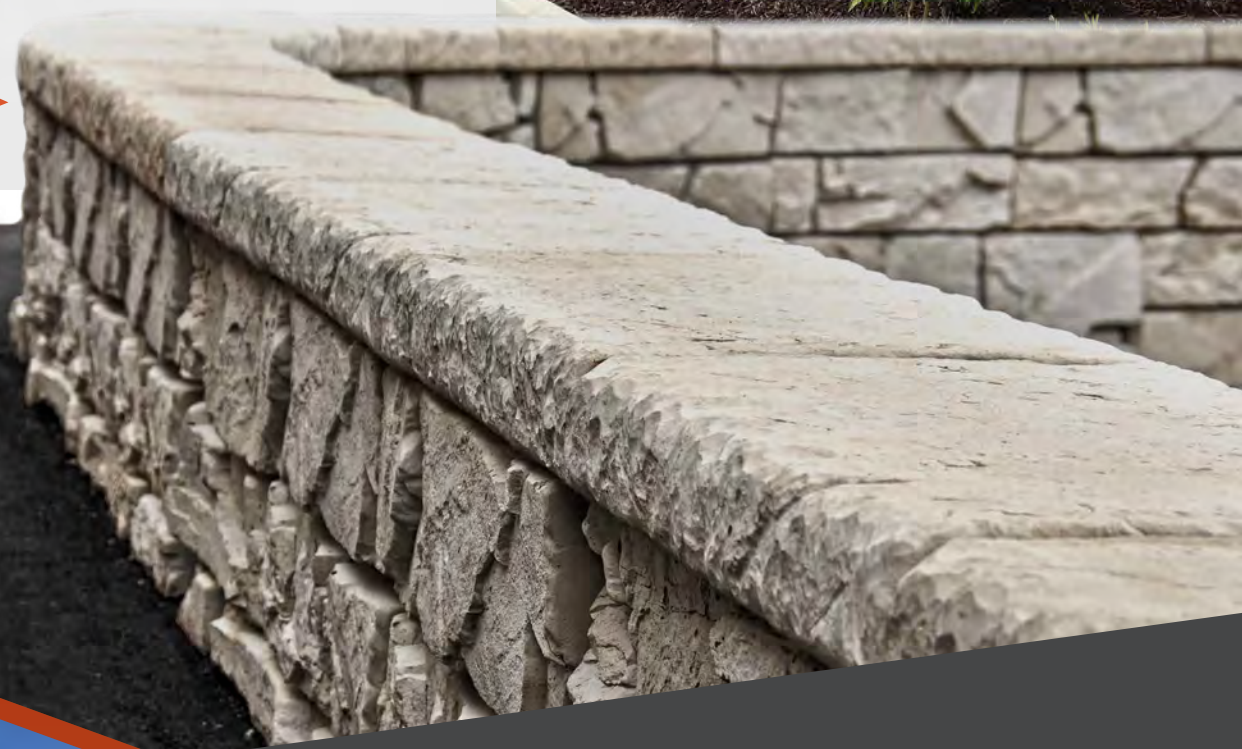
Double-Sided Verti-Block  
parapet wall with 6" Cap

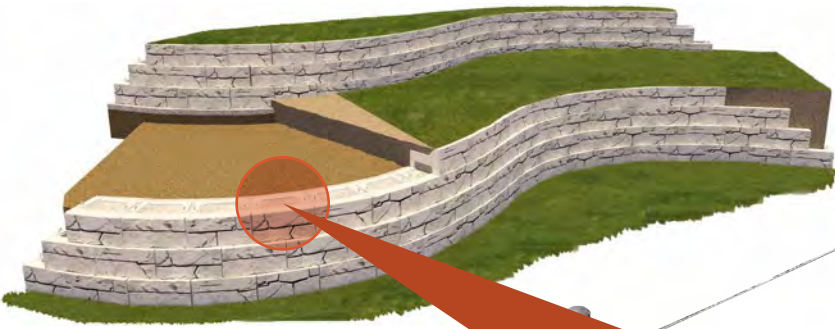
# Convex and Concave Verti-Block Walls

Verti-Block is ideal for a variety of landscaping projects including residential communities, commercial campuses, schools, parks, back yards, and more. Able to accommodate winding landscapes and even tight curves, Verti-Block is designed to add interest to any landscape while securely retaining earth.

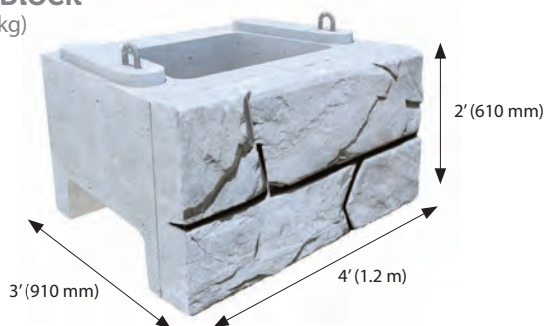
## Standard Block

1,755 lbs. (790 kg)

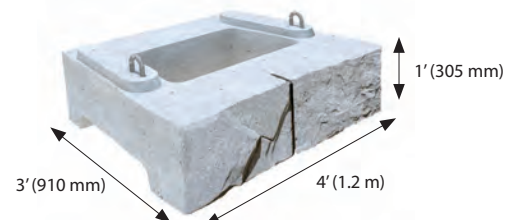
## Half Step Block

973 lbs. (440 kg)

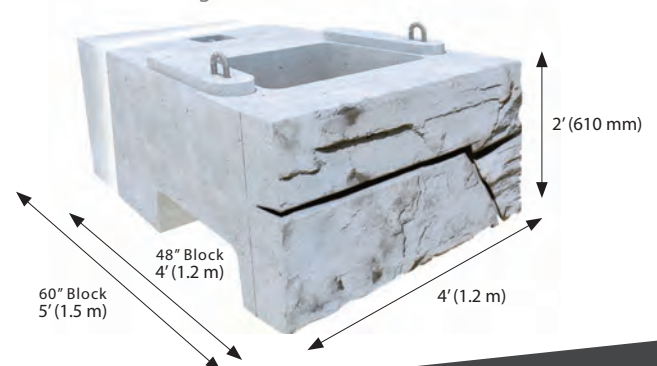
## Mass Extender

48" Block 2,674 lbs. (1,210 kg)

60" Block 3,509 lbs. (1,590 kg)
