**1-132 MAYBAL LANE
CHARLES STURT UNIVERSITY NSW 2678**

**PRELIMINARY SITE
INVESTIGATION**

FOR A PROPOSED PRESCHOOL

REPORT NO: 9956

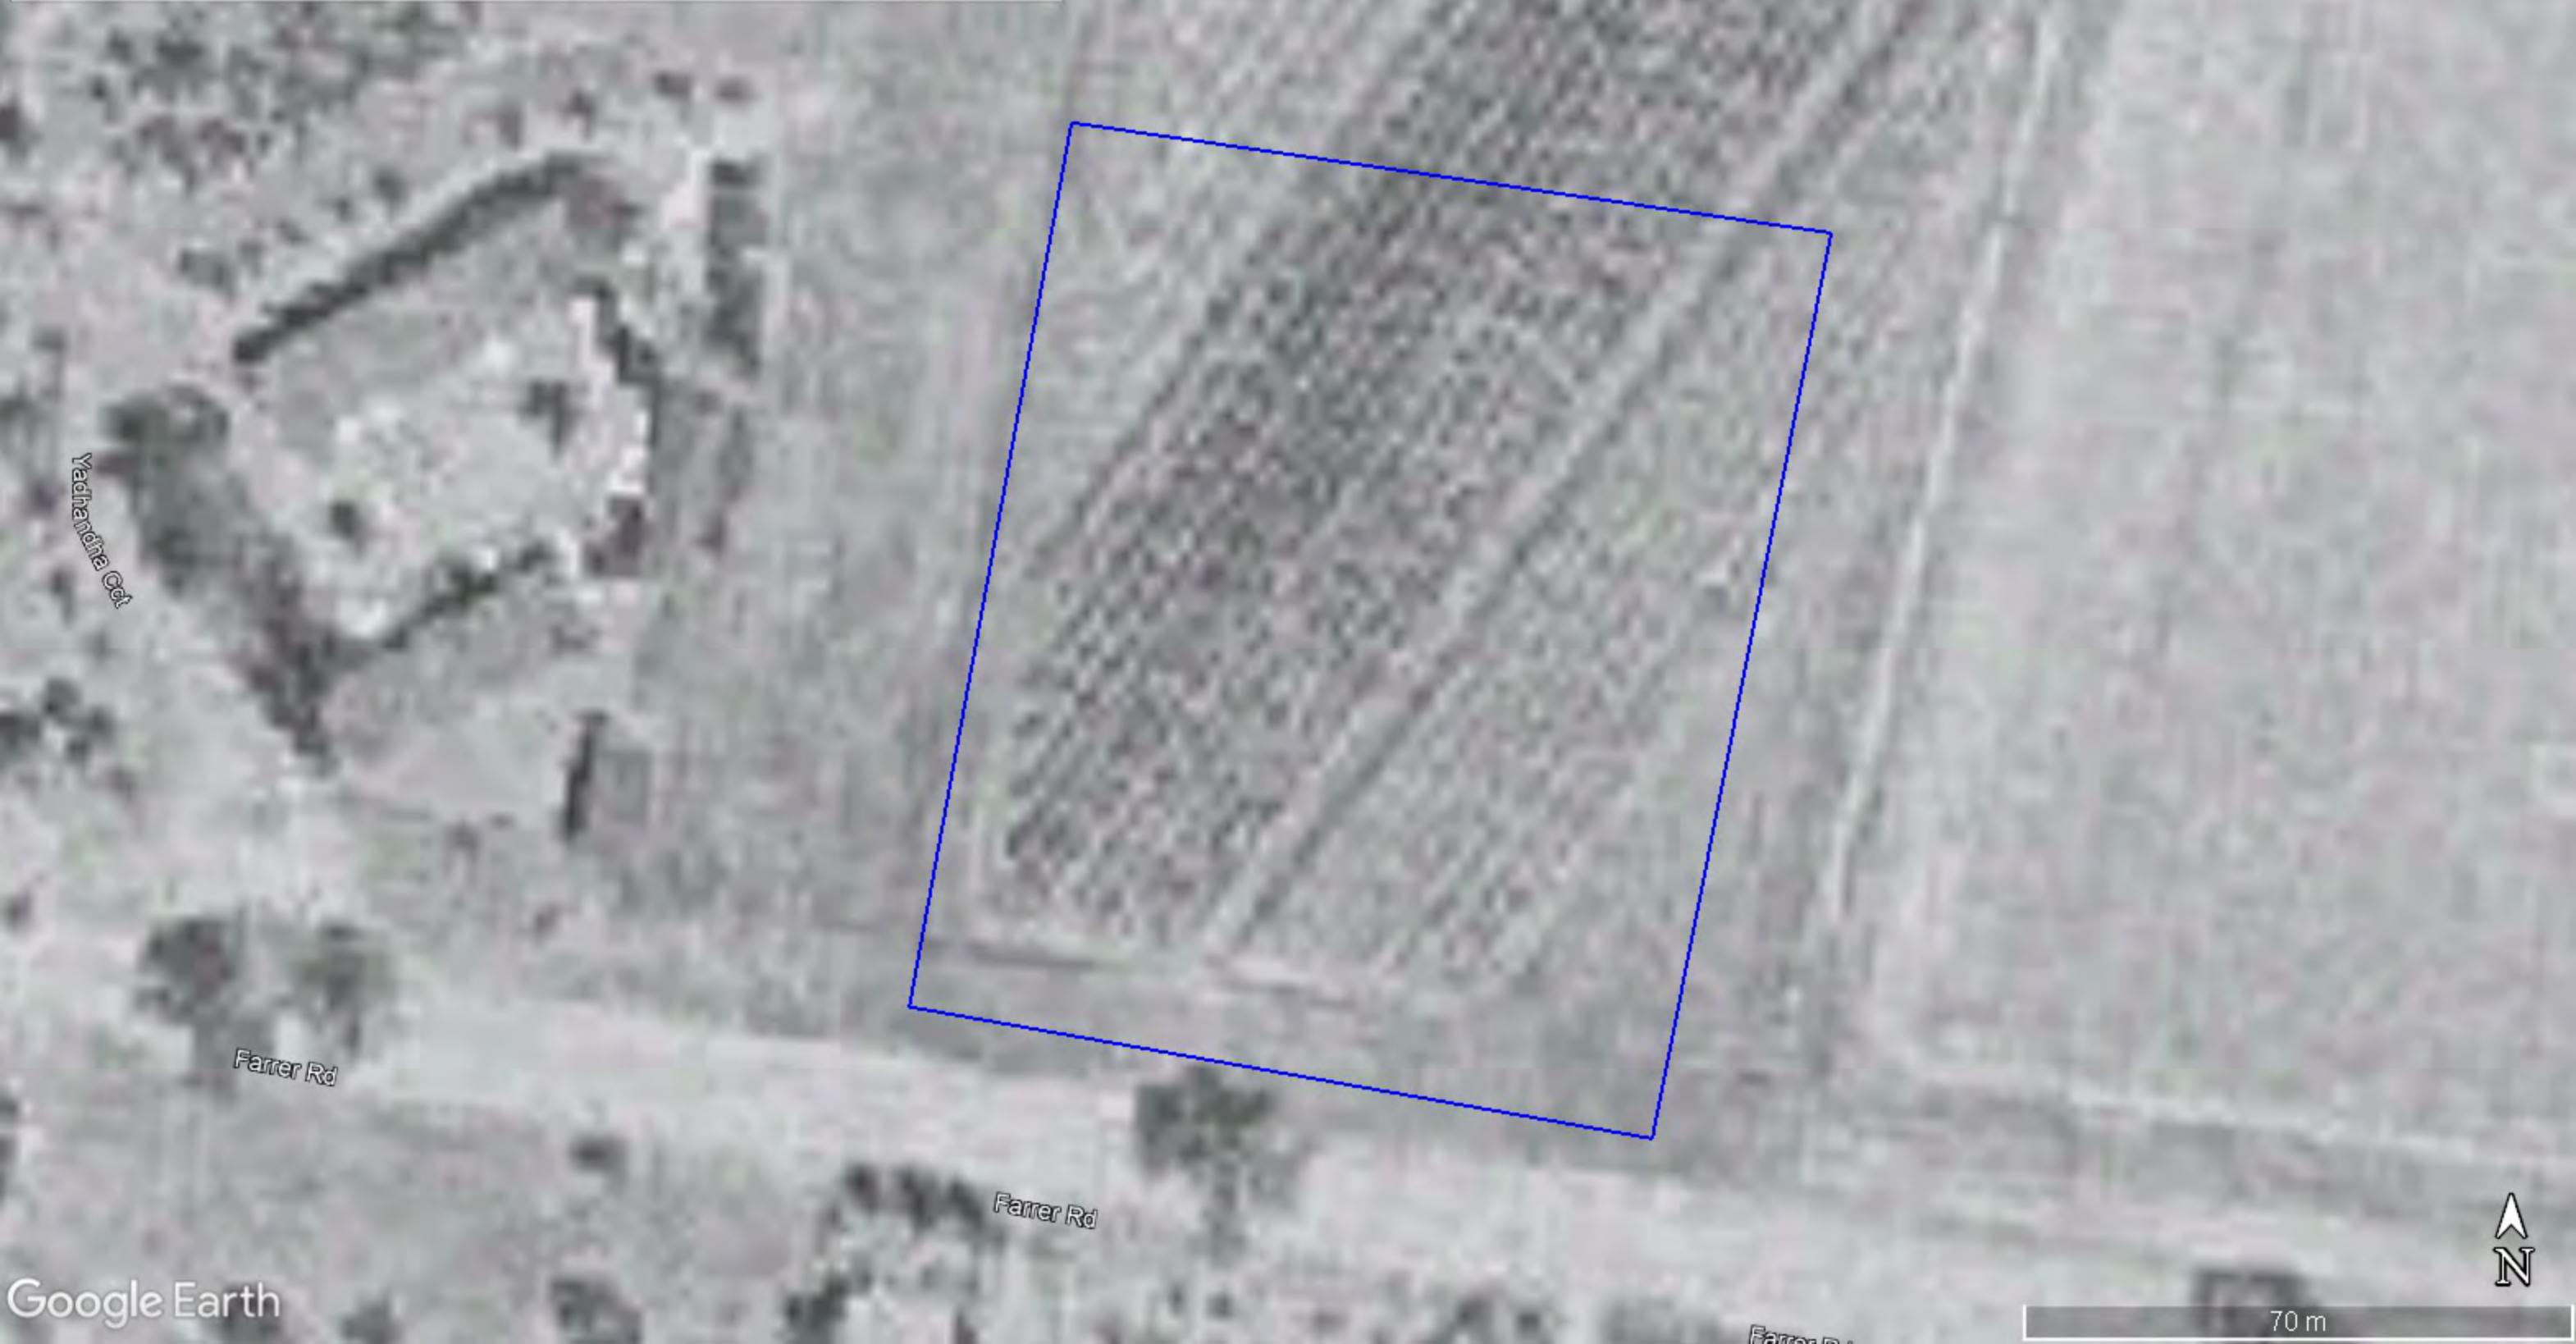
Preliminary Site Investigation
Report No. 9956
NSW Spatial Services image 1980

1980 – Vines have been planted across the site. University buildings can be seen to the west.

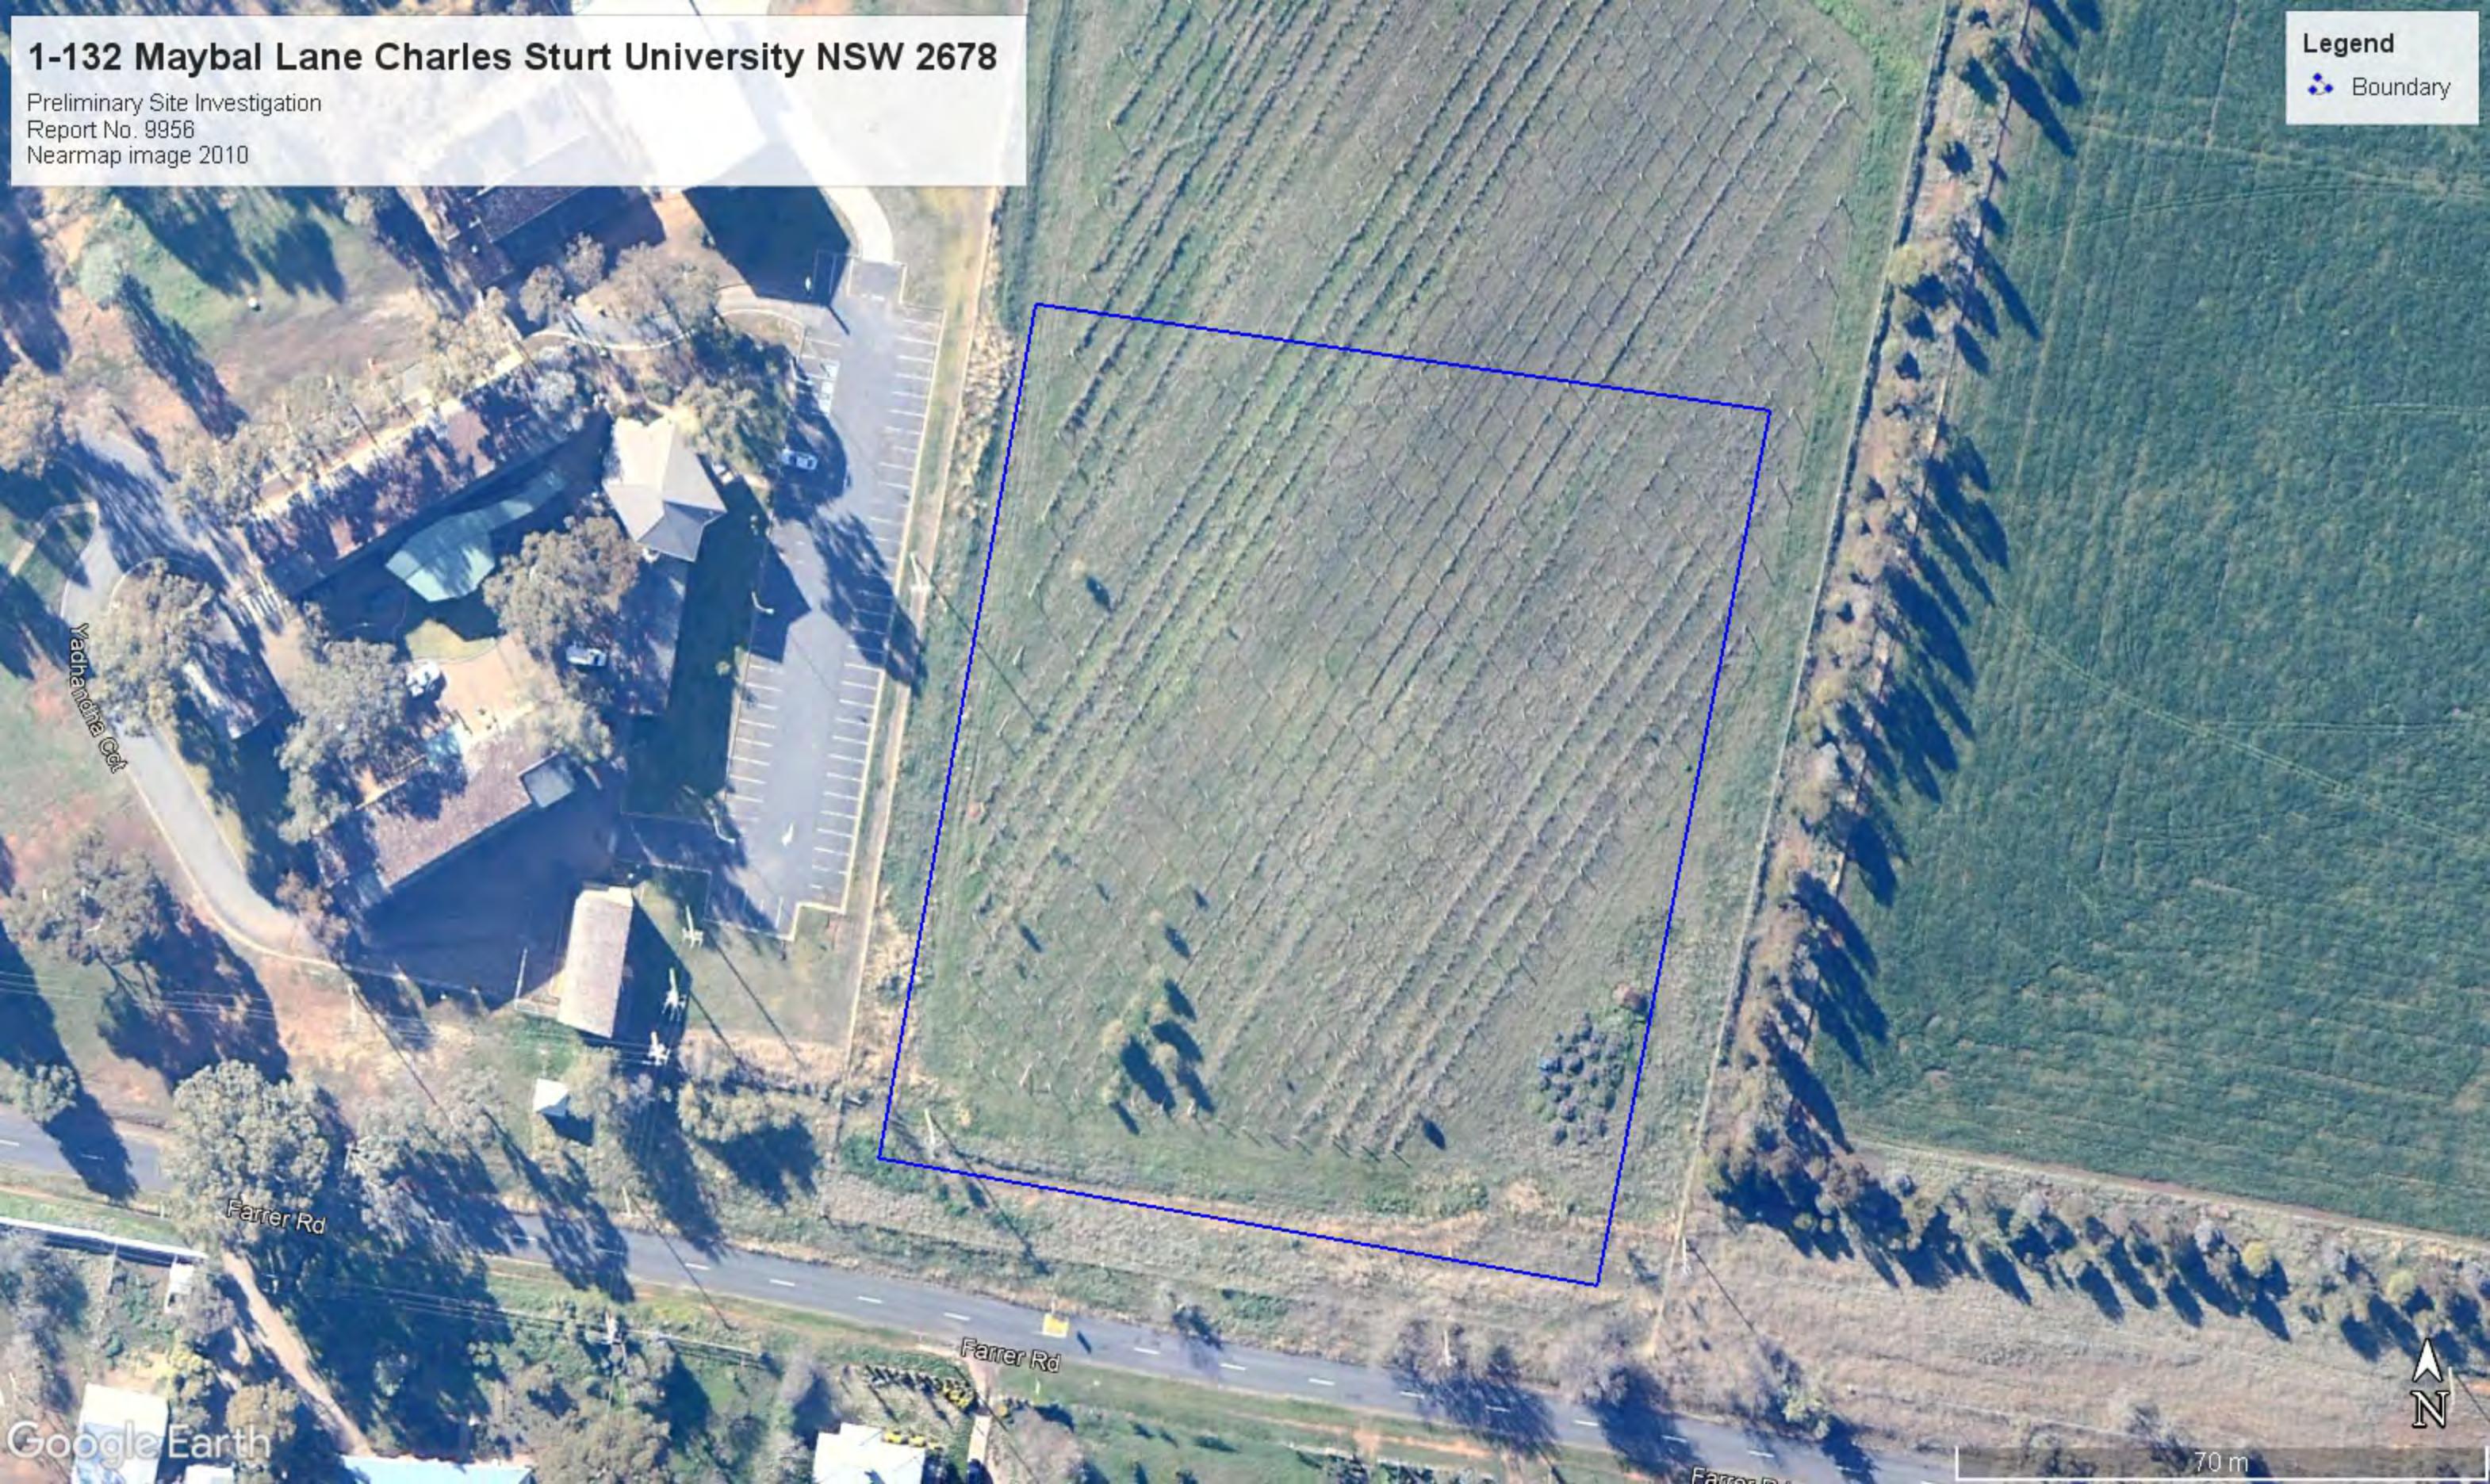
Preliminary Site Investigation
Report No. 9956
Nearmap image 2010

2010 – There are no sheep on the site. Some trees have been planted in the west of the site.

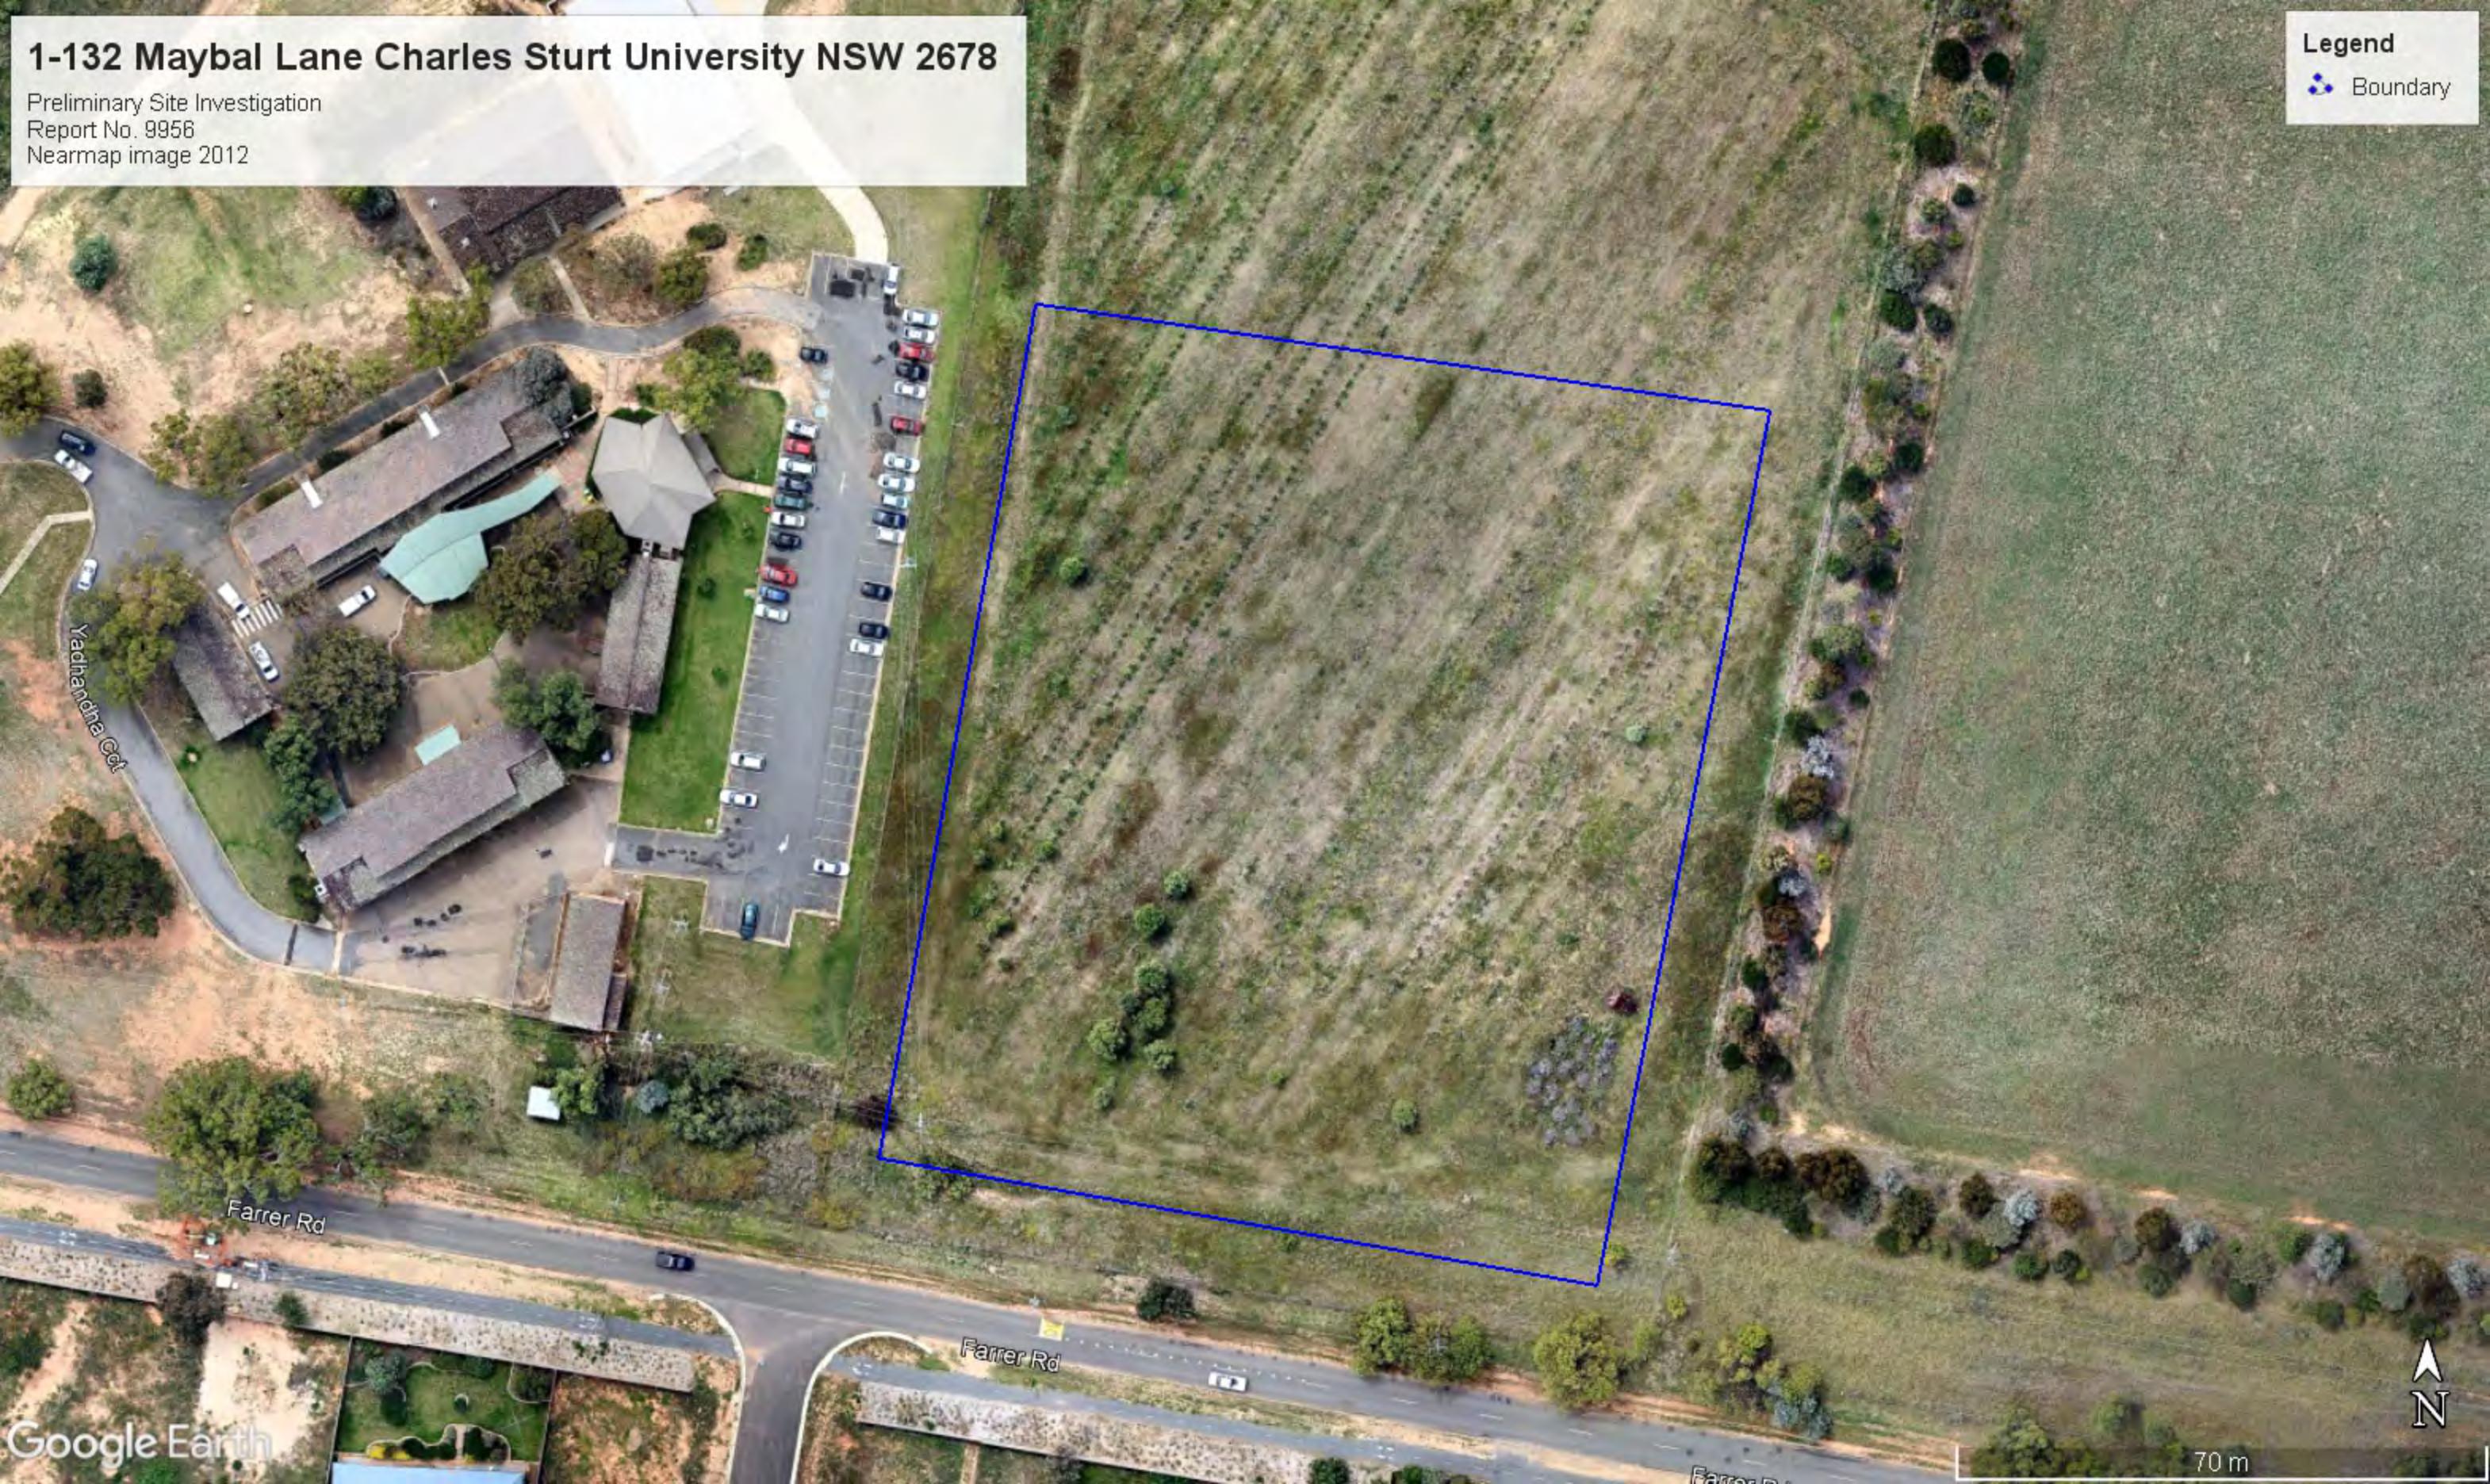
Preliminary Site Investigation
Report No. 9956
Nearmap image 2012

2012 – No change to the site from 2010. Major residential development has occurred to the south, across Farrer Road.

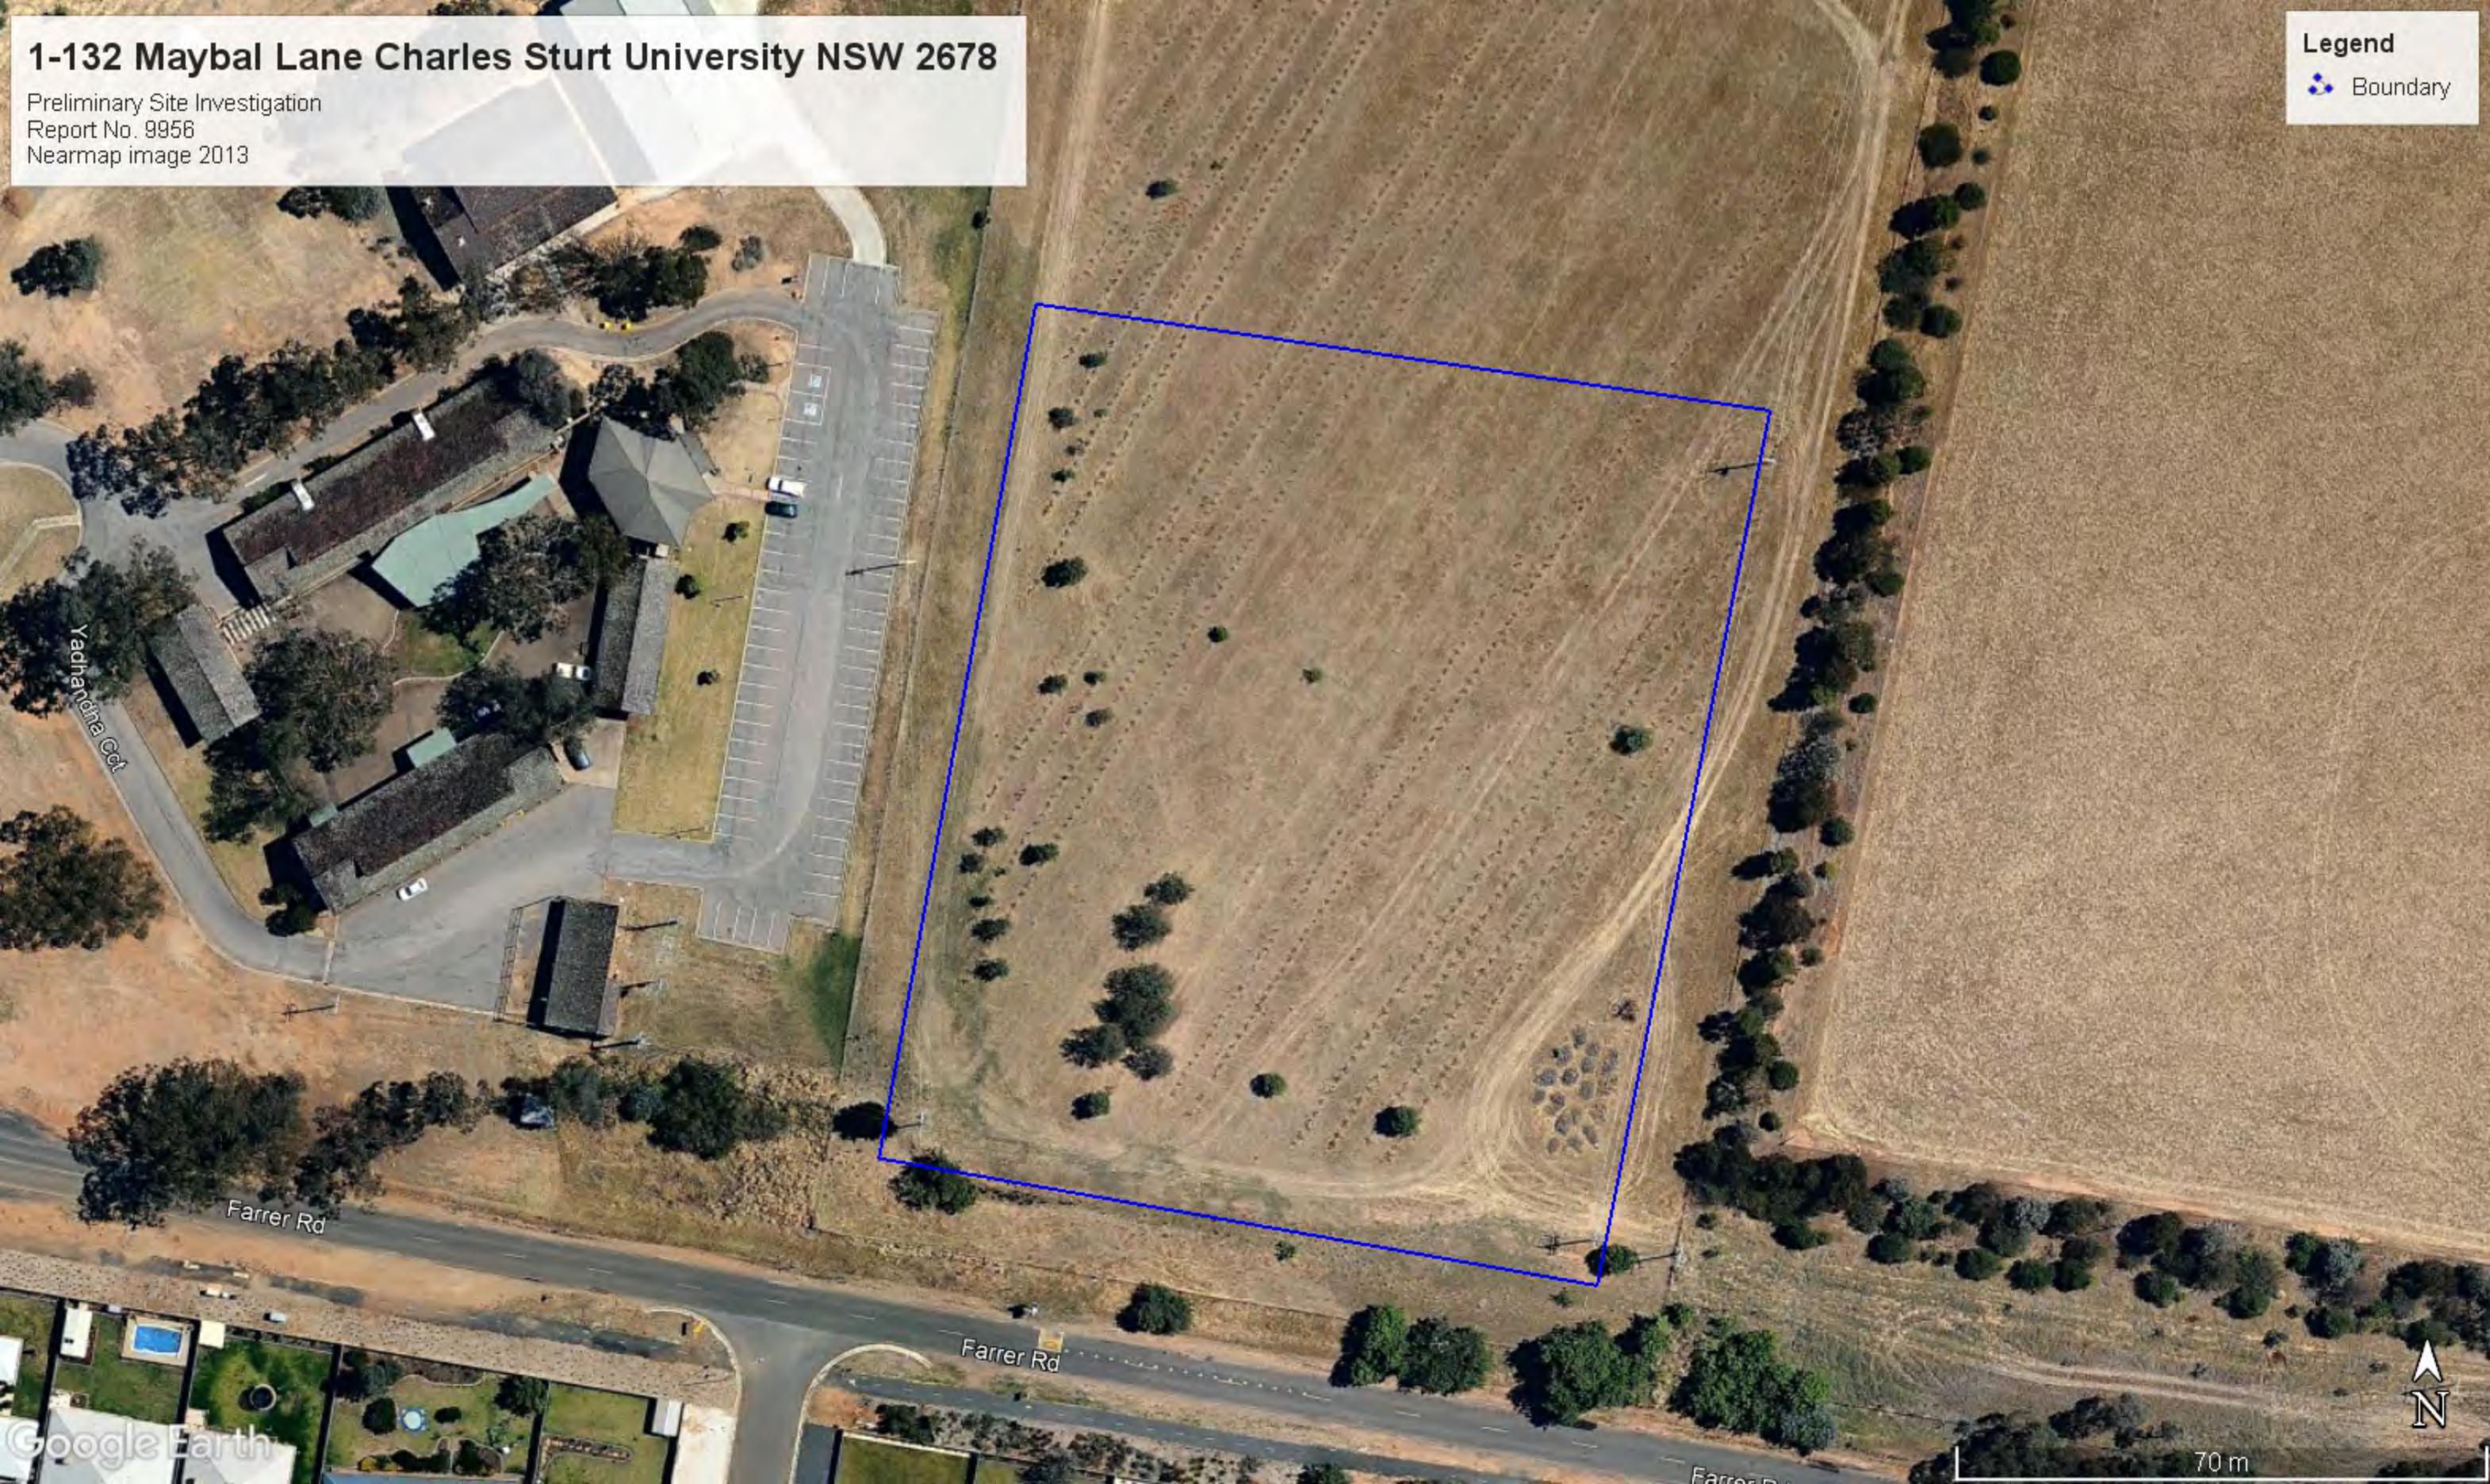
Preliminary Site Investigation
Report No. 9956
Nearmap image 2013

2013 – No change to the site from 2010. Residential development continues to the south, across Farrer Road.

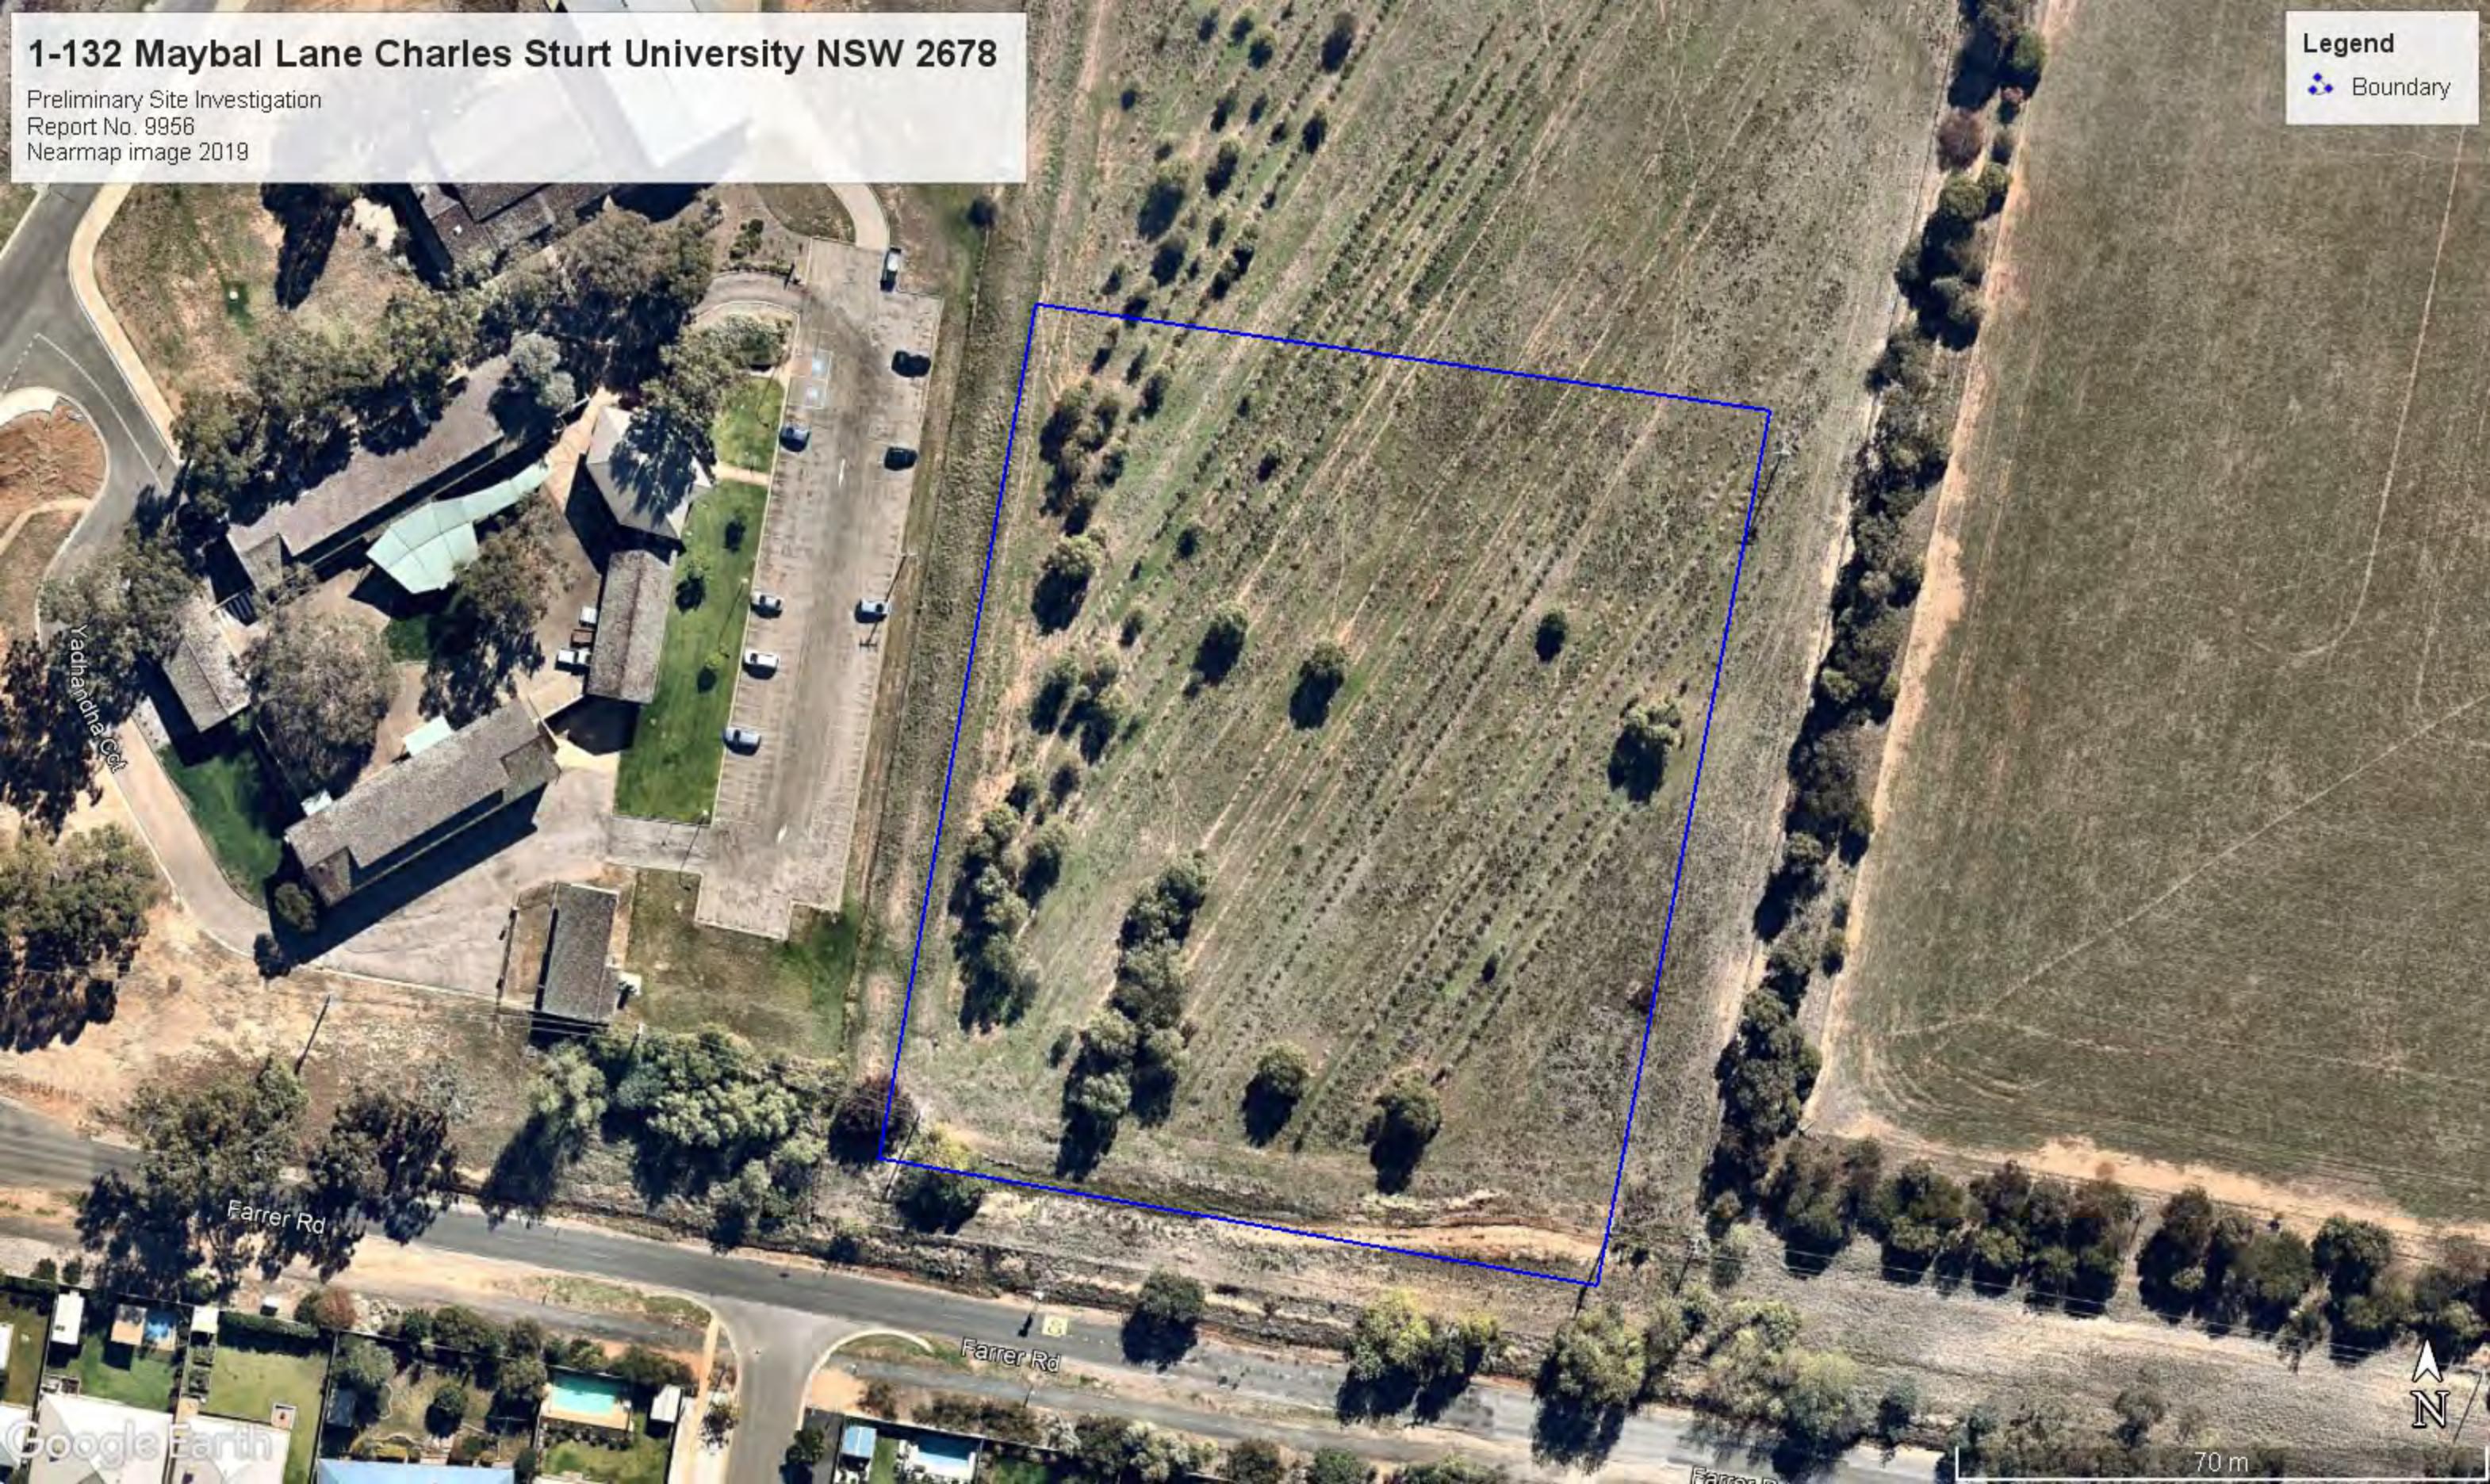
Preliminary Site Investigation
Report No. 9956
Nearmap image 2019

2019 – No change to the site from 2010. Farrer Road has been widened, bring the southern boundary of the site closer to the road.

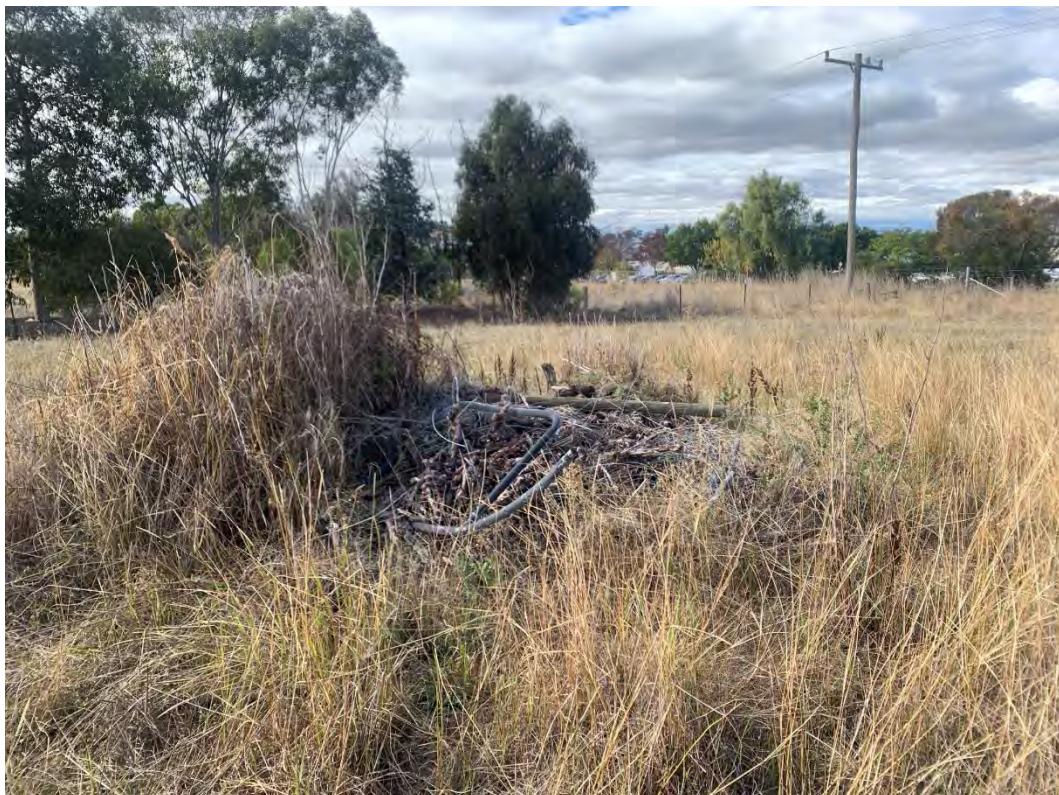
Photograph 4: Small rubbish pile in south east corner. Photograph taken facing east.

- The timber posts are recommended to be removed and disposed of at an appropriately licenced landfill.
- The small rubbish pile in the southeast corner is recommended to be removed and disposed of at an appropriately licenced landfill.

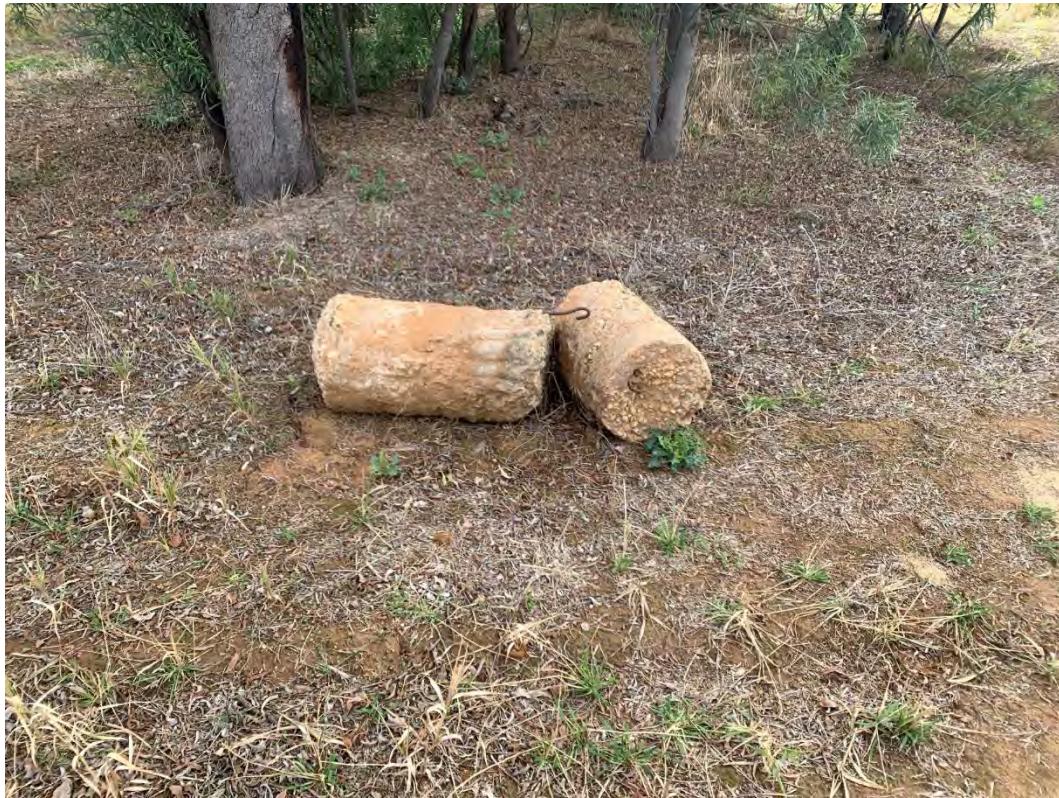
Photograph 5: Concrete bases near the southern boundary. Photograph taken facing north.

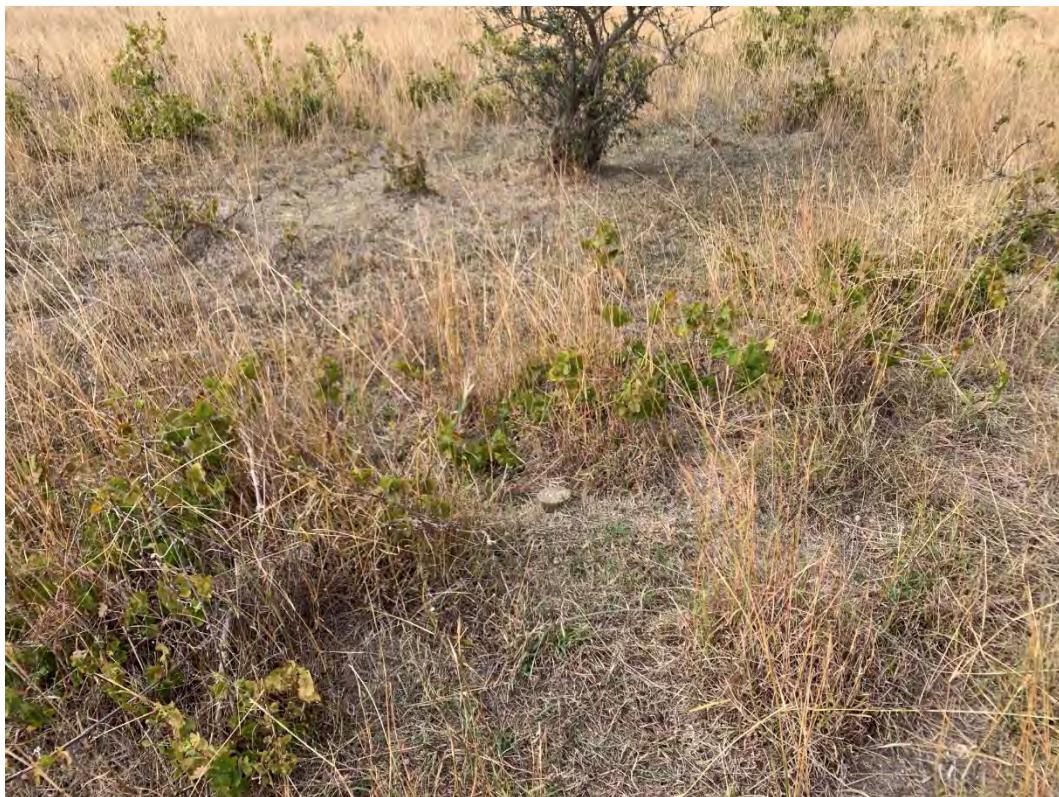
Photograph 6: Timber vineyard post seen in the mid ground. Photograph taken facing south east.

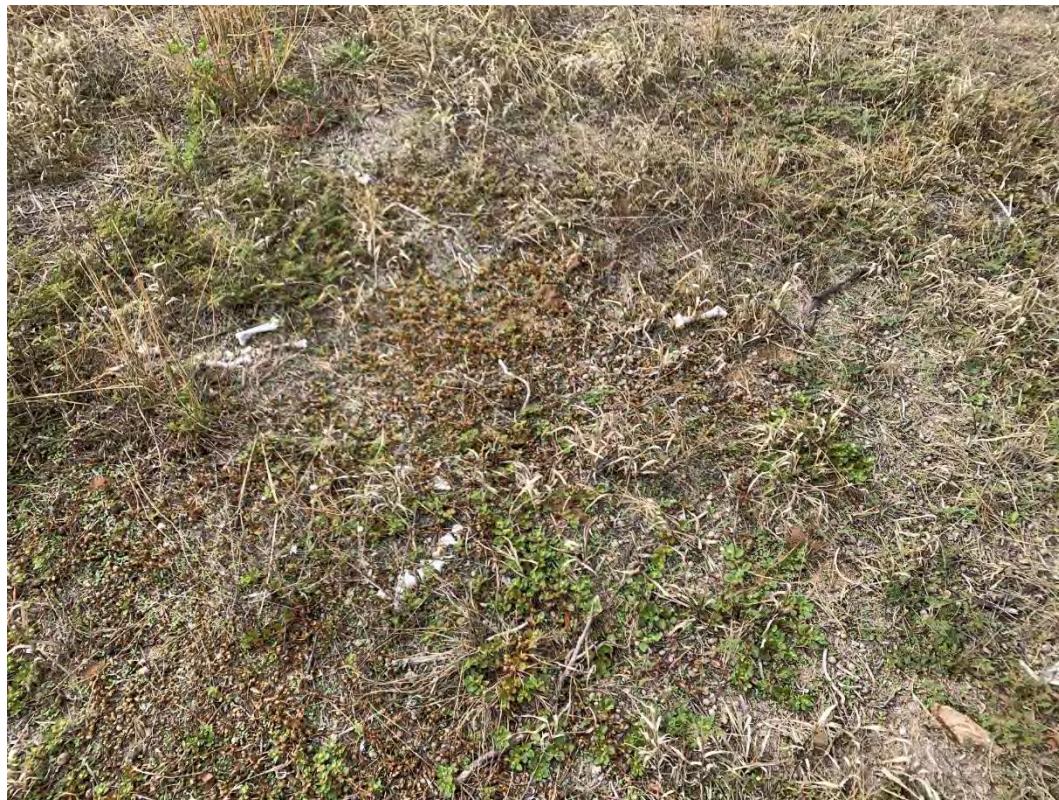
- Sheep droppings and some sheep bones could be seen across the site although no sheep were grazing at the time of investigation. Kangaroos were observed at the time.

Photograph 7: Sheep bones. Photograph taken facing north west.

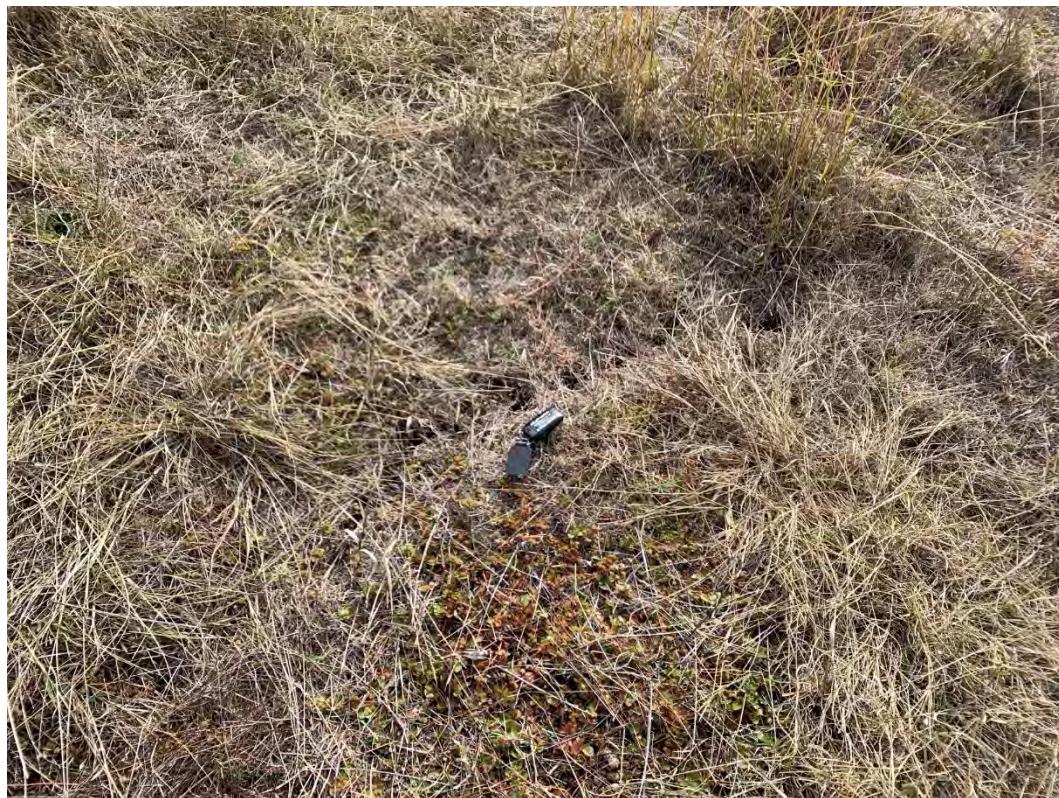
Soils are dark brown clay topsoils overlying colluvial silt which is underlain by colluvial and residual clay with aeolian sand addition. Surface desiccation cracking was observed where the clay is near the surface.

Photograph 8: Surface desiccation cracking. Key for scale.
