**1-132 MAYBAL LANE
CHARLES STURT UNIVERSITY NSW 2678**

**PRELIMINARY SITE
INVESTIGATION**

FOR A PROPOSED PRESCHOOL

REPORT NO: 9956

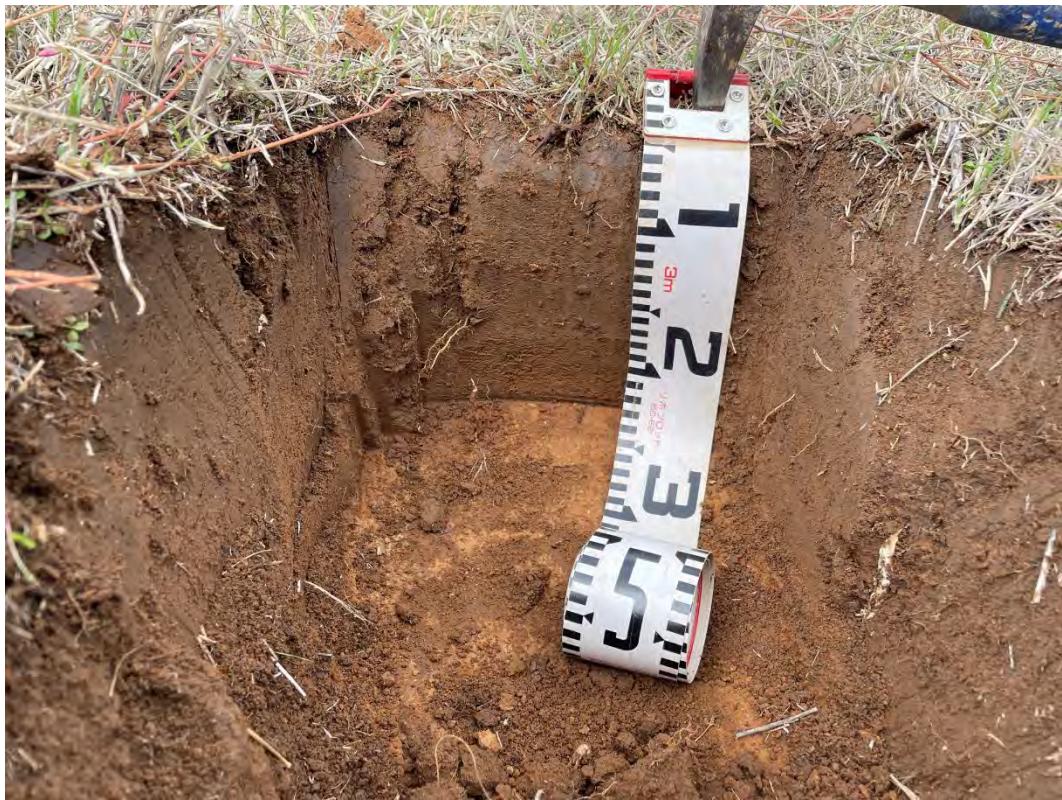
- Soils are dark brown clay topsoils overlying colluvial silt which is underlain by colluvial and residual clay with aeolian sand addition. Surface desiccation cracking was observed where the clay is near the surface.
- There were no visual or olfactory indicators of chemical contamination on site.

Photograph 9: Soil profile.
