# Preliminary Site Investigation

National Circularity Centre

Lot 1 DP1264640, North Bega, NSW

4 October 2023

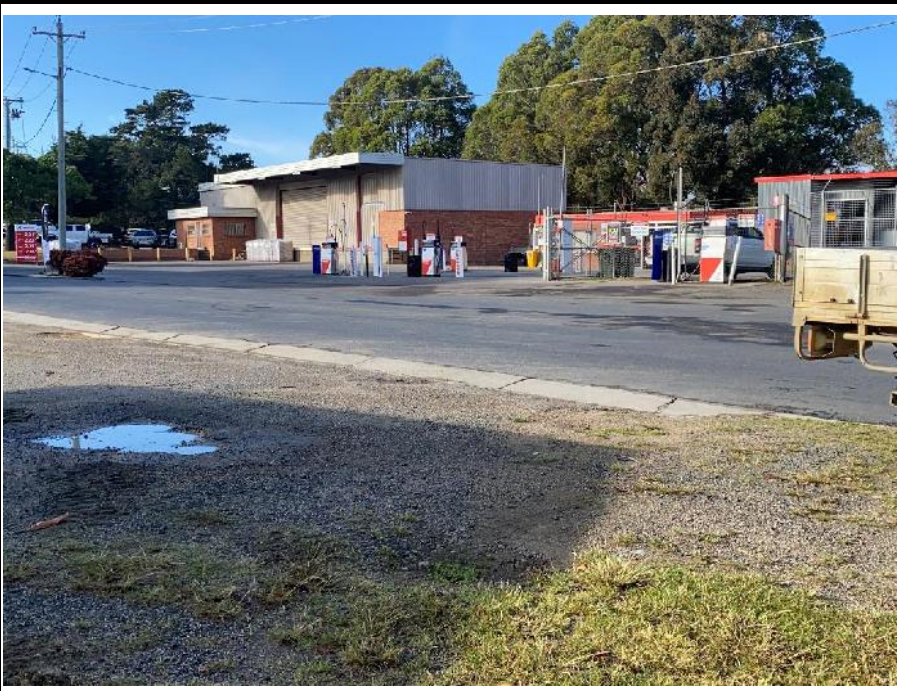
| Photo No. | Date | |
|---|---|---|
| 1. | 31/08/2023 | <p><b>Description</b></p> <p>View of active service station located across Lagoos Street towards the southeast of the site.</p> |

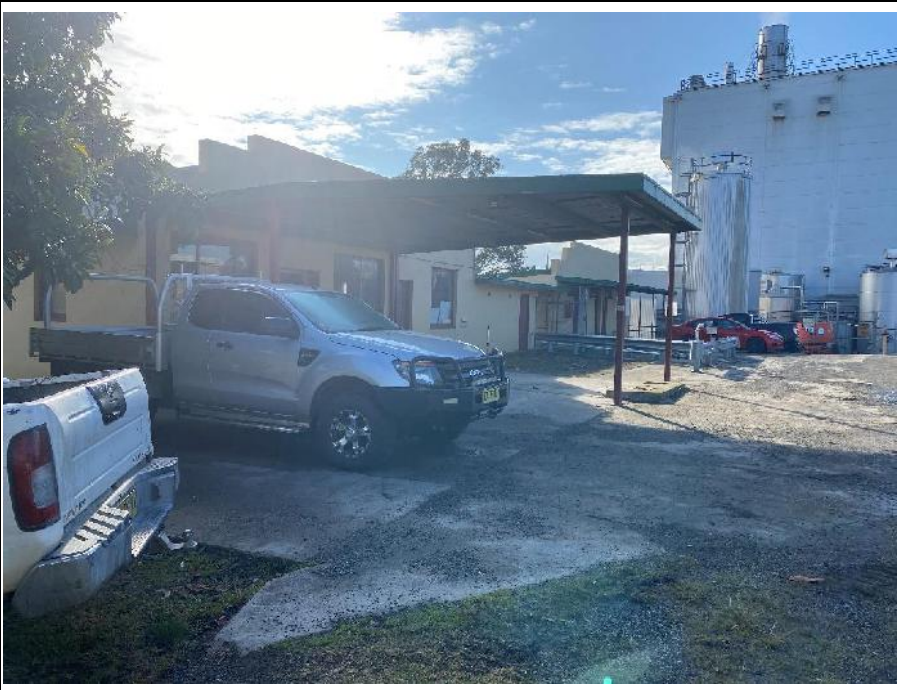
| Photo No. | Date | |
|---|---|---|
| 2. | 31/08/2023 | <p><b>Description</b></p> <p>View of former service station located to the east of southernmost portion of the site.</p> |

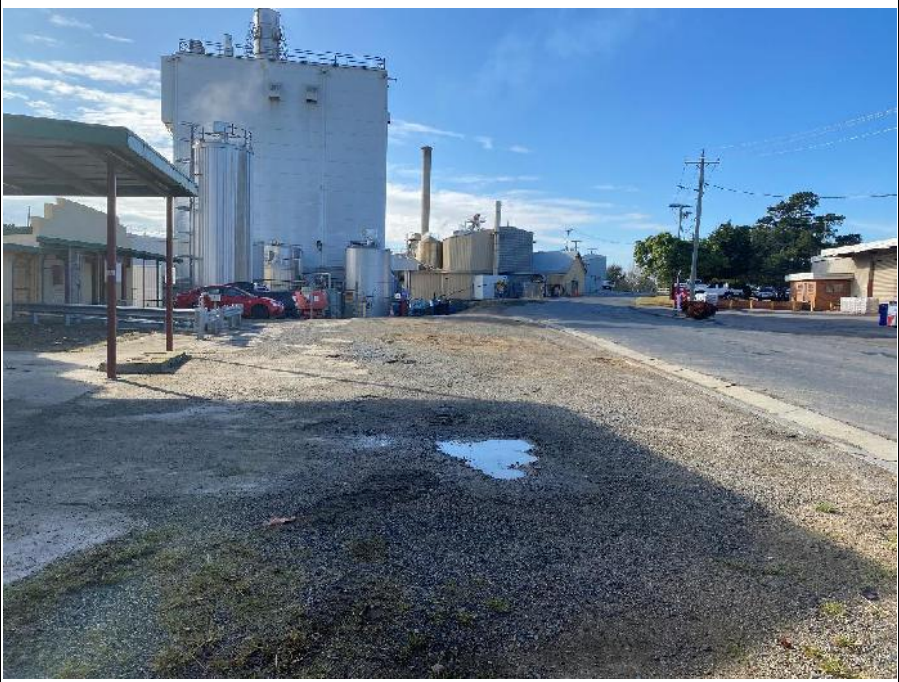
| Photo No. | Date | |
|---|---|---|
| 3. | 31/08/2023 | |

| Photo No. | Date | |
|---|---|---|
| <b>Description</b><br>Lagoon Street view towards the cheese factory. | | |

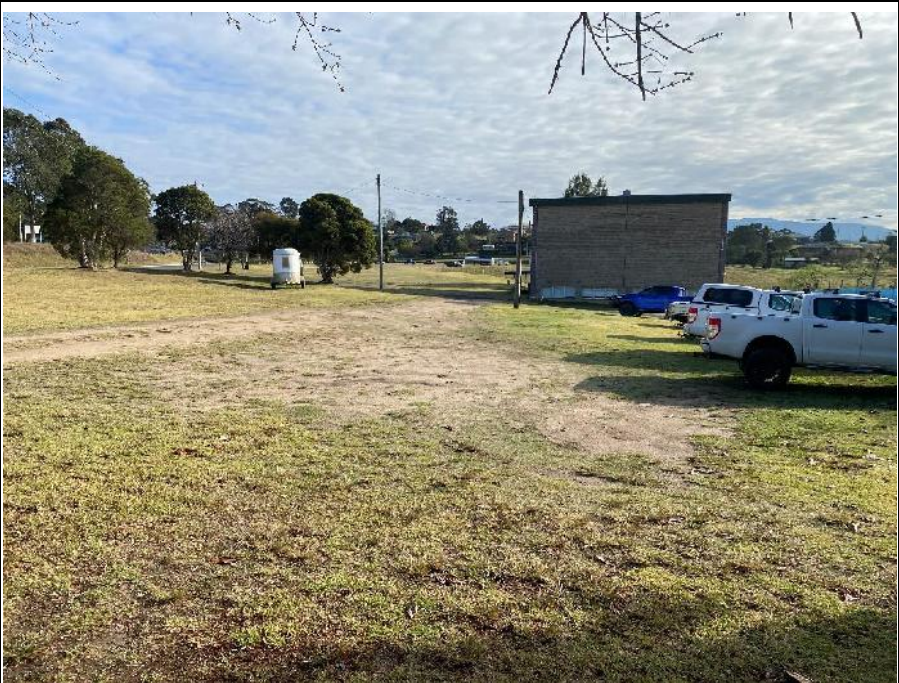
| Photo No. | Date | |
|---|---|---|
| <b>Description</b><br>View of the site towards the north. Parked cars are observed. | | |
