# Stage 1 Residential Detailed Development Application Submission

## Stage 1 Geotechnical Site Investigation & Groundwater Inflow Assessment Report

**Reference: SYDGE330330AB Rev.1**

5 September 2024

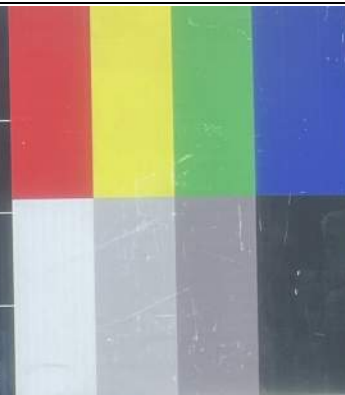
DEPTH: 2.85-7.0m

DATE: 5/10/23

A Coffey geotechnical engineer was present during fieldwork to identify drilling locations, record test results, log the encountered ground conditions and box the rock cores. The borehole logs and rock core photographs are attached in Appendix B together with Coffey soil and rock description and explanation sheets.

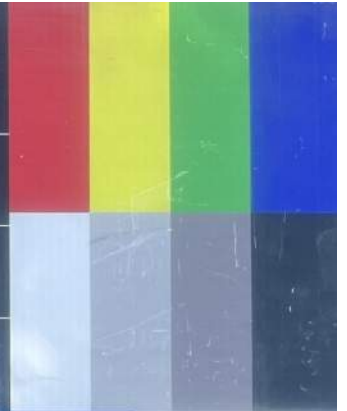
*SYDGE330330 Shellharbour ILUs BH2 6/10/2023 Start Coring at 2.88m*

BOREHOLE No: *BH2*

DEPTH: *2.88-7.0m* DATE: *6/10/23*

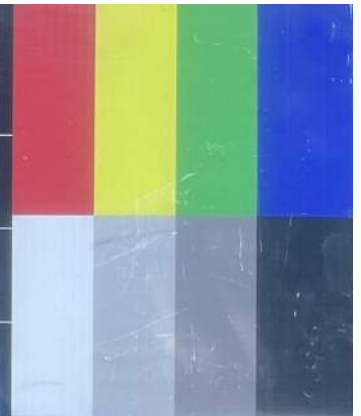
SYDGE330330 Shellharbour ILUs 6/10/2023 BH3 Start Coring at 2.90m

PROJECT: Shellharbour ILUs  
PROJECT No: SYDGE330330  
BOREHOLE No: BH3  
DEPTH: 2.90-7.0m DATE: 6/10/23
