Re: 22-069 – Merimbula Boardwalk Letter of Heritage Advice

Aboriginal Heritage Due Diligence Assessment

Merimbula Boardwalk - Ancillary Areas

December 2023

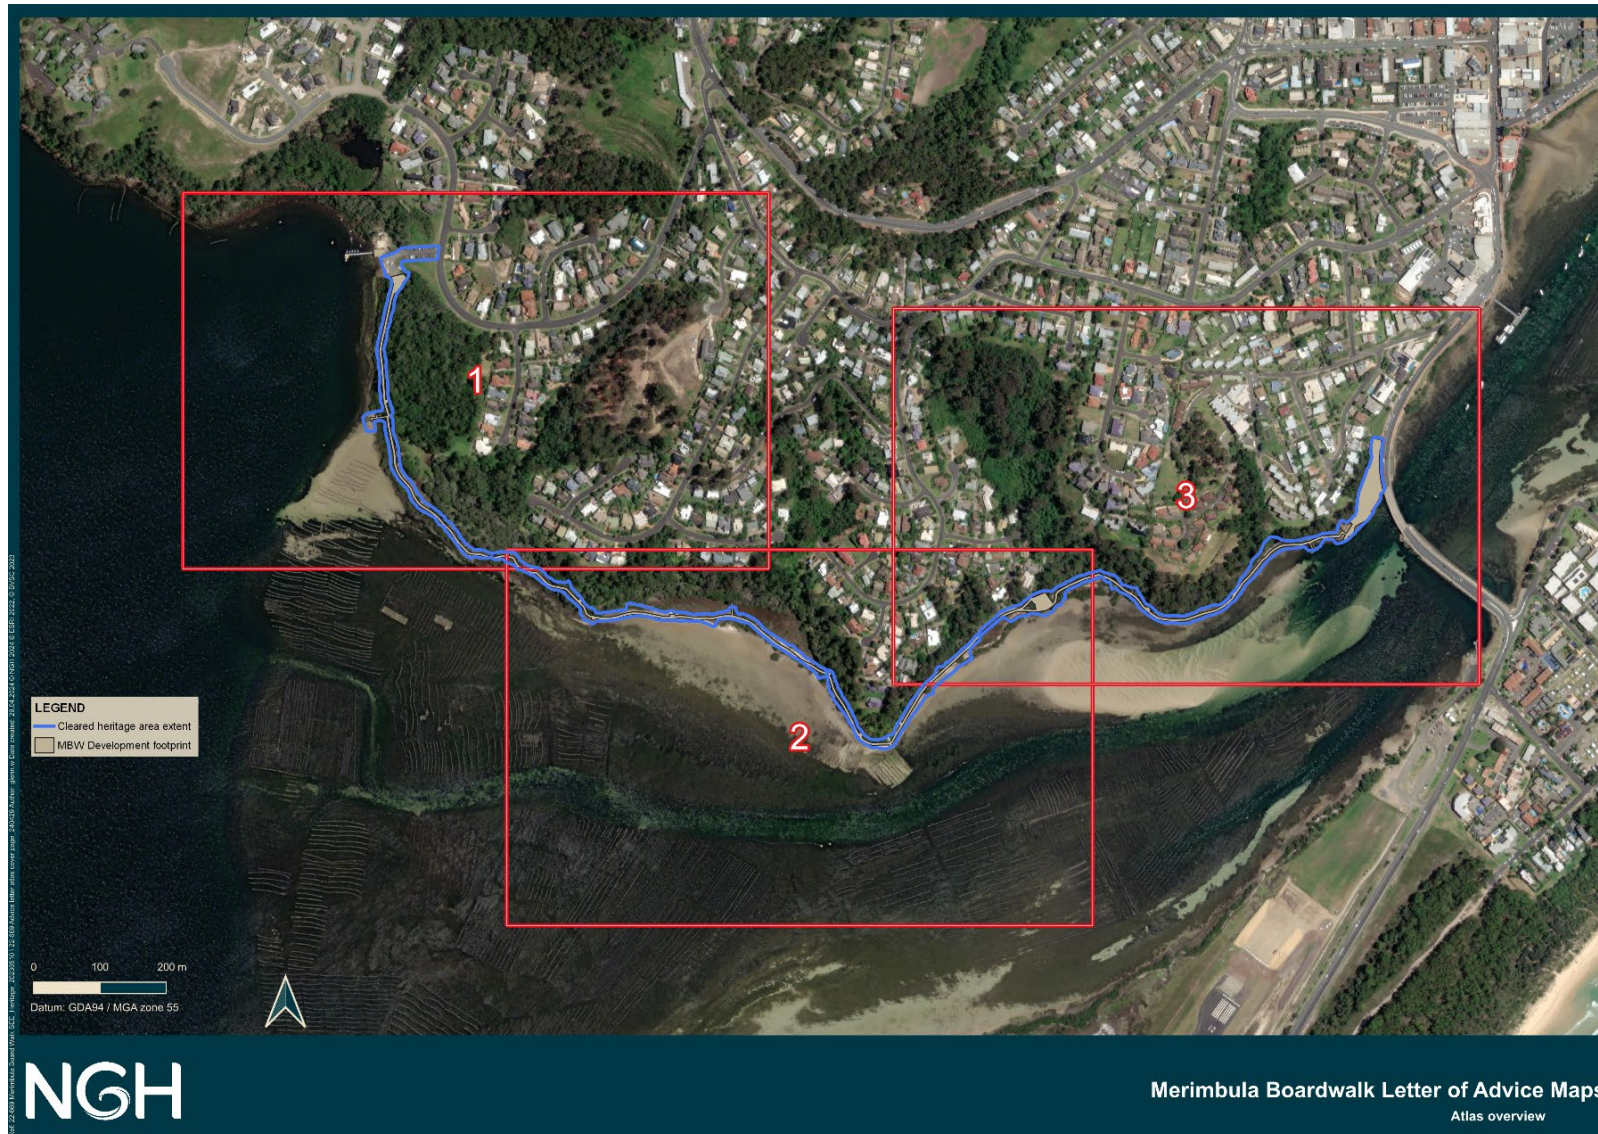
Figure 1 Overview of mapped area

This assessment has found that the proposed works can proceed within the **Cleared heritage area extent** as shown in the Figure 1 to Figure 4 below. This is based on a reasonable understanding of the AHIP C0003582 subject area and the findings of all Aboriginal heritage assessments reviewed for this assessment, including the most recent due diligence assessment (NGH 2019, 2023).

2. **The Cleared heritage area extent** comprises the land to which AHIP C0003582 is understood to apply and some adjacent areas that have been inspected and assessed during the 2023 due diligence assessment. All works should be confined to the **Cleared heritage area extent** (see Figure 1 to Figure 4 below).

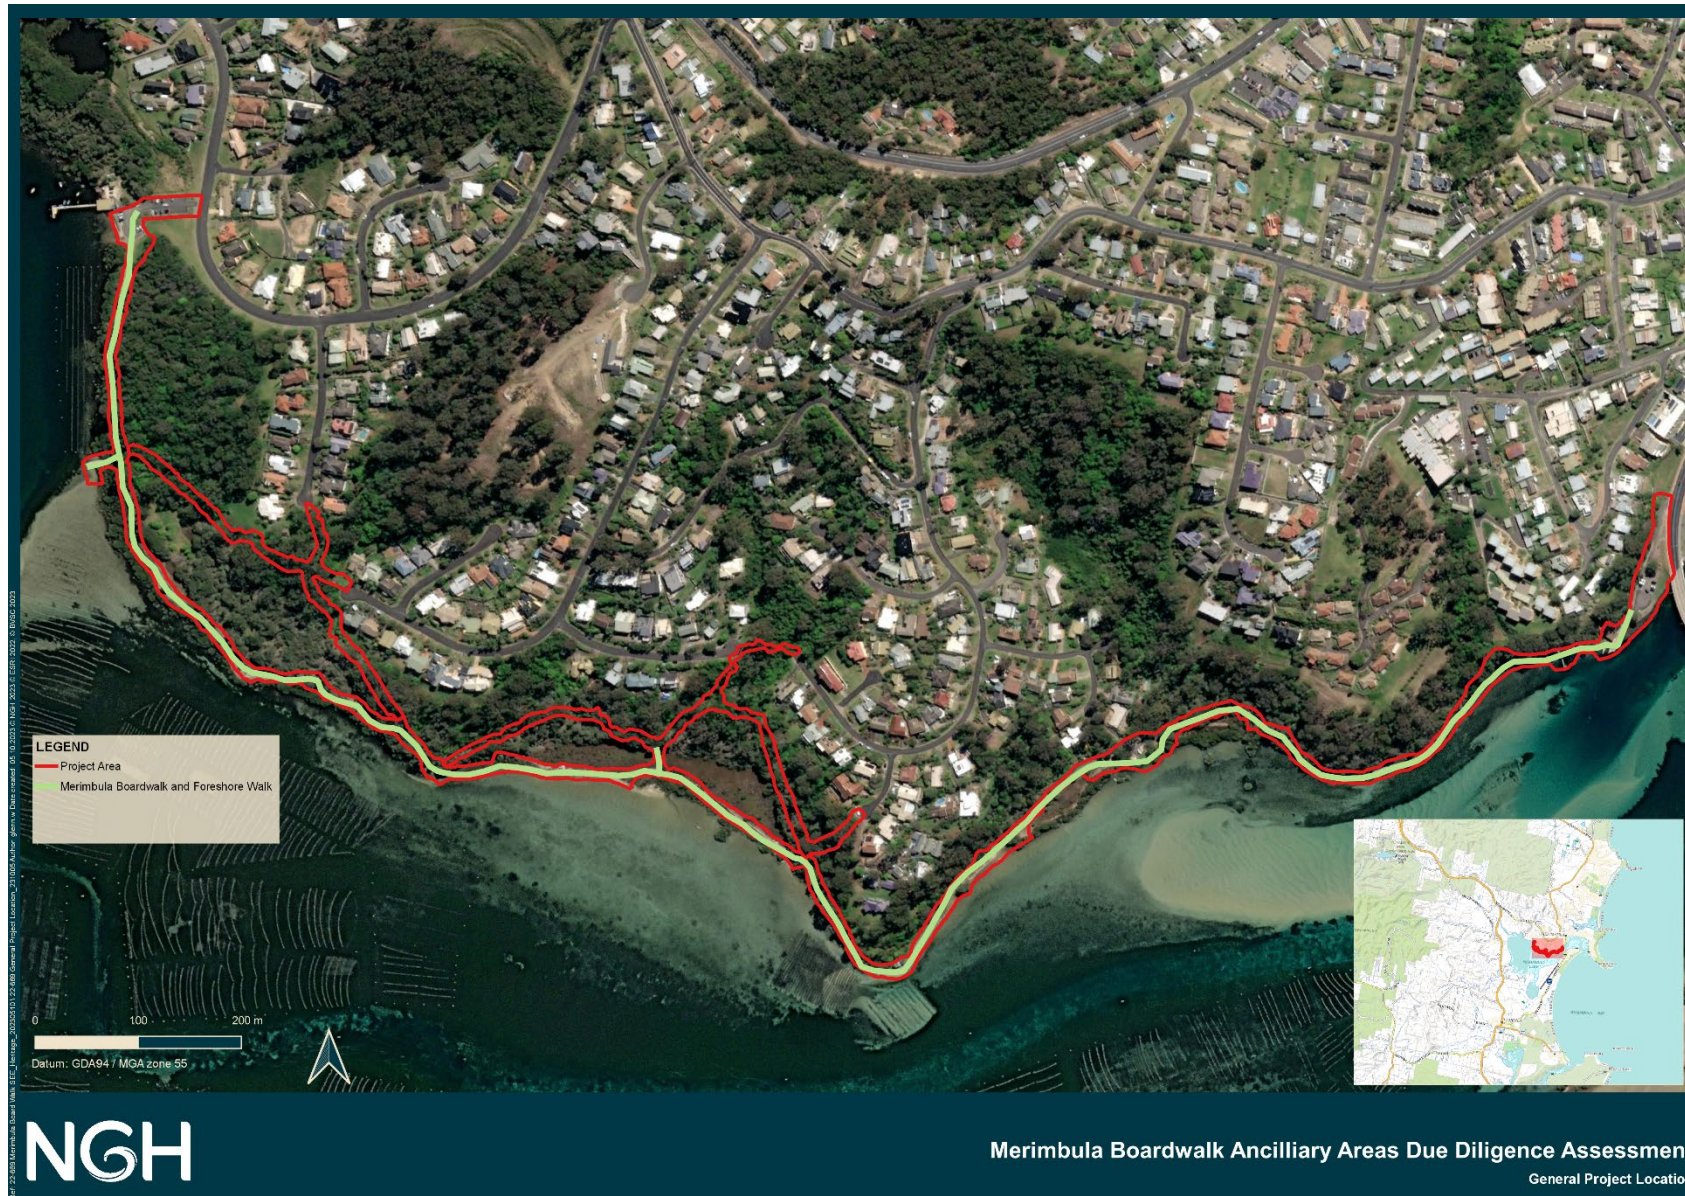
Figure 1-1 General project location

The Project Area includes the current Merimbula Boardwalk and Foreshore Path and the creation of ancillary tracks and trails to manage pedestrian access to the Merimbula Boardwalk and Foreshore Path - see Figure 1-1 below. In addition to the areas of the ancillary tracks and trails the Project Area incorporates a wider area around the Merimbula Boardwalk and Foreshore Path than the area of AHIP C0003582 for the Merimbula Boardwalk and Foreshore Path.

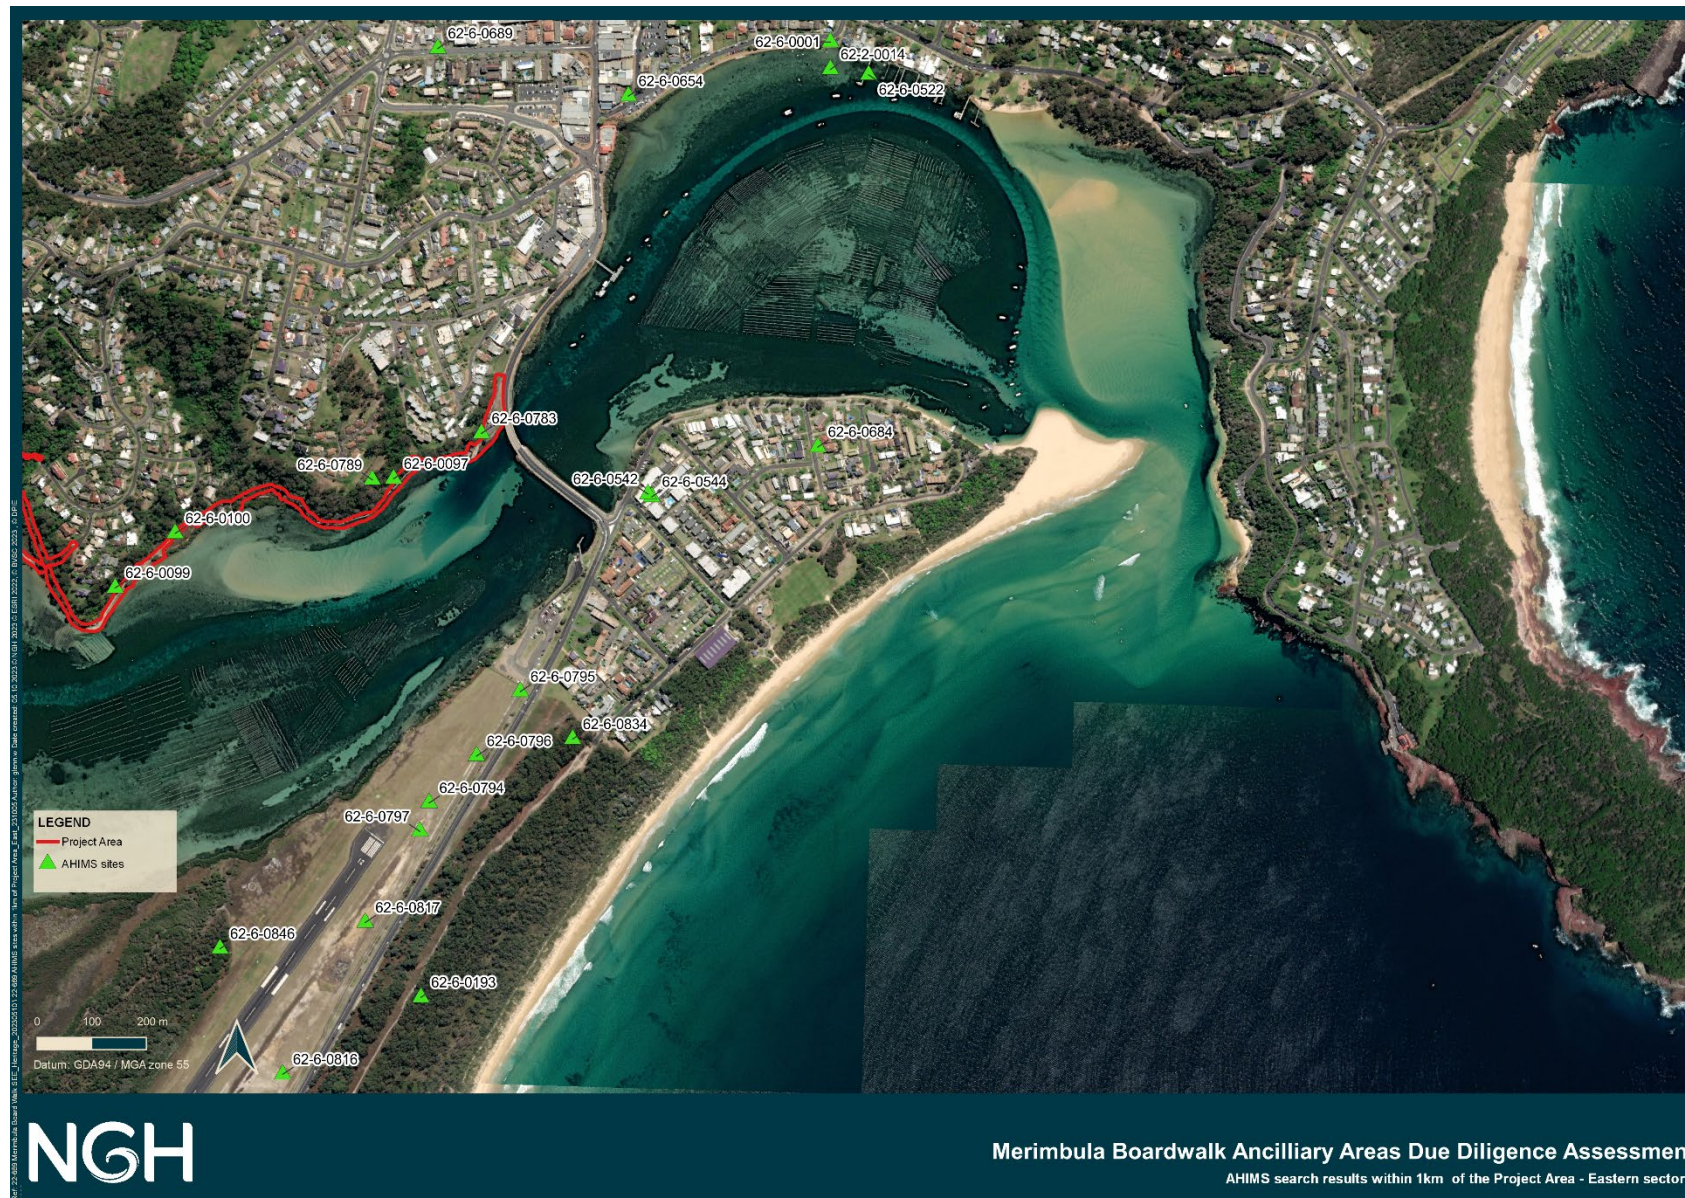
Figure 4-3 AHIMS sites within 1 km of the Project Area – Eastern Sector

There were 117 Aboriginal sites recorded within this search area and no declared Aboriginal Places. Table 4-1 below shows the breakdown of site types and Figure 4-1, Figure 4-2 and Figure 4-3 below show the location of the AHIMS sites in relation to the project area.

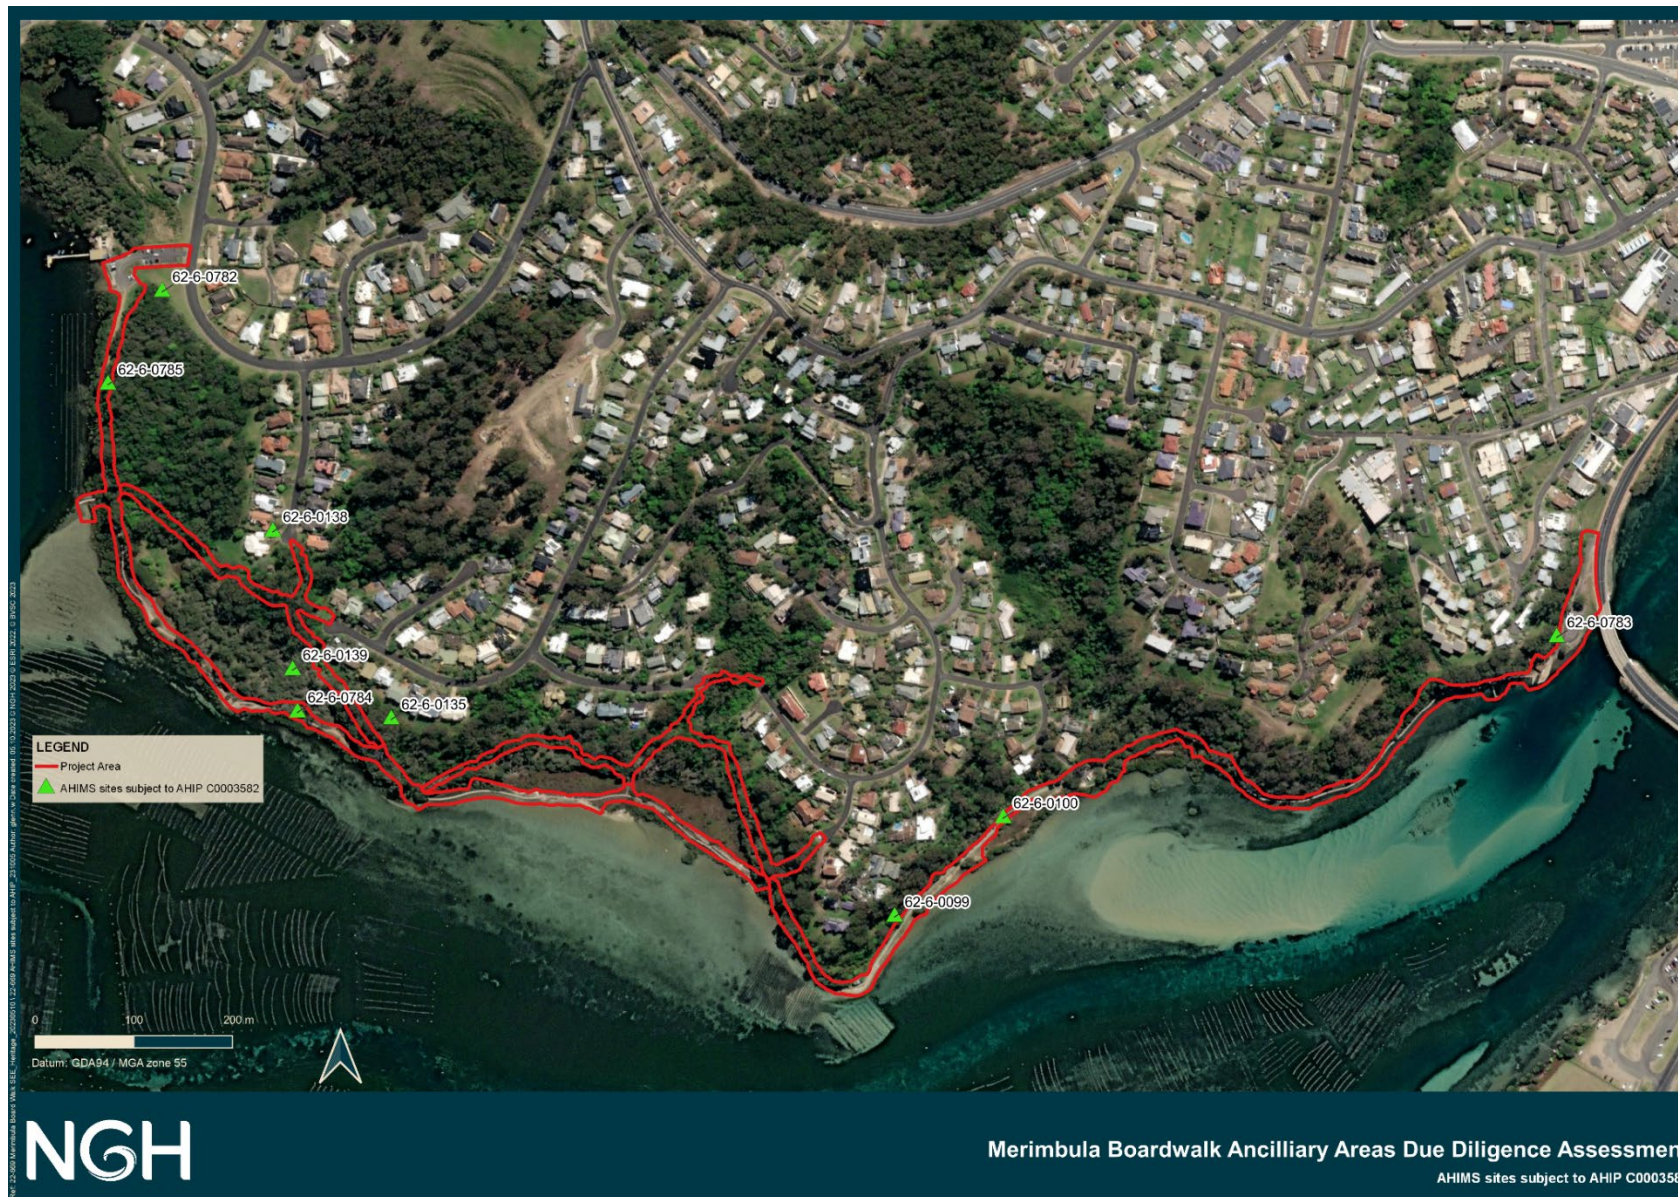
Figure 4-4 AHIMS sites subject to AHIP C0003582

AHIP number C0003582 was issued in June 2018 to authorise impacts from the proposed works to nine sites as shown in the table below for the Merimbula Boardwalk and Foreshore Path upgrade works, however the area covered by the AHIP was not clearly mapped using GIS when it was originally submitted. Based on the hard copy mapping provided within the AHIP documentation, the estimated AHIP area is indicated in yellow in Figure 4-5.

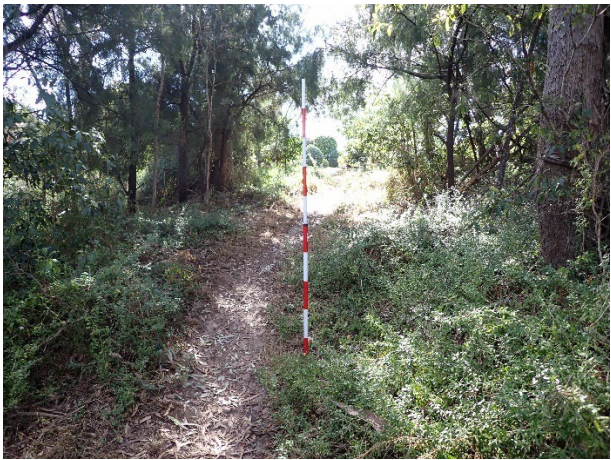
<p>Plate 1 Steep trail to Otway Close facing north</p>	<p>Plate 2 Flaked artefact on steep trail to Otway Close (MBW_AA_Artefact_01)</p>

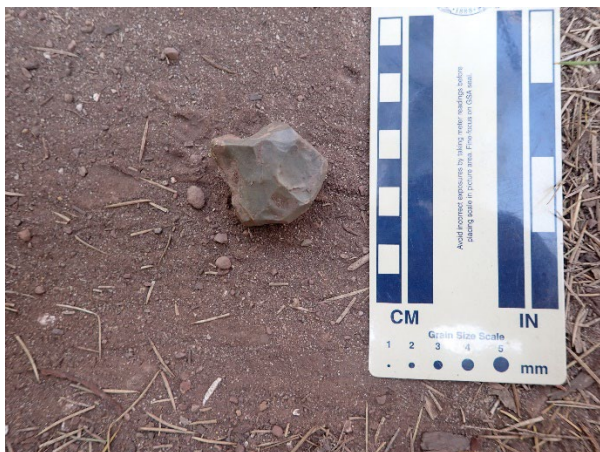
Plate 3 Core (MBW_AA_Artefact_02)

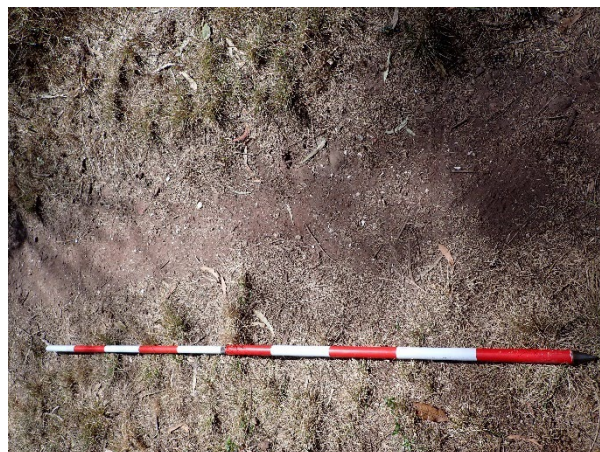
Plate 4 Overview of shell fragments on track (MBW_AA_Shell_01)

Site Name	Description
MBW_AA_Shell_01	Surface scatter of fragmented shell in poor condition on a vehicle track
MBW_AA_Shell_02	Surface scatter of fragmented shell in poor condition on a vehicle track
MBW_AA_Shell_03	Surface scatter of fragmented shell in poor condition eroding from hill side at rear of residential property. Likely associated with AHIMS site # 62 6 0139. 100+ fragments of mud oyster and shell 25+ fragments of Anadara. Mud oyster dominant species present which accords with 1983 recording
MBW_AA_Shell_04	Dense midden of at least 800mm deep stratified deposit exposed by cutting for track creation. Likely part of complex as recorded by Hughes and registered as AHIMS # 62-6-0135
MBW_AA_Shell_05	Dense midden of stratified deposit exposed by cutting for track creation. There may be undisturbed midden on lake side of track but unlikely given limited relief above water. Likely associated with AHIMS 62-6-0134.

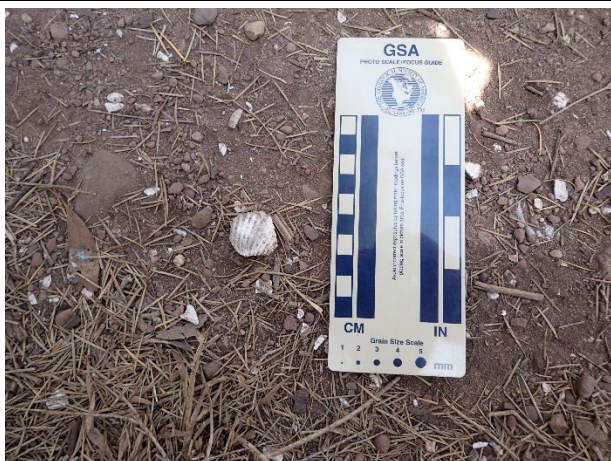
Plate 5 Shell fragments (MBW_AA_Shell_01)

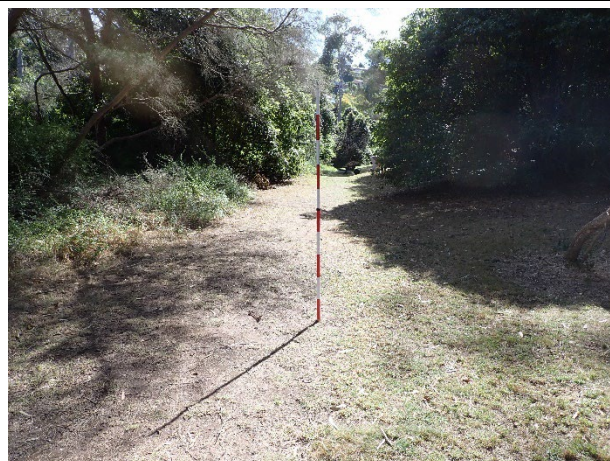
Plate 6 Overview of shell fragments exposed on track (MBW_AA_Shell_02)

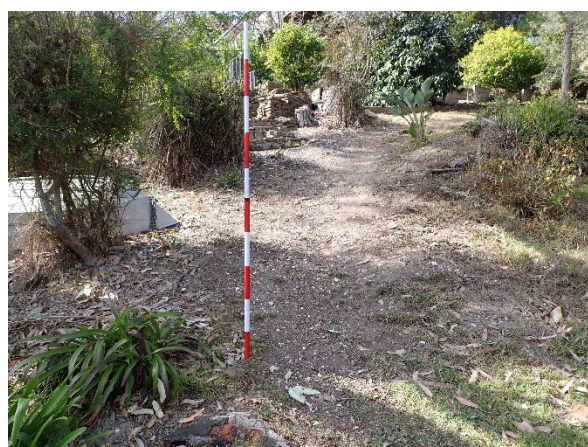
Plate 8 Fragmented shell and artefact location (MBW_AA_Shell_03 & MBW_AA_Artefact_04) likely associated with AHIMS site 62-6-0135

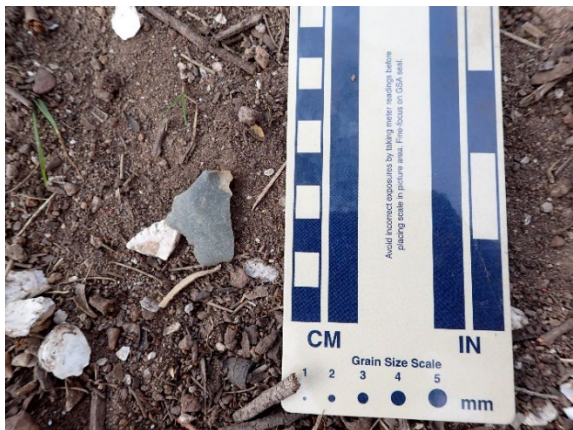
Plate 9 Flaked artefact with fragmented shell (MBW_AA_Shell_03 & MBW_AA_Artefact_04), likely associated with AHIMS site 62-6-0135

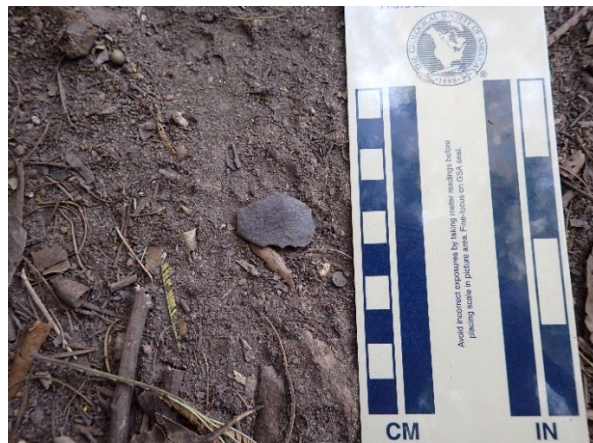
Plate 10 Flaked artefact on lakeshore flat (MBW_AA_Artefact_03)

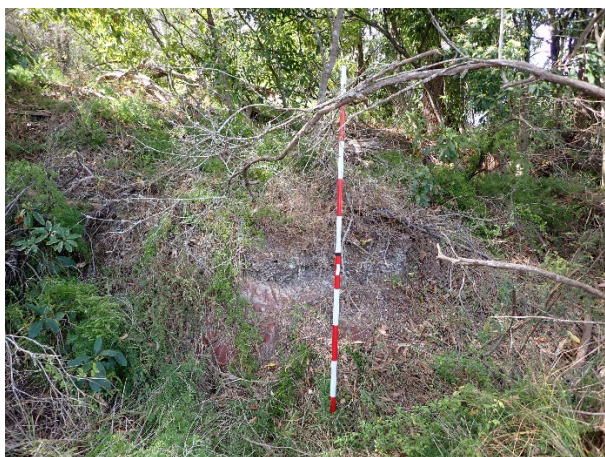
Plate 11 Dense shell midden deposit in cutting near Project Area boundary (MBW_AA_Shell_04)

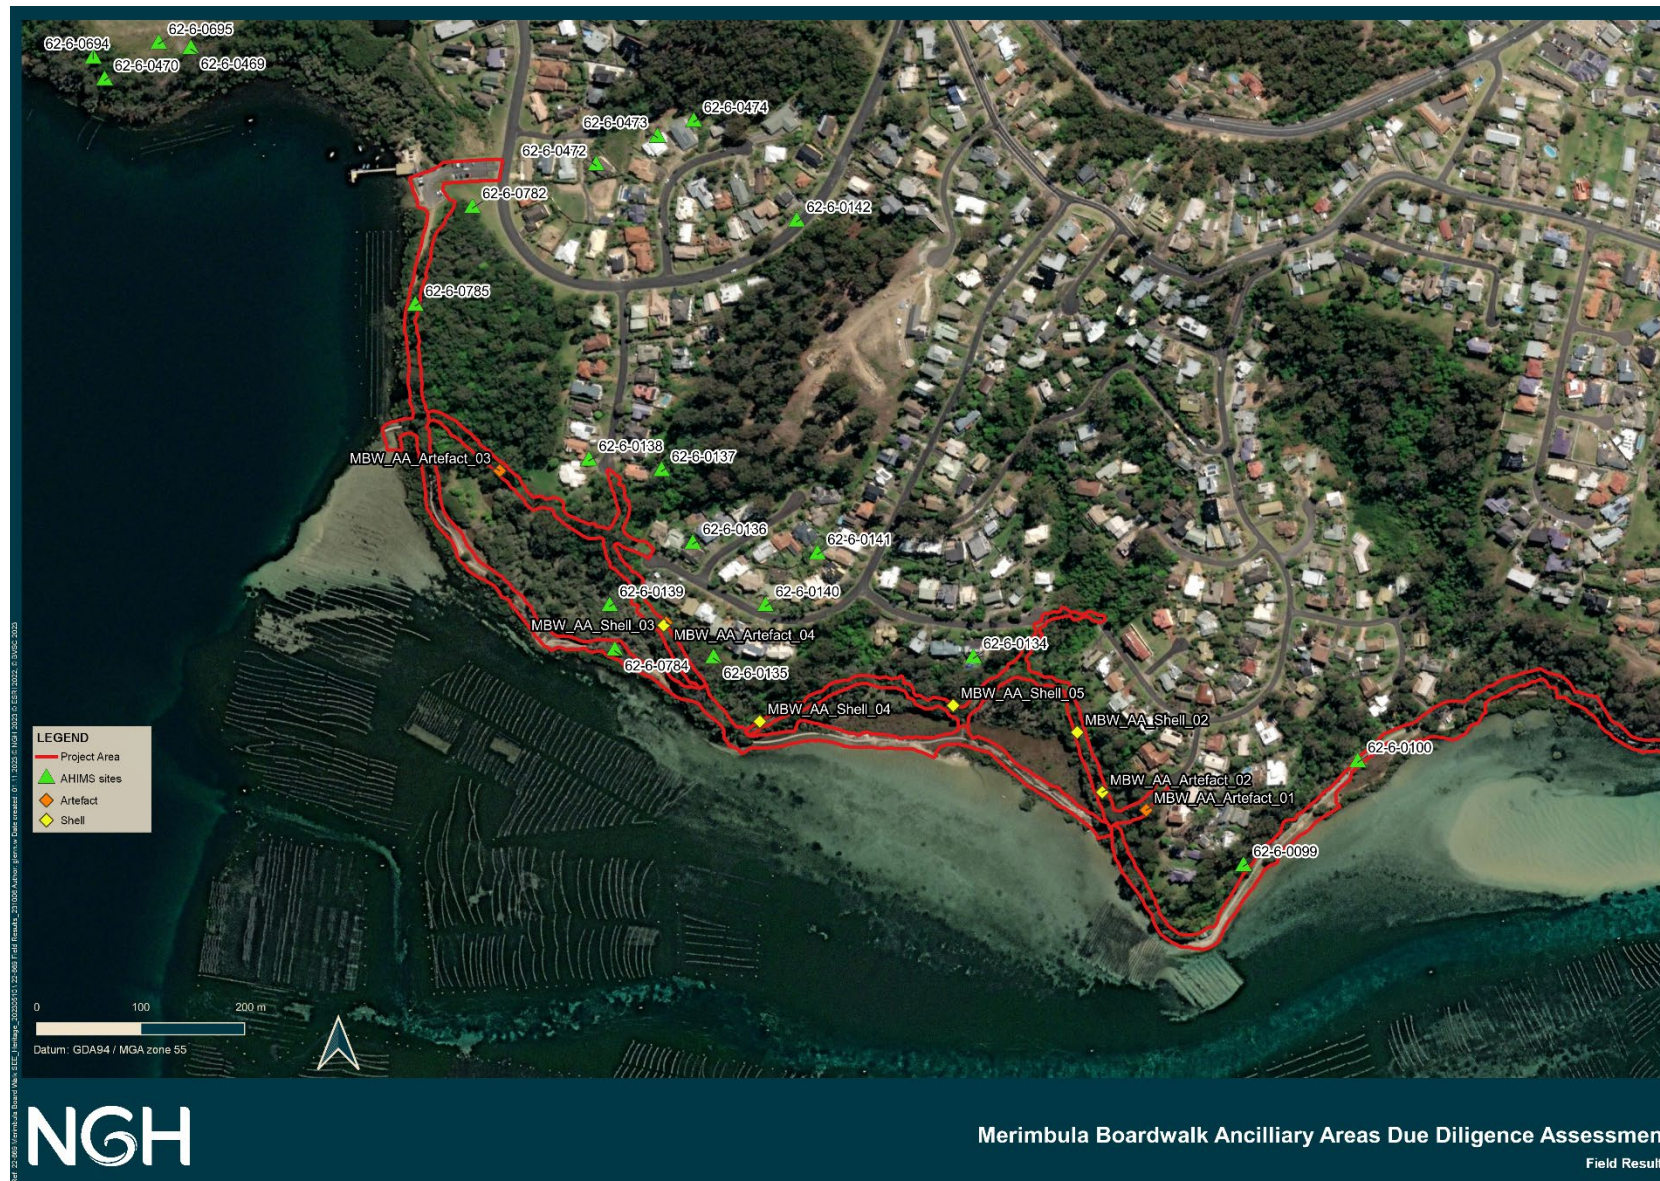
Figure 6-1 Field Results

See Appendix A below for details of shell features and artefacts recorded during the field inspection.
