WRL Ref: WRL2025012 LR20250428ab JTC

Cliff stabilisation works at 217A Beach Road, Denhams Beach

The Water Research Laboratory (WRL) of the School of Civil and Environmental Engineering at UNSW Sydney is pleased to provide this letter report to Canplay Pty Ltd via Beatty Hughes and Associates.

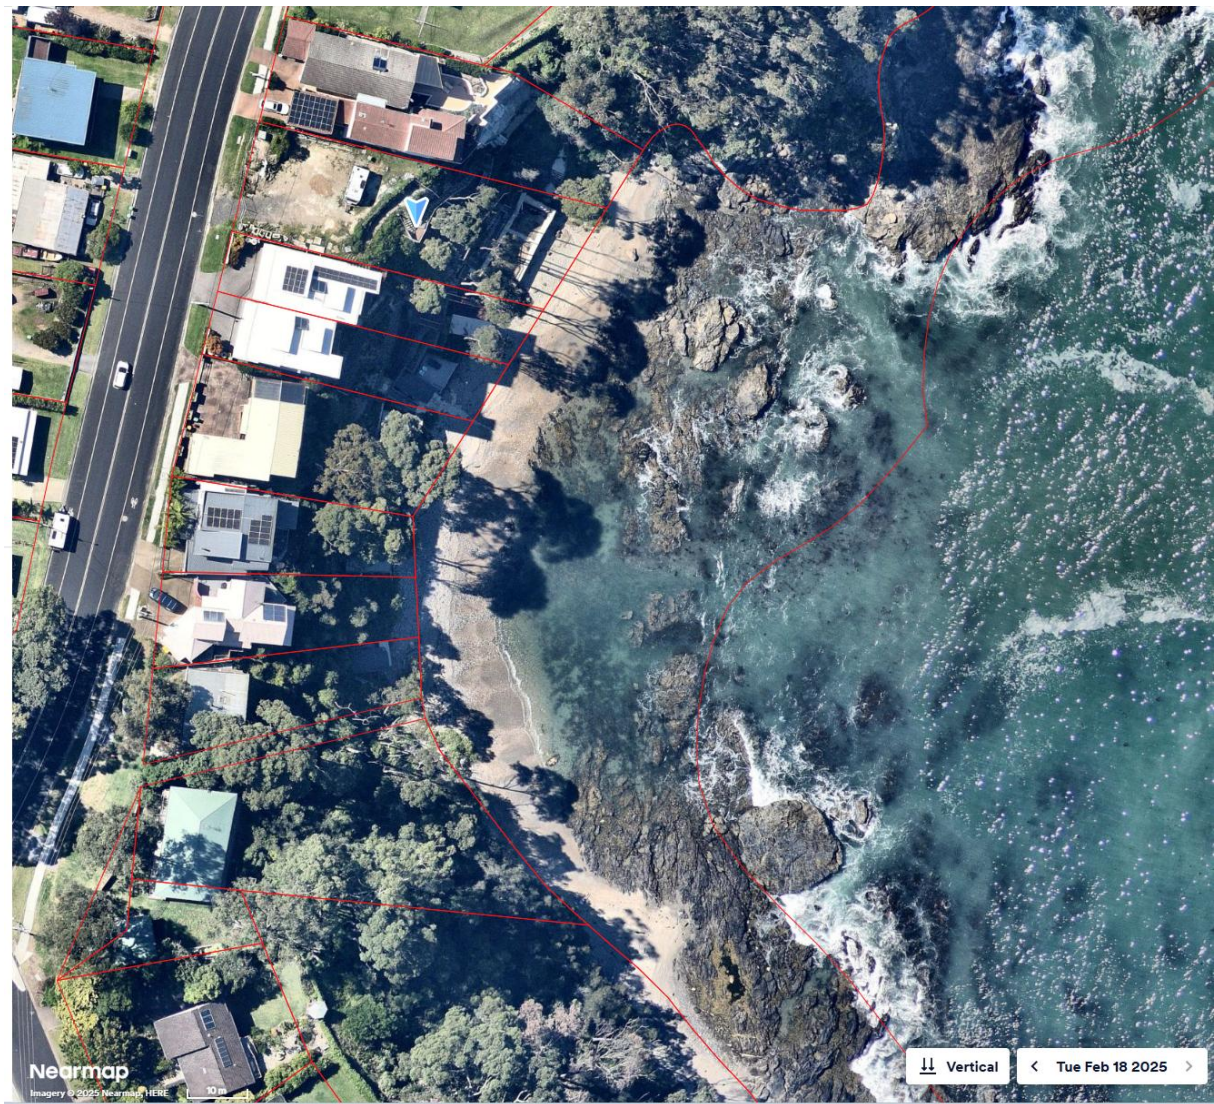
Figure 1-2 Subject property indicated with blue arrow (Nearmap)

The beach is predominantly a rocky cove with steep cliffy headlands at each end, and is backed by a steep cliff fronting private properties. The beach consists of an apparently thin veneer of sand, pebbles and shells, over predominantly exposed bedrock and reef. The sand/pebble/shell beach is suitable for walking on and for entering the water through a narrow keyhole gap between the rocky outcrops (Figure 1-2).

This letter provides advice regarding the coastal engineering aspects of the cliff stabilisation works at 217A Beach Road, Denhams Beach (in Batemans Bay, NSW) – “the subject property” (Figure 1-1 and Figure 1-2).

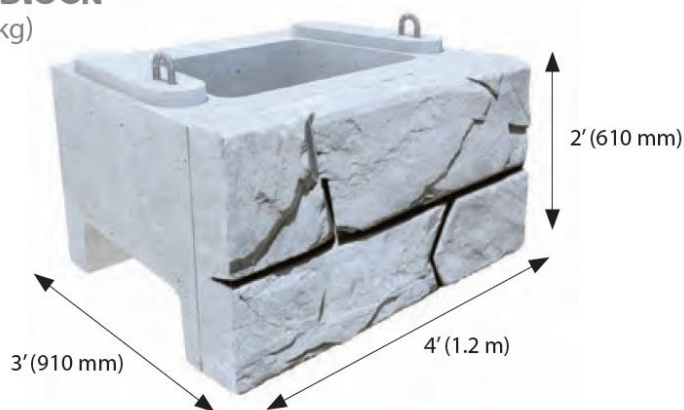
Figure 4-5 Baines Masonry Verti-Block standard block dimensions

Standard Block
1,755 lbs. (790 kg)

The subject property has terraced retaining walls fronting the beach at the base of its cliff. The walls are constructed from Baines Masonry "Verti-Block" precast concrete interlocking blocks. These blocks have hollow cores for gravel and/or reinforced concrete filling. The standard unfilled blocks have a course height of 610 mm and a mass of 790 kg, with various component blocks having a mass ranging from 440 to 1590 kg (Figure 4-5). Neighbouring properties also have cliff stabilisation works, including terraced gabions, timber, (possibly) geogrids and shotcrete.

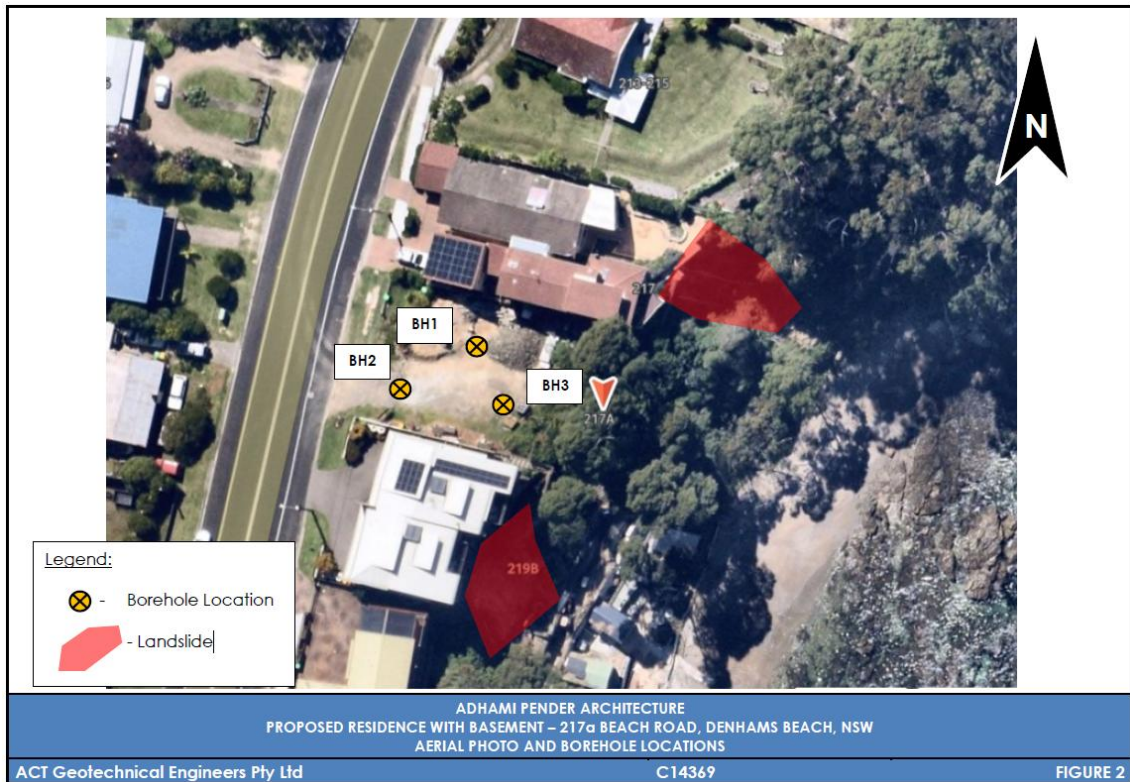
Figure 5-1 Extract from geotechnical report

A Geotechnical report has been prepared by ACT Geotechnical Engineers on 30 June 2023 (ref: OB/C14369). Figure 2 of the Geotechnical report indicates that landslides have occurred on the properties on either side of the subject property (Figure 5-1 of this WRL letter). The bedrock found at three boreholes on the upper portion of the site was described as:

“SHALE: Extremely weathered and Highly weathered, excavated as Sandy CLAY, extremely weak, pale grey, some gravel, fine grained.”
