Report on
Updated Contamination Assessment

Jumping Creek Estate Development
Ellerton Drive, Queanbeyan

Prepared for
Peet Limited

Project 88224.06
September 2020

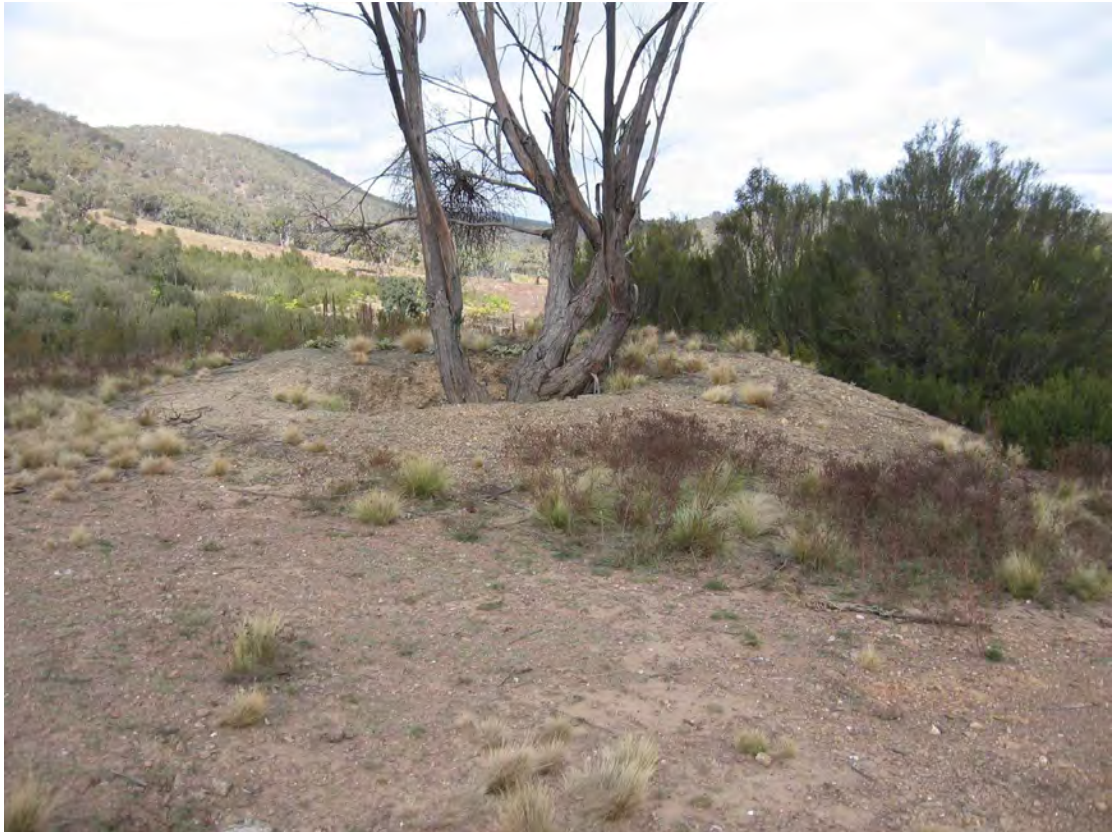
Photograph 1: Mine Site 1 looking South

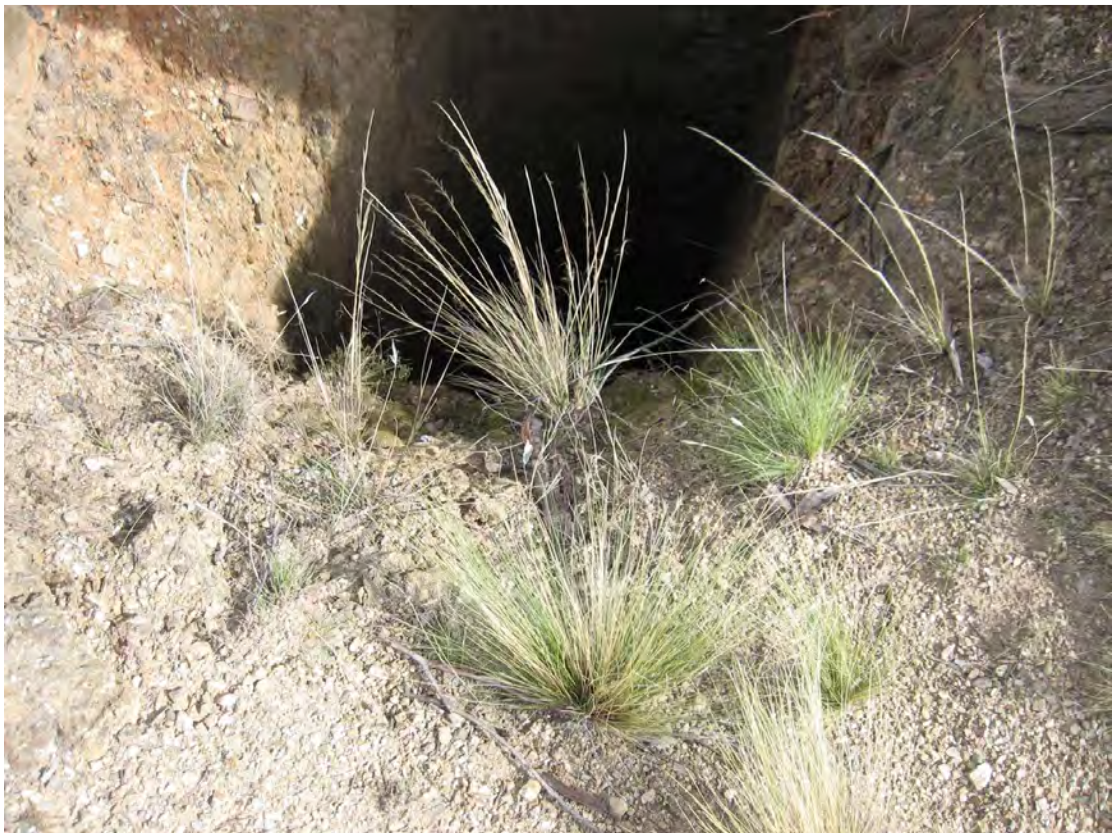
Photograph 2: Mine Site 1 shaft

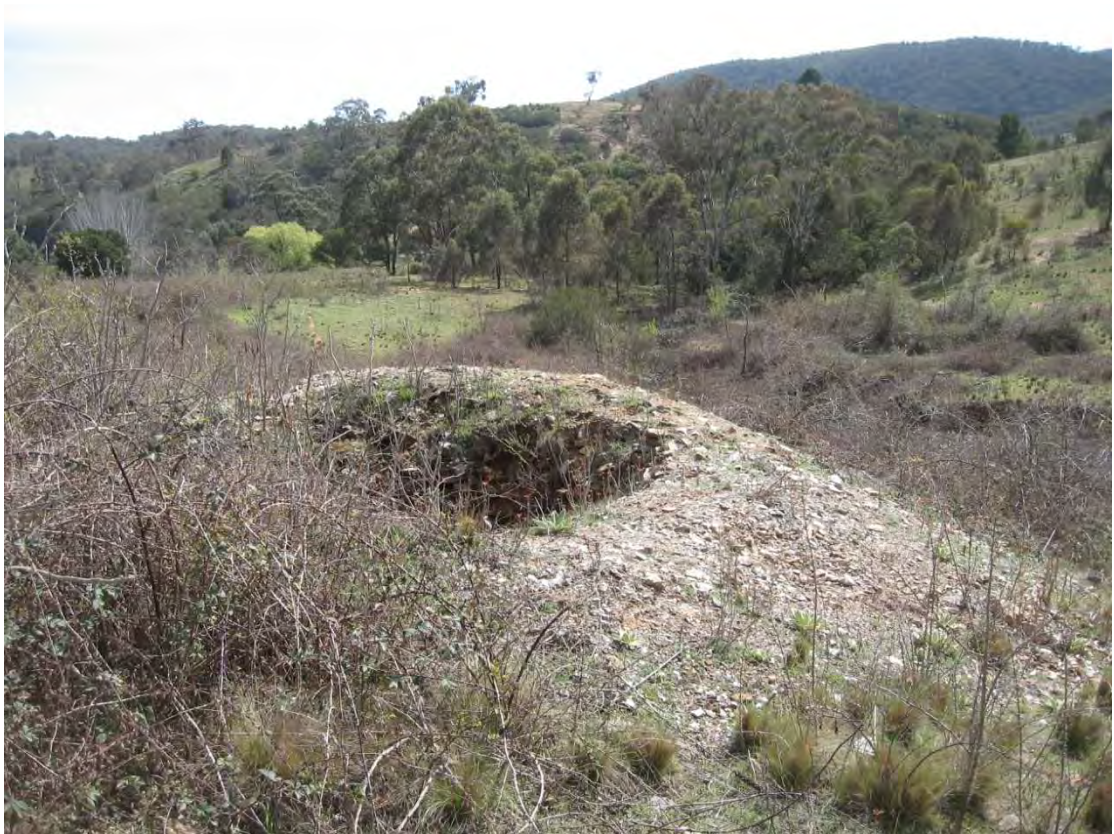
Photograph 8: Mine Site 3 looking North

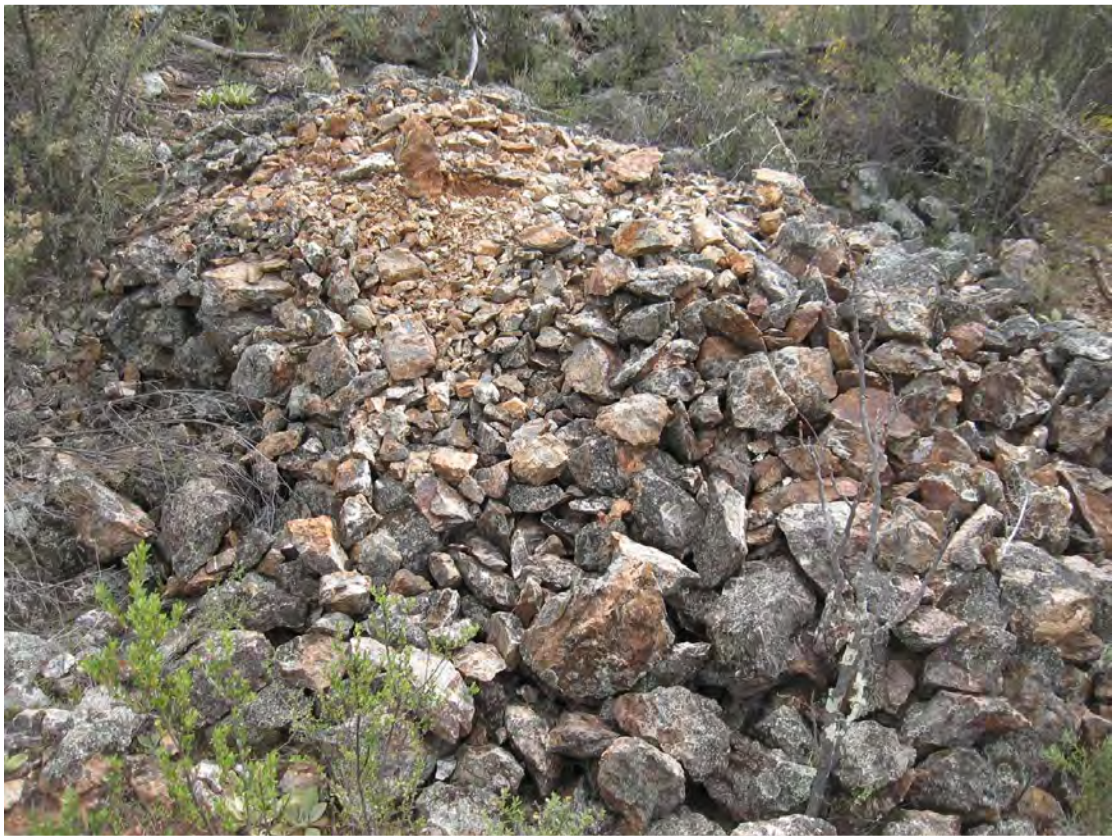
Photograph 12: Mine Site 4 stockpiled material

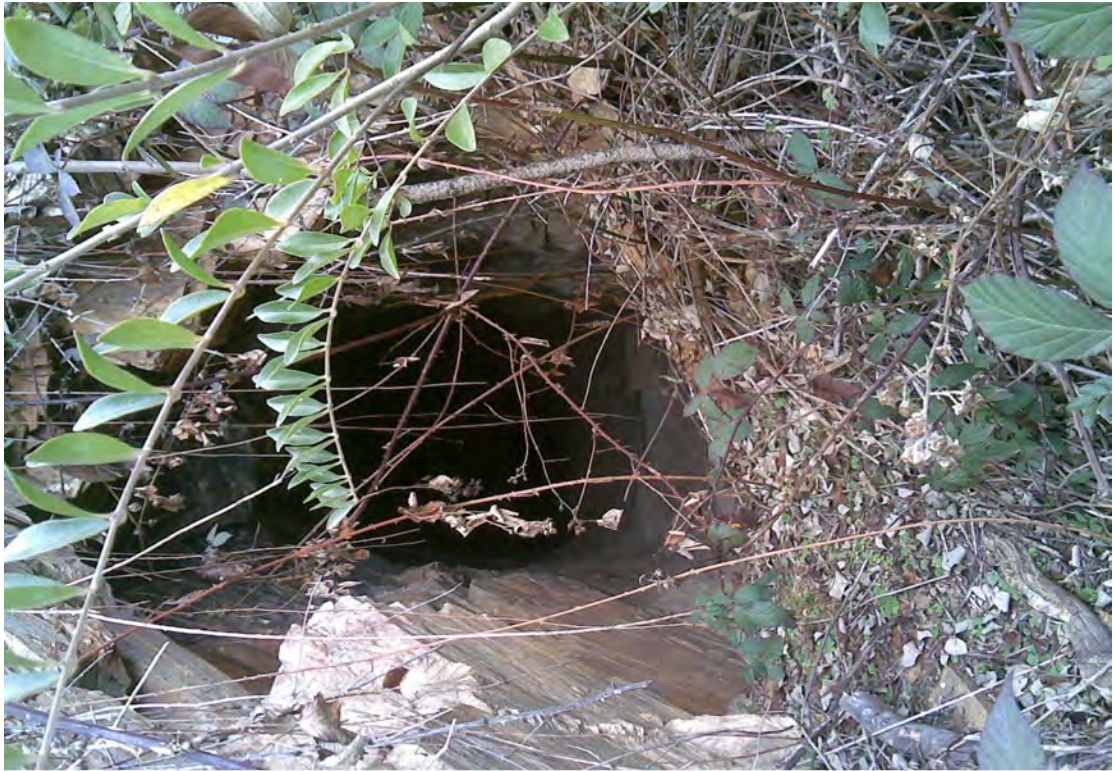
Photograph 19: Mine Site 4 – Shaft

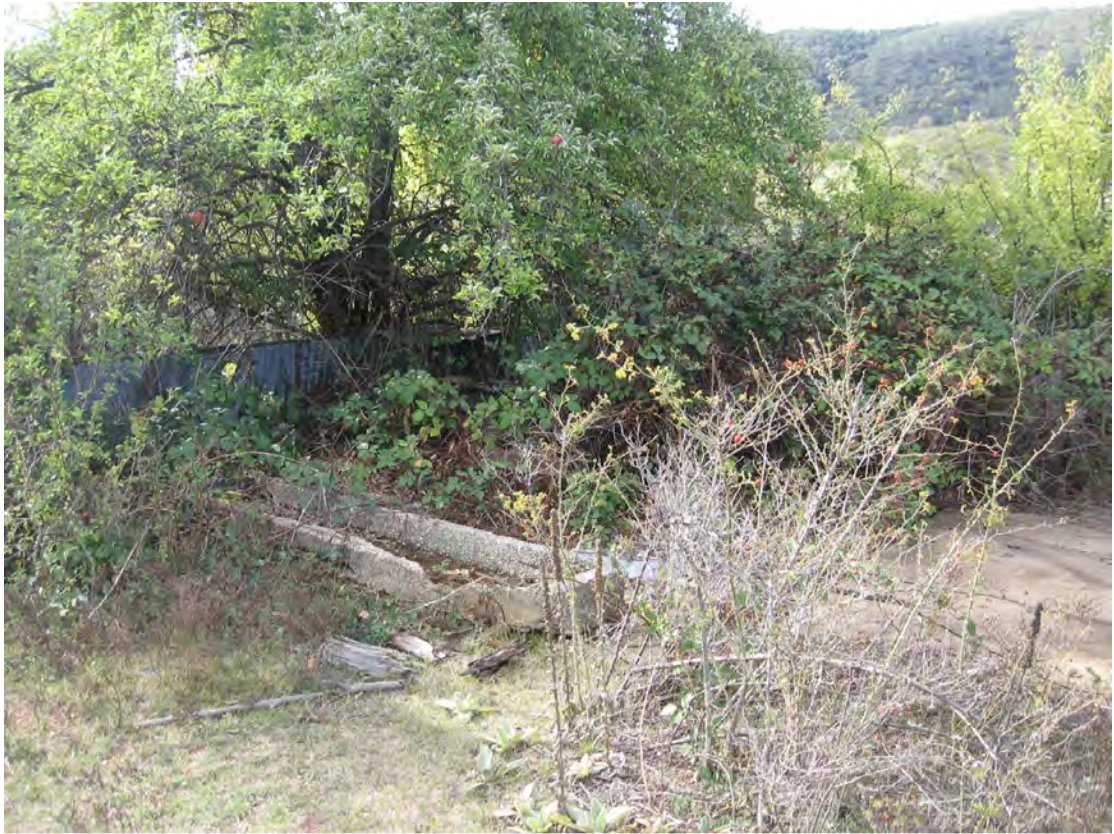
Photograph 21: Minerals Processing Area – Trough structure

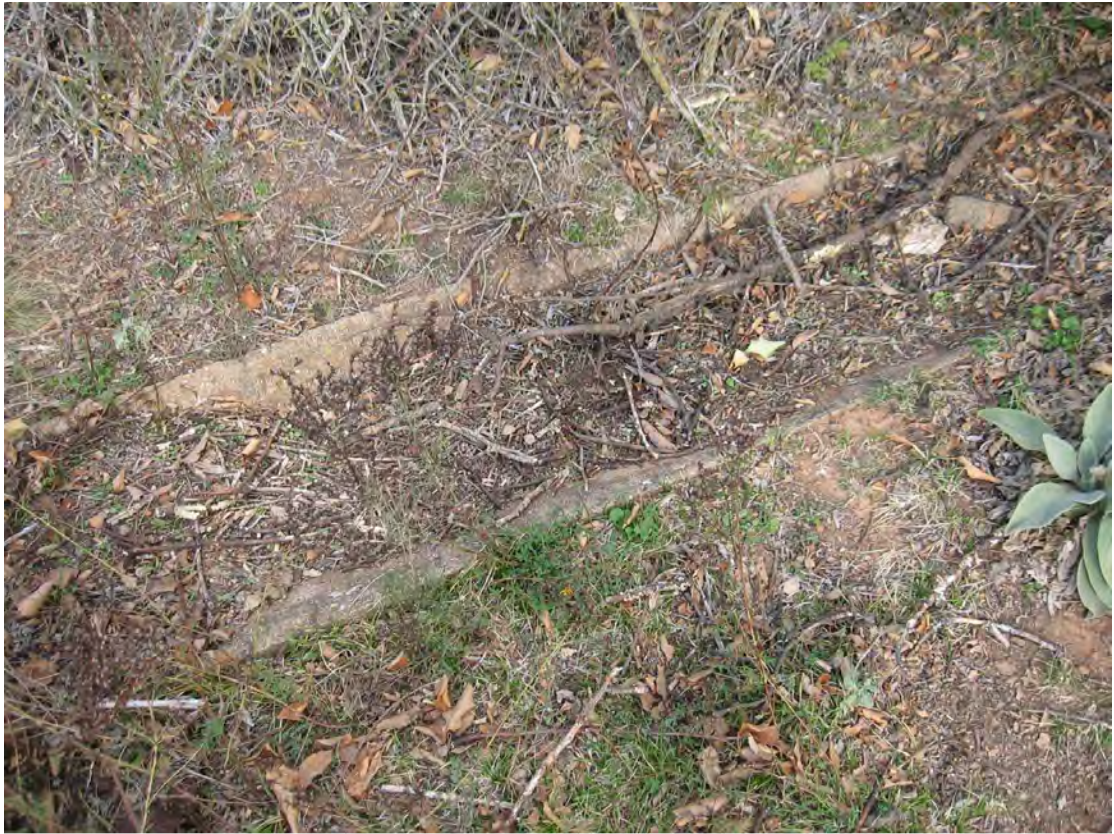
Photograph 25: Minerals processing Area – shallow concrete drain to sump structure

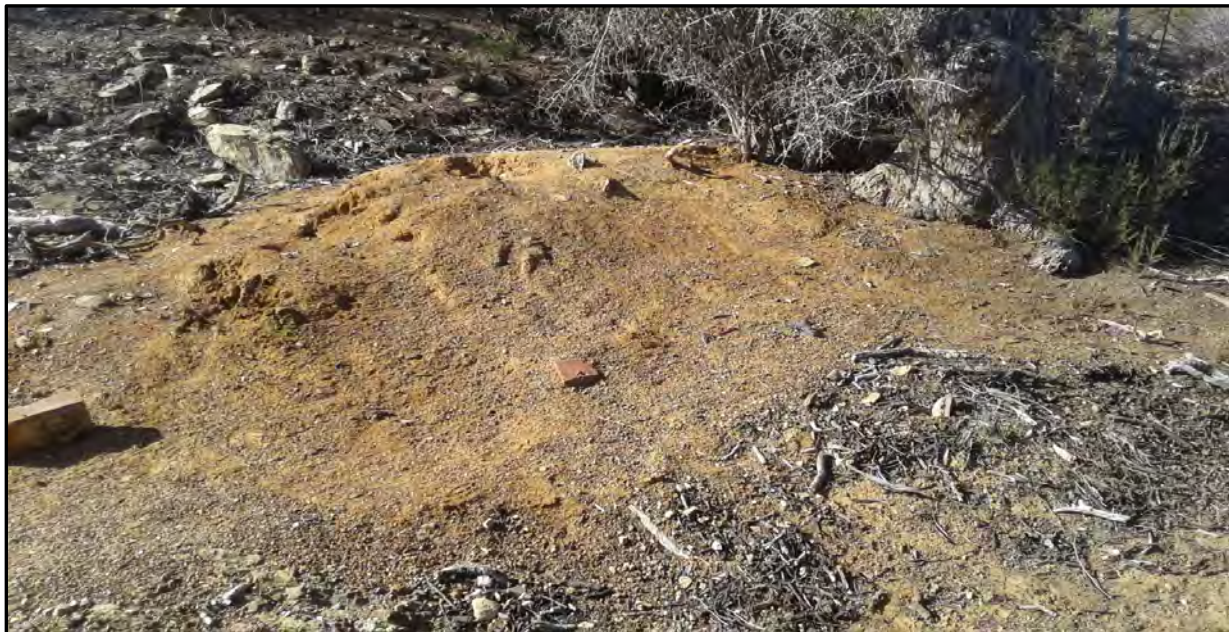
Photo 36: View of small stockpile in east of the site containing asbestos material
