GEOTECHNICAL INVESTIGATION REPORT

Proposed Residential Development

96-98 Lethbridge Street & 42-46 Evan Street

Penrith, NSW

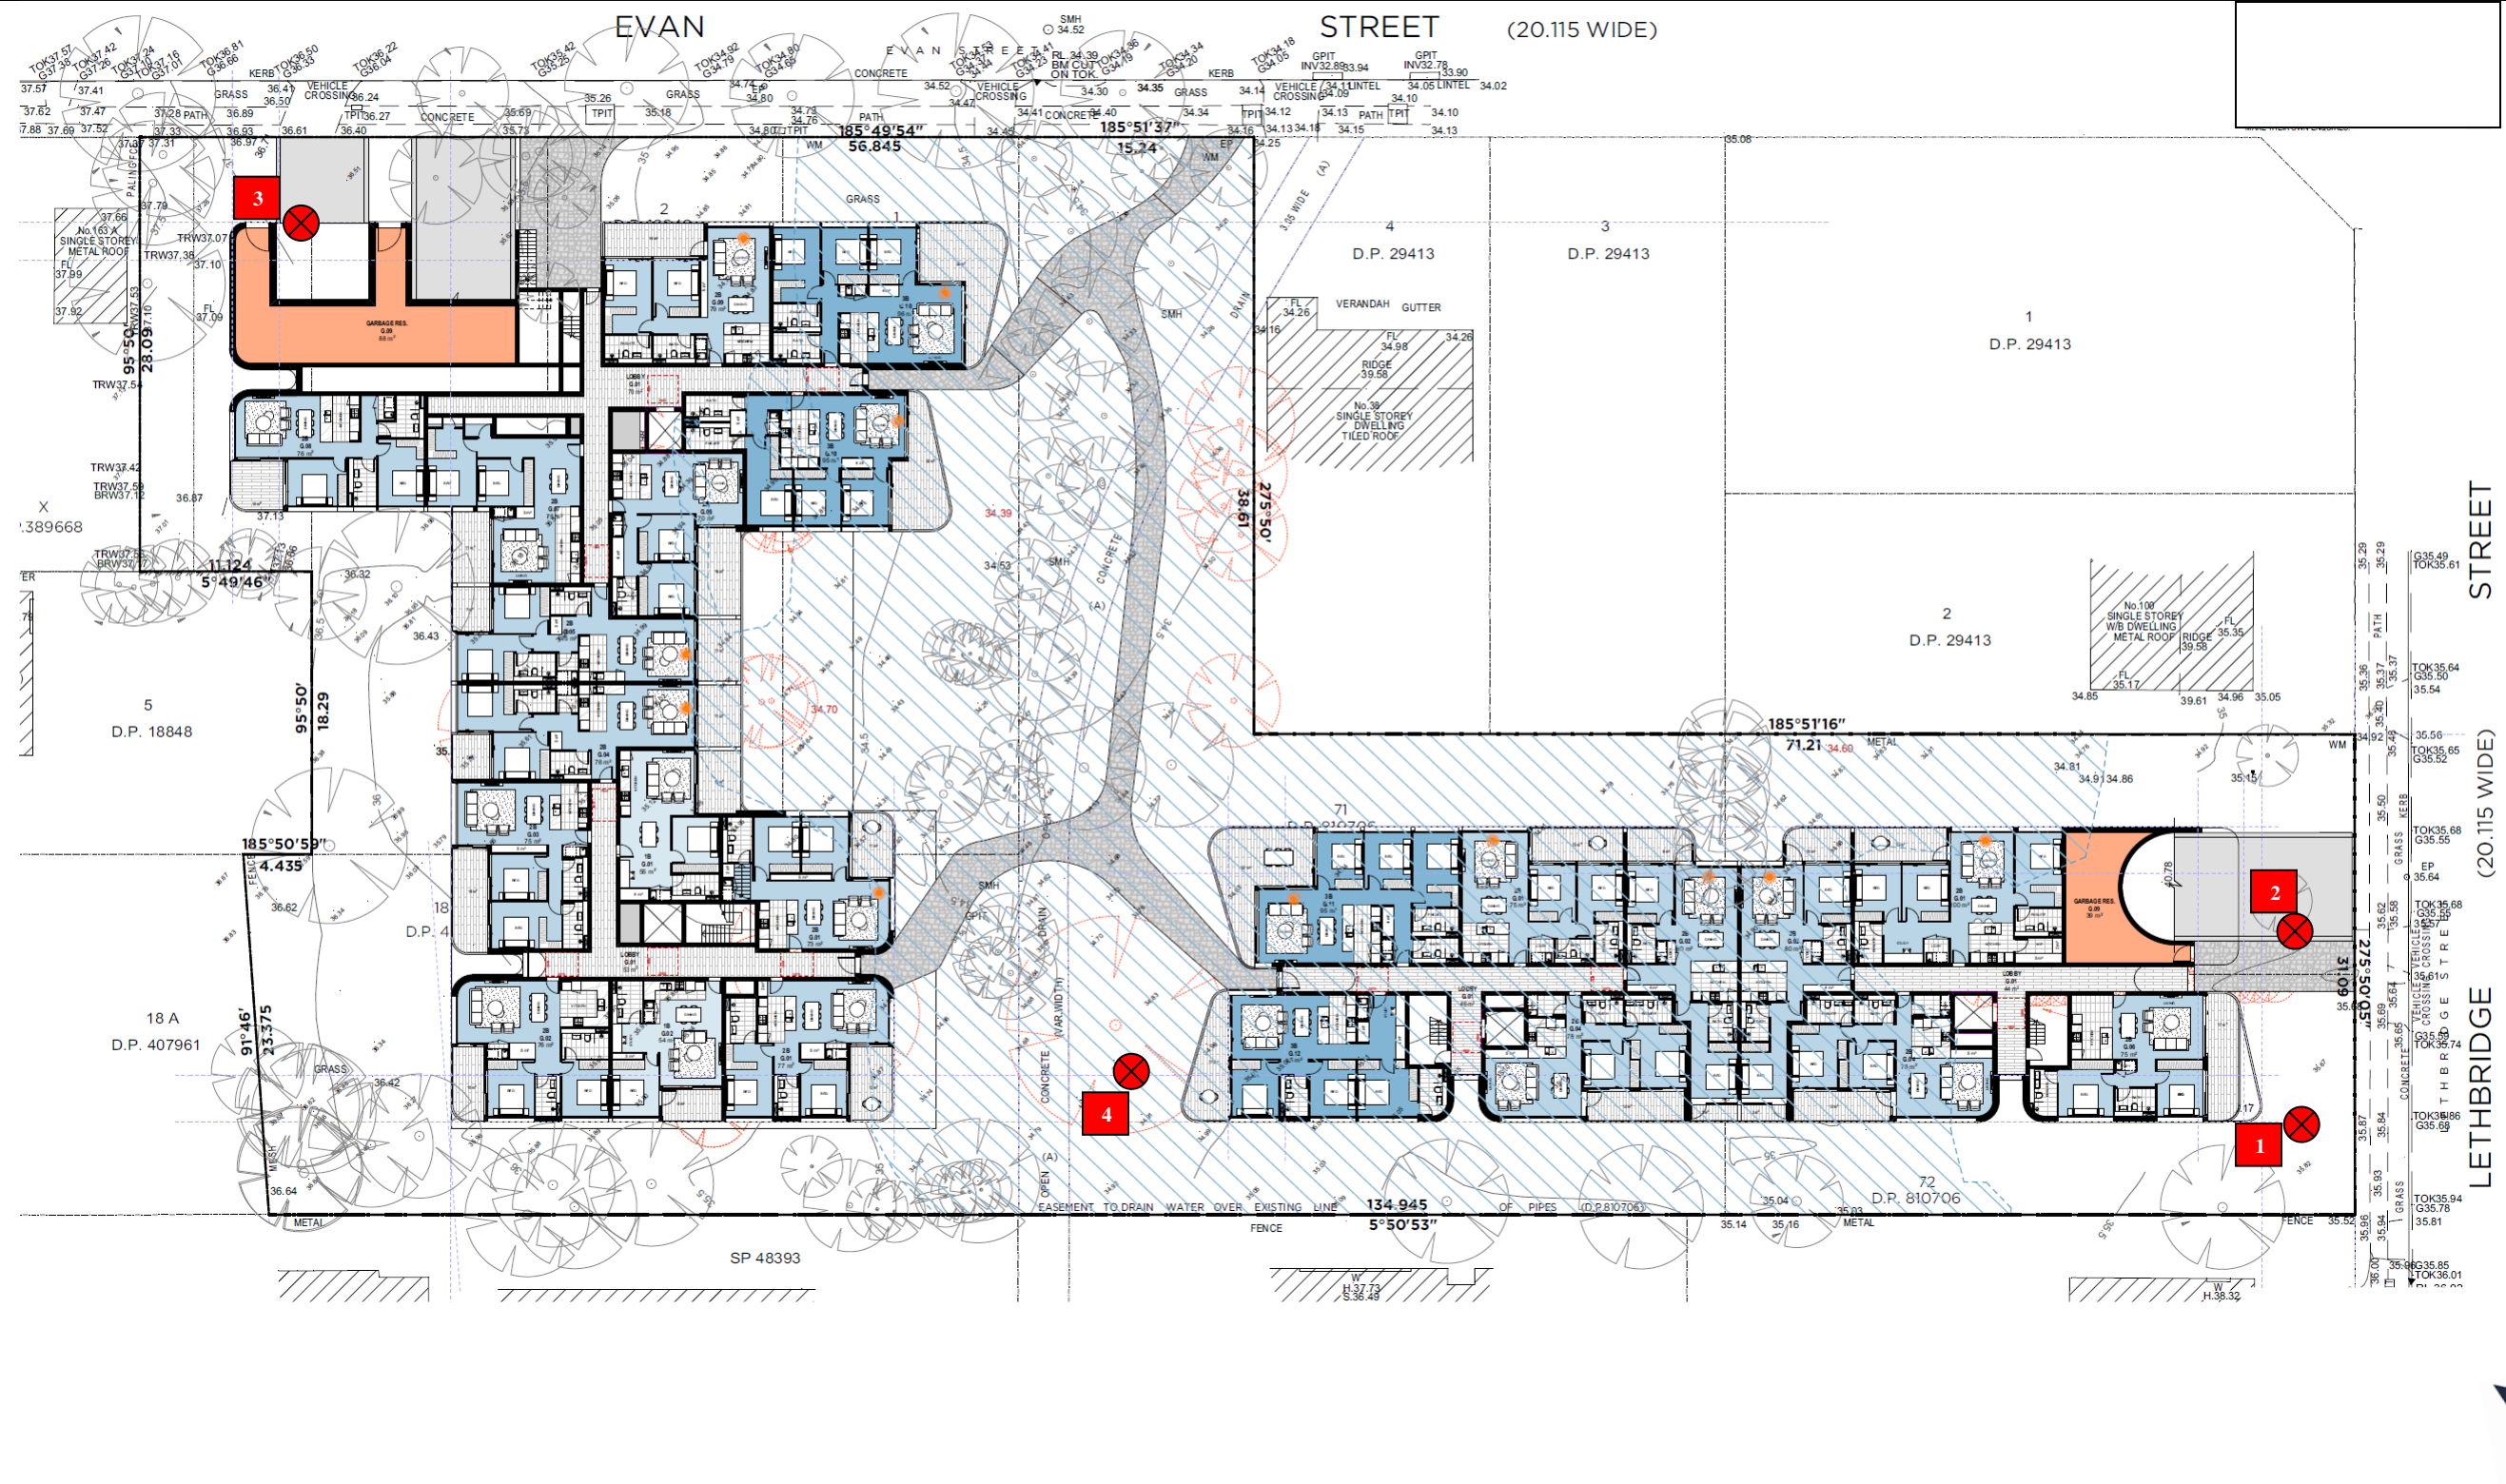
Borehole Location Plan

Source: Project 19107 Drawing DA-103 prepared by Urbanlink Pty Ltd

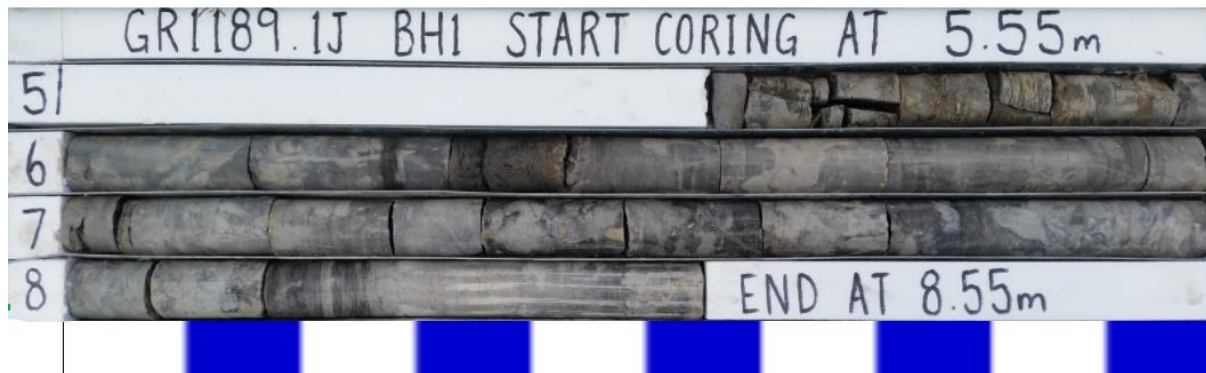
GW Observation	Depth (m)	Graphic Log	Material Description	Weathering Condition	Strength	DEFECT DESCRIPTION	Defect Spacing mm	Point Load(a)							
								EL<0.03	VL0.03-0.1	L0.1-0.3	M0.3-1.0	H1.0-3.0	VH3.0-10.0	EH>10.0	
			Start coring at 5.55m Shale: grey and dark grey bedded at 0° 10° with claystone lenses.	DW	L-M	5.65,JT,70°,P,SM 5.83,JT,80°,P,SM	30 100 300 1000 3000	0.04	0.1	0.3	1	2	3	5	8
	6				M	6.37,CS,60mm									
	7														
	8														
	9		End of Borehole at 8.55m												
	10														
	11														
	12														
	13														
	14

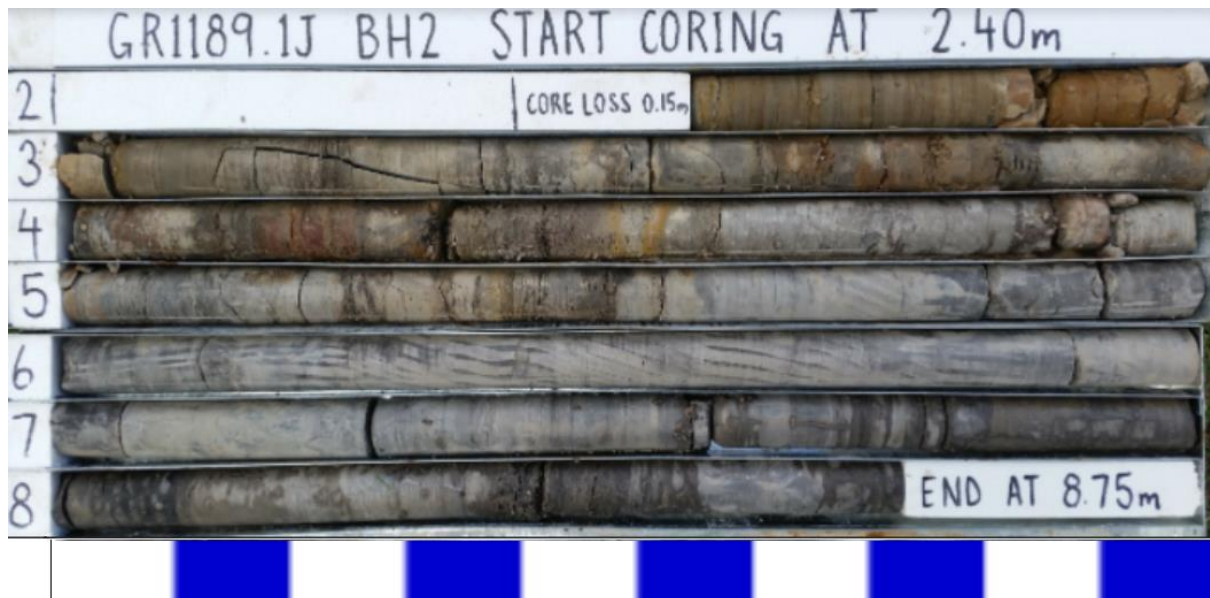
Borehole No: 2
Project No: GR1189.1J

GW Observation	Depth (m)	Graphic Log	Material Description	Weathering Condition	Strength	DEFECT DESCRIPTION	Defect Spacing mm	Point Load(a)							
								EL<0.03	VL0.03-0.1	L0.1-0.3	M0.3-1.0	H1.0-3.0	VH3.0-10.0	EH>10.0	
			Start coring at 2.40m	-	-		30 100 300 1000 3000	0.04 0.1 0.3 1 2 3 5 8							
			Core Loss, 150mm												
	3		Sandstone: fine grained, orange brown and light brown, bedded at 0°-10°.	DW	L-M	2.86,Cr,25mm 2.98,JT,60°,P,SM 3.25,JT,70°,P,SM									
			Shale: orange brown and brown.												
	4		As above, but grey, light grey, red brown and orange brown.		VL	3.66,CS,20mm 3.79,CS,100mm									
					L	4.14,CS,20mm 4.23,CS,60mm 4.48,CS,50mm									
	5				L-M	4.86,Cr,10mm 4.91,Be,5°,P,SM									
			Shale: dark grey and grey.	SW	M	5.46,CS,20mm									
	6														
	7

7.57,Be,5°,P,SM									
	8			DW											
						8.42,XWS,30mm,0°									
	9		End of Borehole at 8.75m.												
	10														
	11

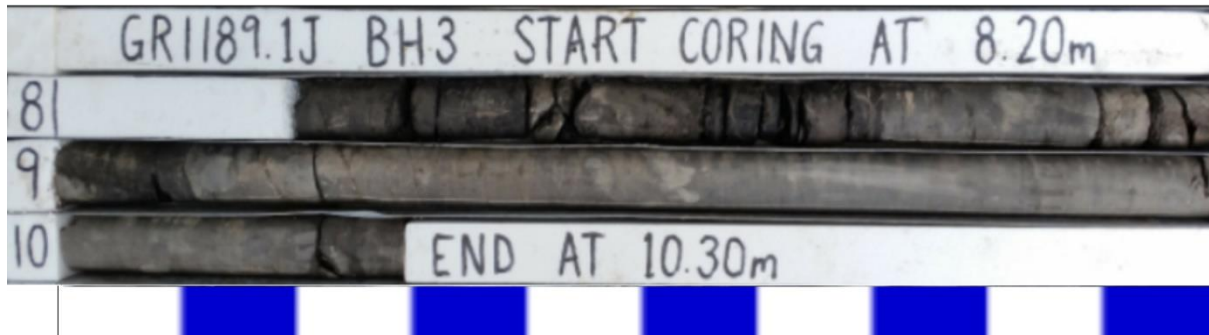
Borehole No: 3
Project No: GR1189.1J

GW Observation	Depth (m)	Graphic Log	Material Description	Weathering Condition	Strength	DEFECT DESCRIPTION	Defect Spacing mm	Point Load(a)							
								EL<0.03	VL0.03-0.1	L0.1-0.3	M0.3-1.0	H1.0-3.0	VH3.0-10.0	EH>10.0	
100 % Return	9

10		Shale: grey, bedded at 0°-10°.	SW	M										
	11		End of Borehole at 10.30m												
	12														
	13														
	14														
	15														
	16														
	17
