Watercourse Constraints Assessment Report

Proposed River Gardens
Cemetery,

Lot 1 DP 776645
1290 Greendale Road,
Wallacia, NSW

November 2020

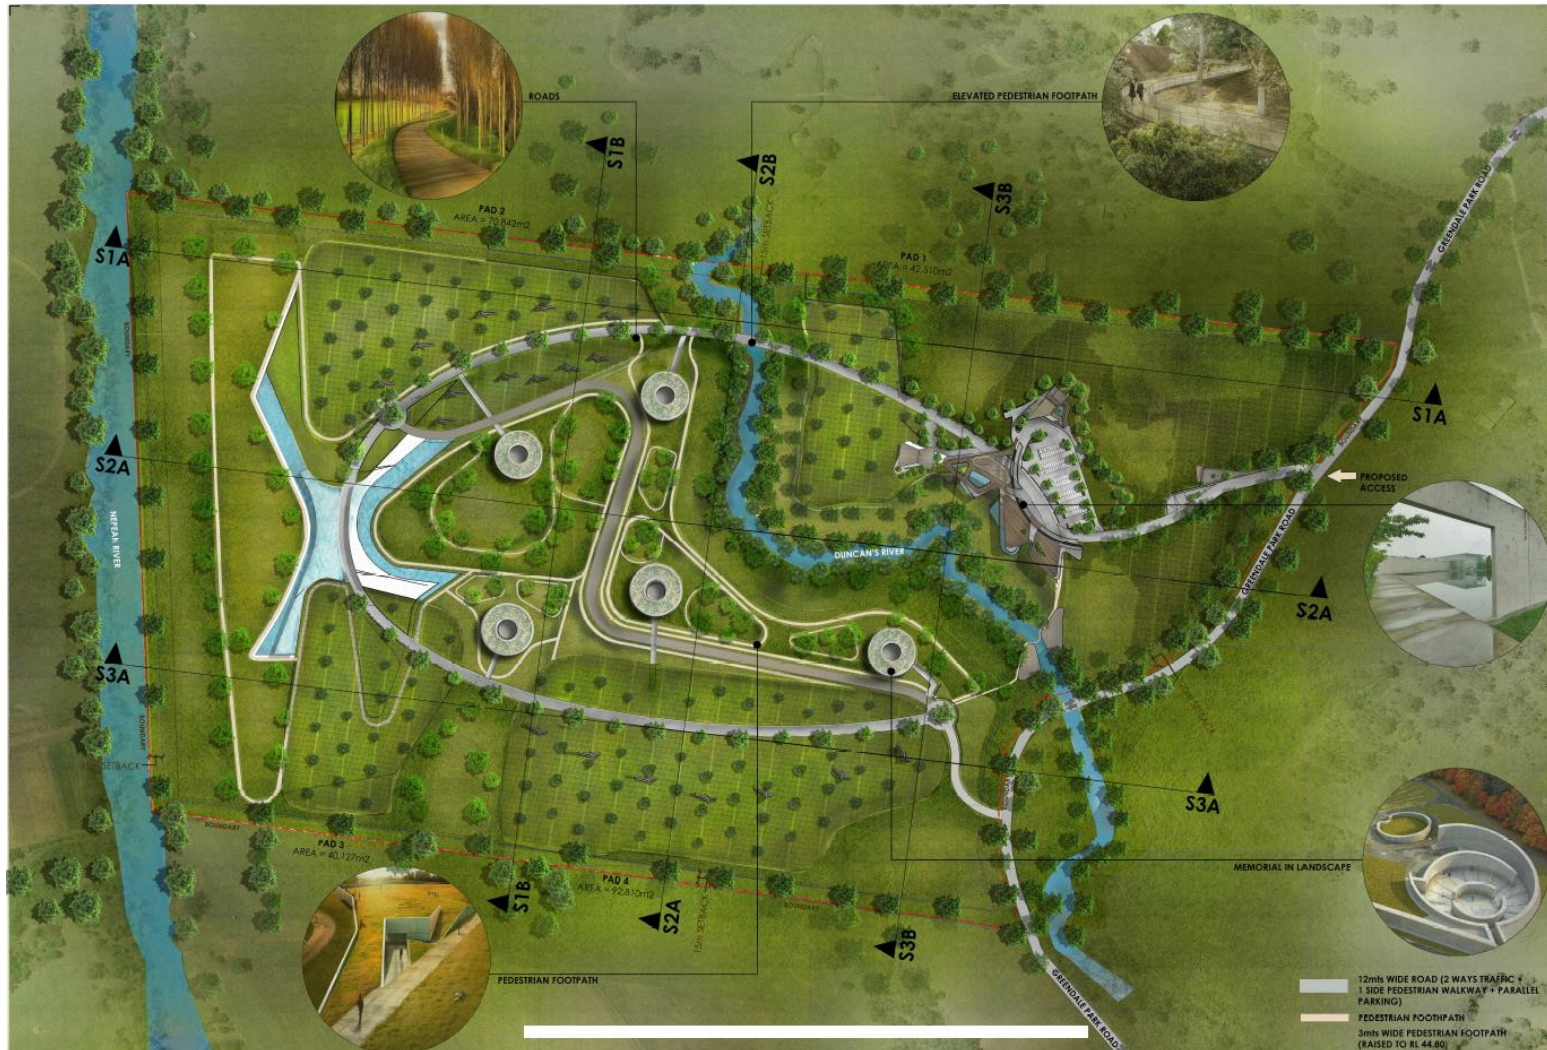
Figure 2 – Masterplan Layout of proposed cemetery
 (Source: MKDarchitects – drawing number B4.01 – November 2020)

Figure 2 demonstrates the proposed site plan for the river gardens cemetery.

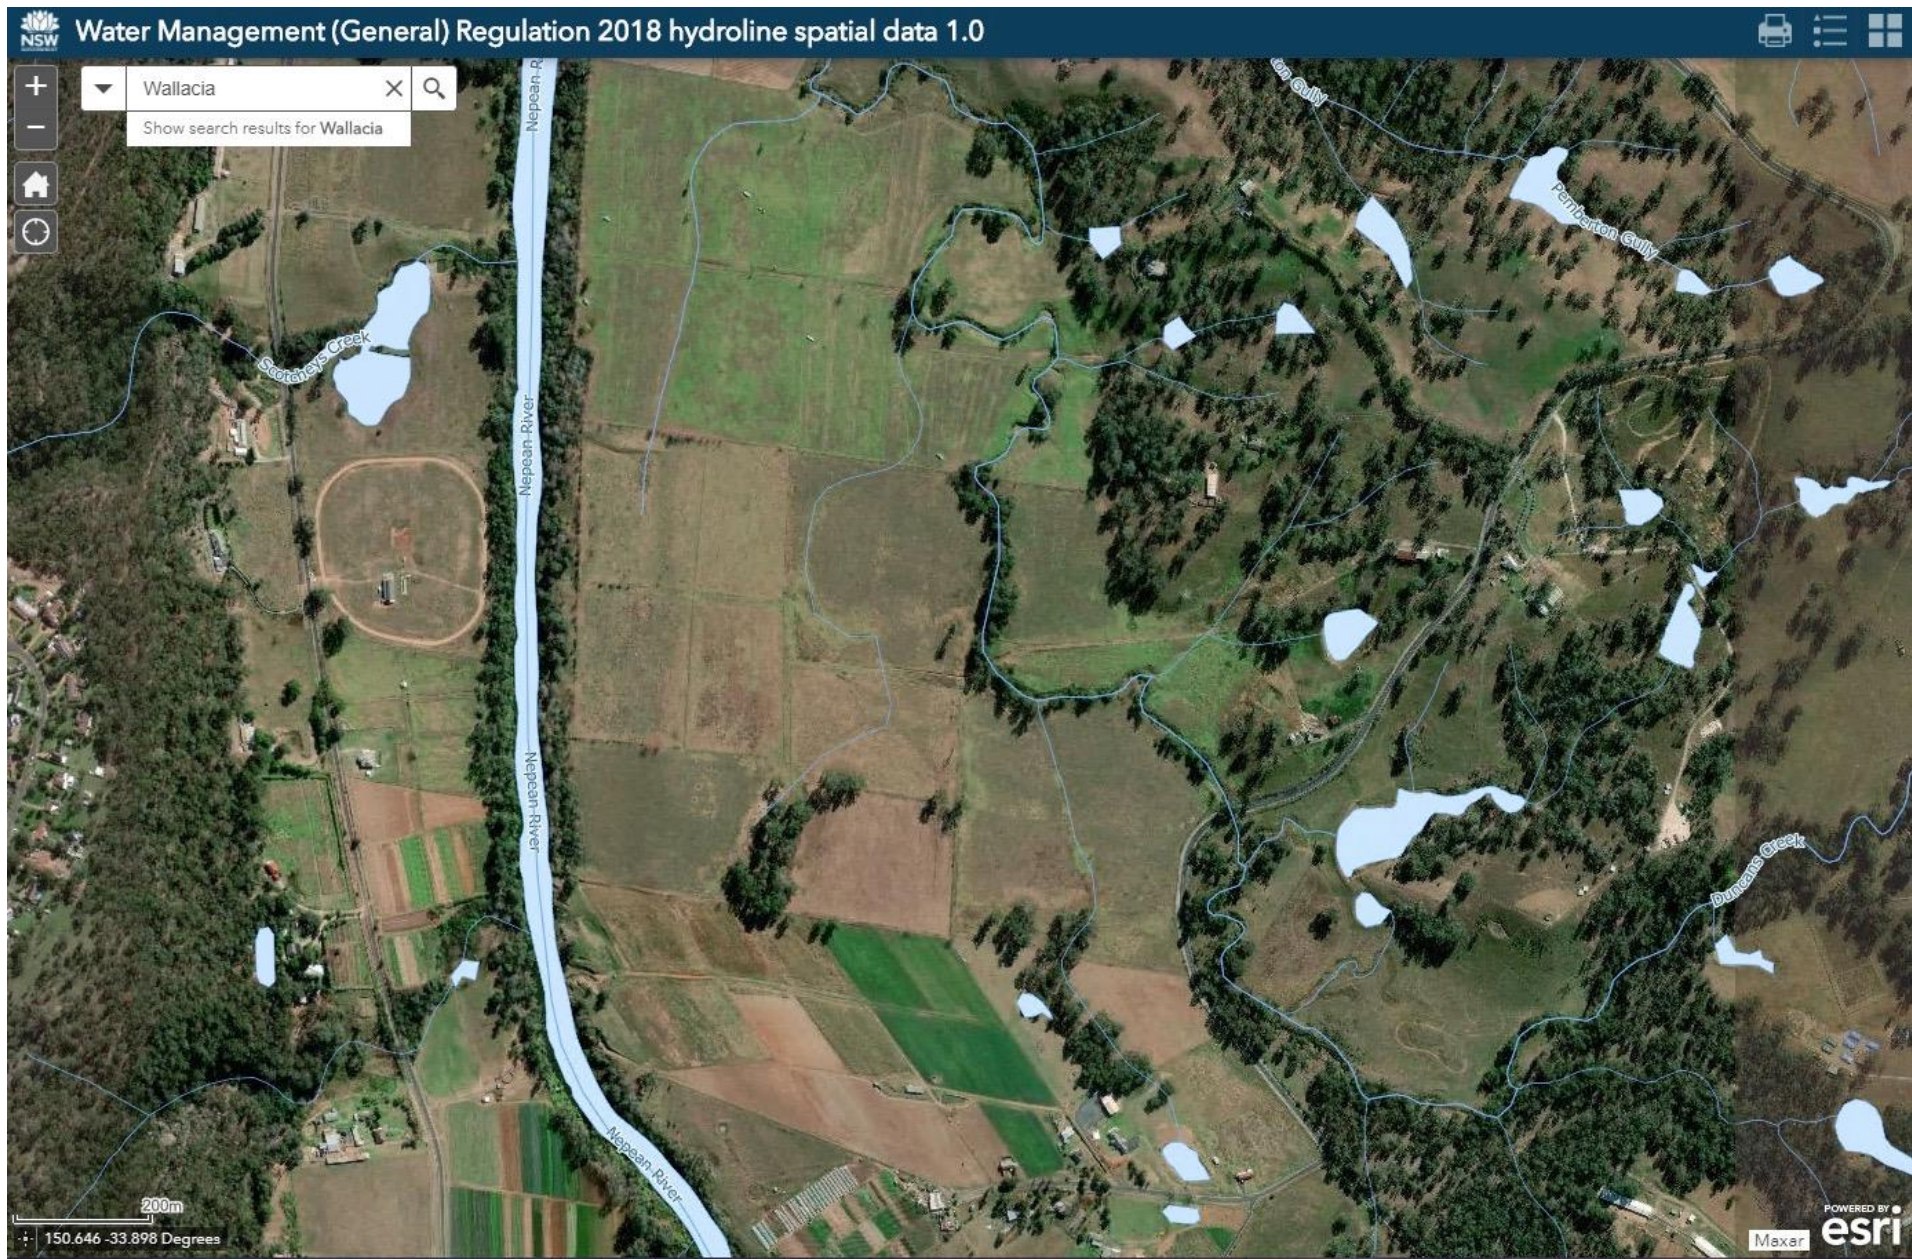
Figure 6 – Mapped Watercourses
 (Source: Water Management (General) Regulation 2018 Hydro Line spatial data)

Duncan's Creek is mapped as a fourth order stream, which requires a 40m vegetated riparian zone from top of bank.

The Nepean River is located to the west of the site boundary and drains in a northerly direction. The Nepean River is classified using the Strahler system as being greater than a fifth order river, which requires a 40m vegetated riparian zone.

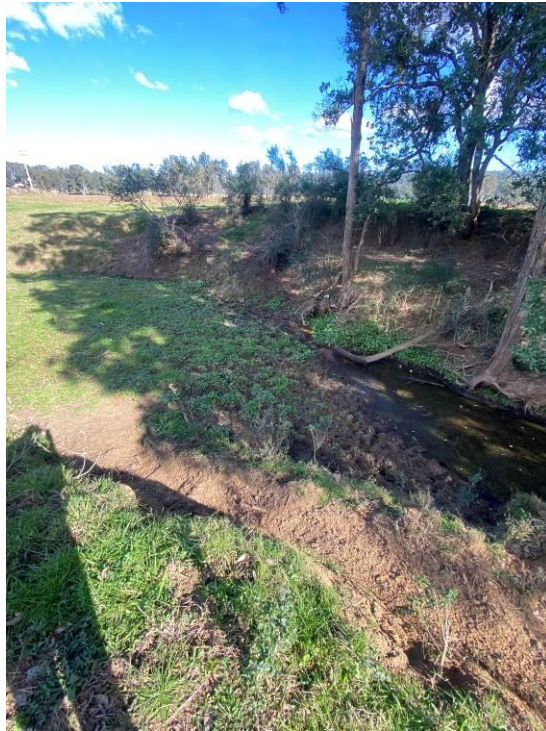
- Intermittent flow, defined channels with highly incised banks;
- Degraded riparian vegetation present on the banks to the south but a restricted canopy present immediately adjacent to the channel;
- Increased riparian vegetation was found along the channel in the north, however, still very sparse;
- Highly eroded banks;
- Sedimentation in the channel;
- Sandstone bridge without any culverts to allow for flow; and
- Debris blocking the channel.

Photo 6 – Centre of channel on Duncans Creek at the south eastern portion just inside the lot boundary

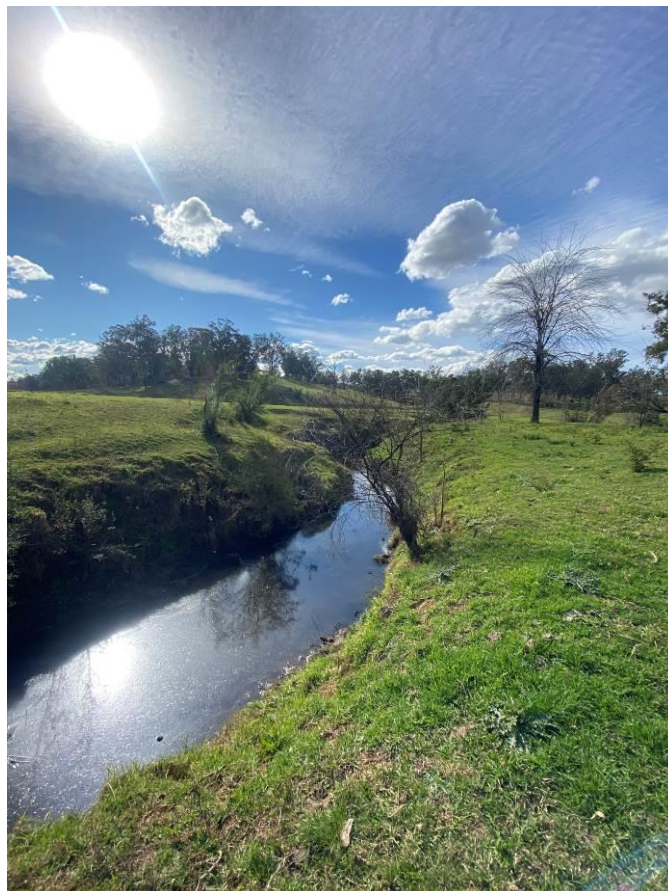
*Photo 7 – Duncans Creek channel approximately in the middle of the channel length
– photo taken facing east*

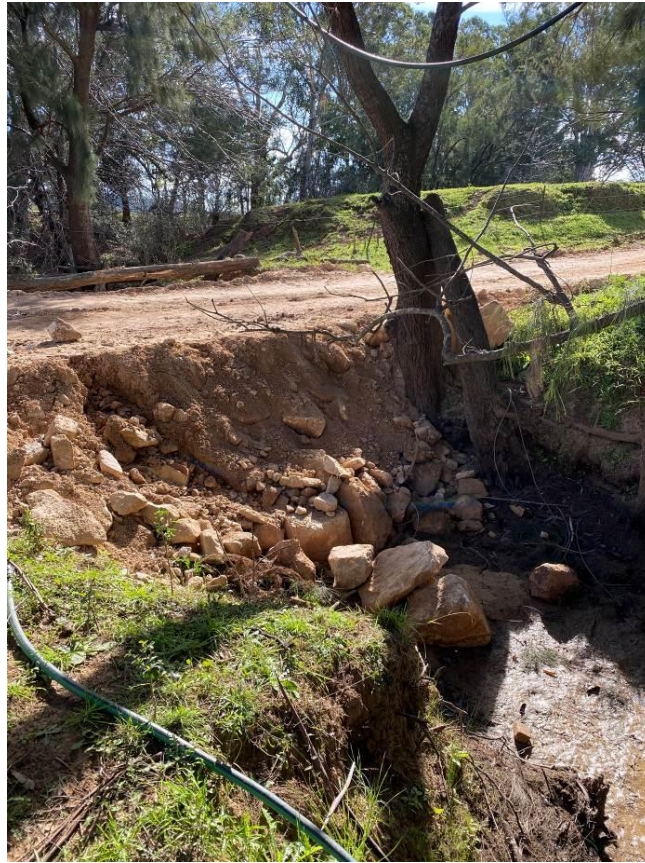
Photo 8 – Duncans Creek existing sandstone road across creek – photo taken facing downstream

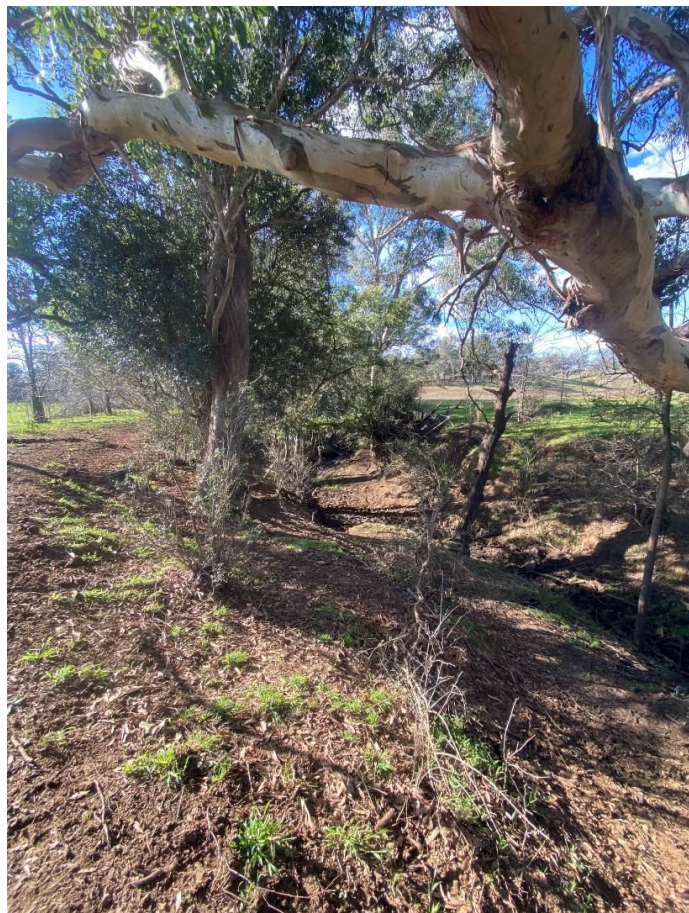
Photo 9 – Northern end of Duncans Creek – photo taken facing downstream

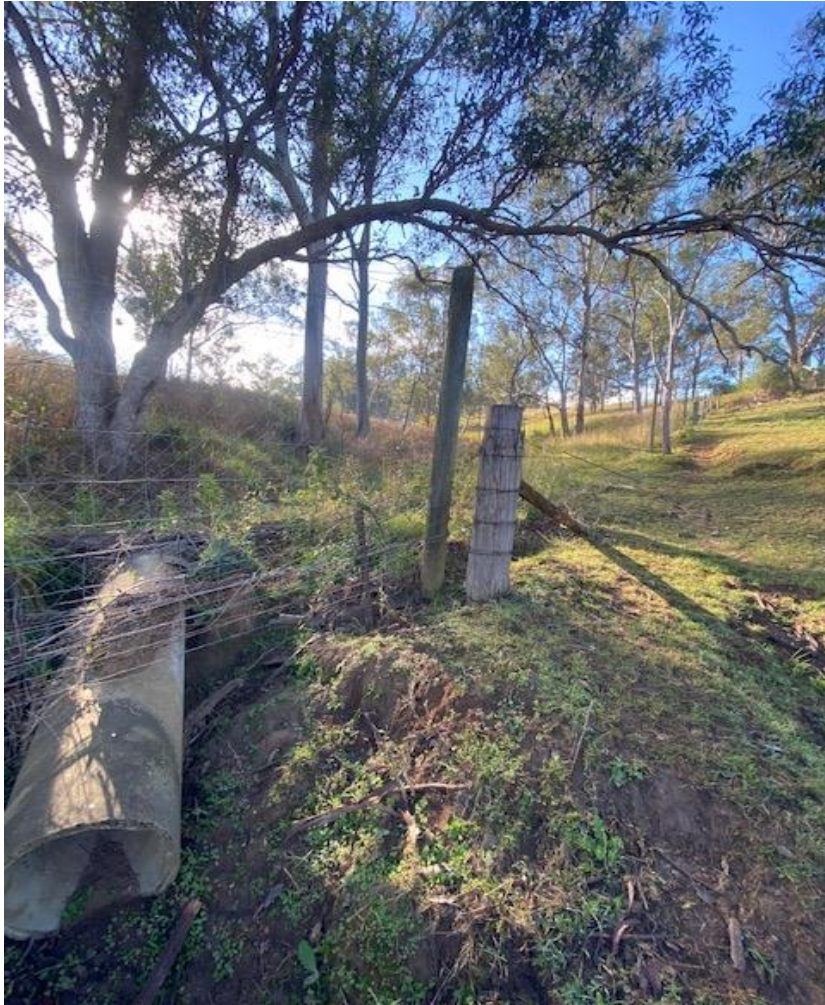
Photo 1 – Split drainage lines entering property along the northern boundary

- No riparian land constraint applies and is categorised as an overland flow path or drainage line
- Collection and management of runoff from the sub catchment and direct through the proposed stormwater drainage system
- Delivery through stormwater outlet into Duncans Creek

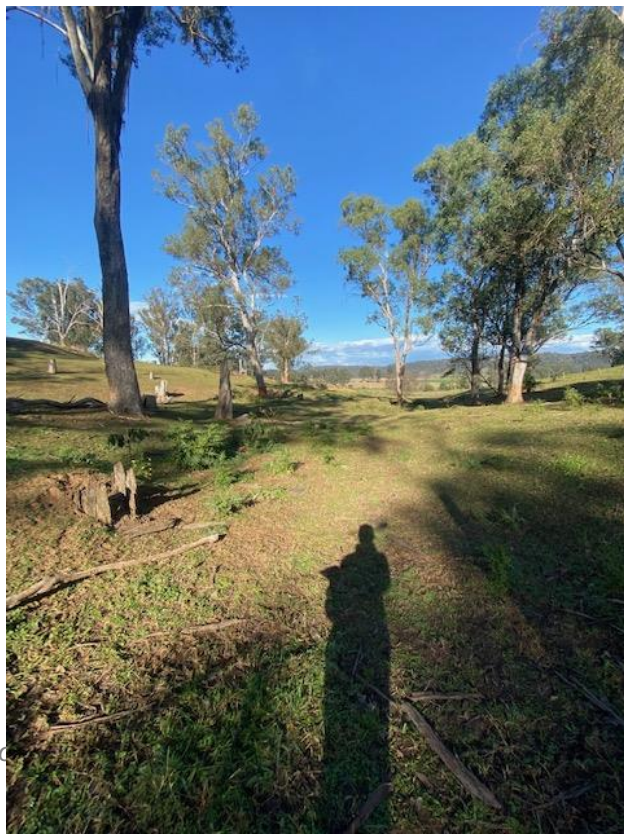
Photo 2 – Overland flow path below junction of drainage lines looking downhill presenting as an overland flow path

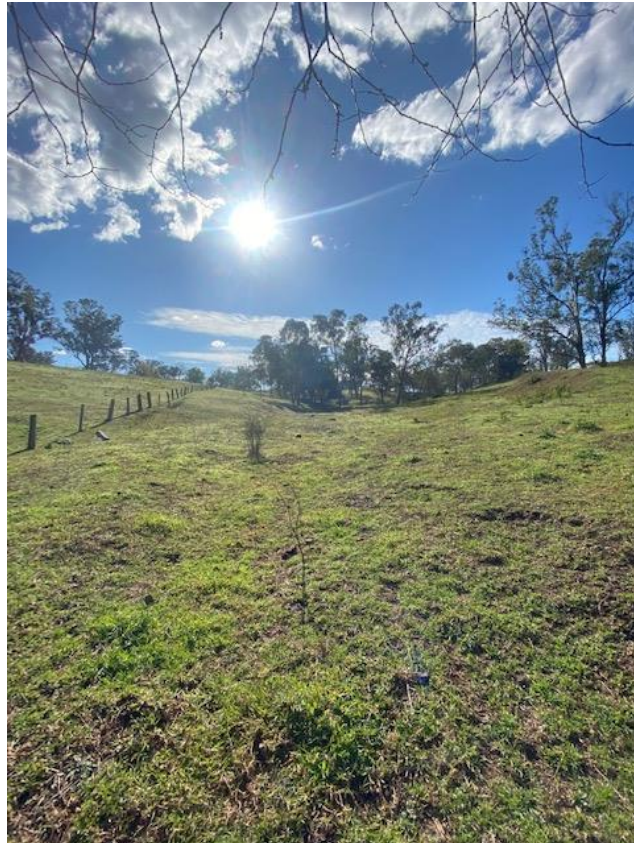
Photo 3 – Lowest reach of the drainage line prior to crossing existing farm access track

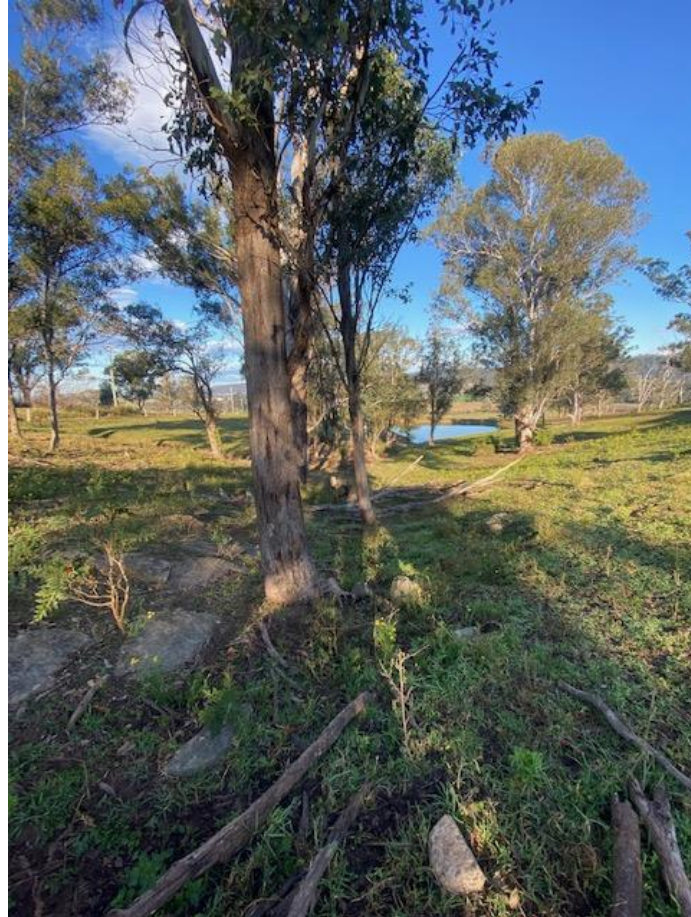
Given the lack of riparian vegetation and lack of channelisation downstream of the existing dam, the Hydroline mapped watercourse has consequently been reclassified as a drainage line. Consequently we recommend that a riparian constraint does not apply.

Photo 4 – Top end of drainage line facing south towards dam with incised drainage line closer to the dam

- Stabilise drainage line
- Filling of the dam
- Implement scour protection works

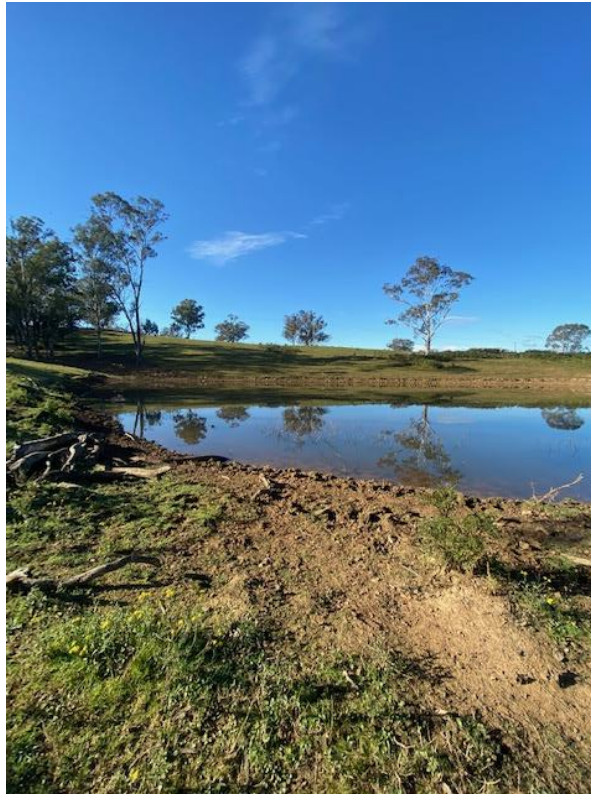
Photo 5 – Existing Dam proposed to be removed

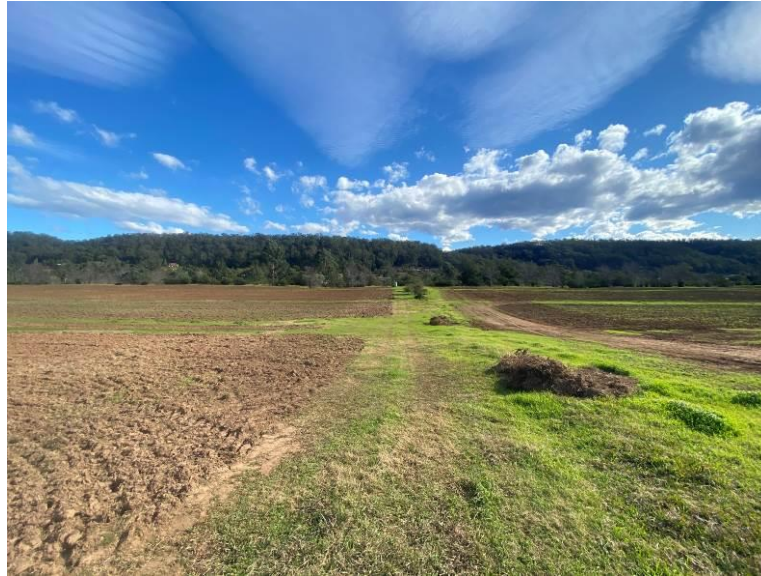
The Nepean River is categorised as being greater than a fifth order stream using the Strahler method. The Nepean River runs from south to north, parallel to the property boundary. Riparian vegetation occurs adjacent to the river along the entire length of the boundary. Whilst weed vegetation is present the existing native vegetation is in relatively good condition for its location.

Photo 10 – Flood plain next to The Nepean River and Riparian Zone – Photo taken facing west

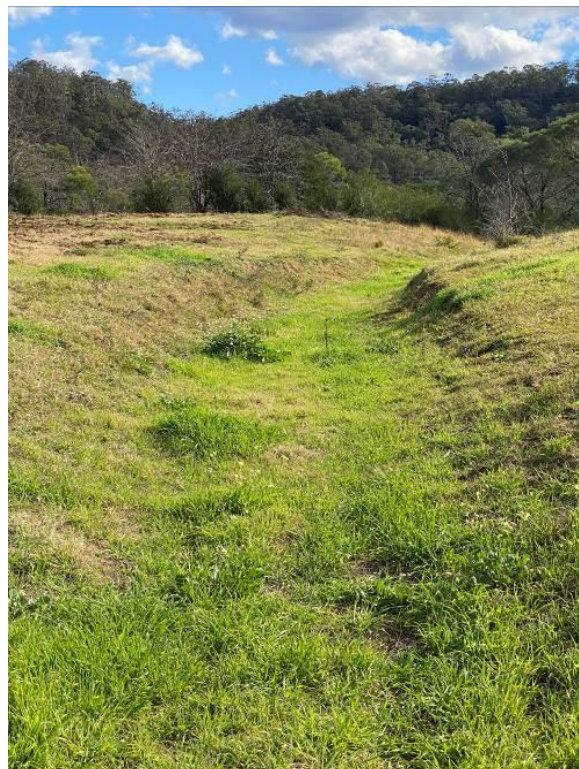
Photo 11 – Drainage line that delivers excess flood flows into The Nepean River, located to the north west of the site

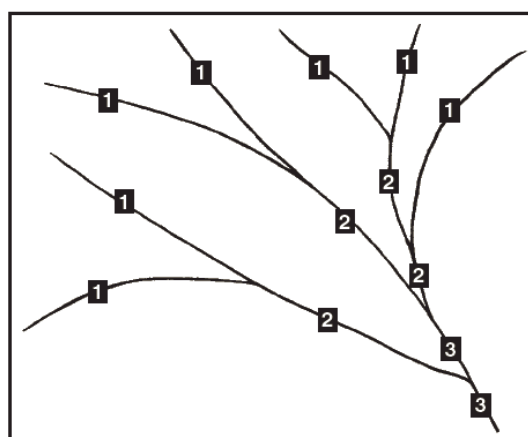
A VRZ width based on stream order as classified under the Strahler System of ordering watercourses and using current 1:25 000 topographic maps (see Figure 9 and Table 2). The width of the VRZ should be measured from the top of the highest bank on both sides of the watercourse (*NSW Department of Industry - Guidelines for controlled activities on waterfront land - Riparian corridors* (2018))

Figure 9 - The Strahler System
