Detailed Site Investigation

Proposed Development at:

1290 Greendale Road

E20111-1

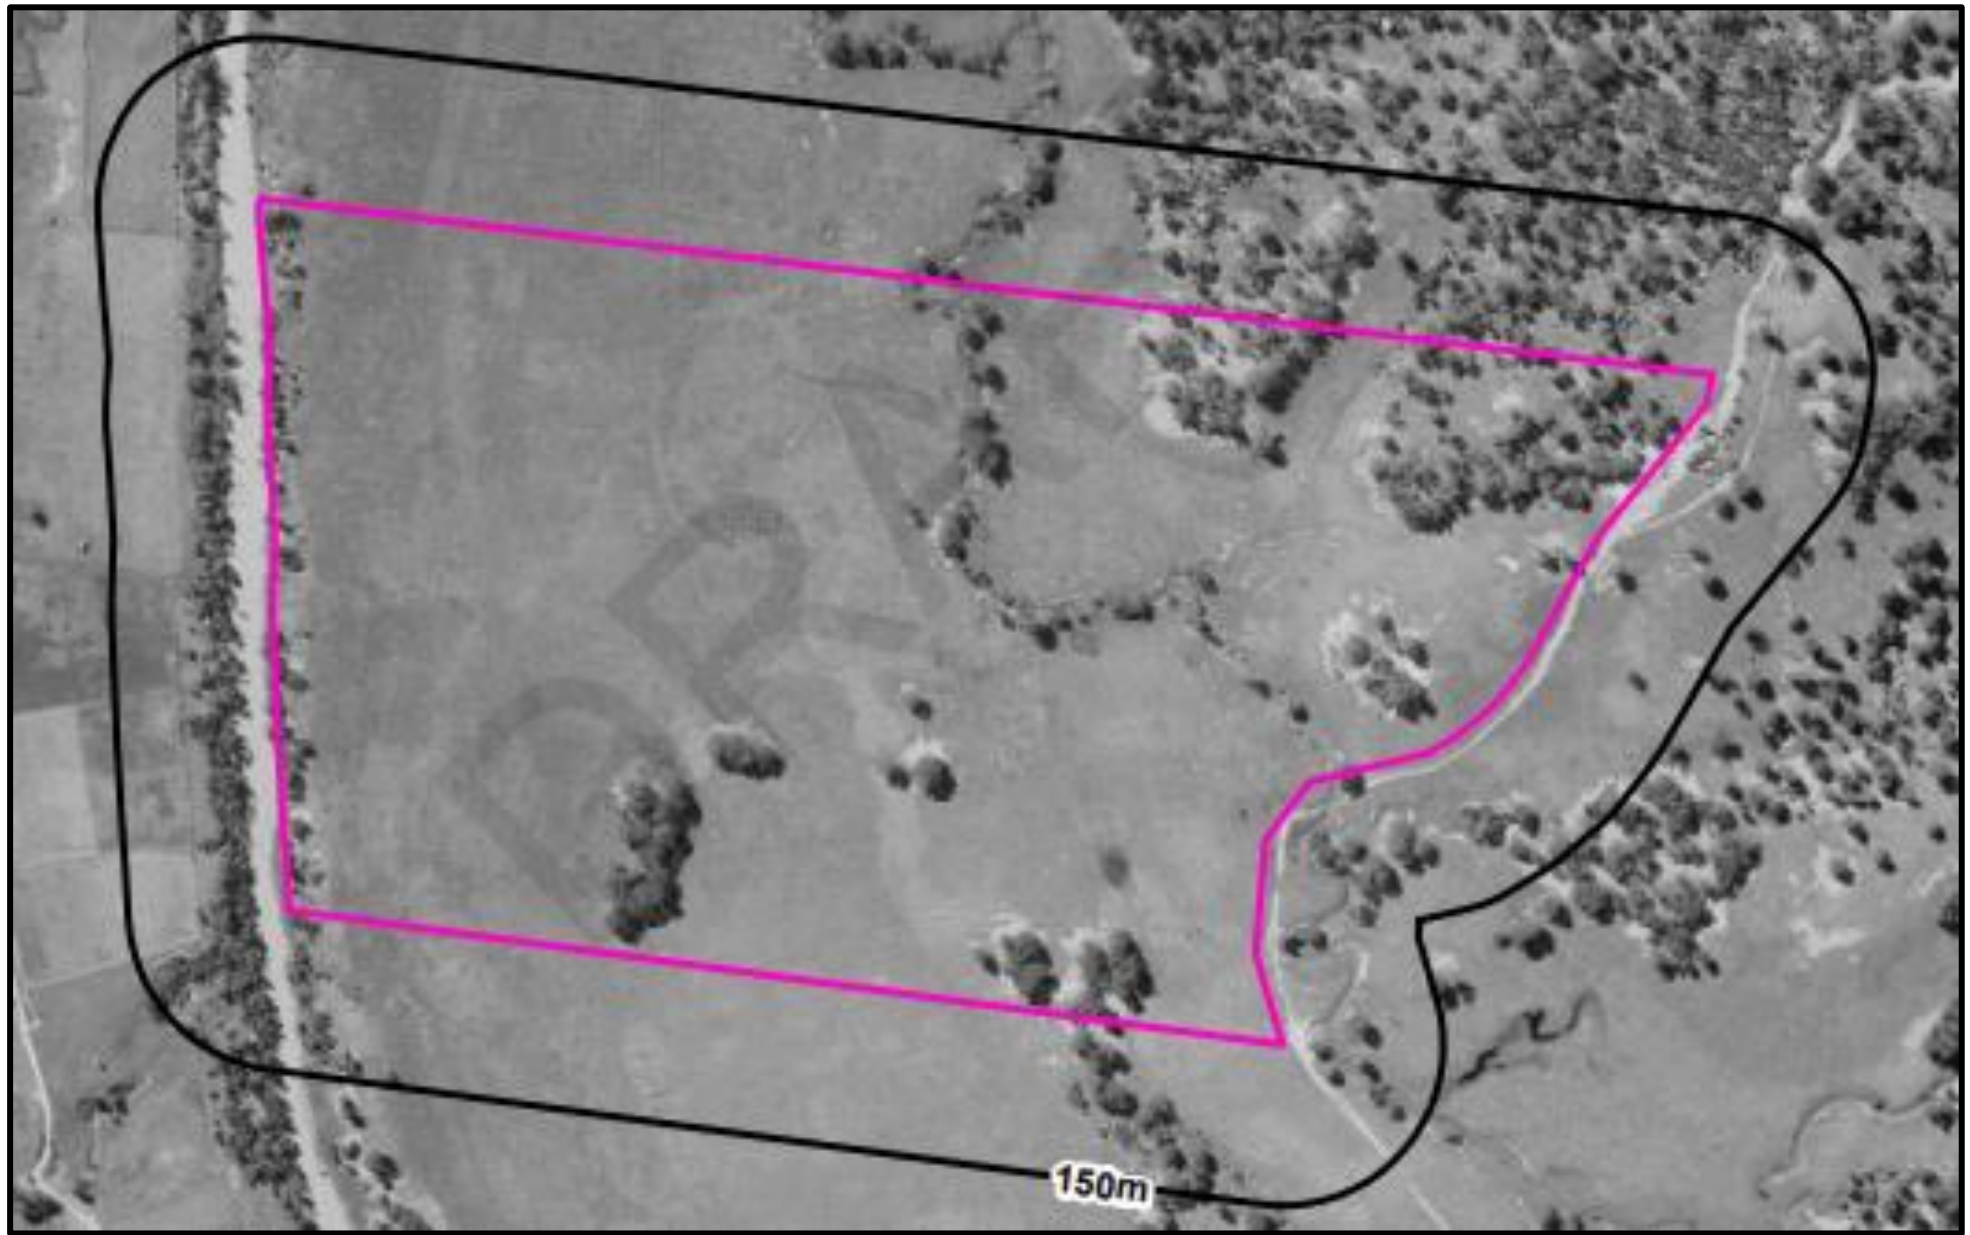
Figure 3	Historical Image: 1949
Project	1290 Greendale Road, Wallacia, NSW, 2745

Figure 3: Depicts an aerial image of the site in 1949. From this image, it does not appear that any of the structures located on the site in 2020 had been built at this time.

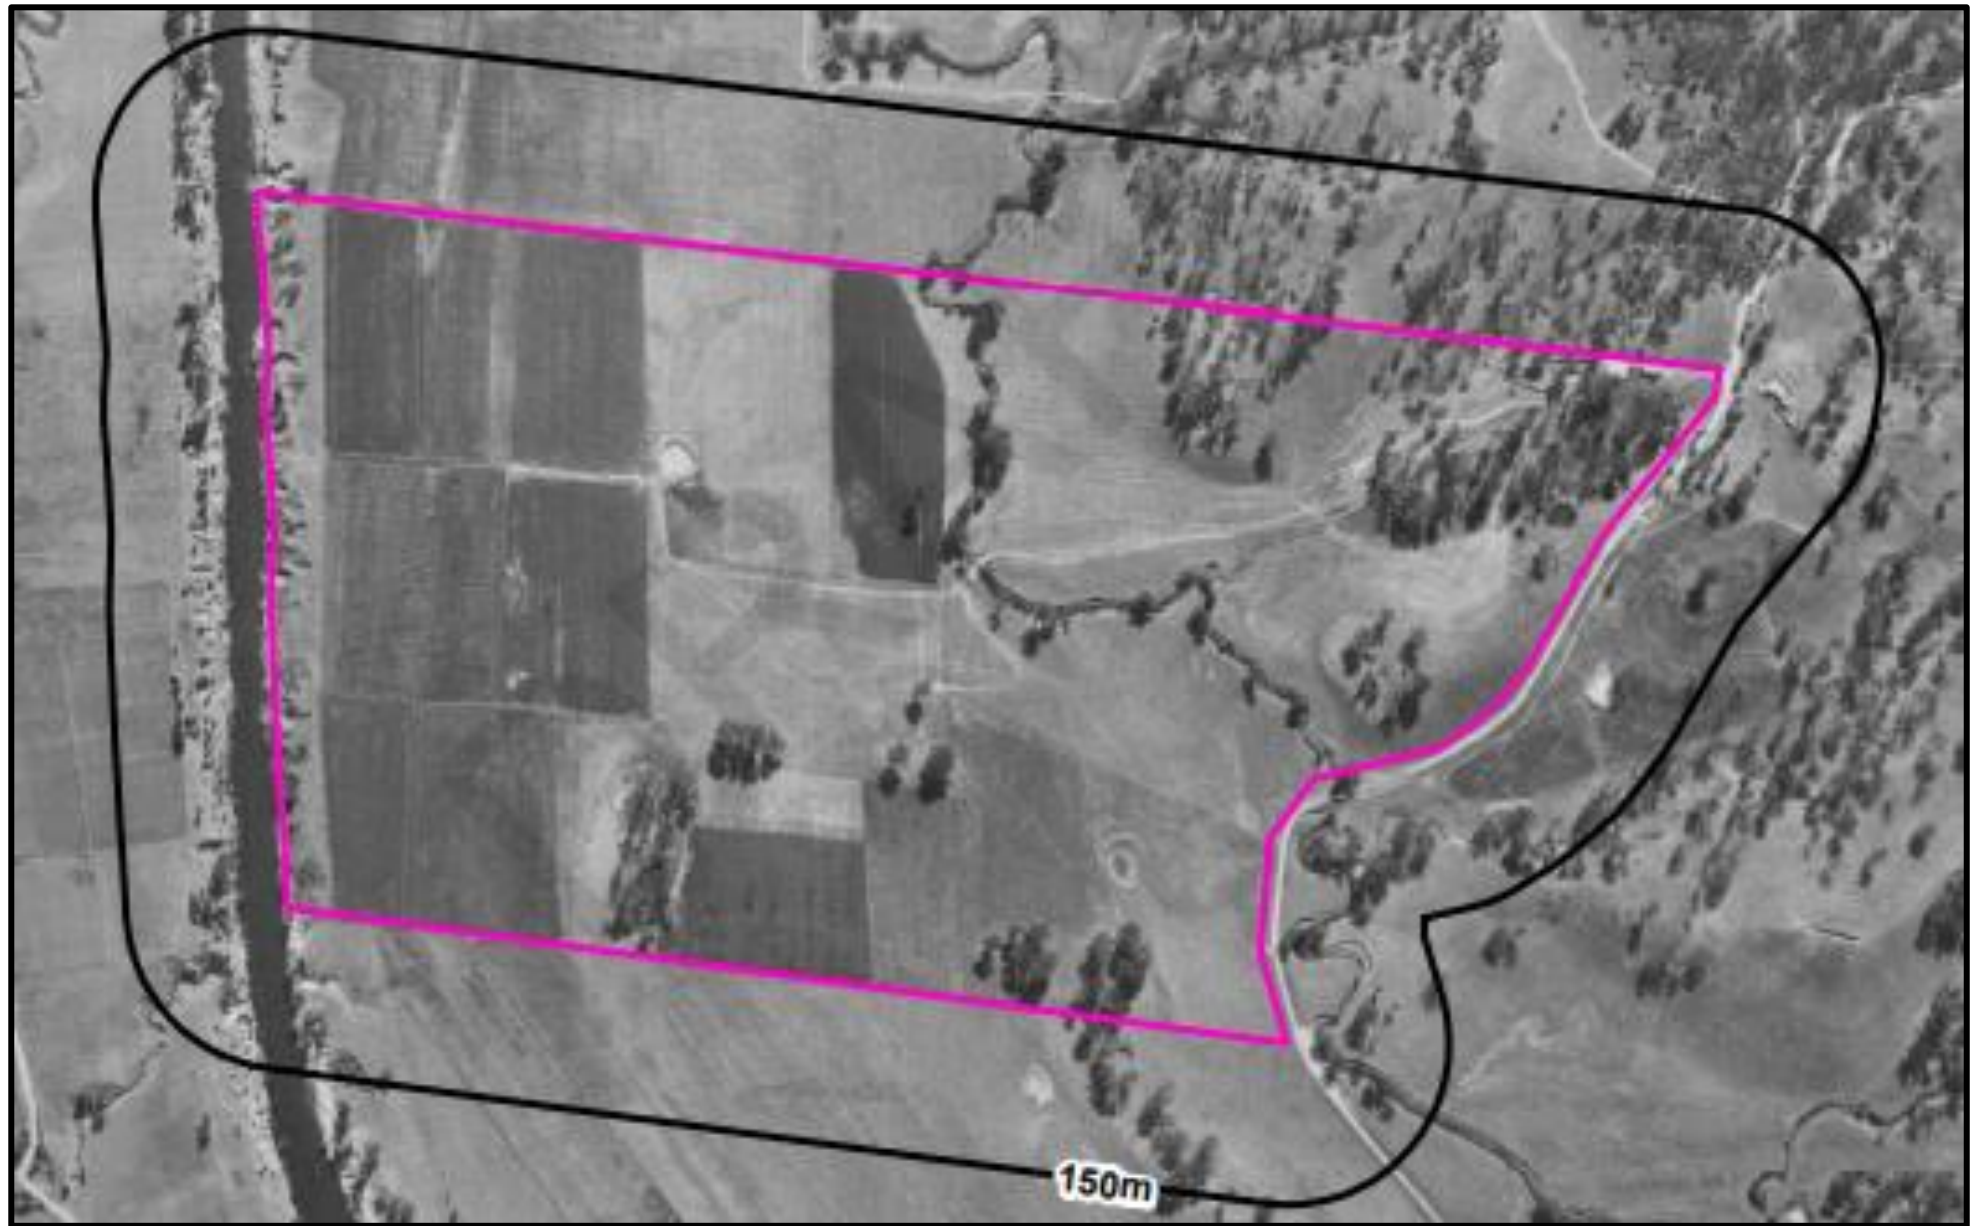
Figure 4	Historical Image: 1965
Project	1290 Greendale Road, Wallacia, NSW, 2745

Figure 4: Depicts an aerial image of the site in 1965. Structures are now visible in the north-eastern corner of the property, and there is visible evidence that agricultural practices have commenced.

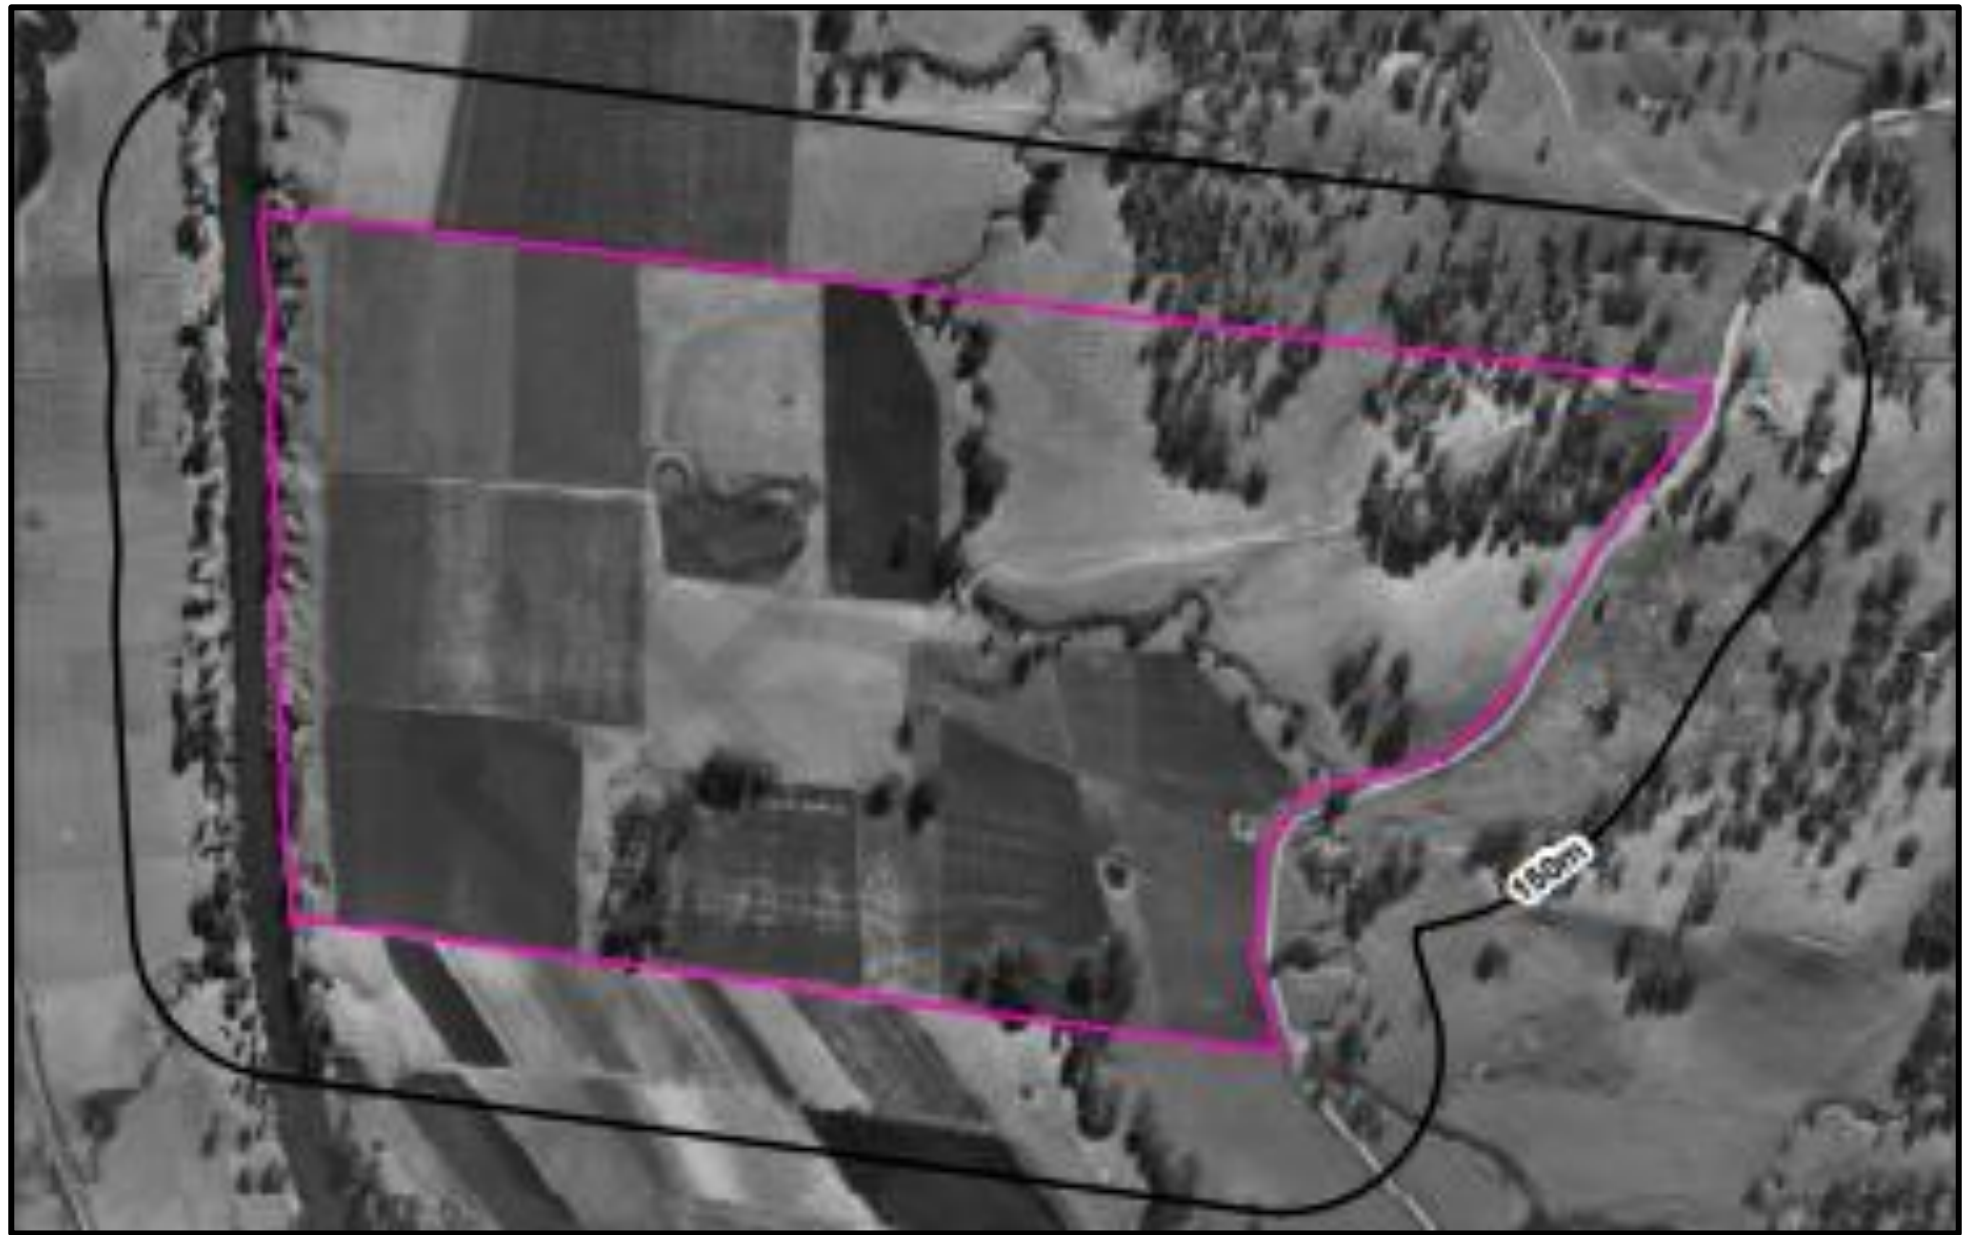
Figure 5	Historical Image: 1970
Project	1290 Greendale Road, Wallacia, NSW, 2745

Figure 5: Depicts an aerial image of the site in 1970: More of the site's eastern portion has now been incorporated into the use of the site for farmland.

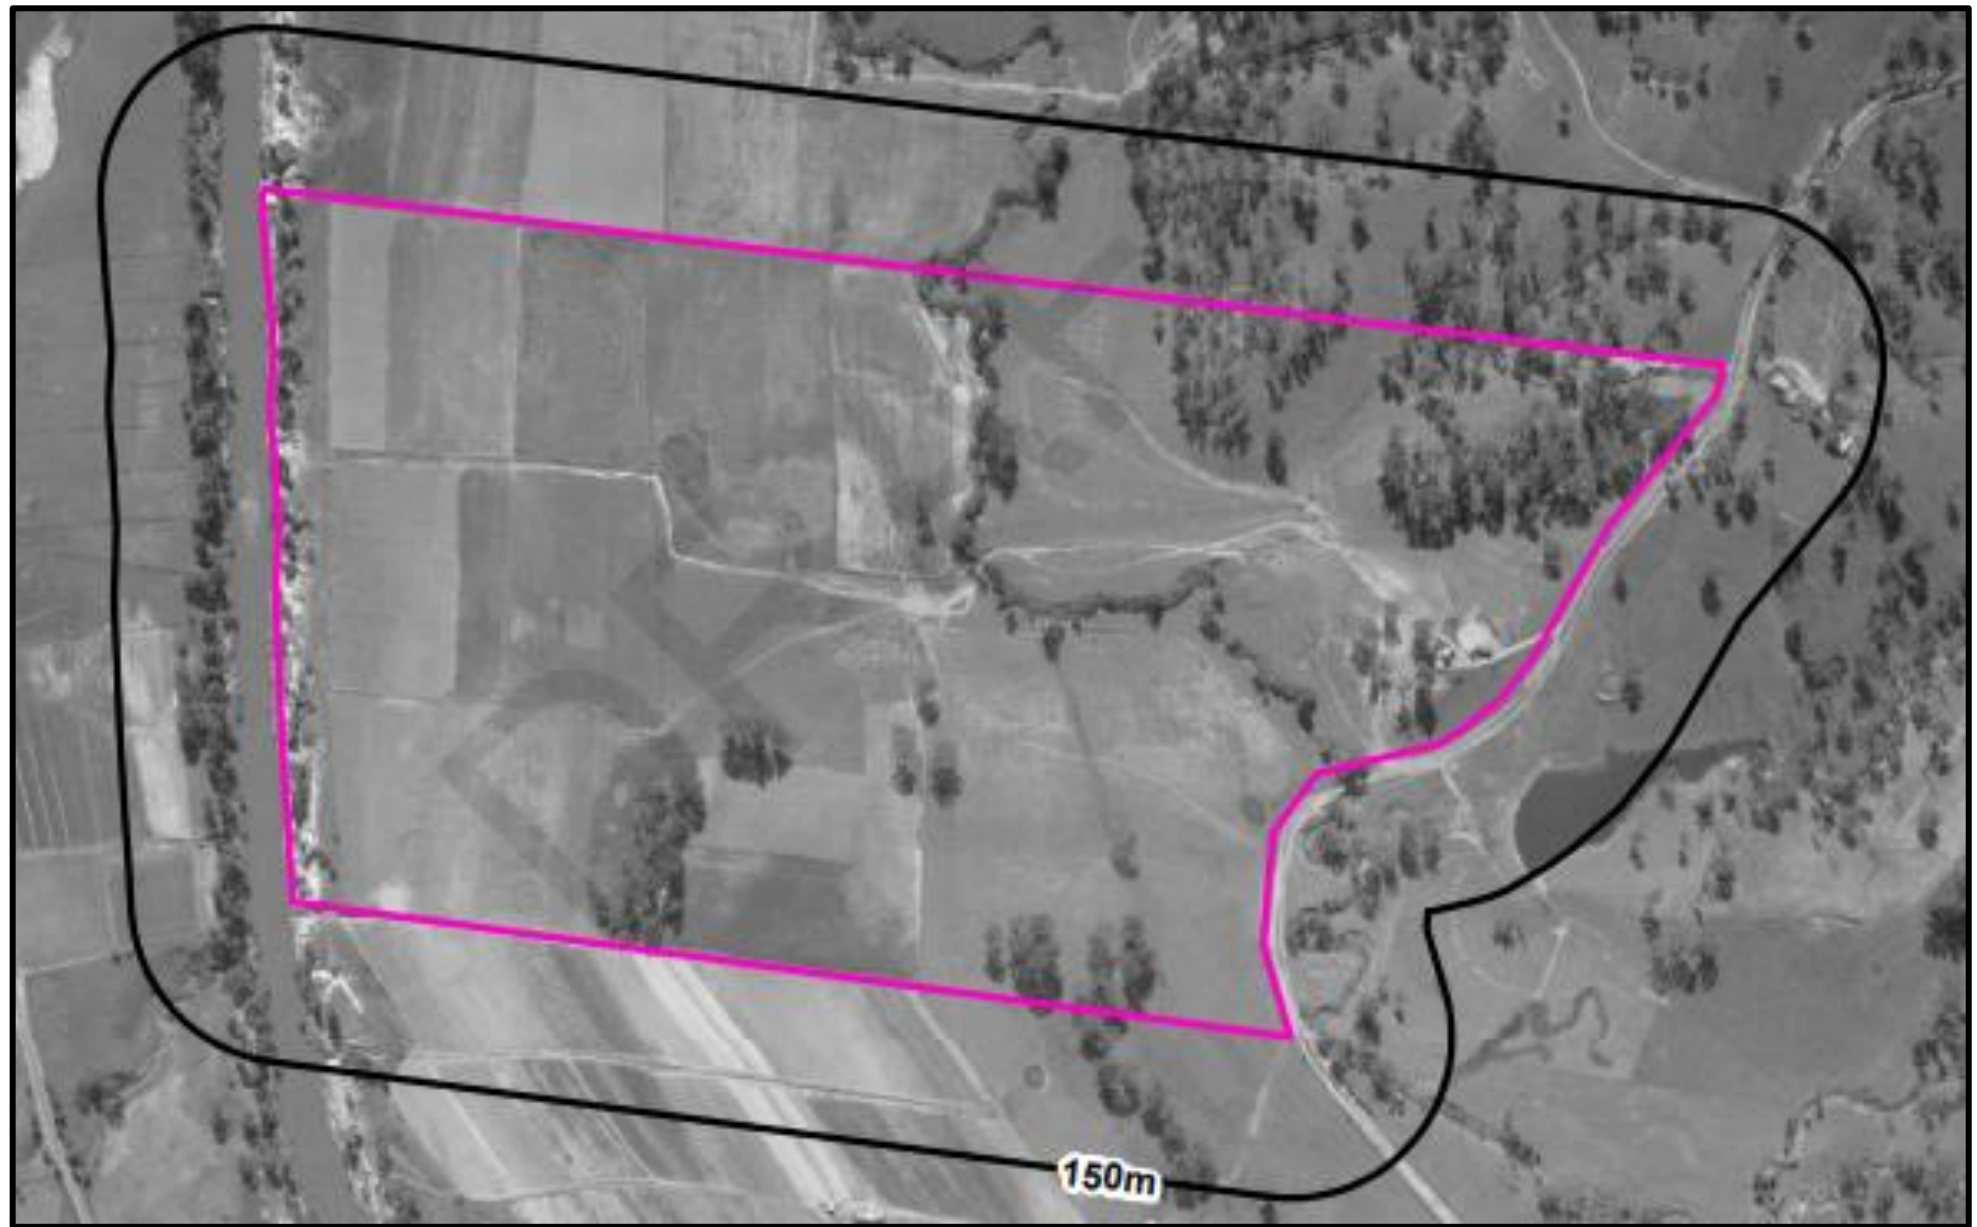
Figure 6	Historical Image: 1978
Project	1290 Greendale Road, Wallacia, NSW, 2745

Figure 6: Depicts an aerial image of the site in 1978: A second entrance has been constructed and structures have been erected in the centre of the site's eastern border.

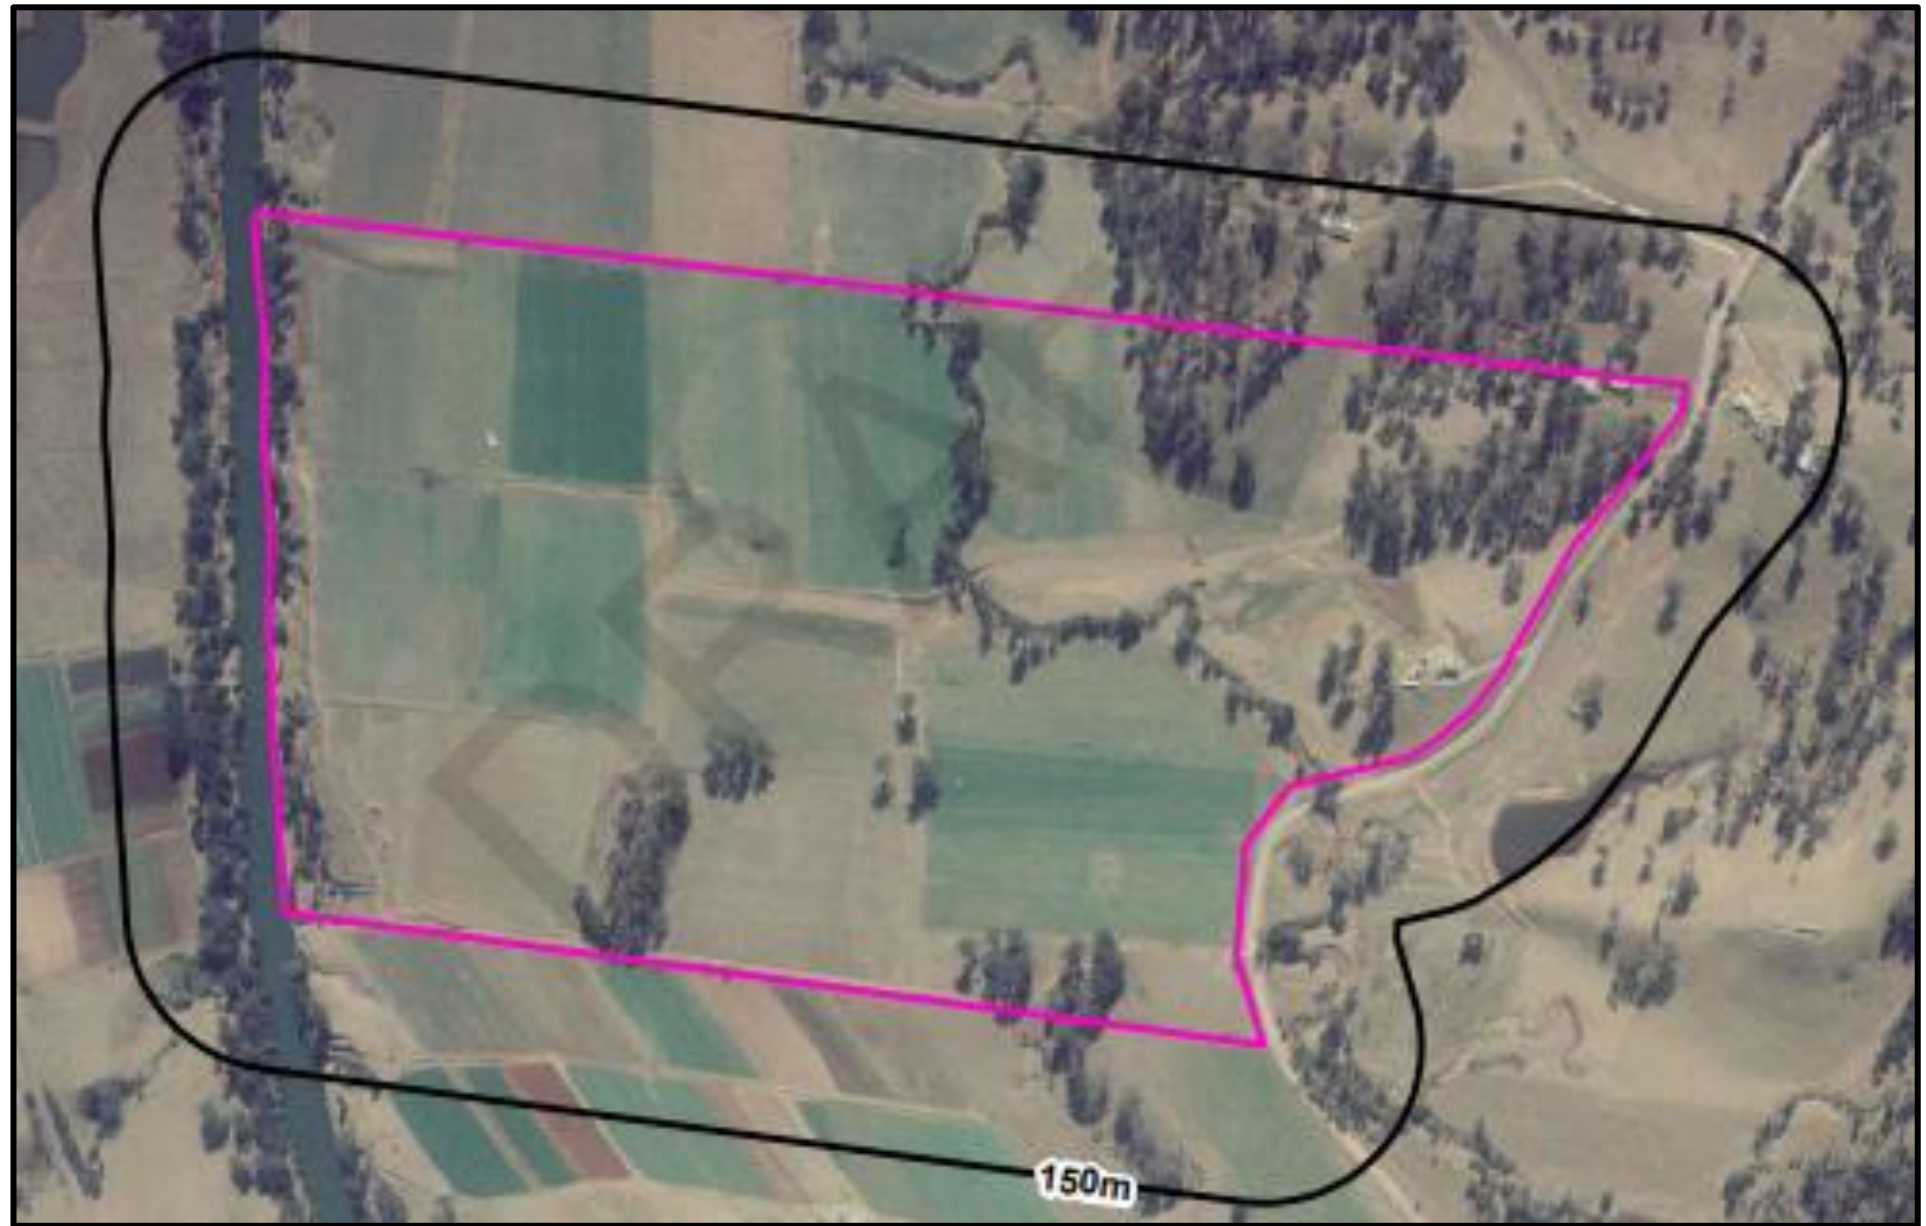
Figure 7	Historical Image: 1986
Project	1290 Greendale Road, Wallacia, NSW, 2745

Figure 7: Depicts an aerial image of the site in 1986: At this time, the site's state largely resembles it's state in 1978.

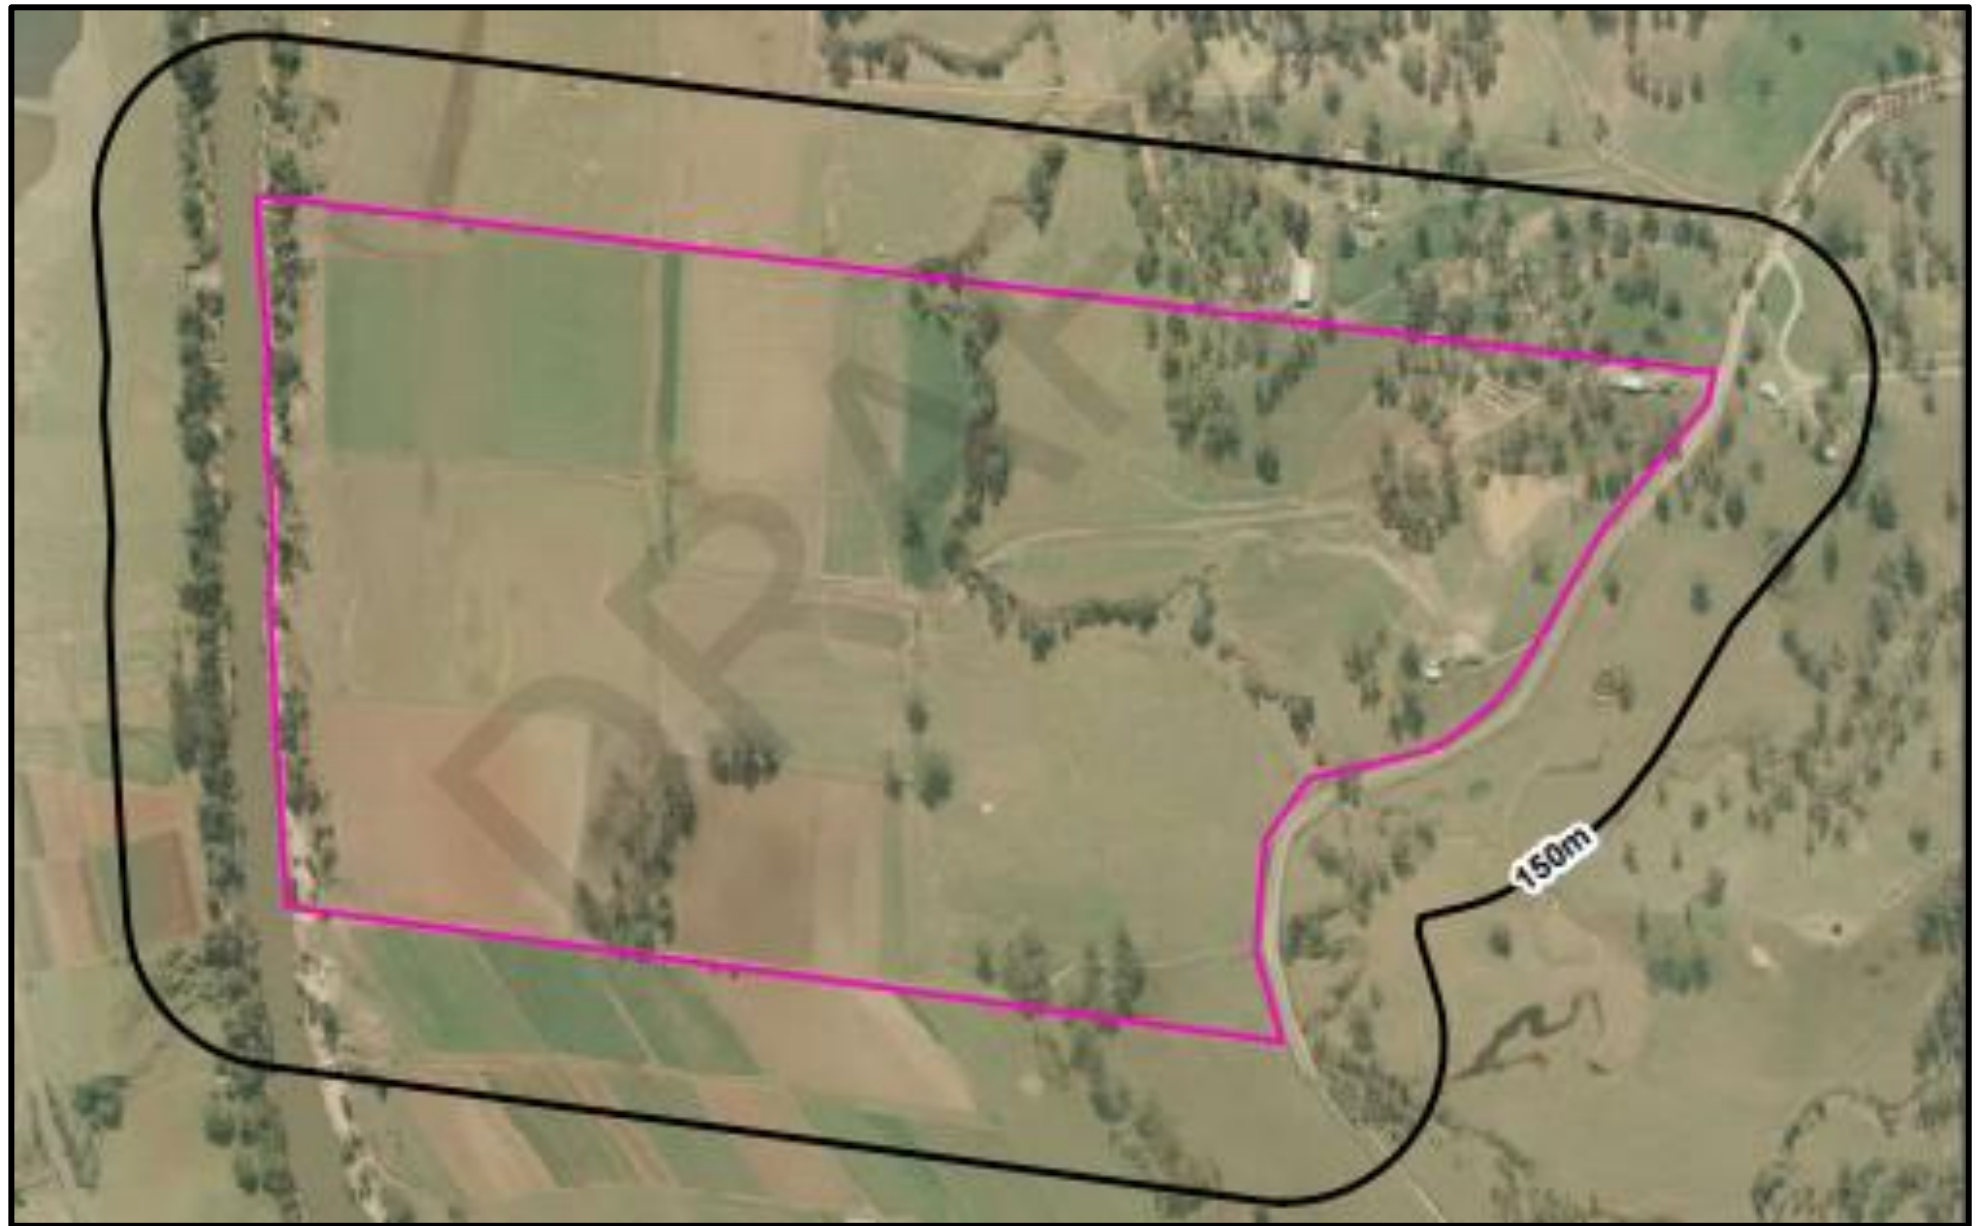
Figure 8	Historical Image: 1991
Project	1290 Greendale Road, Wallacia, NSW, 2745

Figure 8: Depicts an aerial image of the site in 1991: This image shows that the northern dam onsite has been constructed near the properties north-eastern corner.

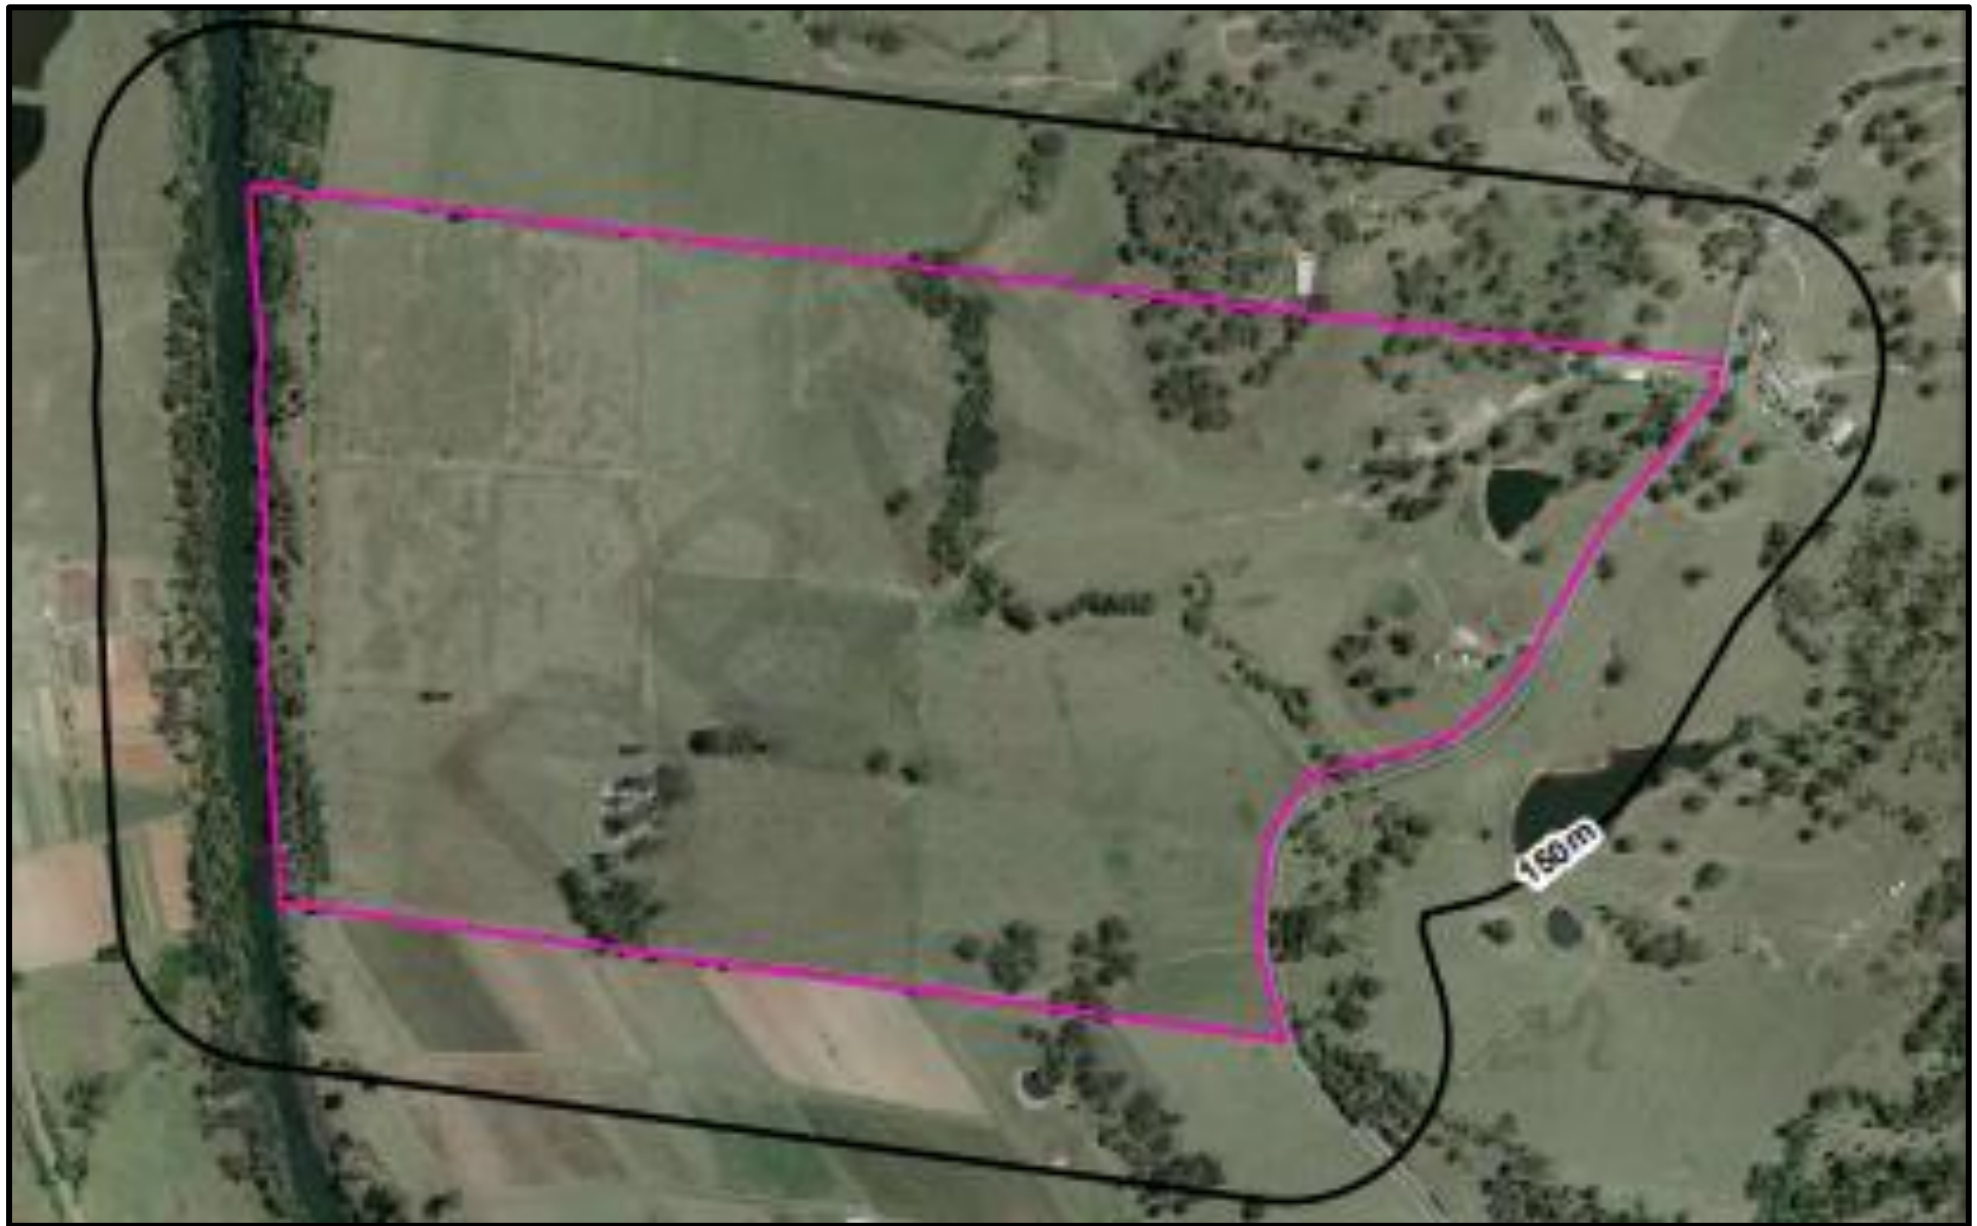
Figure 9	Historical Image: 2009
Project	1290 Greendale Road, Wallacia, NSW, 2745

Figure 9: Depicts an aerial image of the site in 2009: The southern dam has now been built on the site, north-west of the silos and dairy shed.

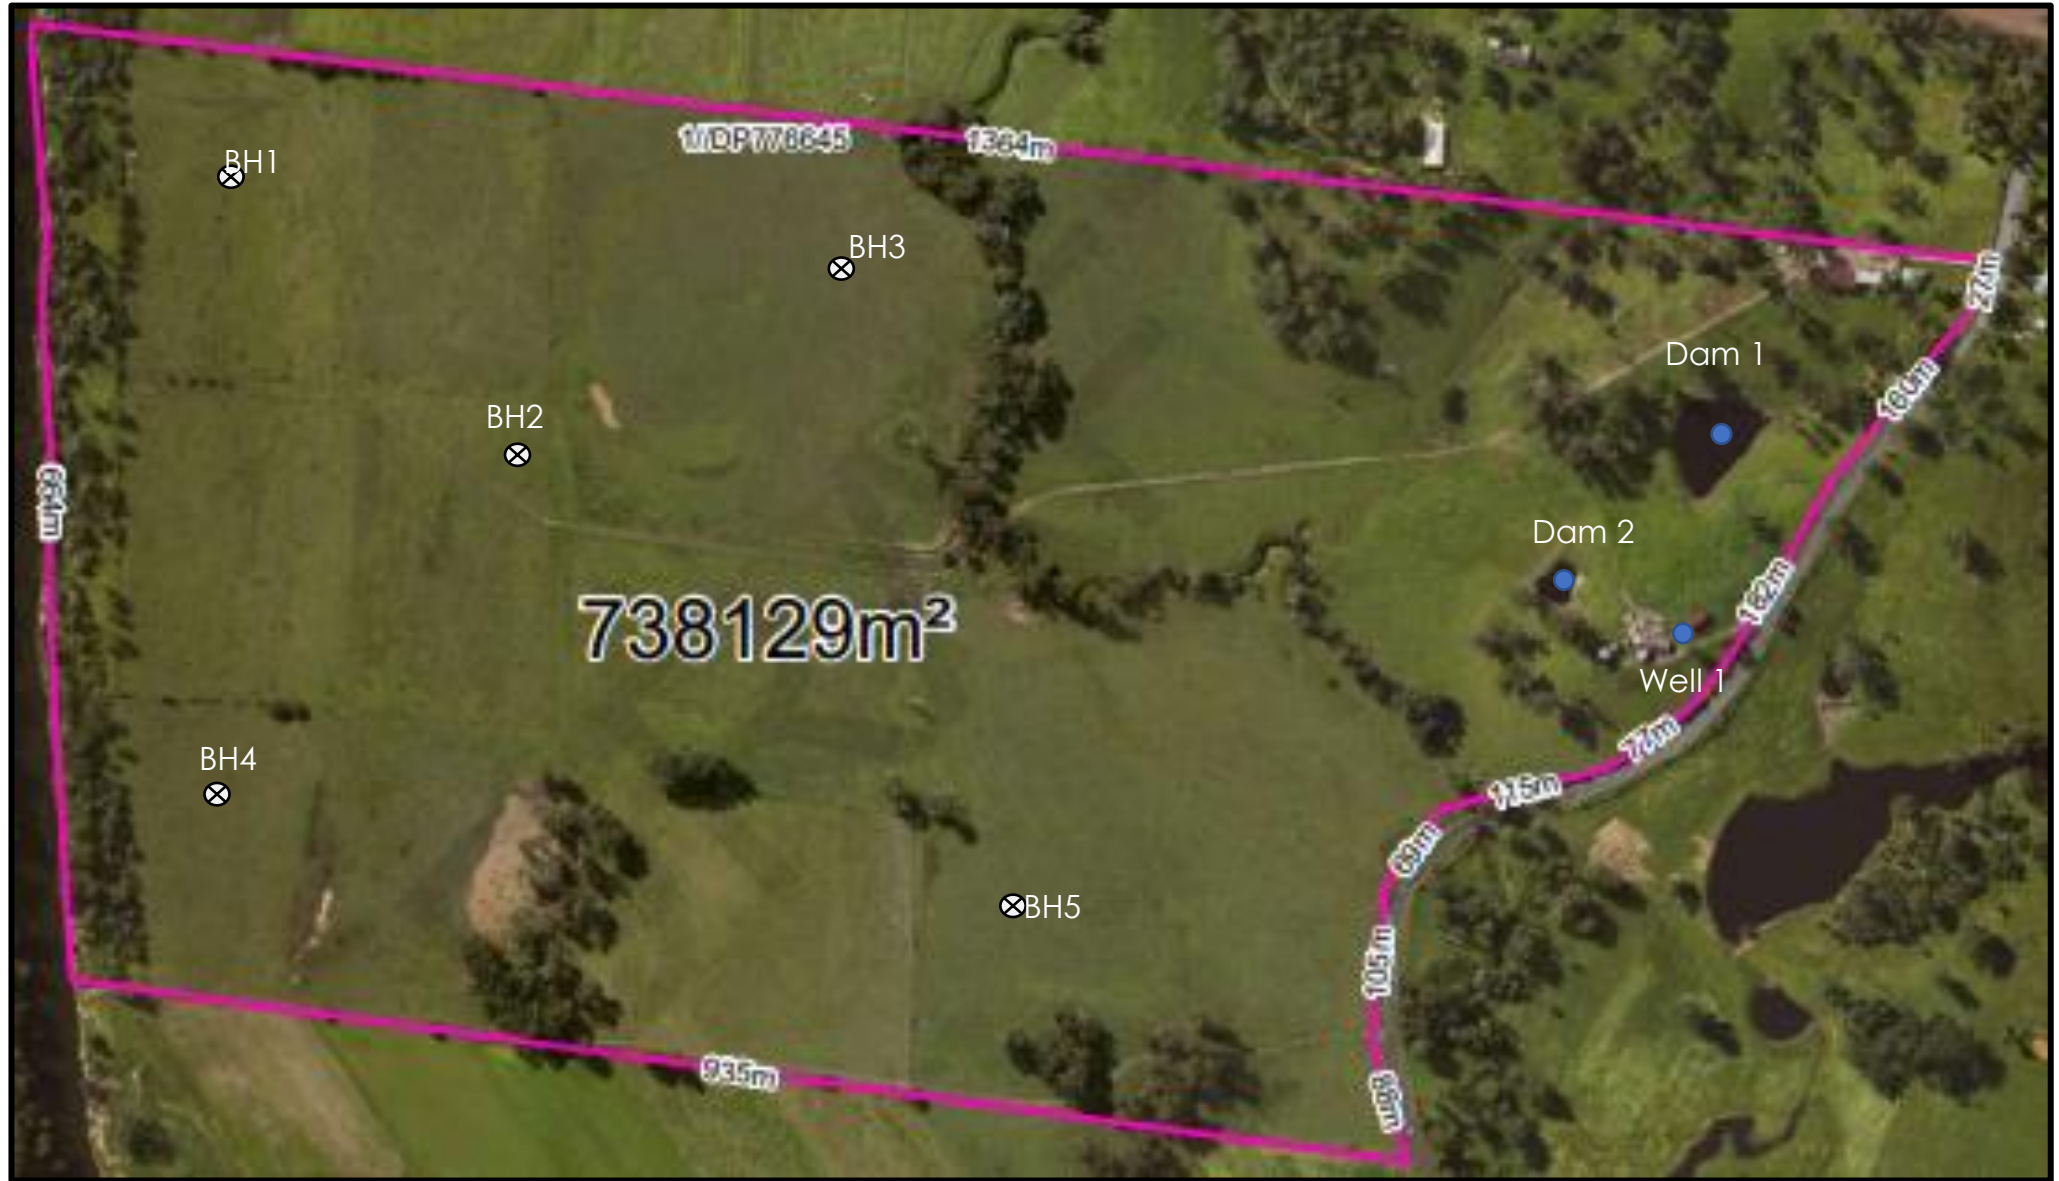
Figure 12	Water and Bore hole Sample Locations
Project	1290 Greendale Road, Wallacia, NSW, 2745

Subsurface conditions across the site as observed during borehole excavations are summarised in **Table 6**. Borehole and pit locations are referenced in **Figures 10 to 12**.
