Geotechnical Investigation

164-170 Croatia Avenue, Edmondson Park NSW

Report No: E24744.G03

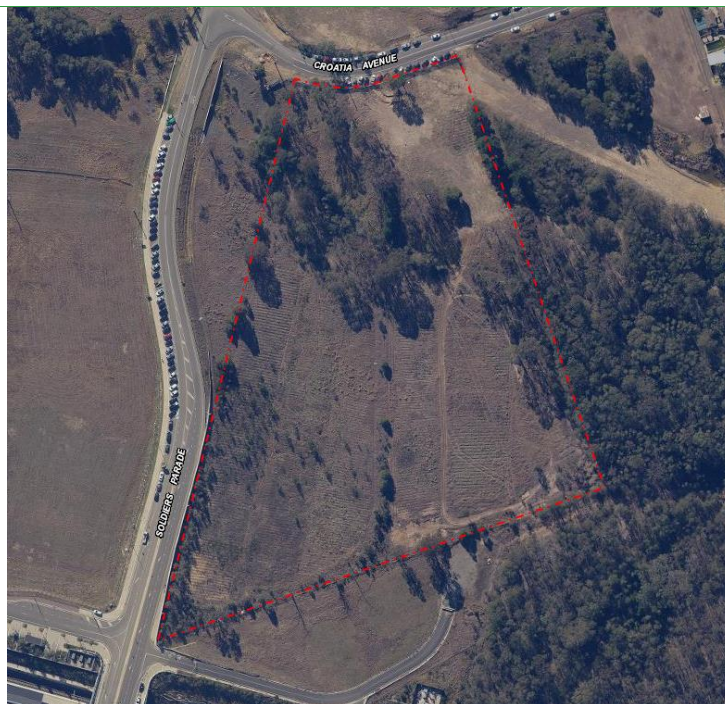
Plate 1: Aerial photograph of the site (source: SIX Maps, accessed 28 August 2020)

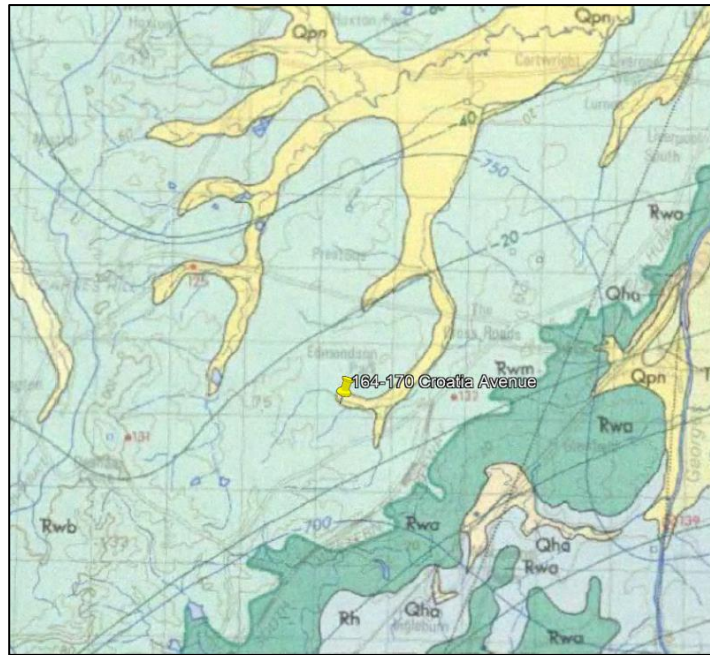
Plate 2: Excerpt of geological map showing location of site.

Attribute	Description
Topography	The site is located on the low eastern side of Soldiers Parade and the low southern side of Croatia Avenue. Site levels vary from RL 48.6m at the north-western site corner to RL 56.2m at the south-western site corner. The site is within gently dipping northeast topography and dips towards the creek in the northern portion of the site. The level of the creek is below RL 47.0m.
Regional Geology	Information on regional sub-surface conditions, referenced from the Department of Mineral Resources Geological Map Penrith 1:100,000 Geological Series Sheet 9030 (DMR 1991) indicates the site is located at the boundary between Bringelly Shale (Rwb) which typically comprises of shale, carbonaceous claystone, claystone, laminite, fine to medium-grained lithic sandstone, rare coal and tuff; and Quaternary Fluvial Deposits (Qpn) which typically comprises of medium-grained sand, clay and silt.

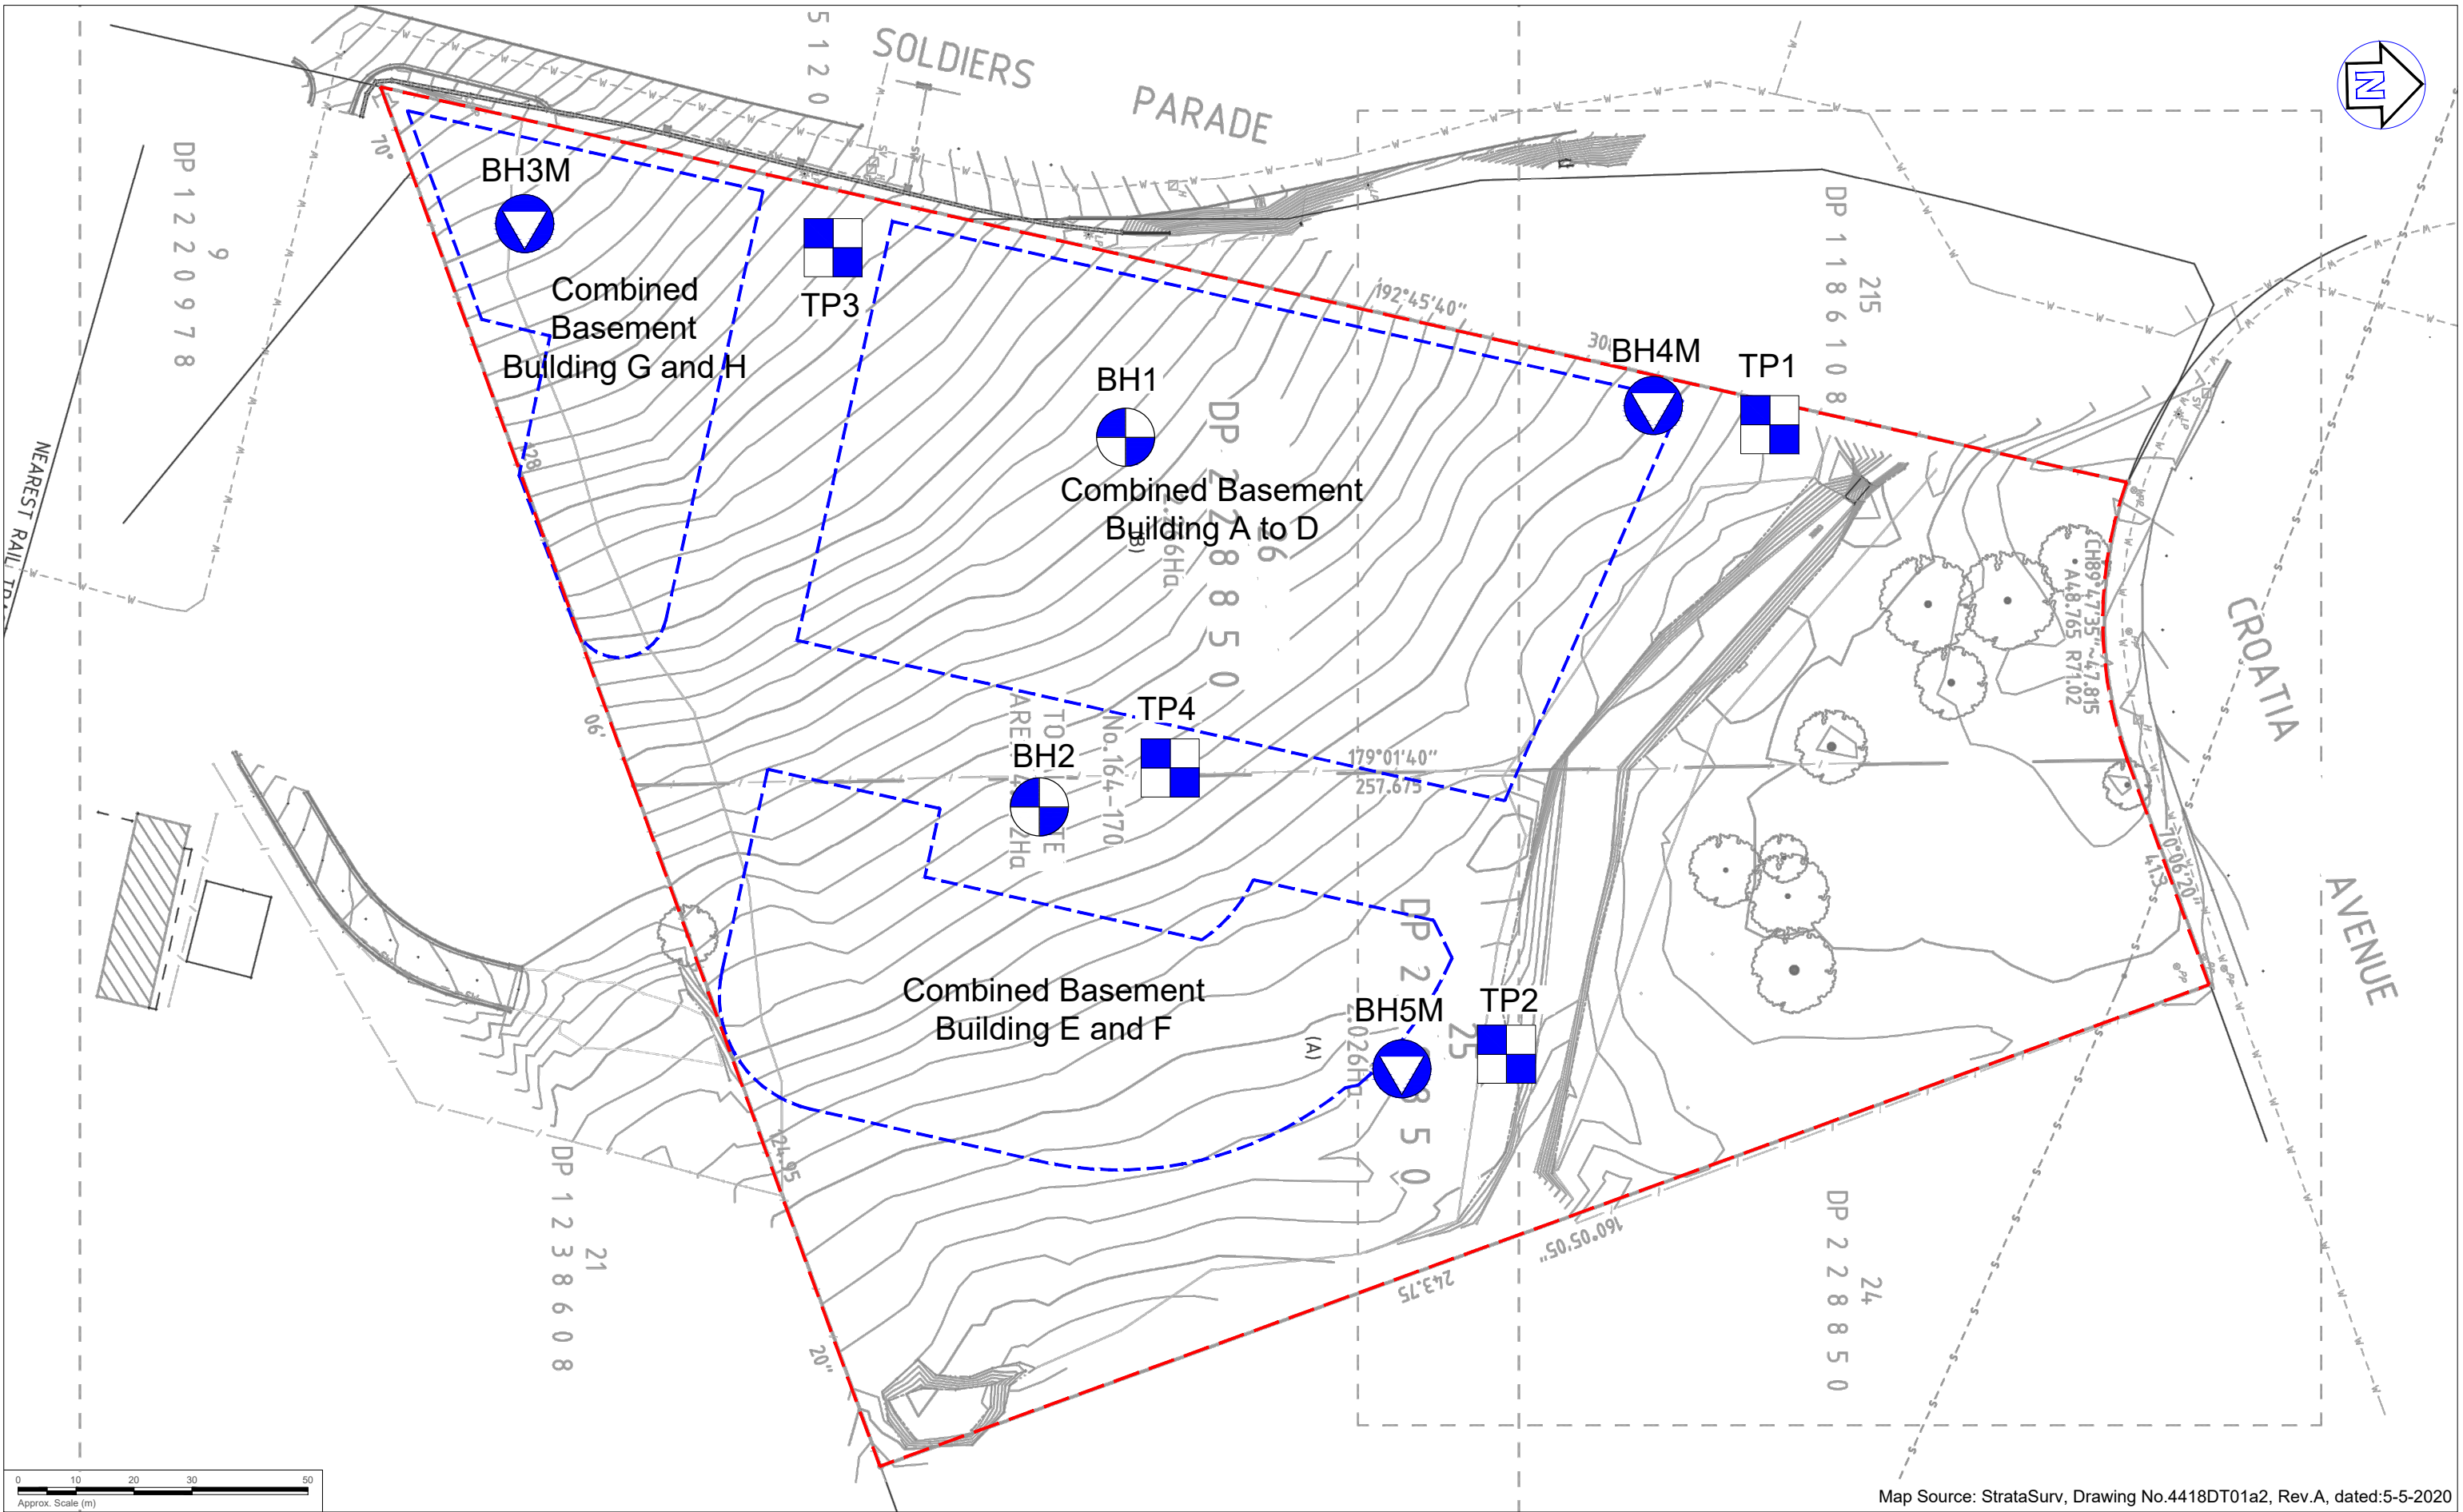
Figure 2 Borehole Location Plan

- Approximate outline of site boundary
- Approximate outline of combined basement boundaries
- Approximate borehole location
- Approximate borehole / monitoring well location
- Approximate test pit location

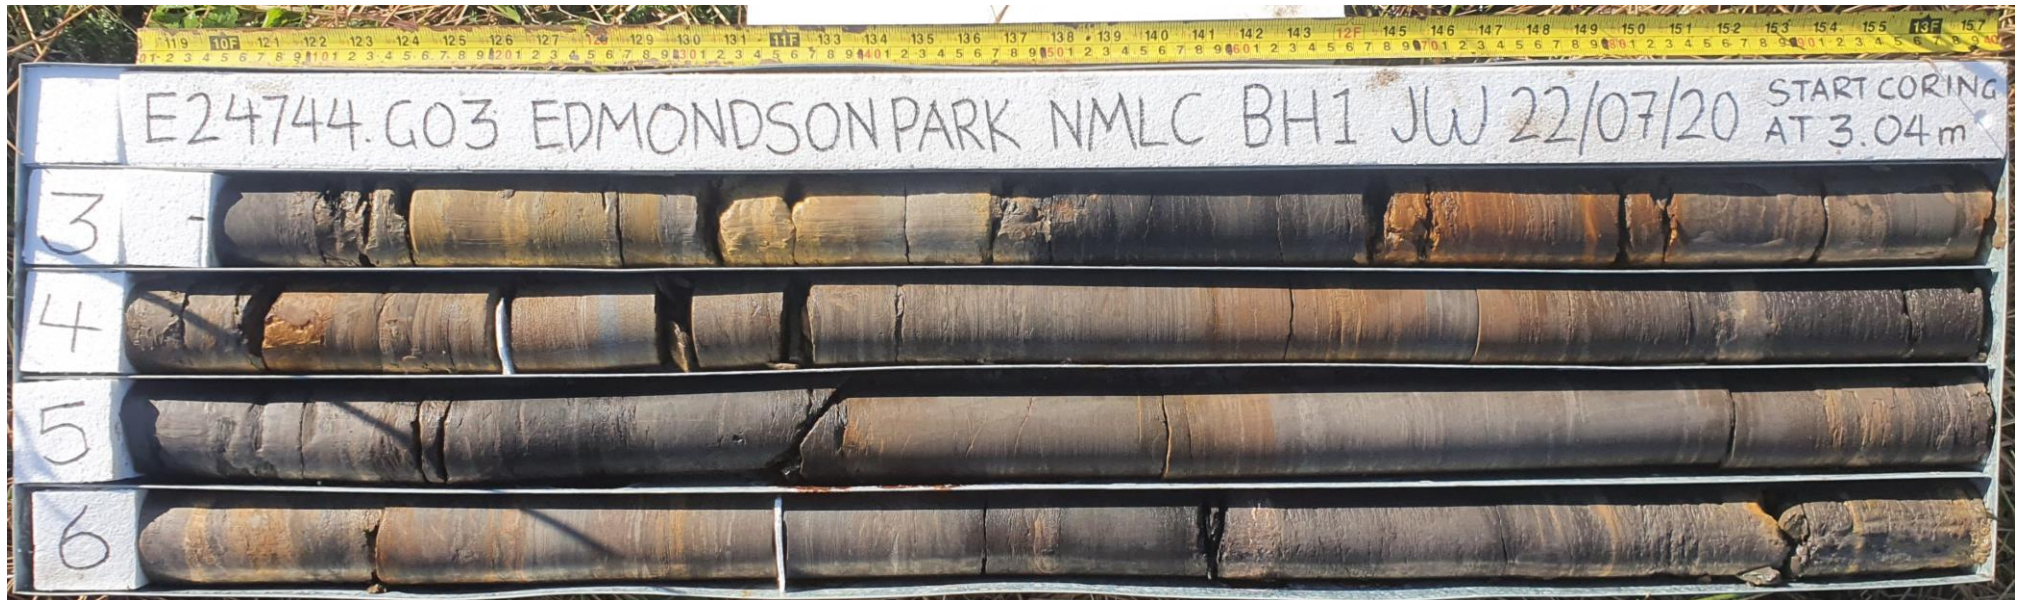
CORE PHOTOGRAPH OF BOREHOLE: BH1

Project	Proposed Residential Development	Depth Range	3.04m to 7.00m BEGL	
Location	164-170 Croatia Avenue, Edmondson Park NSW	Contractor	Rockwell Drilling Services Pty Ltd	
Position	See Figure 2	Drill Rig	Hanjin D&B 8D	
Job No.	E24744.G03	Logged	JW	Date 22 / 07 / 2020
Client	Tony Owen Pty Ltd	Inclination	-90°	Checked SK
		Box	1 of 3	Date 17 / 07 / 2020

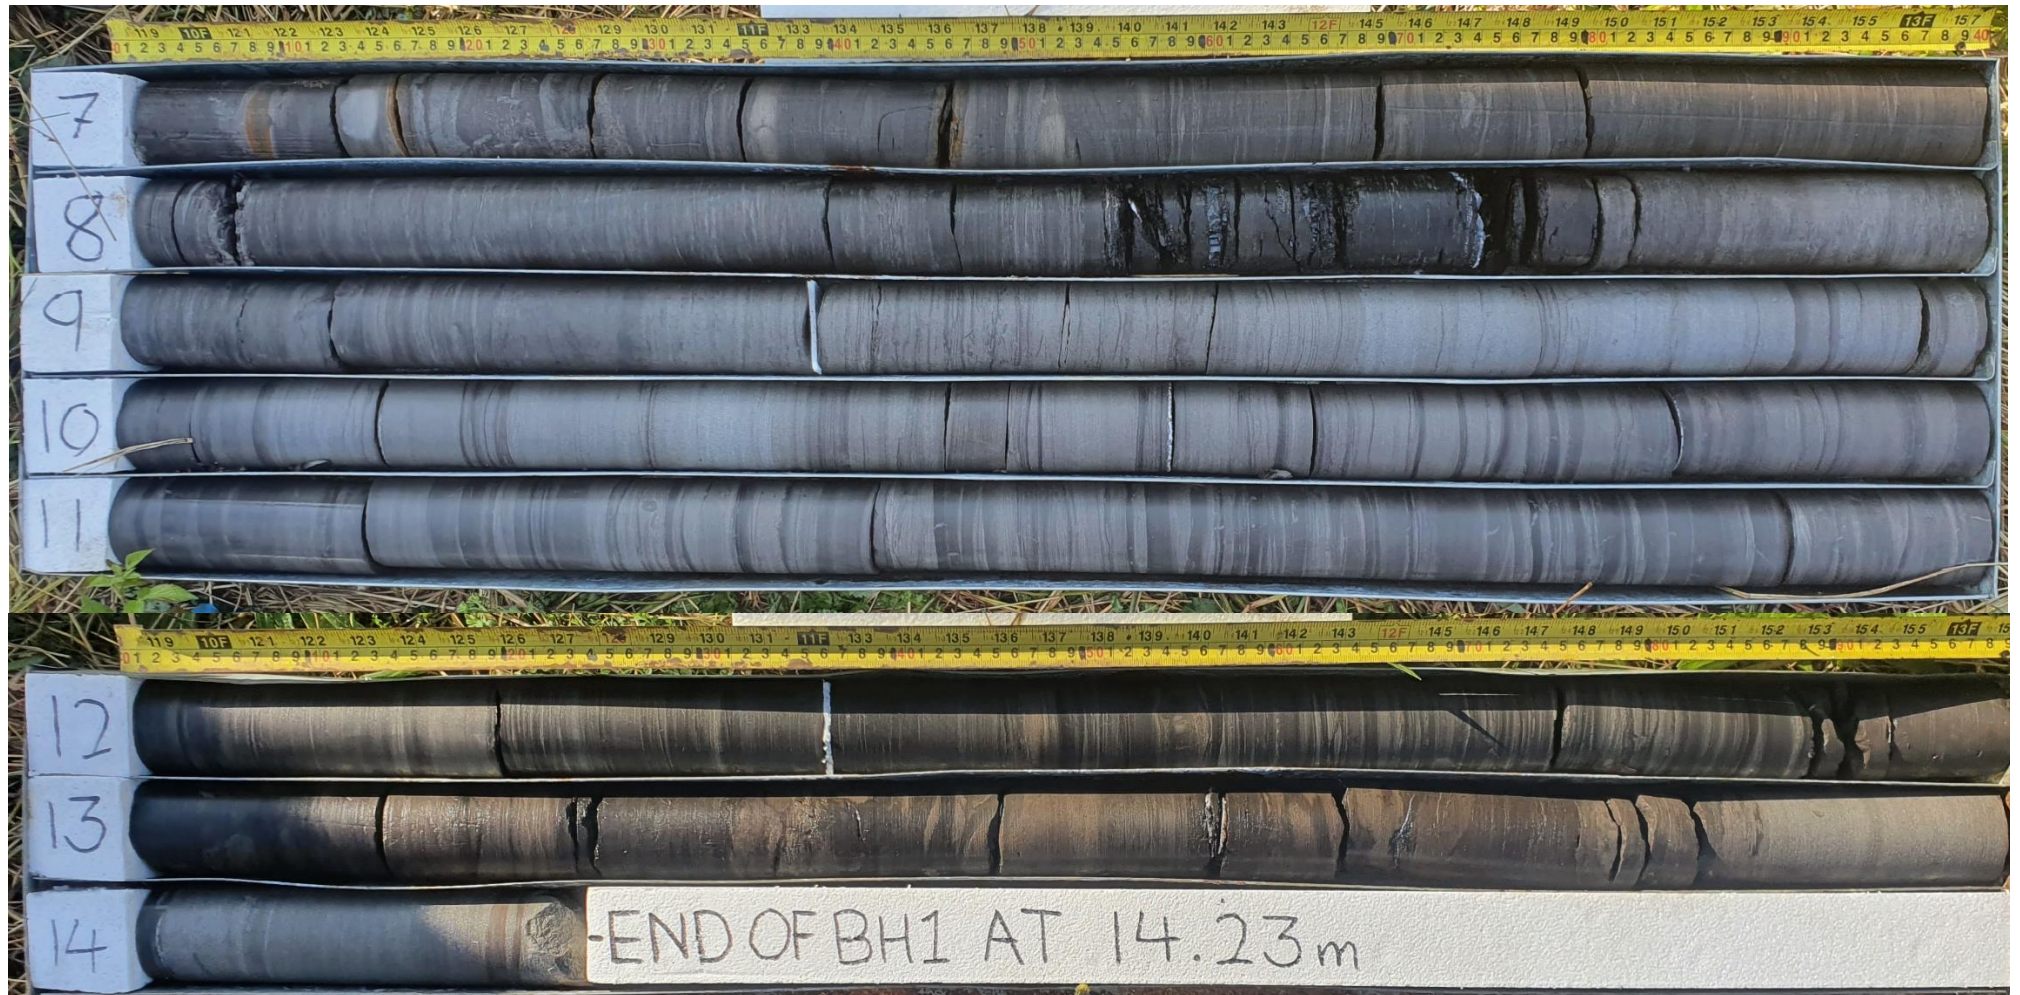
CORE PHOTOGRAPH OF BOREHOLE: BH1

Project	Proposed Residential Development	Depth Range	7.00m to 14.23m BEGL	
Location	164-170 Croatia Avenue, Edmondson Park NSW	Contractor	Rockwell Drilling Services Pty Ltd	
Position	See Figure 2	Drill Rig	Hanjin D&B 8D	
Job No.	E24744.G03	Logged	JW	Date 22 / 07 / 2020
Client	Tony Owen Pty Ltd	Box	2-3 of 3	Checked SK Date 17 / 07 / 2020

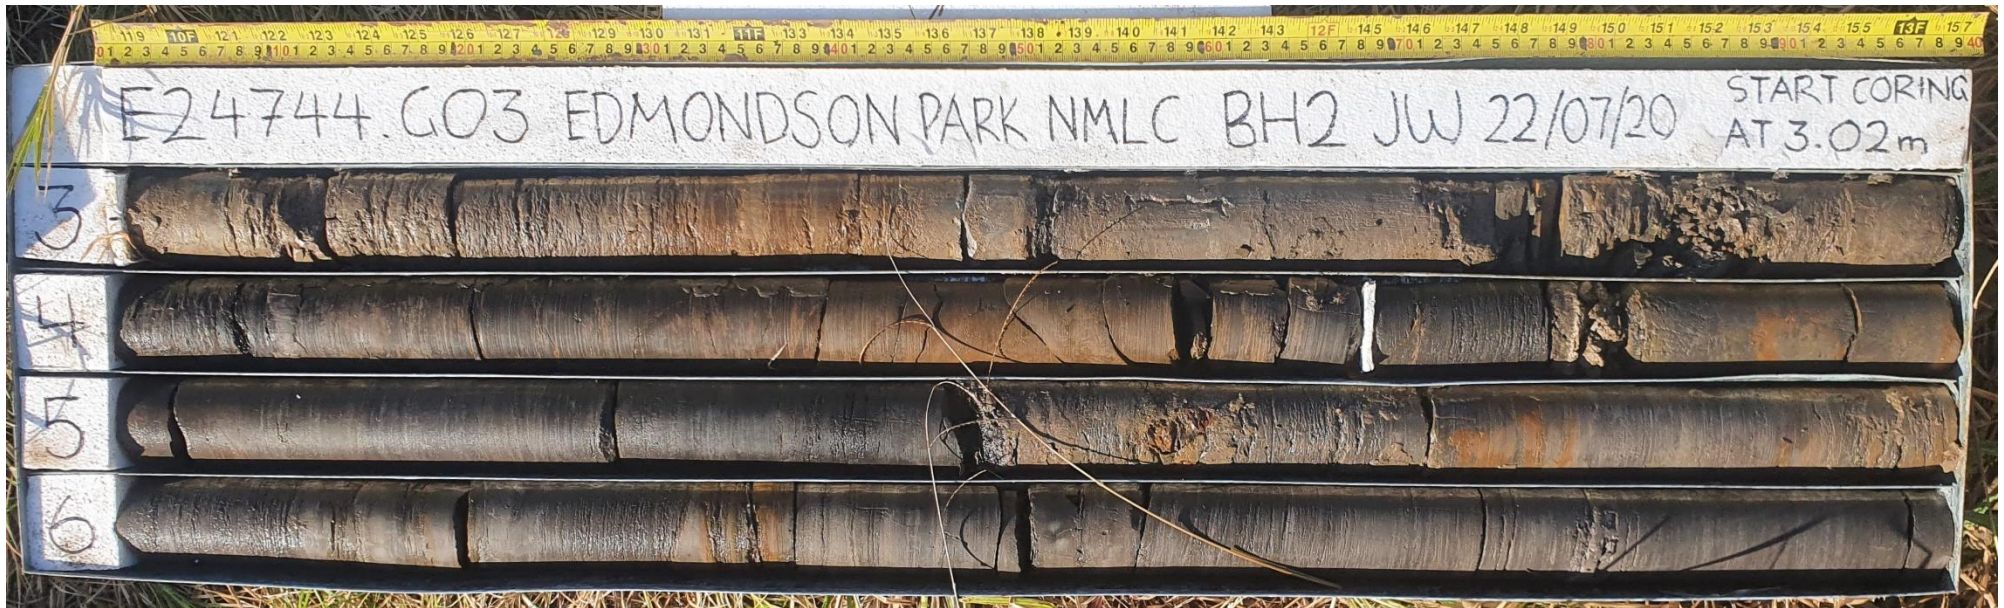
CORE PHOTOGRAPH OF BOREHOLE: BH2

Project	Proposed Residential Development	Depth Range	3.02m to 7.00m BEGL	
Location	164-170 Croatia Avenue, Edmondson Park NSW	Contractor	Rockwell Drilling Services Pty Ltd	
Position	See Figure 2	Drill Rig	Hanjin D&B 8D	
Job No.	E24744.G03	Logged	JW	Date 22 / 07 / 2020
Client	Tony Owen Pty Ltd	Inclination	-90°	Date 17 / 07 / 2020
		Box	1 of 3

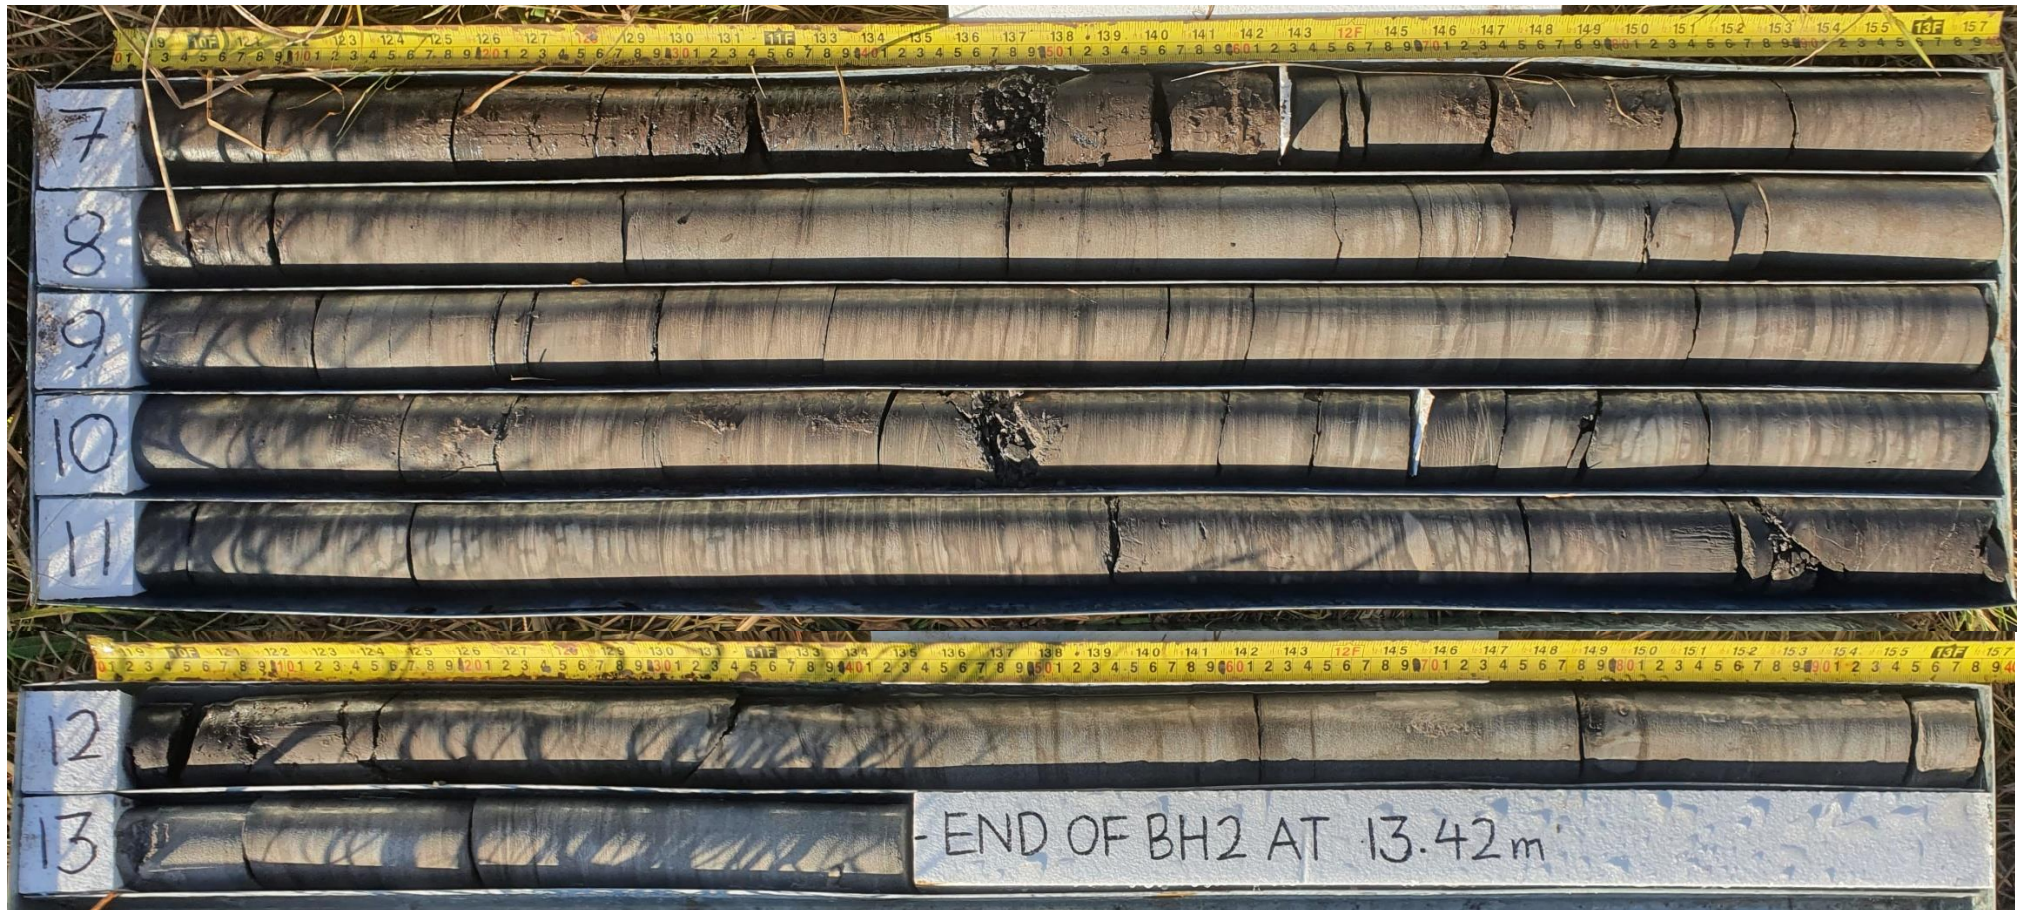
CORE PHOTOGRAPH OF BOREHOLE: BH2

Project	Proposed Residential Development	Depth Range	7.00m to 13.42m BEGL	
Location	164-170 Croatia Avenue, Edmondson Park NSW	Contractor	Rockwell Drilling Services Pty Ltd	
Position	See Figure 2	Drill Rig	Hanjin D&B 8D	
Job No.	E24744.G03	Logged	JW	Date 22 / 07 / 2020
Client	Tony Owen Pty Ltd	Inclination	-90°	Date 17 / 07 / 2020
		Box	2-3 of 3	
		Checked	SK

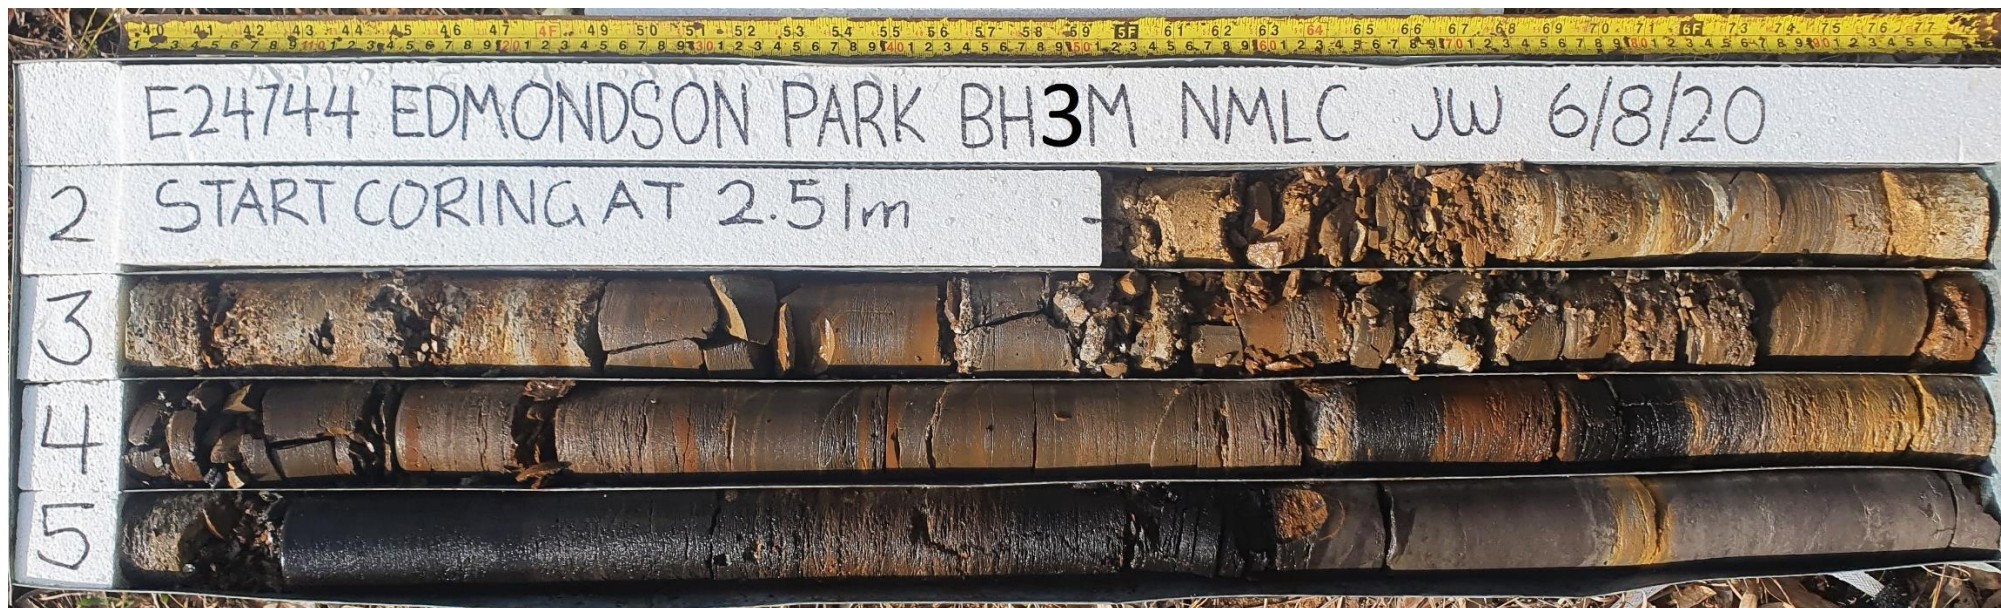
CORE PHOTOGRAPH OF BOREHOLE: BH3M

Project	Proposed Residential Development	Depth Range	2.51m to 6.00m BEGL	
Location	164-170 Croatia Avenue, Edmondson Park NSW	Contractor	Rockwell Drilling Services Pty Ltd	
Position	See Figure 2	Drill Rig	Hanjin D&B 8D	
Job No.	E24744.G03	Logged	JW	Date 06 / 08 / 2020
Client	Tony Owen Pty Ltd	Box	1 of 3	Checked SK Date 17 / 07 / 2020

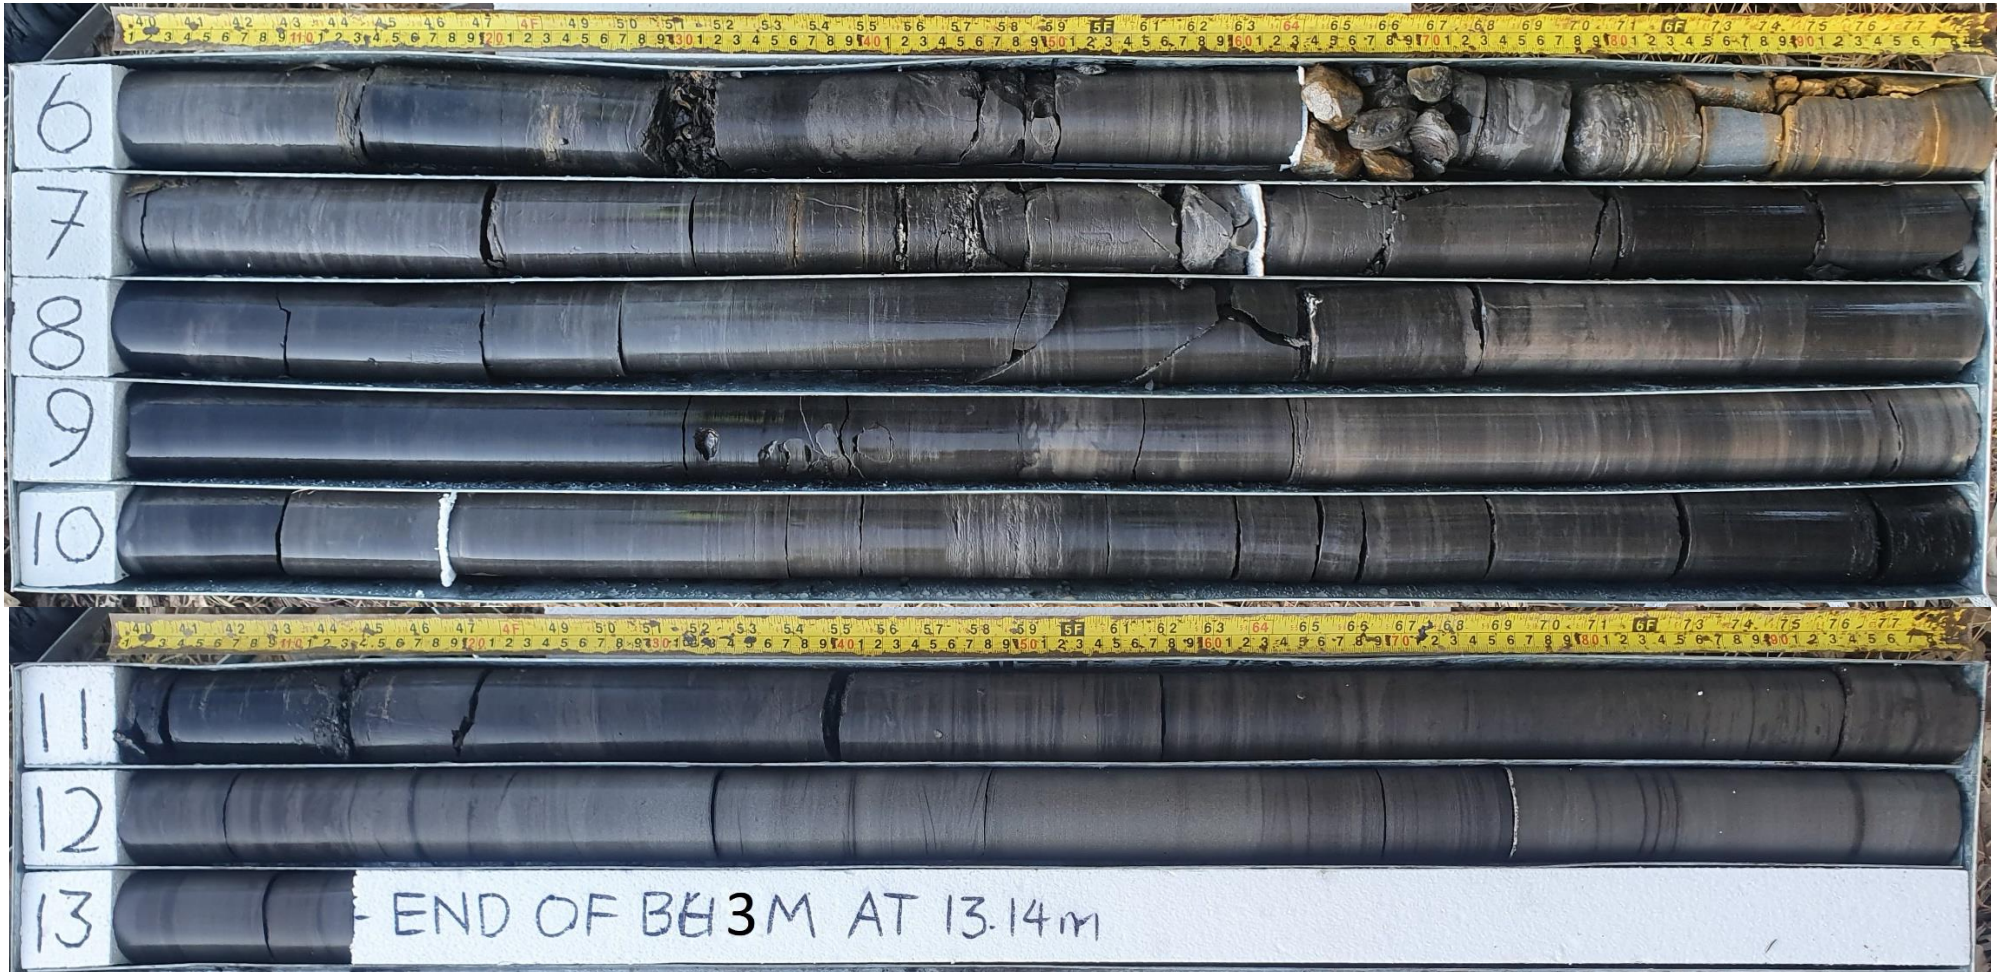
CORE PHOTOGRAPH OF BOREHOLE: BH3M

Project	Proposed Residential Development	Depth Range	6.0m to 13.14m BEGL	
Location	164-170 Croatia Avenue, Edmondson Park NSW	Contractor	Rockwell Drilling Services Pty Ltd	
Position	See Figure 2	Drill Rig	Hanjin D&B 8D	
Job No.	E24744.G03	Logged	JW	Date 06 / 08 / 2020
Client	Tony Owen Pty Ltd	Inclination	-90°	Date 17 / 07 / 2020
		Box	2-3 of 3	
		Checked	SK

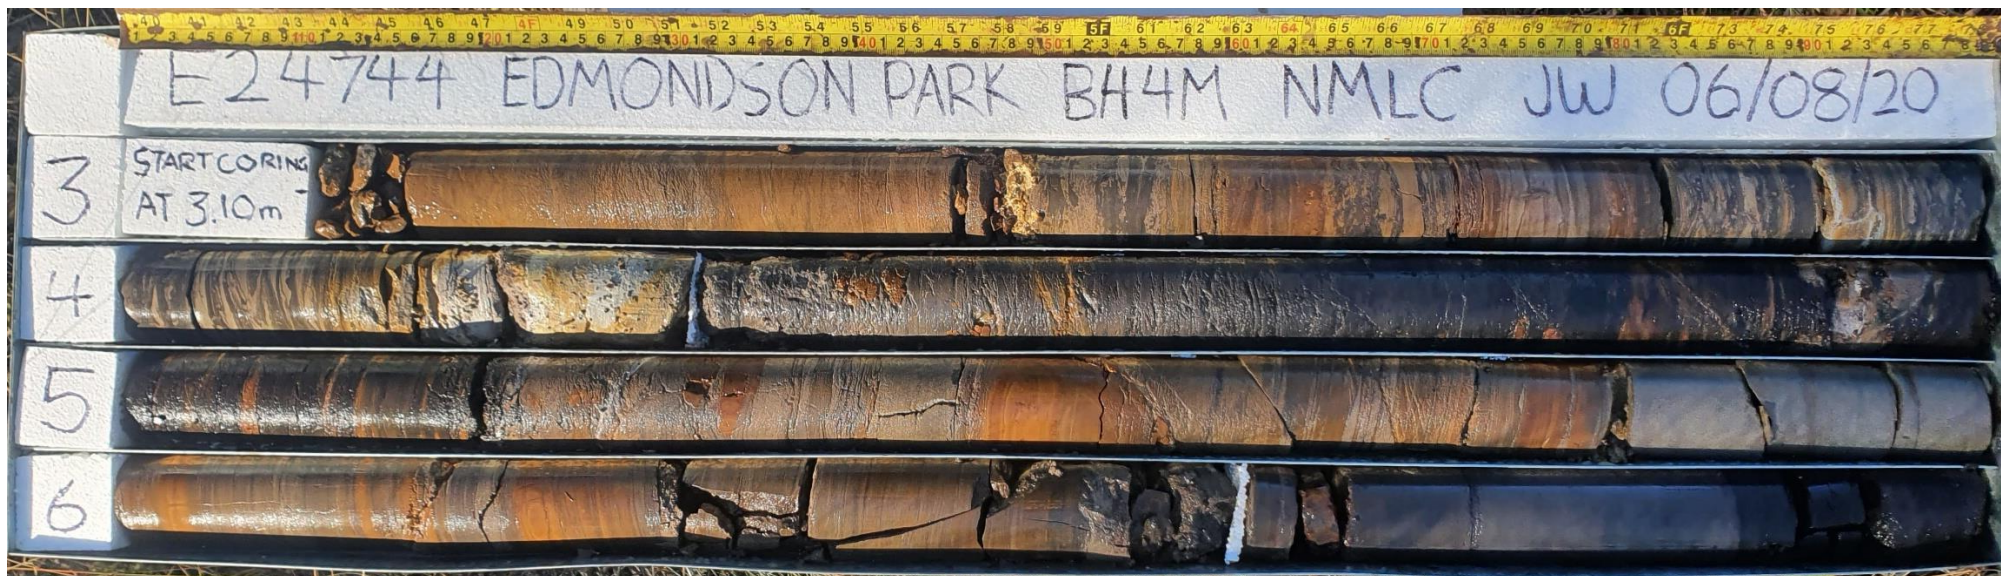
CORE PHOTOGRAPH OF BOREHOLE: BH4M

Project	Proposed Residential Development	Depth Range	3.10m to 7.00m BEGL	
Location	164-170 Croatia Avenue, Edmondson Park NSW	Contractor	Rockwell Drilling Services Pty Ltd	
Position	See Figure 2	Drill Rig	Hanjin D&B 8D	
Job No.	E24744.G03	Logged	JW	Date 06 / 08 / 2020
Client	Tony Owen Pty Ltd	Box	1 of 3	Checked SK Date 17 / 07 / 2020

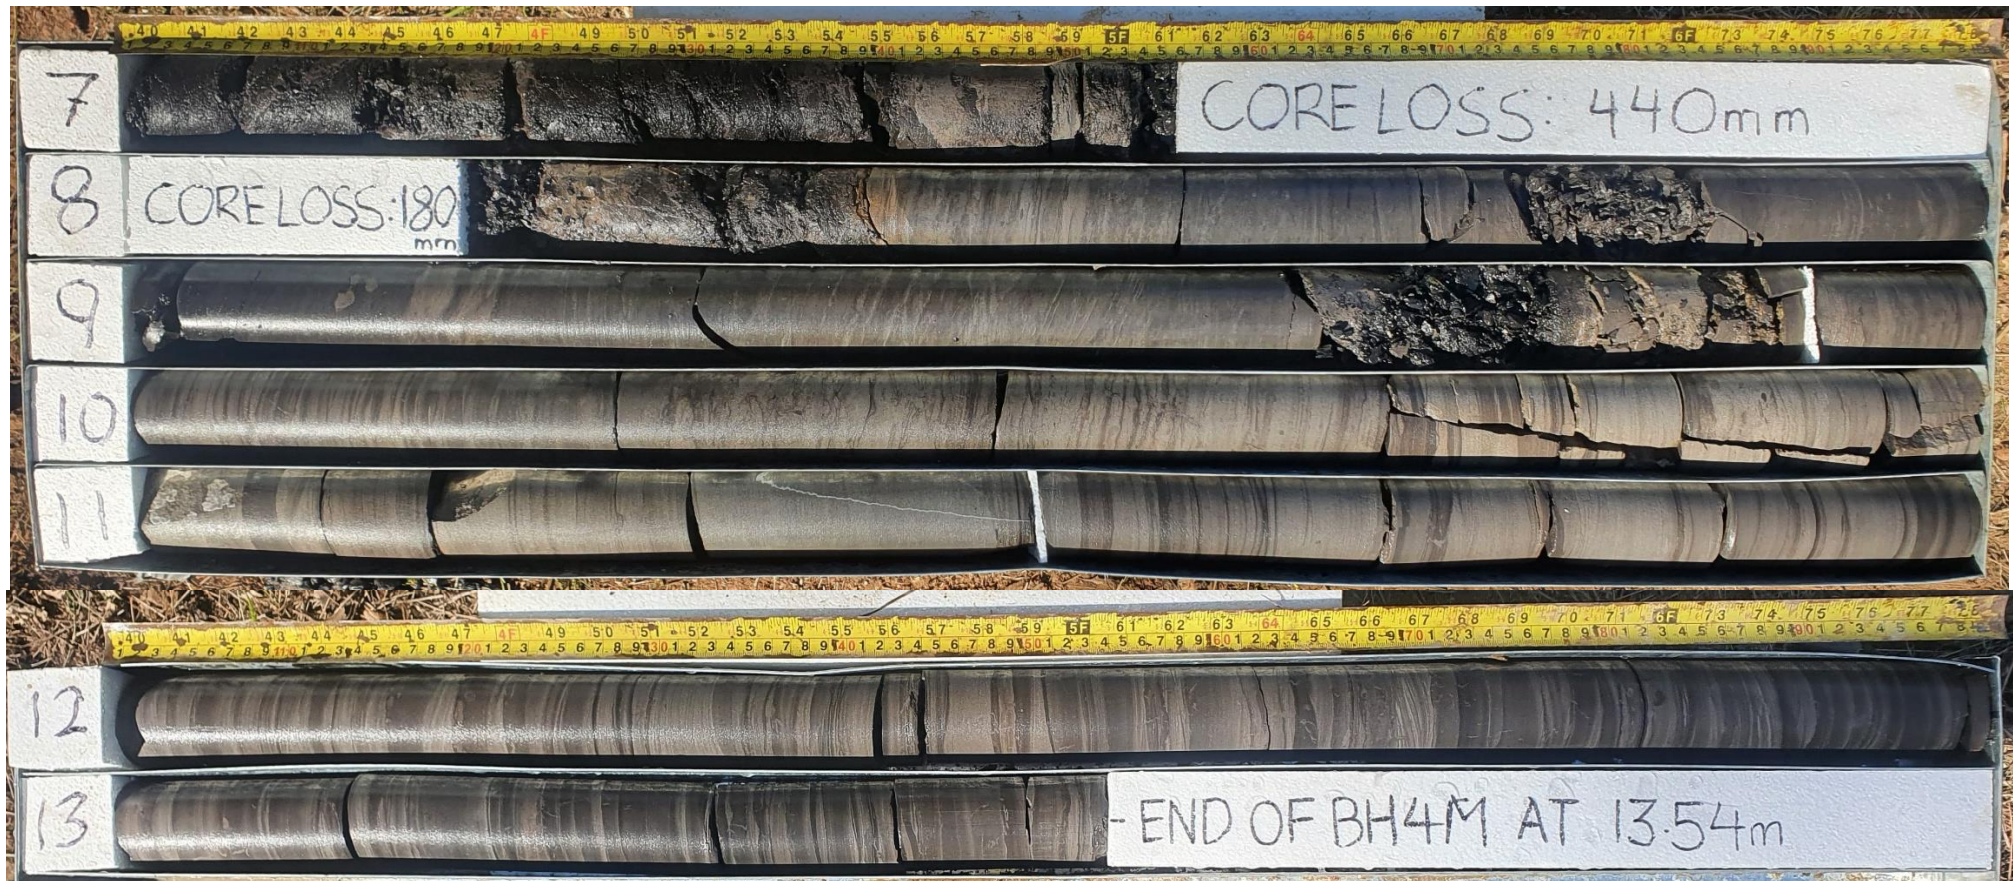
CORE PHOTOGRAPH OF BOREHOLE: BH4M

Project	Proposed Residential Development	Depth Range	7.00m to 13.54m BEGL	
Location	164-170 Croatia Avenue, Edmondson Park NSW	Contractor	Rockwell Drilling Services Pty Ltd	
Position	See Figure 2	Drill Rig	Hanjin D&B 8D	
Job No.	E24744.G03	Logged	JW	Date 06 / 08 / 2020
Client	Tony Owen Pty Ltd	Inclination	-90°	Date 17 / 07 / 2020
		Box	2-3 of 3	
		Checked	SK

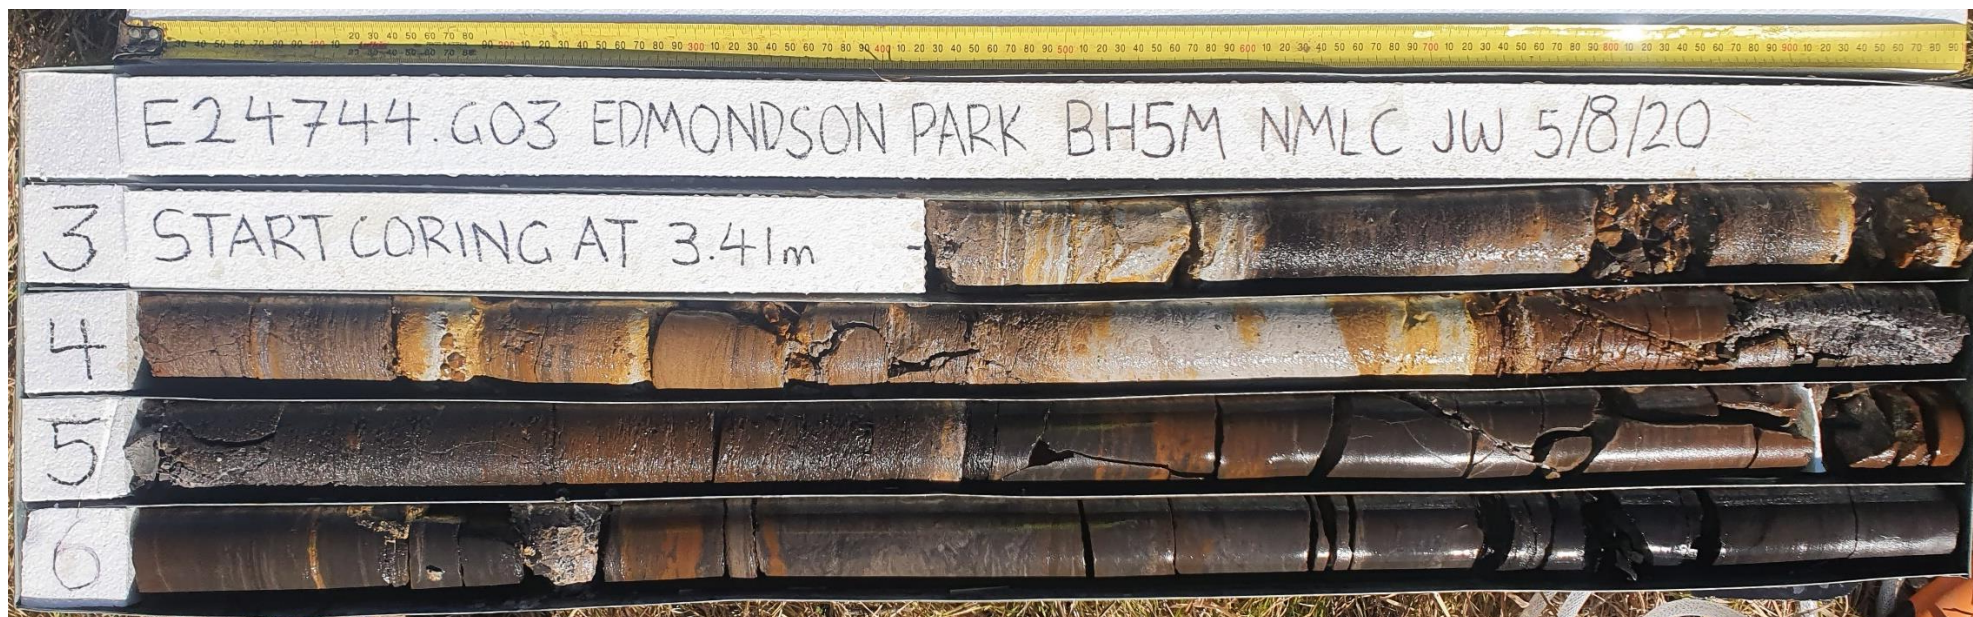
CORE PHOTOGRAPH OF BOREHOLE: BH5M

Project	Proposed Residential Development	Depth Range	3.41m to 7.00m BEGL	
Location	164-170 Croatia Avenue, Edmondson Park NSW	Contractor	Rockwell Drilling Services Pty Ltd	
Position	See Figure 2	Drill Rig	Hanjin D&B 8D	
Job No.	E24744.G03	Logged	JW	Date 05 / 08 / 2020
Client	Tony Owen Pty Ltd	Box	1 of 3	Checked SK Date 17 / 07 / 2020

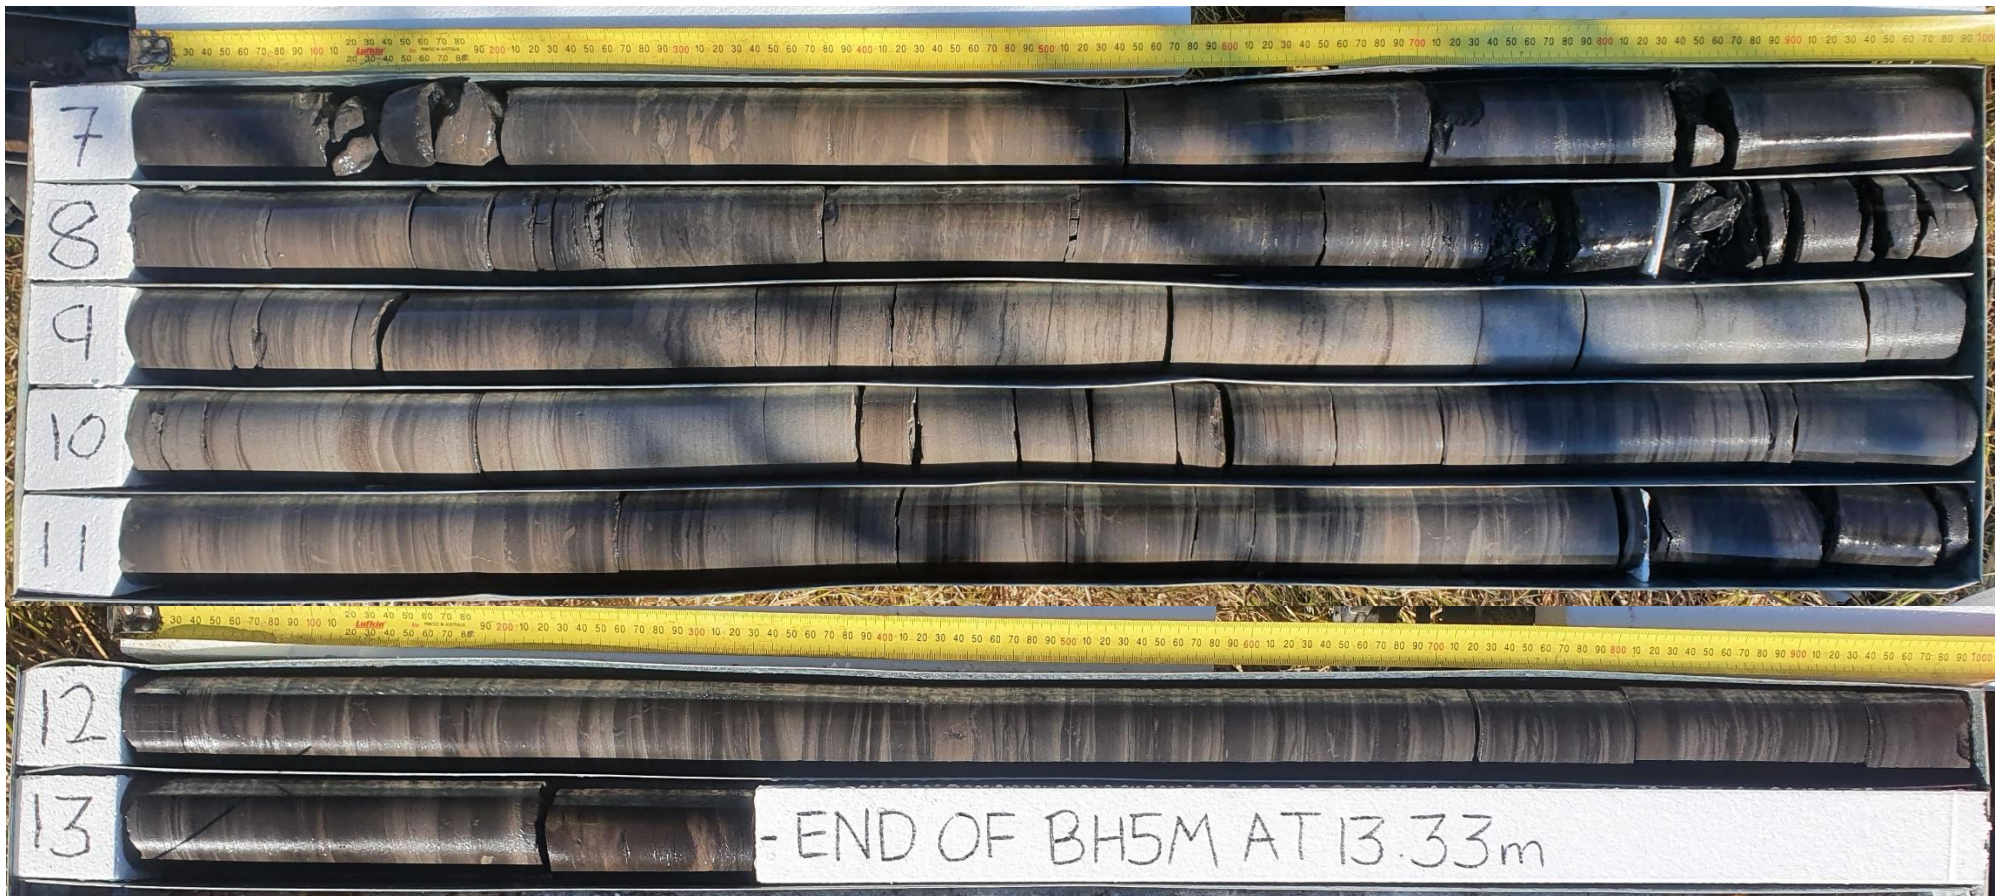
CORE PHOTOGRAPH OF BOREHOLE: BH5M

Project	Proposed Residential Development	Depth Range	7.00m to 13.33m BEGL	
Location	164-170 Croatia Avenue, Edmondson Park NSW	Contractor	Rockwell Drilling Services Pty Ltd	
Position	See Figure 2	Drill Rig	Hanjin D&B 8D	
Job No.	E24744.G03	Logged	JW	Date 05 / 08 / 2020
Client	Tony Owen Pty Ltd	Inclination	-90°	Date 17 / 07 / 2020
		Box	2-3 of 3	
		Checked	SK

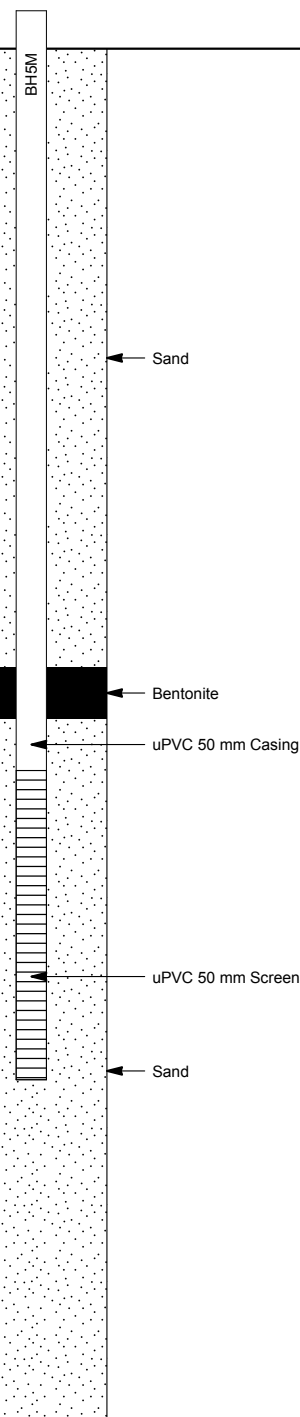
MONITORING WELL LOG

ID	Type	Stick Up & RL	Tip Depth & RL	Installation Date	Static Water Level
BH5M	Standpipe	0.55 m 37.95 m	10.00 m 37.40 m

METHOD	WATER	DEPTH (m)	RL (m AHD)	GRAPHIC LOG	SOIL/ROCK MATERIAL DESCRIPTION
AD/T	GWNE				
		0			FILL: Silty CLAY; medium plasticity, brown, trace of fine grained sub-rounded to rounded gravels and some rootlets.
					Silty CLAY; high plasticity, pale grey to orange-red, trace rootlets.
		2			
					From 2.8 m, grading to pale grey extremely weathered shale.
		4			SHALE; dark grey to brown-orange, thinly to medium bedded with occasional fine grained pale grey brown sandstone laminations, with occasional layers of claystone.
		6			
		8			
		10			SANDSTONE; pale grey, fine grained, medium bedded with shale laminations.
		12			SHALE; dark grey, with fine grained pale grey sandstone laminations.
		13.33			Hole Terminated at 13.33 m

We note that artesian flow was observed within the wells BH4M and BH5M, with steady water flow within BH4M and a stable, above surface groundwater level within the stick up section of the monitoring well BH5M.

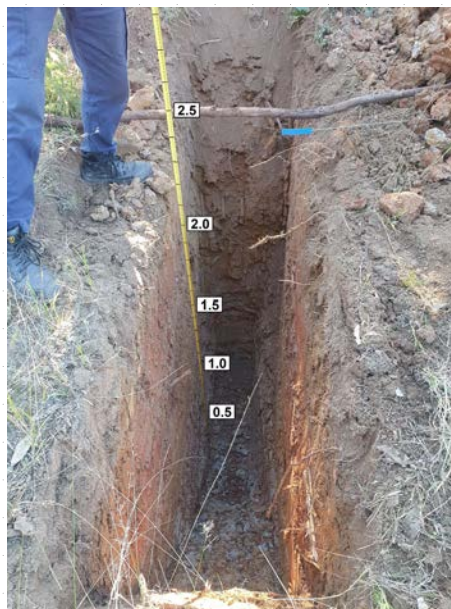
Sketch & Other Observations

-	SHALE; grey, very low strength, distinctly weathered.	-	-	BEDROCK		
			3						Hole Terminated at 2.55 m Refusal on shale bedrock

Comments
 Refusal on shale bedrock

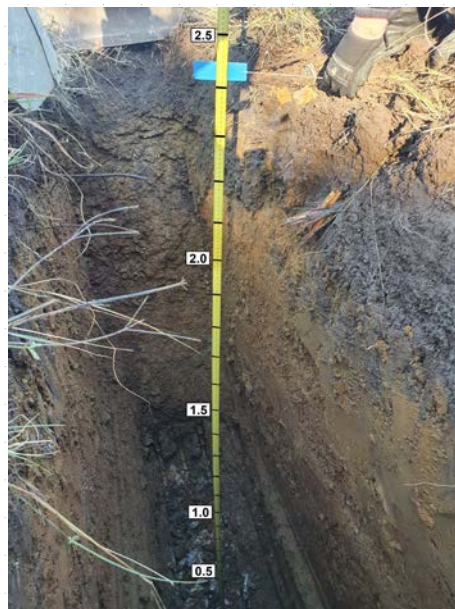
Sketch & Other Observations

Excavation				Sampling		Field Material Description				
METHOD	EXCAVATION RESISTANCE	WATER	DEPTH (metres)	DEPTH RL	SAMPLE OR FIELD TEST	RECOVERED GRAPHIC LOG	GROUP SYMBOL	SOIL/ROCK MATERIAL DESCRIPTION	MOISTURE CONDITION CONSISTENCY DENSITY	STRUCTURE AND ADDITIONAL OBSERVATIONS
E	L	GWNE	0	47.10	DS 0.10-0.30 m		-	FILL: Silty CLAY; medium plasticity, brown, trace of fine grained sub-round to round gravel and some rootlets.	M (<PL)	FILL/TOPSOIL
				0.30						
				46.80	DS 0.80-1.10 m		CH	Silty CLAY; high plasticity, pale grey to orange-red, trace rootlets.	M (>PL)	RESIDUAL SOIL
			1							
			2	2.30			-		M (<PL)	
				2.40				SHALE; grey, very low strength, distinctly weathered.	-	BEDROCK
			3					Hole Terminated at 2.40 m Refusal on shale bedrock		
			4

Comments
 Refusal on shale bedrock
