Geotechnical Investigation

164-170 Croatia Avenue, Edmondson Park NSW

Report No: E24744.G03

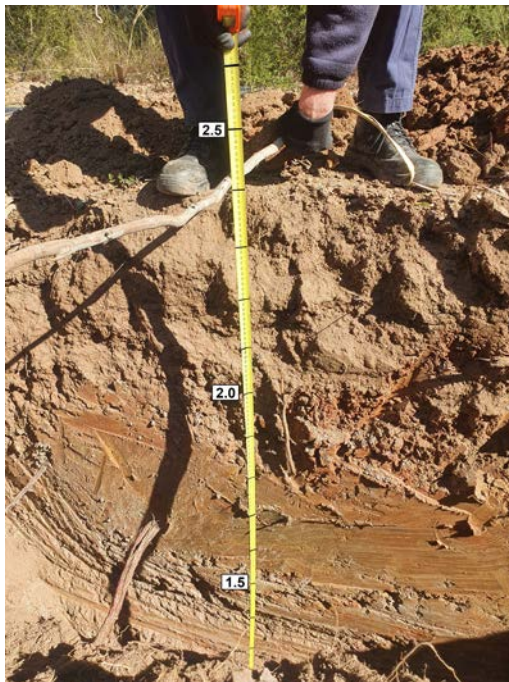
Sketch & Other Observations

CI	Silty CLAY; medium plasticity, pale grey to orange-red, trace rootlets.			RESIDUAL SOIL	
			1	1.10									
				52.30									
				1.80					From 1.1 m, pale grey.	M (<PL)	-		
				51.60					From 1.8 m, bands of ironstone.				
			2										
				2.40									
			3						Hole Terminated at 2.40 m Target Depth Reached.

Comments
 Target Depth Reached.

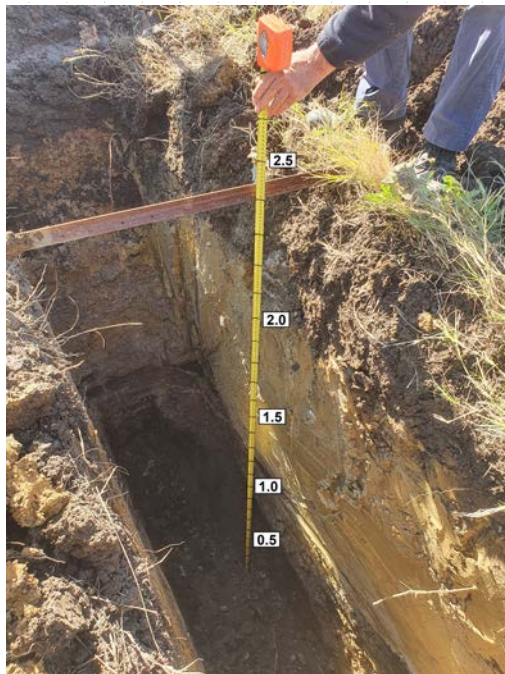
Sketch & Other Observations

47.50				From 1.9 m, bands of ironstone.	M (<PL)	
				2.30						
				2.40			-	SHALE; grey, very low strength, distinctly weathered.	-	BEDROCK
			3					Hole Terminated at 2.40 m Refusal on shale bedrock		
			4

Comments
 Refusal on shale bedrock

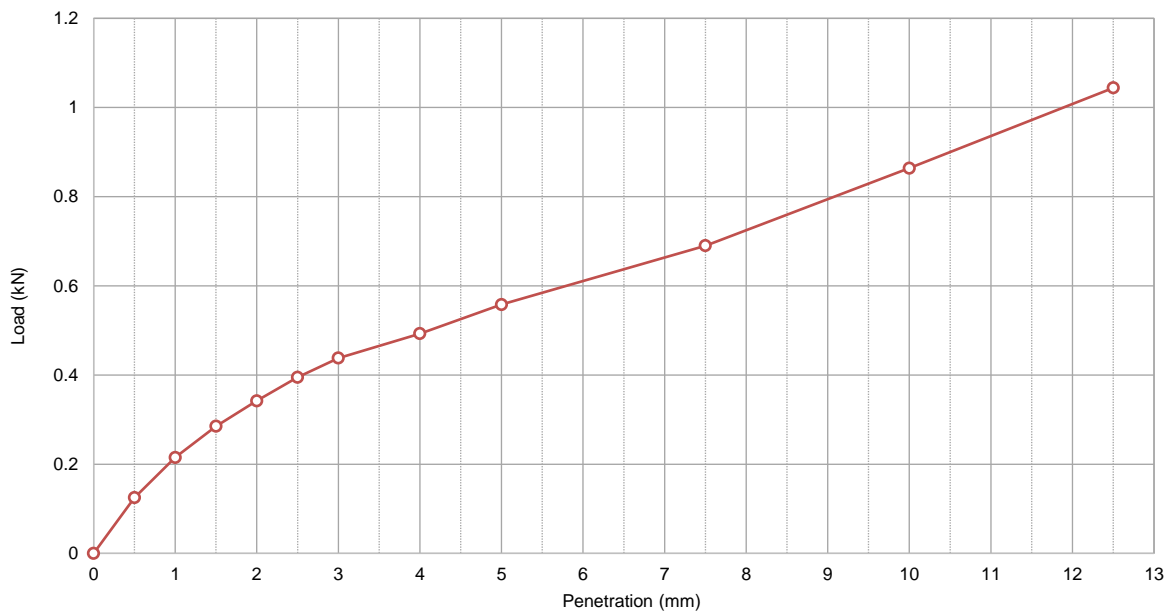
Preparation & Specification		Density & Moisture			Achieved	Target
Retained on 19.0mm Sieve (%)	0	Lab Moisture Ratio - LMR (%)			99.5	100.0
Method of Establishing Plasticity Level	Technician Assessment	Lab Density Ratio - LDR (%)			99.5	100.0
Sample Curing Time (hrs)	148 hrs	Dry Density - At Compaction (t/m³)			1.78	1.79
Compaction Hammer Used	Standard	Dry Density - After Soaking (t/m³)			1.74	
Surcharge Mass Applied (kg)	9.0	Specimen Swell (%)			2.6	
Period of Soaking (Days)	4	Moisture Content - At Compaction (%)			17.6	
Maximum Dry Density - MDD (t/m³)	1.79	Moisture Content - Top 30mm (%)			26.1	
Optimum Moisture Content - OMC (%)	17.7	Moisture Content - Remainder (%)			18.1

Material CBR Value (%): 3 at a penetration of 2.5 mm

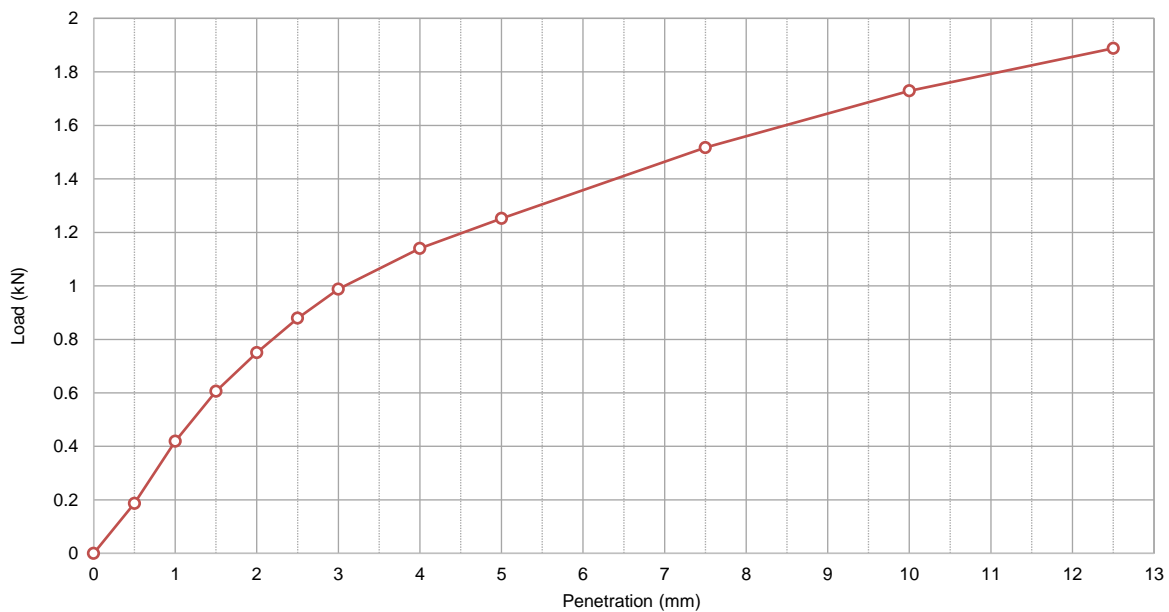
Preparation & Specification		Density & Moisture			Achieved	Target
Retained on 19.0mm Sieve (%)	0	Lab Moisture Ratio - LMR (%)			100.5	100.0
Method of Establishing Plasticity Level	Technician Assessment	Lab Density Ratio - LDR (%)			100.0	100.0
Sample Curing Time (hrs)	150 hrs	Dry Density - At Compaction (t/m³)			1.78	1.78
Compaction Hammer Used	Standard	Dry Density - After Soaking (t/m³)			1.76	
Surcharge Mass Applied (kg)	9.0	Specimen Swell (%)			1.2	
Period of Soaking (Days)	4	Moisture Content - At Compaction (%)			17.6	
Maximum Dry Density - MDD (t/m³)	1.78	Moisture Content - Top 30mm (%)			21.2	
Optimum Moisture Content - OMC (%)	17.5	Moisture Content - Remainder (%)			17.4

Material CBR Value (%): 7 at a penetration of 2.5 mm

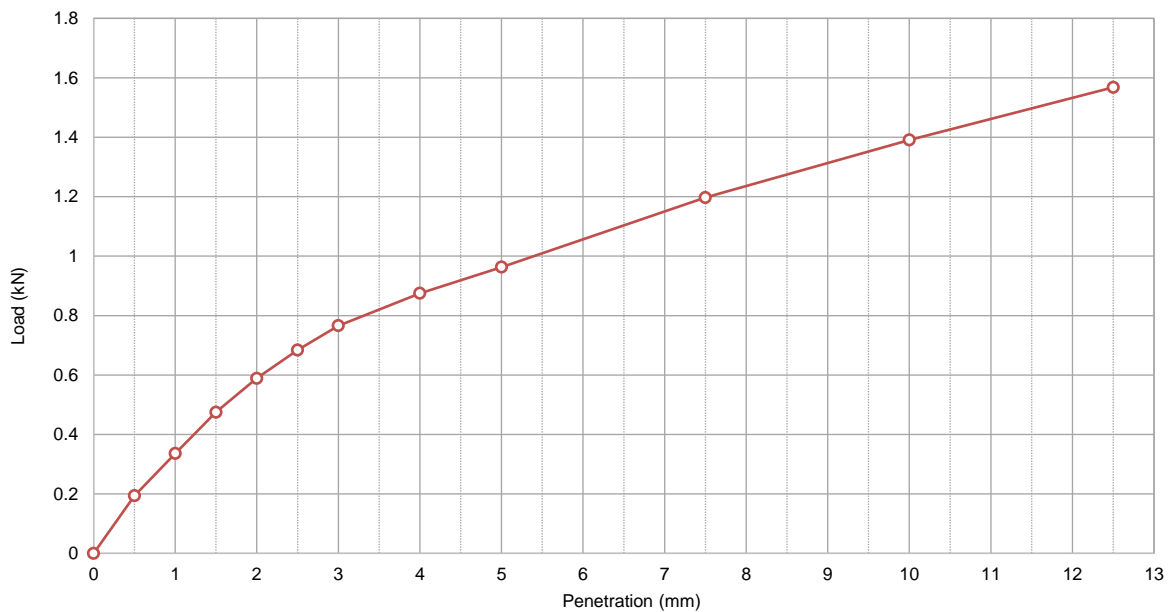
Preparation & Specification		Density & Moisture		Achieved	Target
Retained on 19.0mm Sieve (%)	0	Lab Moisture Ratio - LMR (%)		100.5	100.0
Method of Establishing Plasticity Level	Technician Assessment	Lab Density Ratio - LDR (%)		99.5	100.0
Sample Curing Time (hrs)	149 hrs	Dry Density - At Compaction (t/m³)		1.60	1.61
Compaction Hammer Used	Standard	Dry Density - After Soaking (t/m³)		1.58	
Surcharge Mass Applied (kg)	9.0	Specimen Swell (%)		1.6	
Period of Soaking (Days)	4	Moisture Content - At Compaction (%)		23.1	
Maximum Dry Density - MDD (t/m³)	1.61	Moisture Content - Top 30mm (%)		29.3	
Optimum Moisture Content - OMC (%)	23.0	Moisture Content - Remainder (%)		23.9

Material CBR Value (%): 5 at a penetration of 2.5 mm
