ARBORICULTURAL IMPACT ASSESSMENT

Bonnyrigg Living Communities Project
Subdivision Stages 1 & 2. Bonnyrigg NSW 2177

LGA: Fairfield City Council
Date: 4 November 2020
Revision: A
Job No: D786

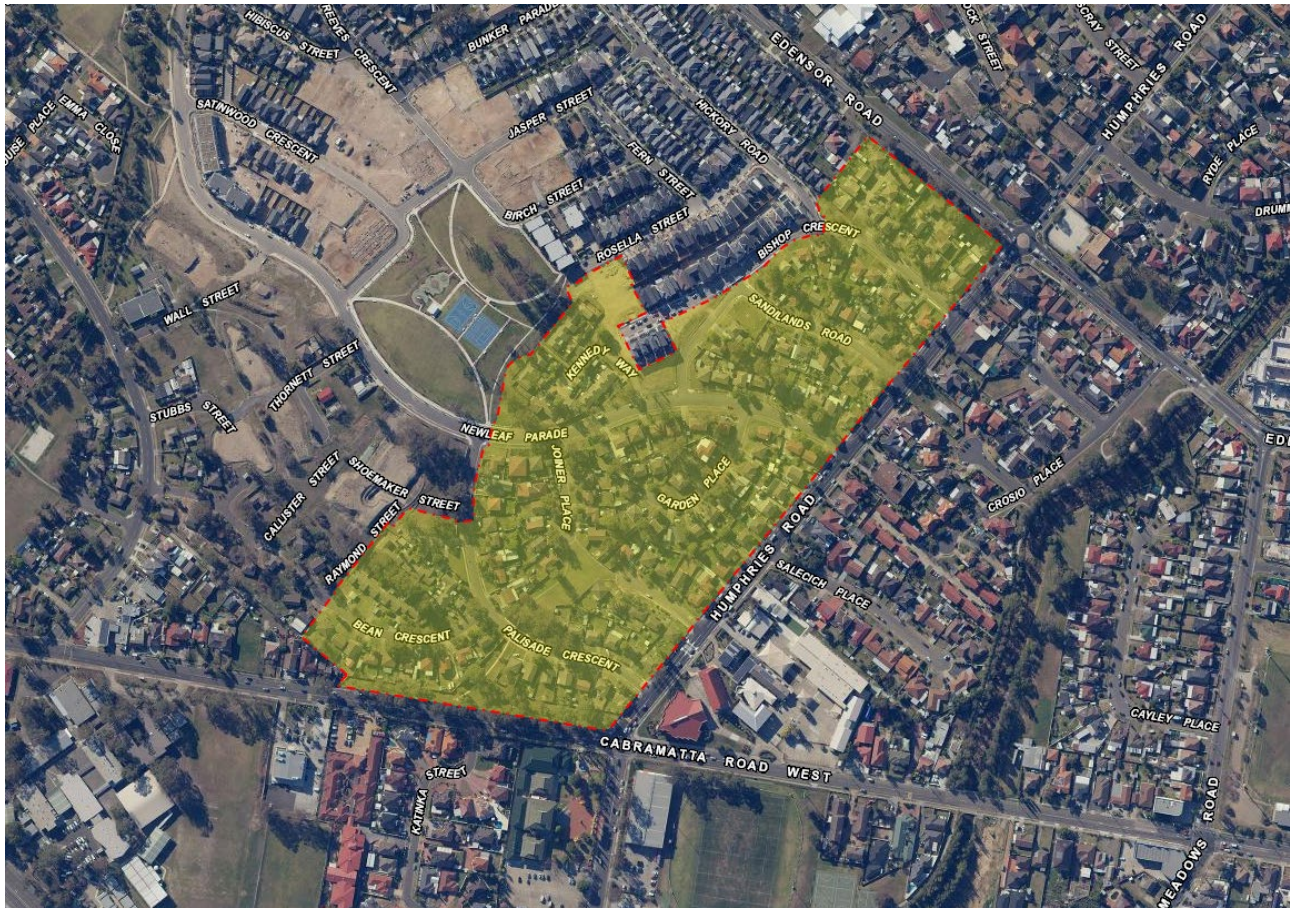
Figure 1 - Aerial image indicating subject site (highlighted yellow)

This Arboricultural Impact Assessment (AIA) was commissioned by Paul Parfenow of Land & Housing Corporation on the 7th of August 2020 to evaluate the potential impacts that proposed redevelopment works will have on existing trees located on and adjacent to land associated with a new residential subdivision within the suburb of Bonnyrigg, NSW (refer to **Figure 1**).

The site area subject to this assessment is approximately 13.58-hectares in size and consists of a mix of existing private and publicly owned residential dwellings within an existing public housing estate in Bonnyrigg NSW. The site is defined by a series of roadway corridors and is bound by Edensor Road to the North, Humphries Road to the East and Cabramatta Road to the South. A series of recently completed subdivision stages are located to the sites West (refer to **Figure 1** below).

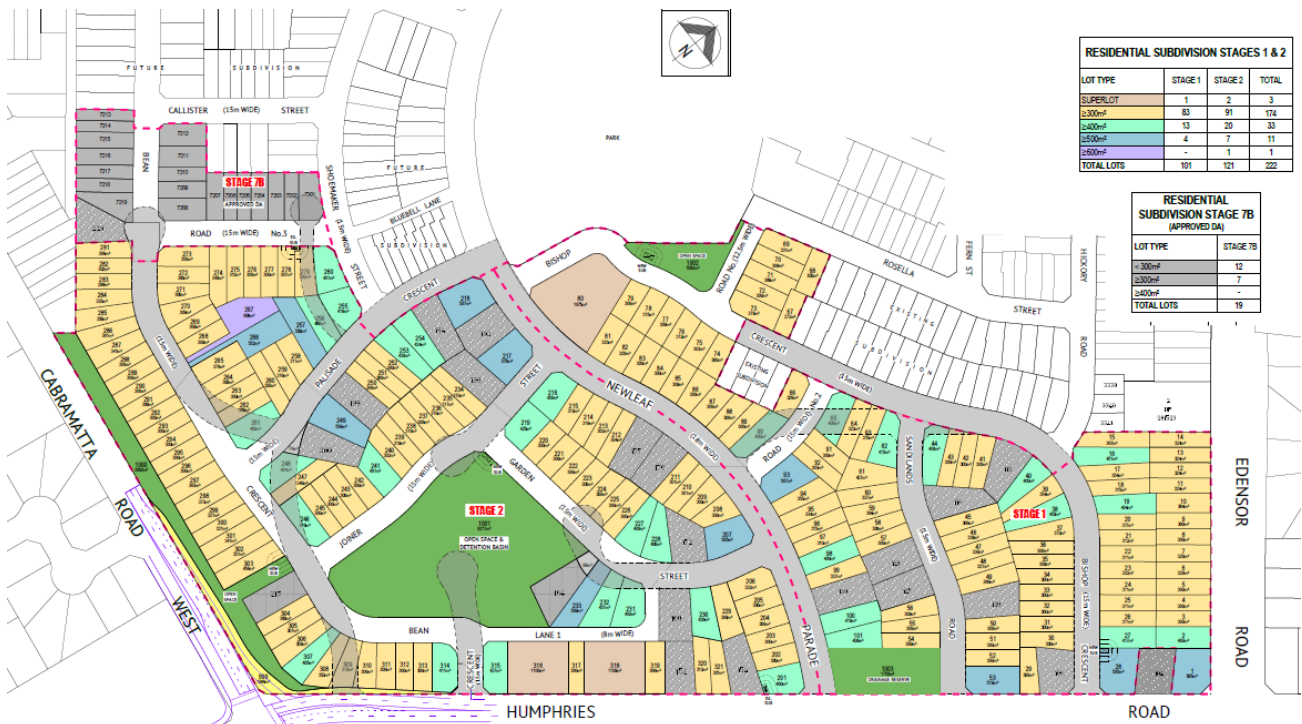
Figure 2 – Proposed Subdivision Plan extract showing the proposed layout of new roadways, allotments and open space areas.

The proposed development is for the demolition of the majority of the publicly owned dwellings and establishment of a new subdivision representing Stages 1-2 of the Bonnyrigg Living Communities Project. In addition to the demolition of existing site structures, the proposed works will include extensive site regrading, roadway & footpath reconfiguration and services infrastructure works (refer to **Figure 2** below).
