Detailed Site Investigation: Proposed Opal Aged Care Facility, 94 – 100 Explorers Way, St Clair, NSW

P207910JR03V01
December 2021

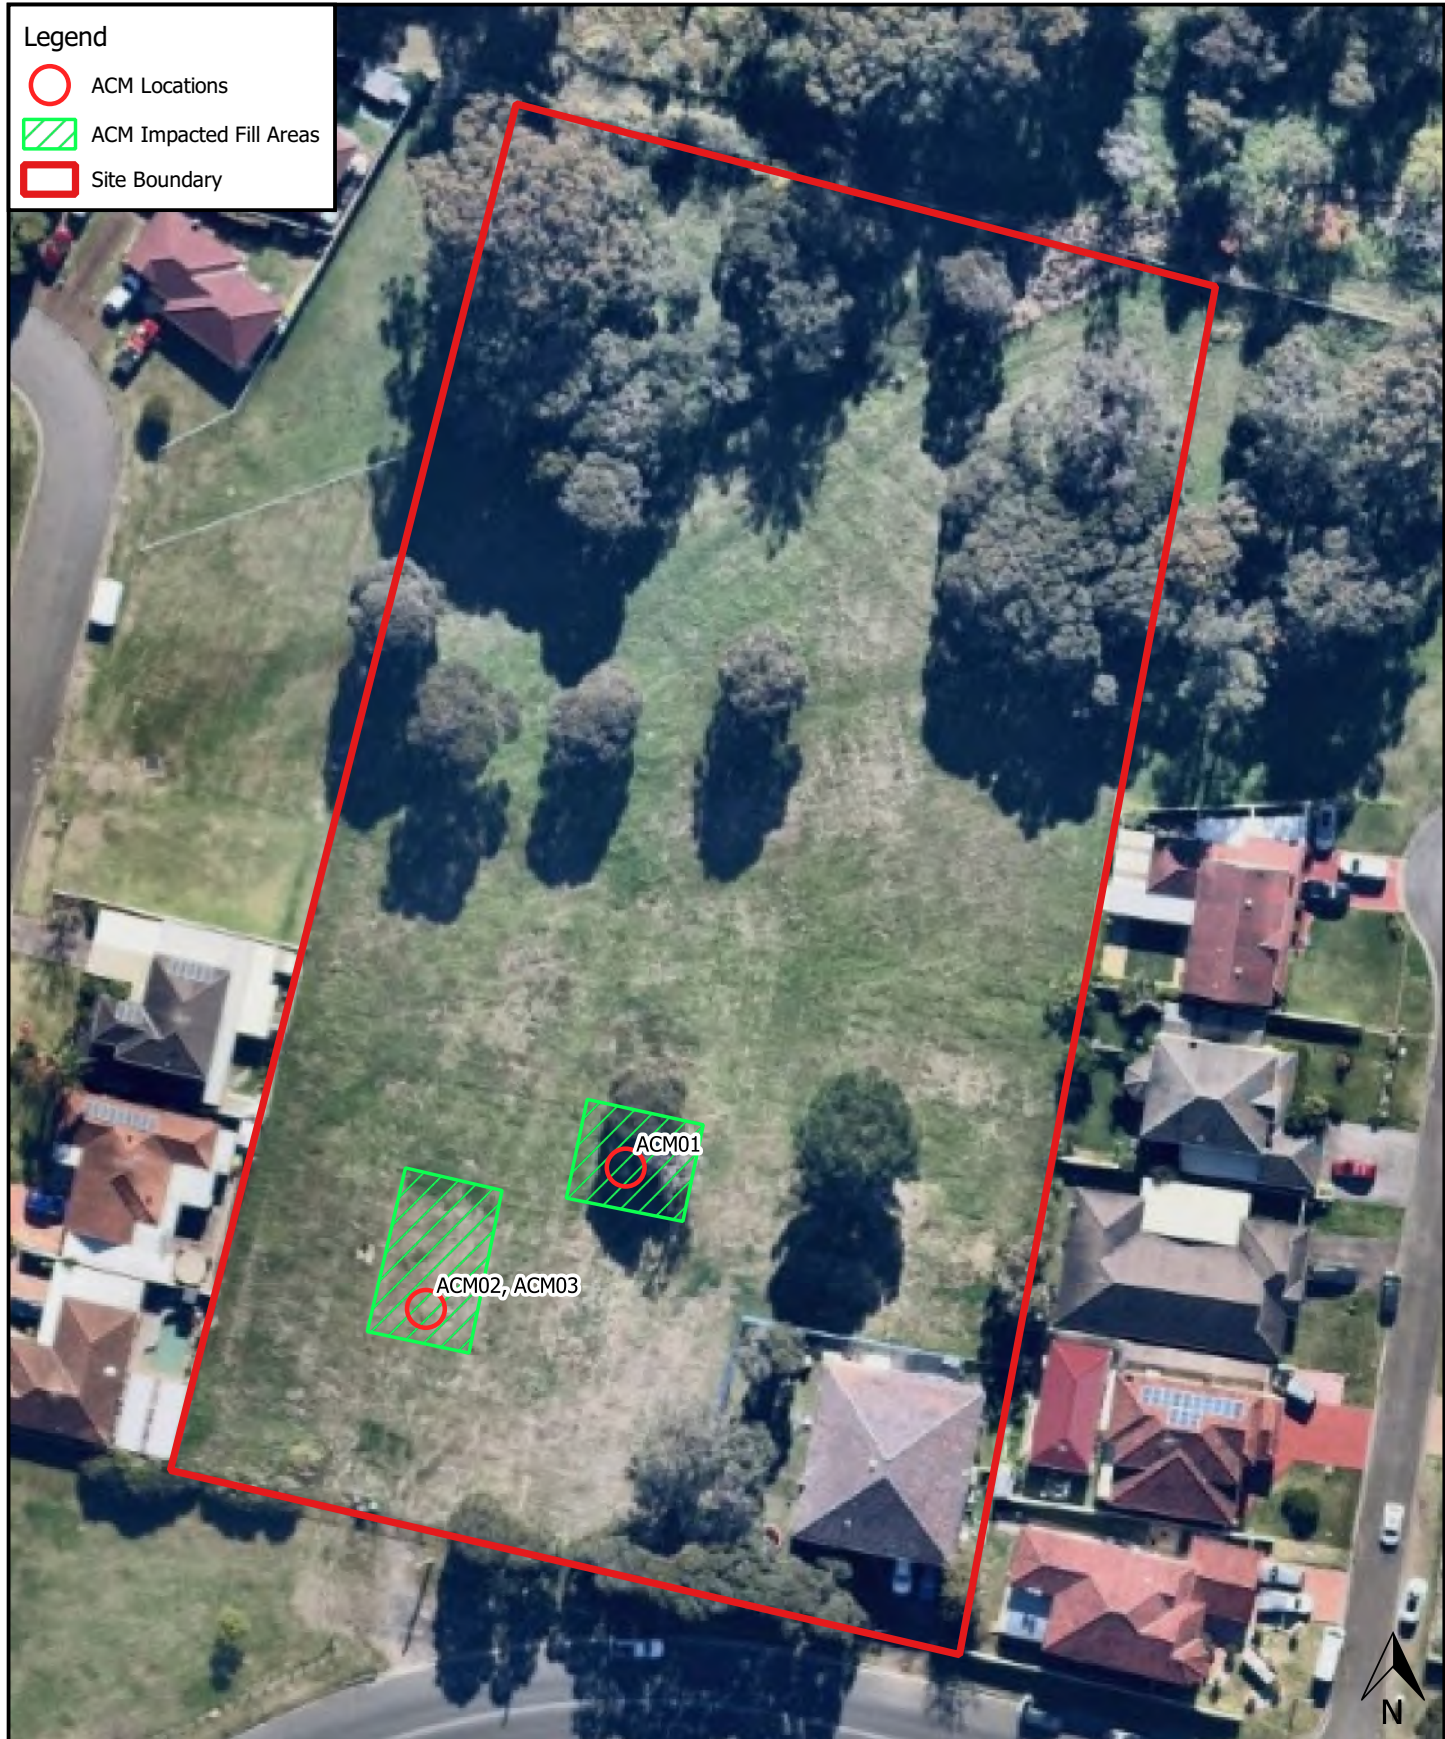
Buried building rubble consisting primarily of bricks, metal, timber and fibre cement sheeting to depths of between 0.3 and 0.4 mbgl was observed within the fill layer at three test pit locations which were within the footprints of the former dwelling (TP222 and TP223) and former garage (TP220). Fibre cement sheeting samples ACM01 and ACM02 collected from TP220 and TP223 respectively were confirmed to contain asbestos through laboratory analysis. Test pits excavated in the southern section of the former garage (TP221 and TP224) were not observed to contain building rubble or ACM.

- ACM Locations
- ▨ ACM Impacted Fill Areas
- Site Boundary
