REPORT TO ERILYAN PTY LTD

ON GEOTECHNICAL INVESTIGATION

FOR PROPOSED GENESISCARE CAMPBELLTOWN

Date: 7 October 2020 Ref: 33438Arpt

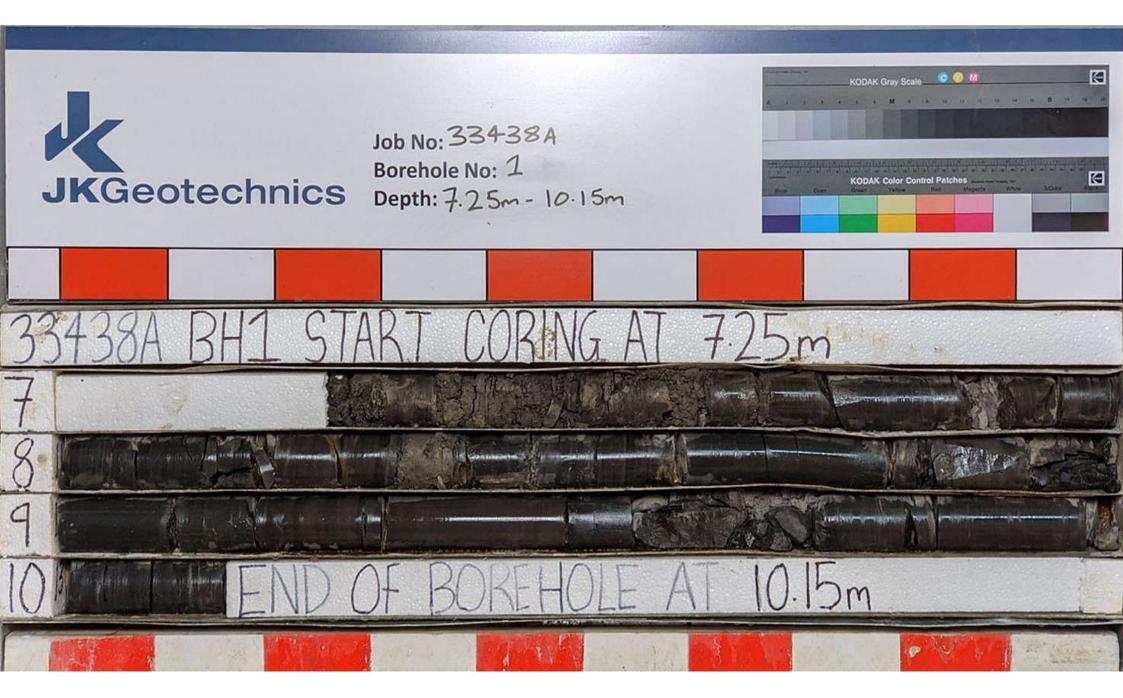
-		-	START CORING AT 7.25m					- (7.05) VAIO 00 55			
		_		-	SILTSTONE: grey and brown, bedded at 0-10°.	MW	L-M	0.20		(7.25m) XWS, 0°, 55 mm.t (7.36m) XWS, 0°, 20 mm.t (7.38m) CS, 0°, 35 mm.t			
		60	8-		as above, but dark grey with occasional iron indurated bands.	SW	M			- (7.38m) CS 0°, 35 mm.t - (7.42m) XWS 0°, 60 mm.t - (7.42m) XWS 0°, 60 mm.t - (7.42m) XWS 0°, 40 mm.t - (7.57m) XWS 0°, 40 mm.t - (7.56m) XWS 0°, 40 mm.t - (7.66m) XWS, 0°, 40 mm.t - (7.66m) XWS, 0°, 40 mm.t - (7.93m) Be, 0°, Un, R, Cn - (8.12m) J, 35°, C, R, Cn - (8.12m) J, 35°, C, R, Cn			
90%	KETUKN				SILTSTONE: dark grey, bedded at 0-10°.	FR		•0.60             •0.50   			Ashfield Shale		
001 - DGD   LID: JN 8.02.4 Z018-09-01			9-			SW - FR	L - M	•0.40 		<ul> <li>(8.81m) XWS, 0°, 10 mm.t</li> <li>(8.82-9.00m) J, 80 - 90°, Un, R, Cn</li> <li>(9.09m) XWS, 0°, 5 mm.t</li> <li>(9.53-9.75m) J, 80 - 50°, Un, R, Cn</li> </ul>	Ash

58-	10-	-				0.30 0.20		-			
		- - - 57 - - -	11 -		END OF BOREHOLE AT 10.15 m								
		56	12-							-			
ALE LEY AN COVED BOKEHOLE - MAG		55	13-							- - - - - - - - -			
IN 9.02.4 LID		54								-			
co	PYF	RIGHT				FRACTI	JRES N	OT MARKED	ARE CONSI	DERED TO BE DRILLING AND HANDLING BR	FAKS
