REPORT TO
ERILYAN

ON
**PRELIMINARY (STAGE 1) SITE INVESTIGATION –
CONTAMINATION ASSESSMENT AND WASTE
CLASSIFICATION**

FOR
PROPOSED COMMERCIAL DEVELOPMENT

AT
**CORNER KELLICAR AND CAMDEN ROADS,
CAMPBELLTOWN, NSW**

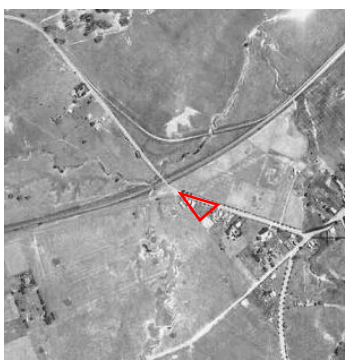
<p>On-site: The northern portion of the site appeared to contain a residential building with associated external structures (i.e. garage/shed). The southern portion of the site appeared to be vacant and grassed (possibly used for grazing purposes).</p> <p>Off-site: The surrounds appeared similar to the site and consisted of small buildings and large areas of vacant grassed land most likely used for grazing. The railway line is already visible to the north of the site.</p>
1970

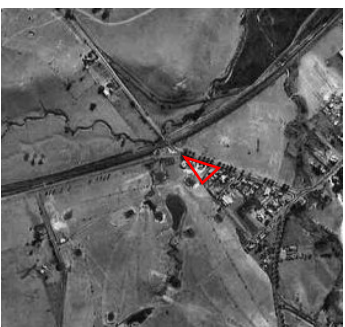
<p>On-site: Some areas in the southern portion of the site appeared to have been partially developed, with grassed cover no longer present and small buildings and/or driveways visible.</p> <p>Off-site: The surrounds immediately to the south-east of the site appeared to have been developed and additional buildings were visible. These appeared to be for residential purposes with potential uses as market garden and/or other agricultural uses in the general surrounds.</p>

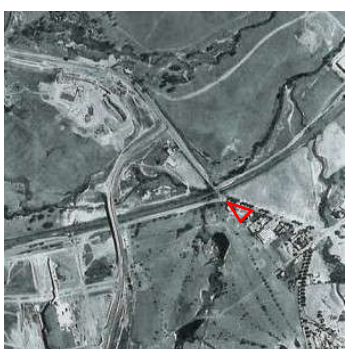
1979

<p>On-site: The site features appeared generally similar to the previous photograph.</p> <p>Off-site: The immediate surrounds appeared generally similar to the previous photograph. New roads including Narellan Road had been constructed to the north of the site.</p>
1984

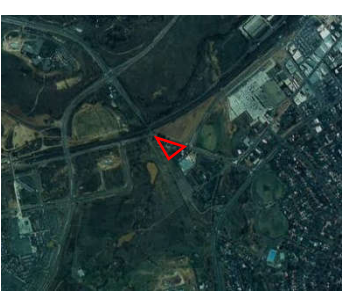
<p>On-site: The site appeared mostly vacant with the northern portion building demolished and replaced by trees. The southern/central portion appeared to contain some remaining structures or driveways.</p> <p>Off-site: The immediate surrounds appeared generally similar to the previous photograph. New buildings and warehouses were visible to the east of the site.</p>

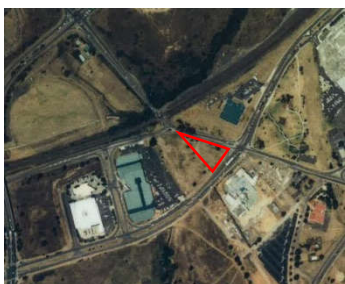
<p>On-site: The site appeared mostly vacant, with trees and vegetation evident along the northern boundary and corner. The former buildings and associated structures had been demolished.</p> <p>Off-site: The immediate surrounds appeared generally similar to the previous photograph. Campbelltown Library was visible to the east of the site. New buildings and warehouses had been constructed to the west of the site.</p>
2002

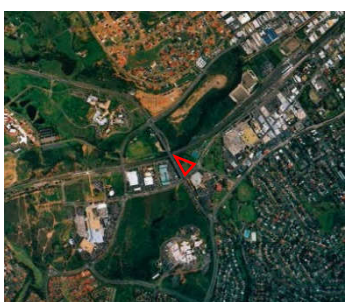
The site and immediate surrounds appeared generally similar to the previous photograph.
2005

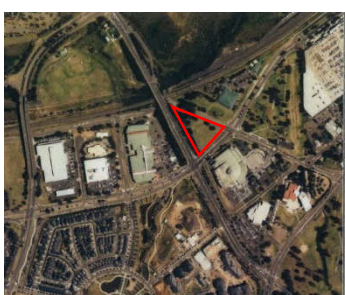
The site and immediate surrounds appeared generally similar to the present day.

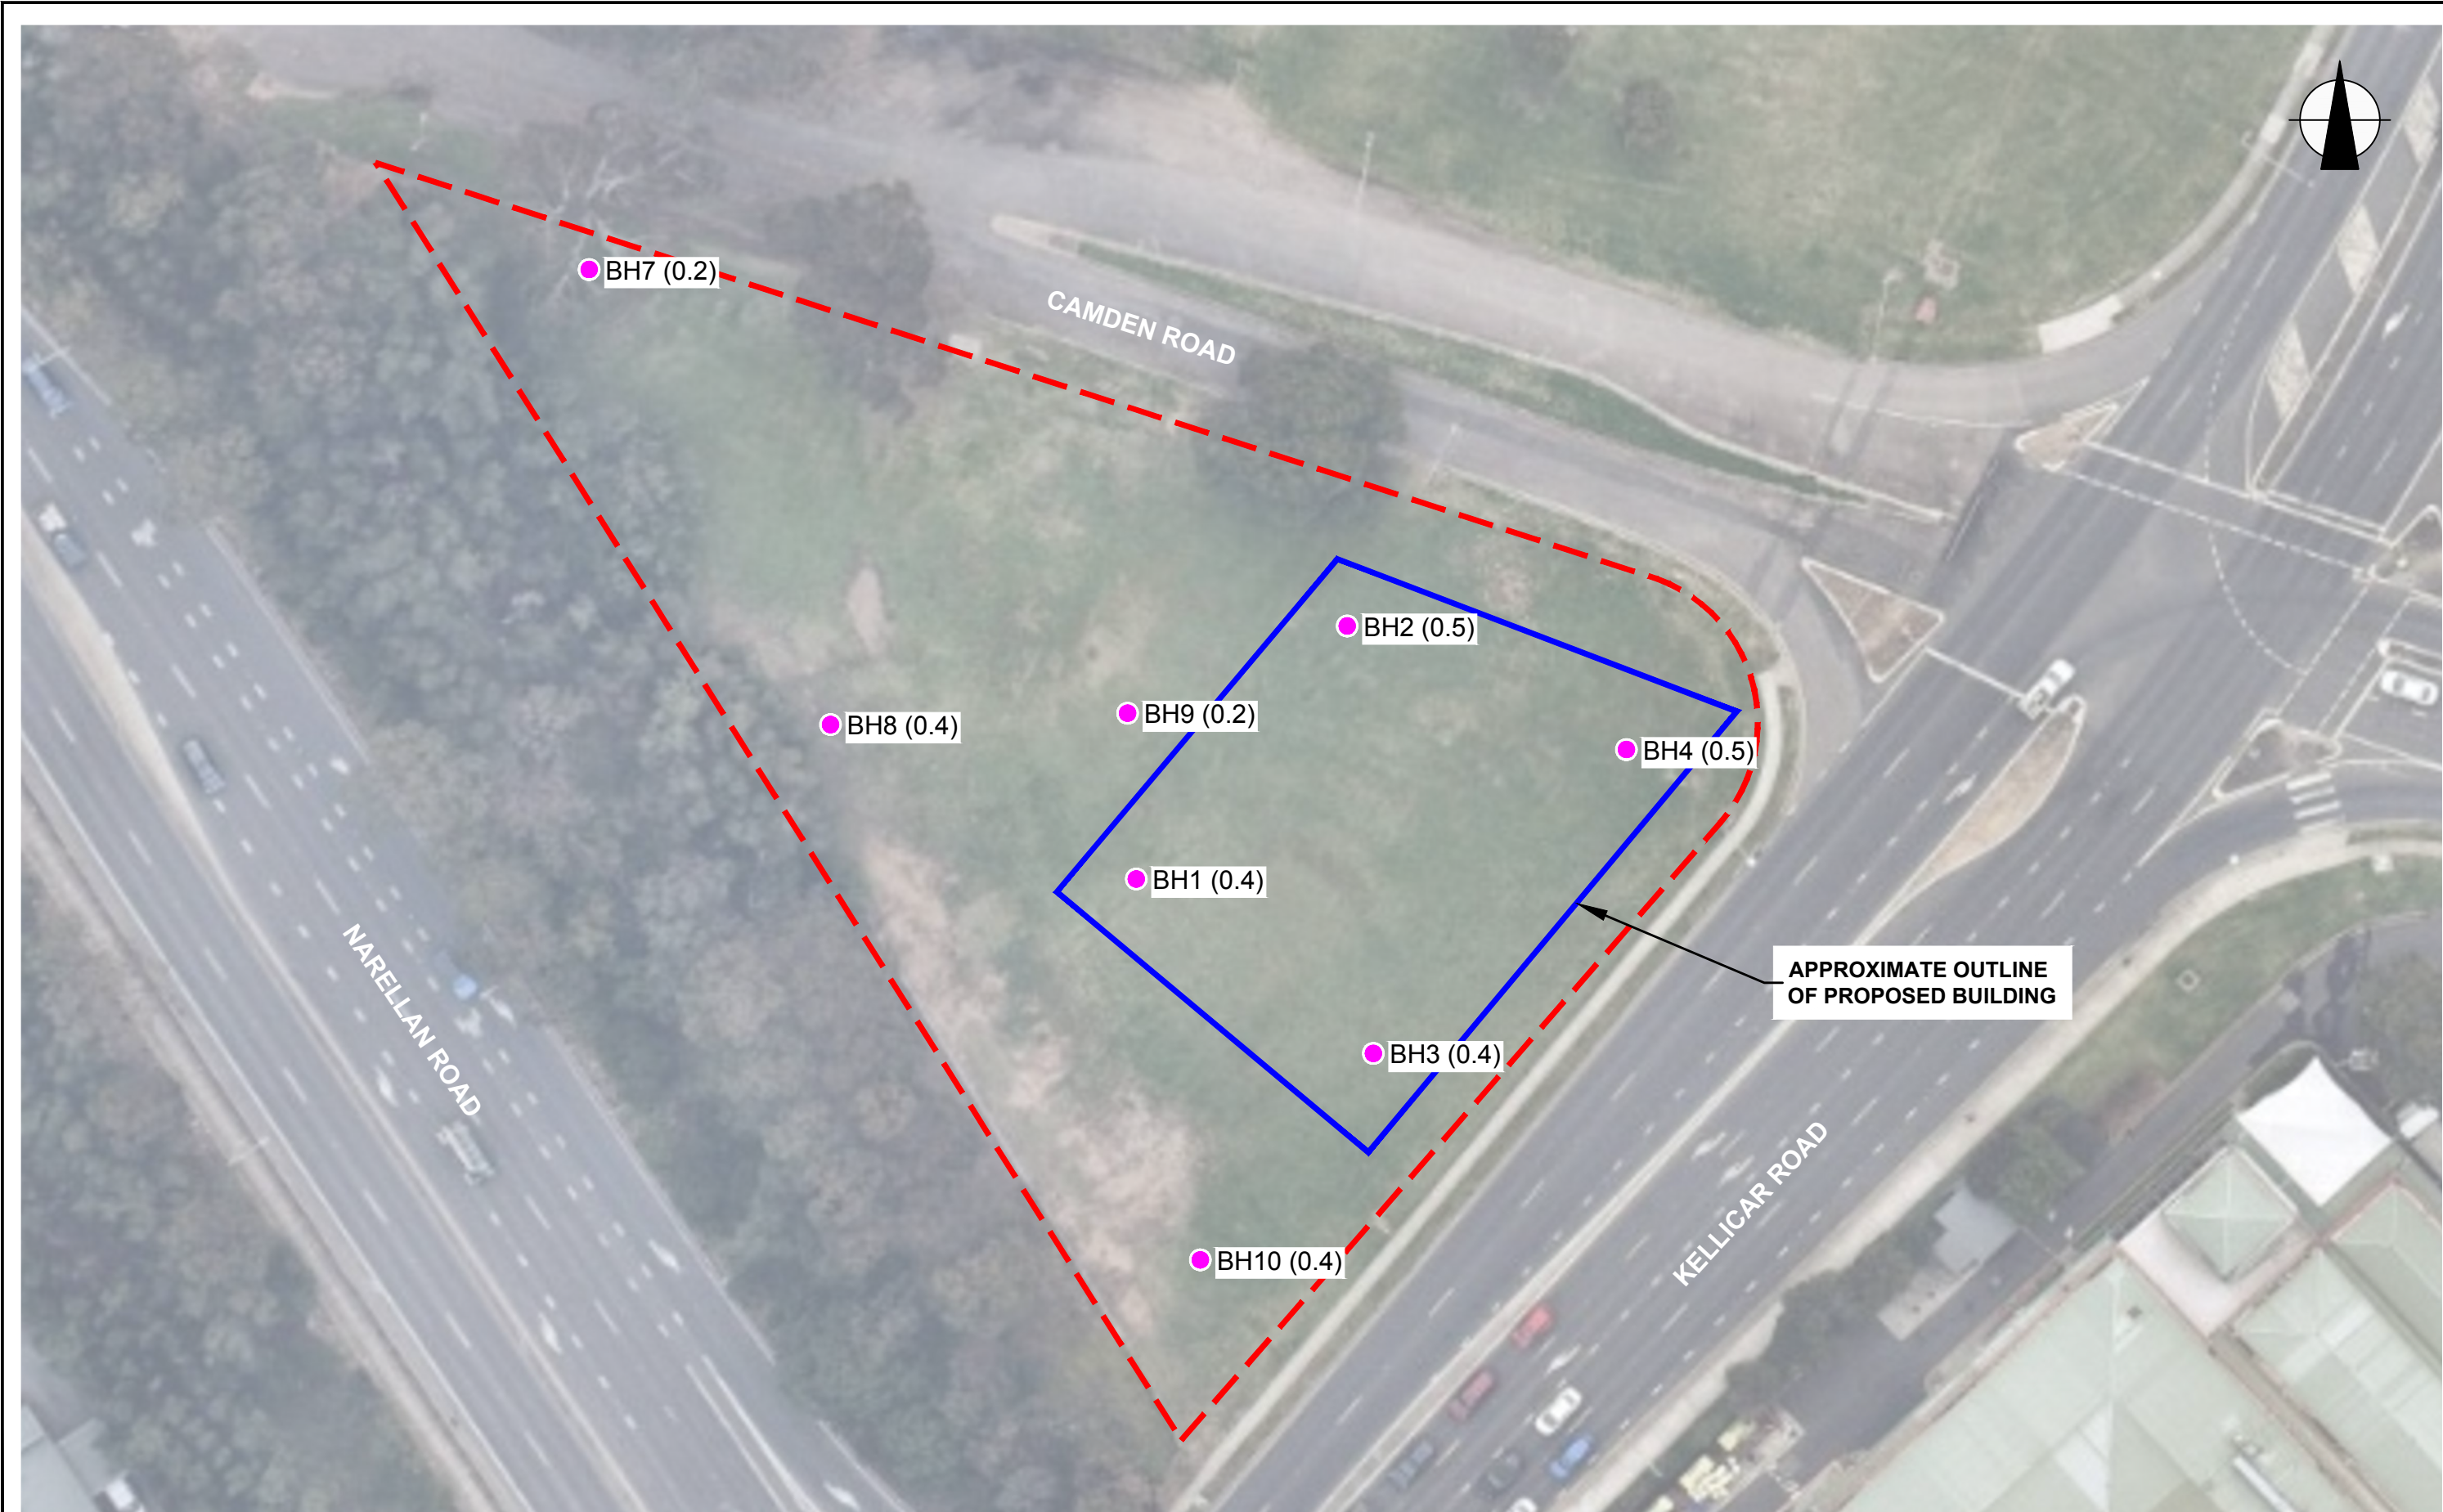
- APPROXIMATE SITE BOUNDARY
- BH(Fill Depth)
- BOREHOLE LOCATION, NUMBER AND DEPTH OF FILL (m)
