**REPORT TO  
ERILYAN**

**ON  
REMEDIATION ACTION PLAN**

**FOR  
PROPOSED COMMERCIAL DEVELOPMENT  
(GENESIS CARE)**

**AT  
CORNER KELLICAR AND CAMDEN ROADS,  
CAMPBELLTOWN, NSW**

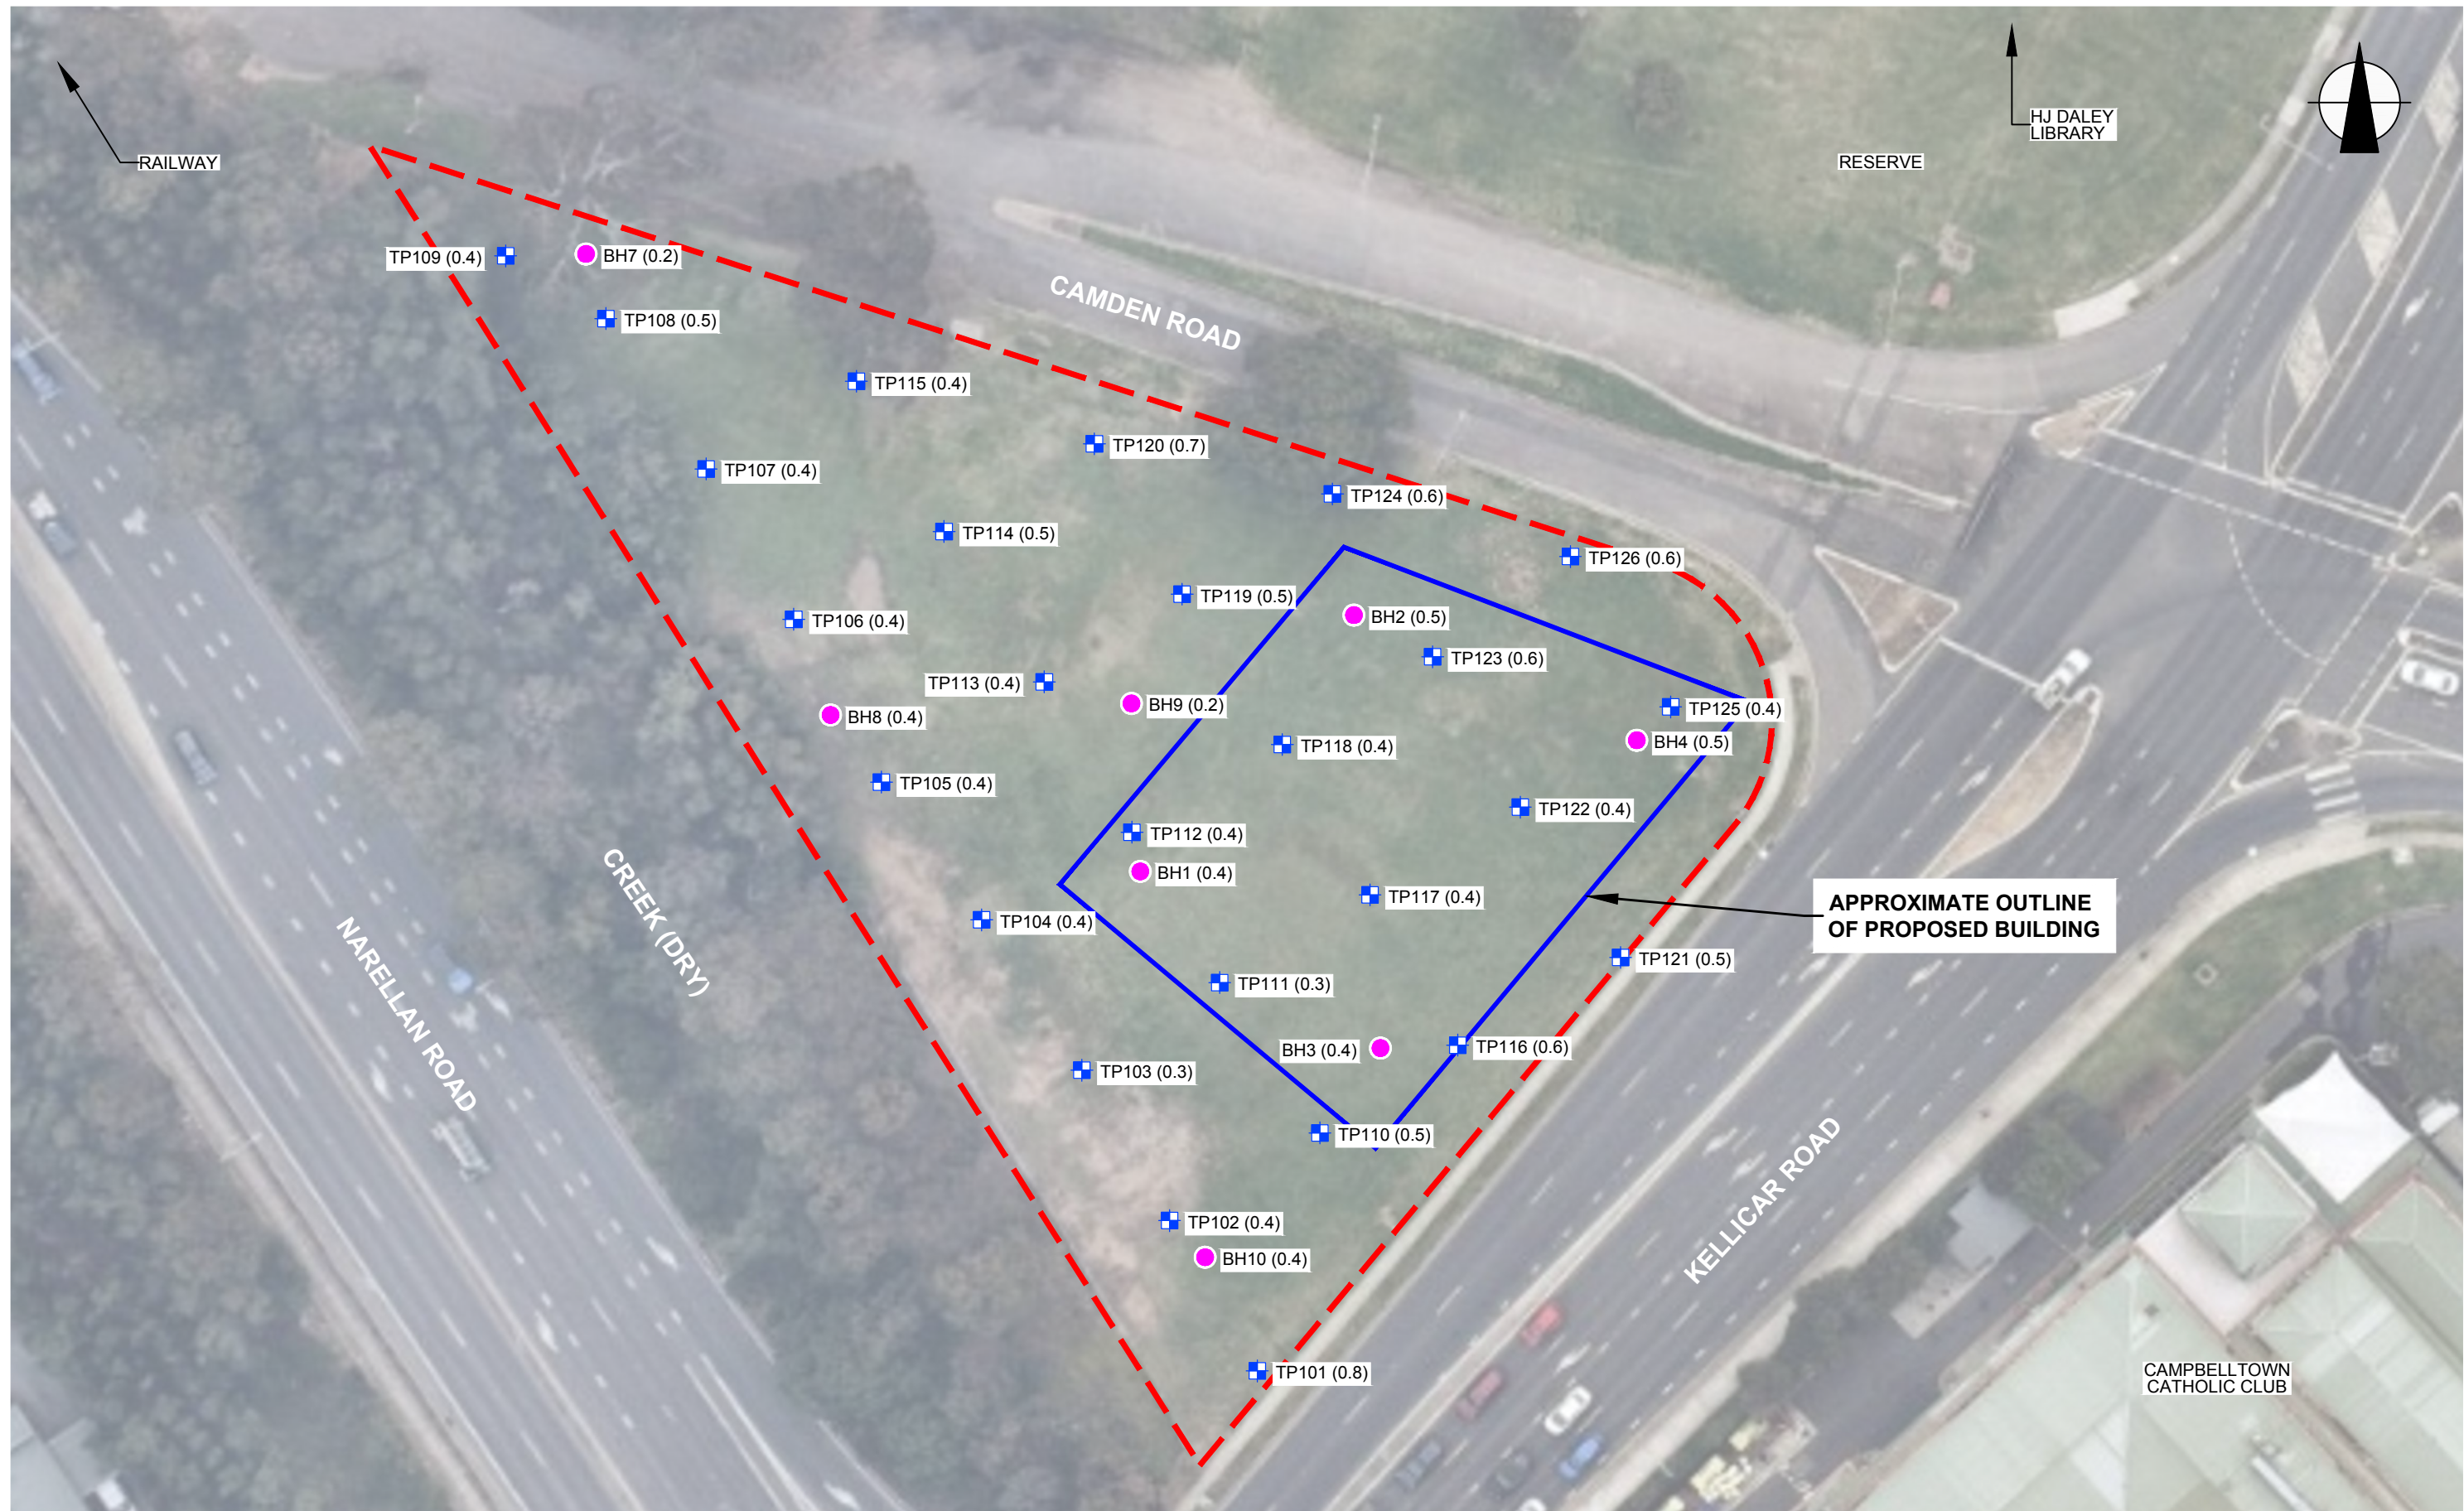
- APPROXIMATE SITE BOUNDARY
- BH(Fill Depth)
- TP(Fill Depth)
- BOREHOLE LOCATION, NUMBER AND DEPTH OF FILL (m) (JKE PSI LOCATIONS DRILLED SEPTEMBER 2020)
- TEST PIT LOCATION, NUMBER AND DEPTH OF FILL (m)

ACM was found in fill in 12 locations as shown on Figure 3 in Appendix A. Regarding the conceptual model, the occurrence of ACM is considered to be widespread in fill and there is no clear delineation/differentiation between the fill where ACM was found and where ACM was not found. On this basis, and for the purpose of the RAP, all fill is considered to be impacted by ACM. The highest asbestos (in ACM) concentration was 0.1247%w/w and there was a total of four locations where the asbestos concentrations exceeded the SAC of 0.05%w/w.

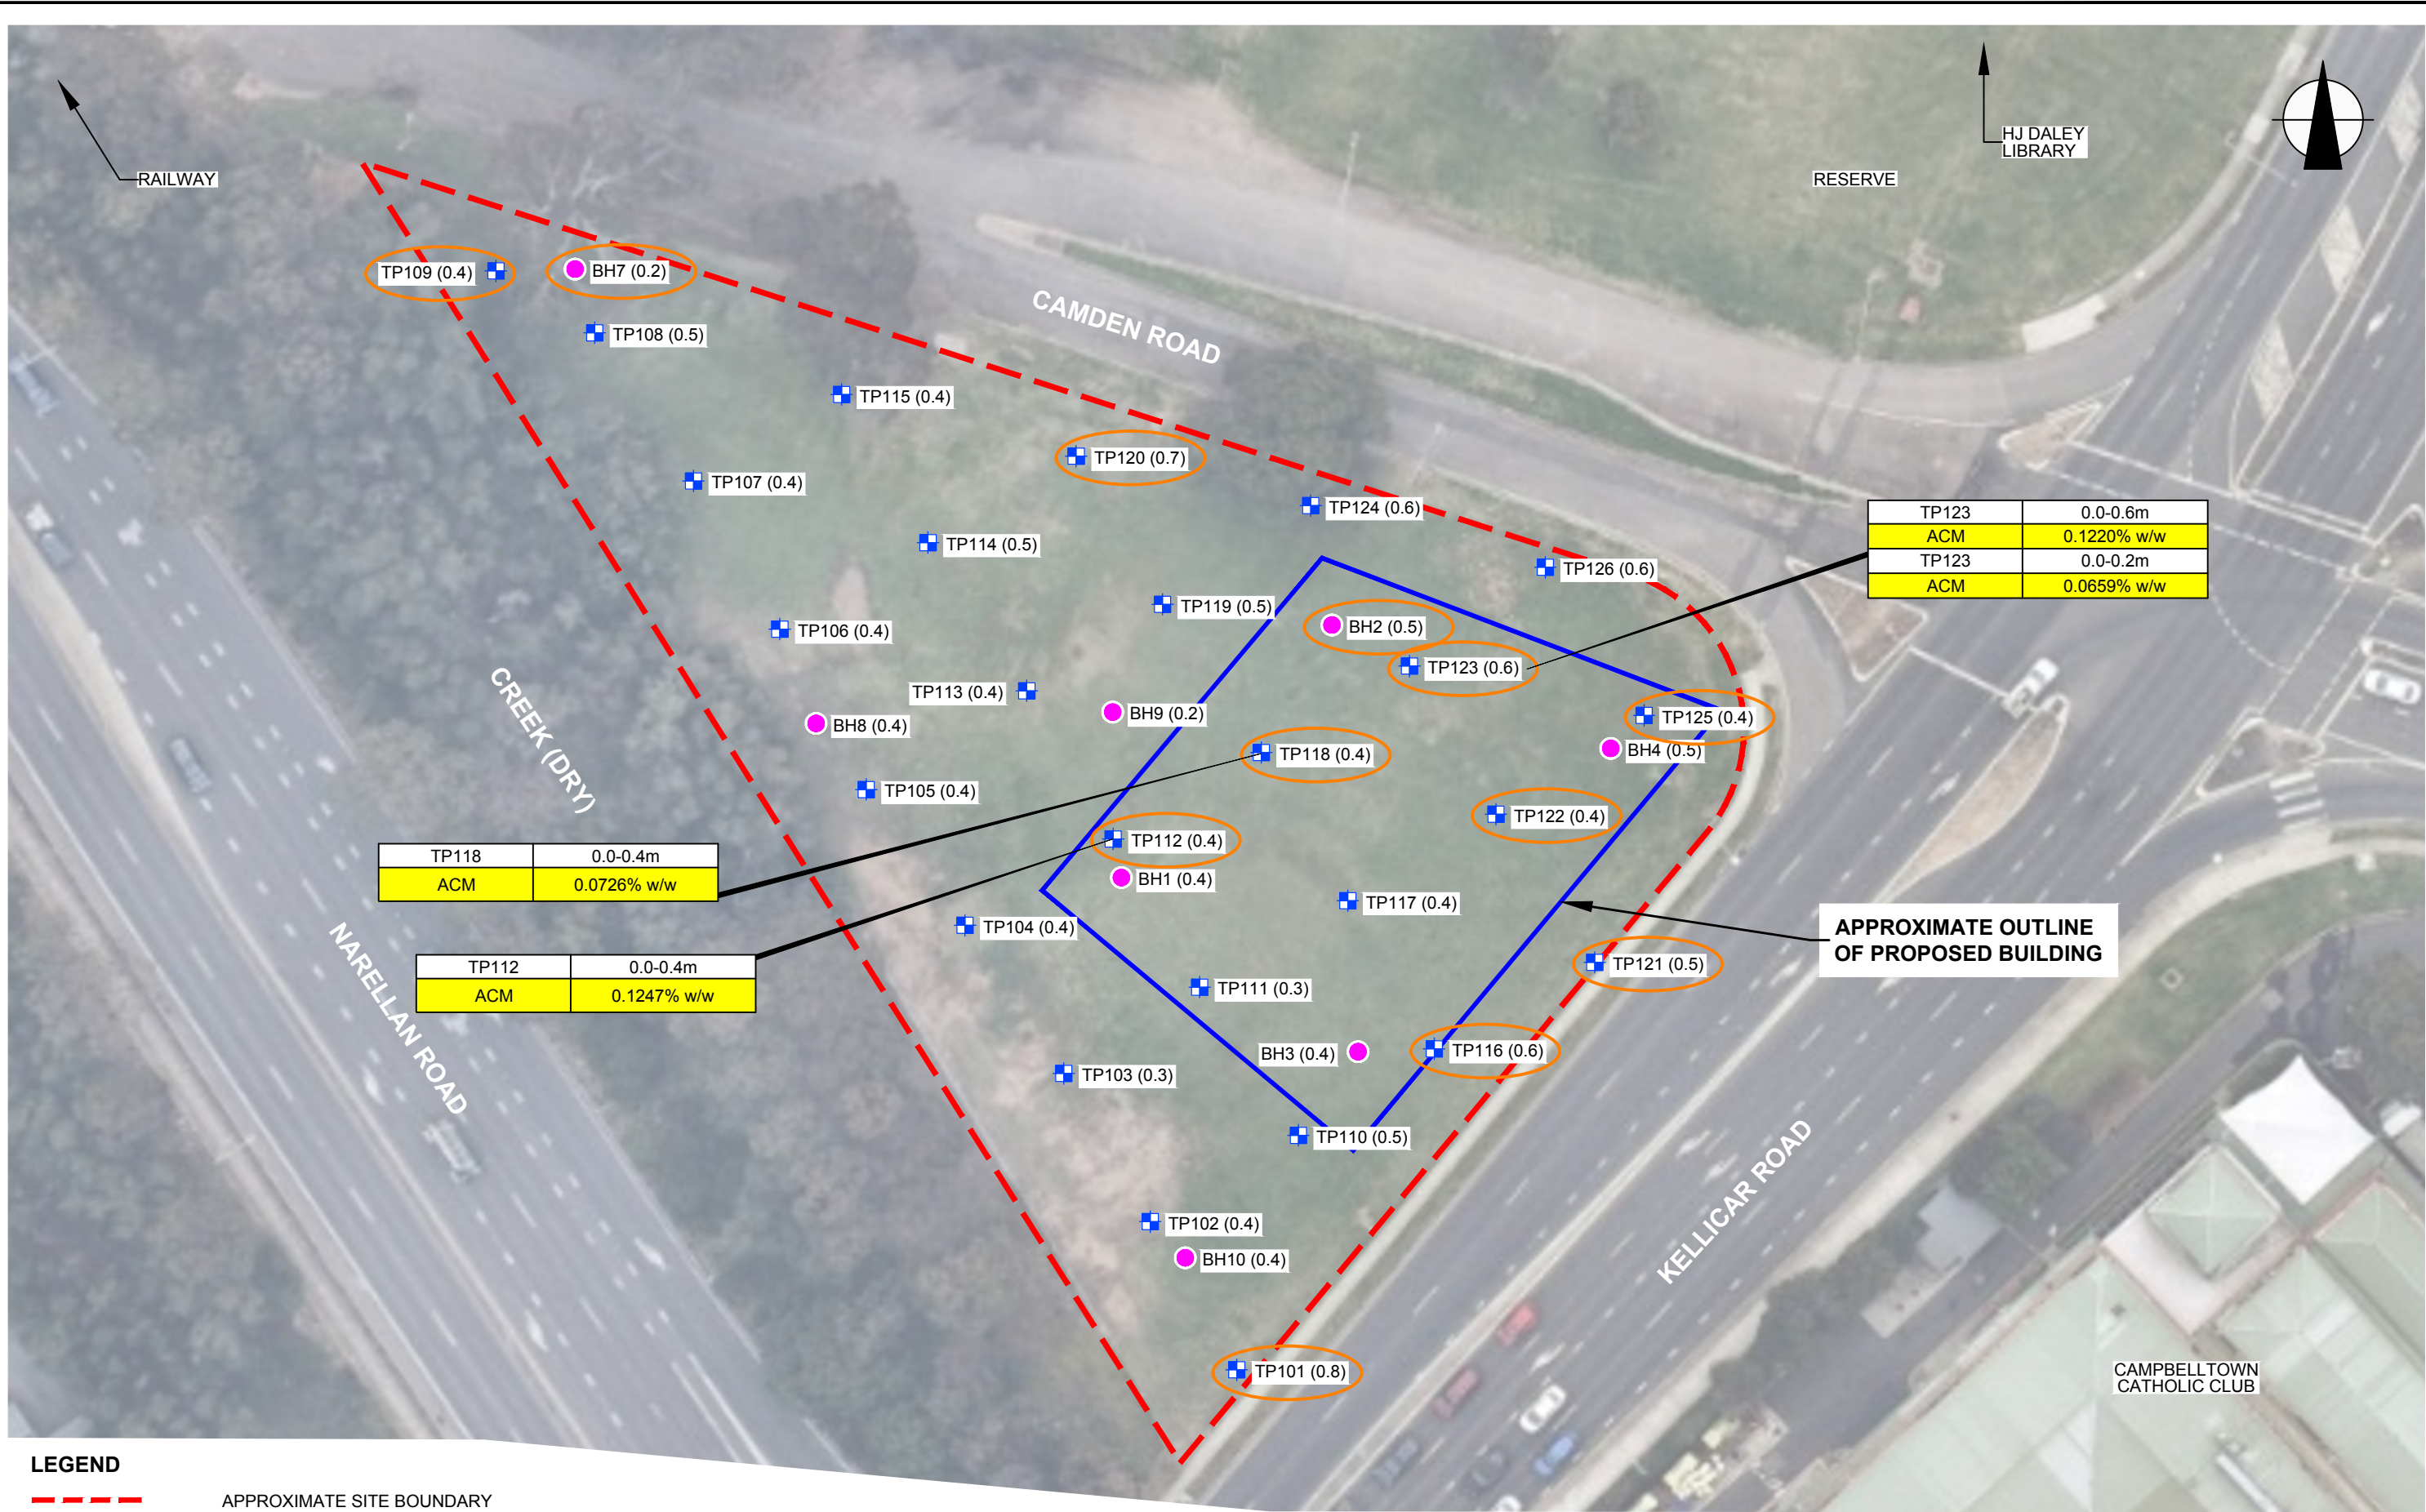
- APPROXIMATE SITE BOUNDARY
  - BH(Fill Depth) BOREHOLE LOCATION, NUMBER AND DEPTH OF FILL (m) (JKE SEPTEMBER 2020 LOCATIONS)
  - TP(Fill Depth) TEST PIT LOCATION, NUMBER AND DEPTH OF FILL (m)
