Report on  
Detailed Site Investigation (Contamination)

Proposed Residential Subdivision  
Gurner Avenue, Austral, NSW

Prepared for  
Landcom

Project 94562.02  
February 2022

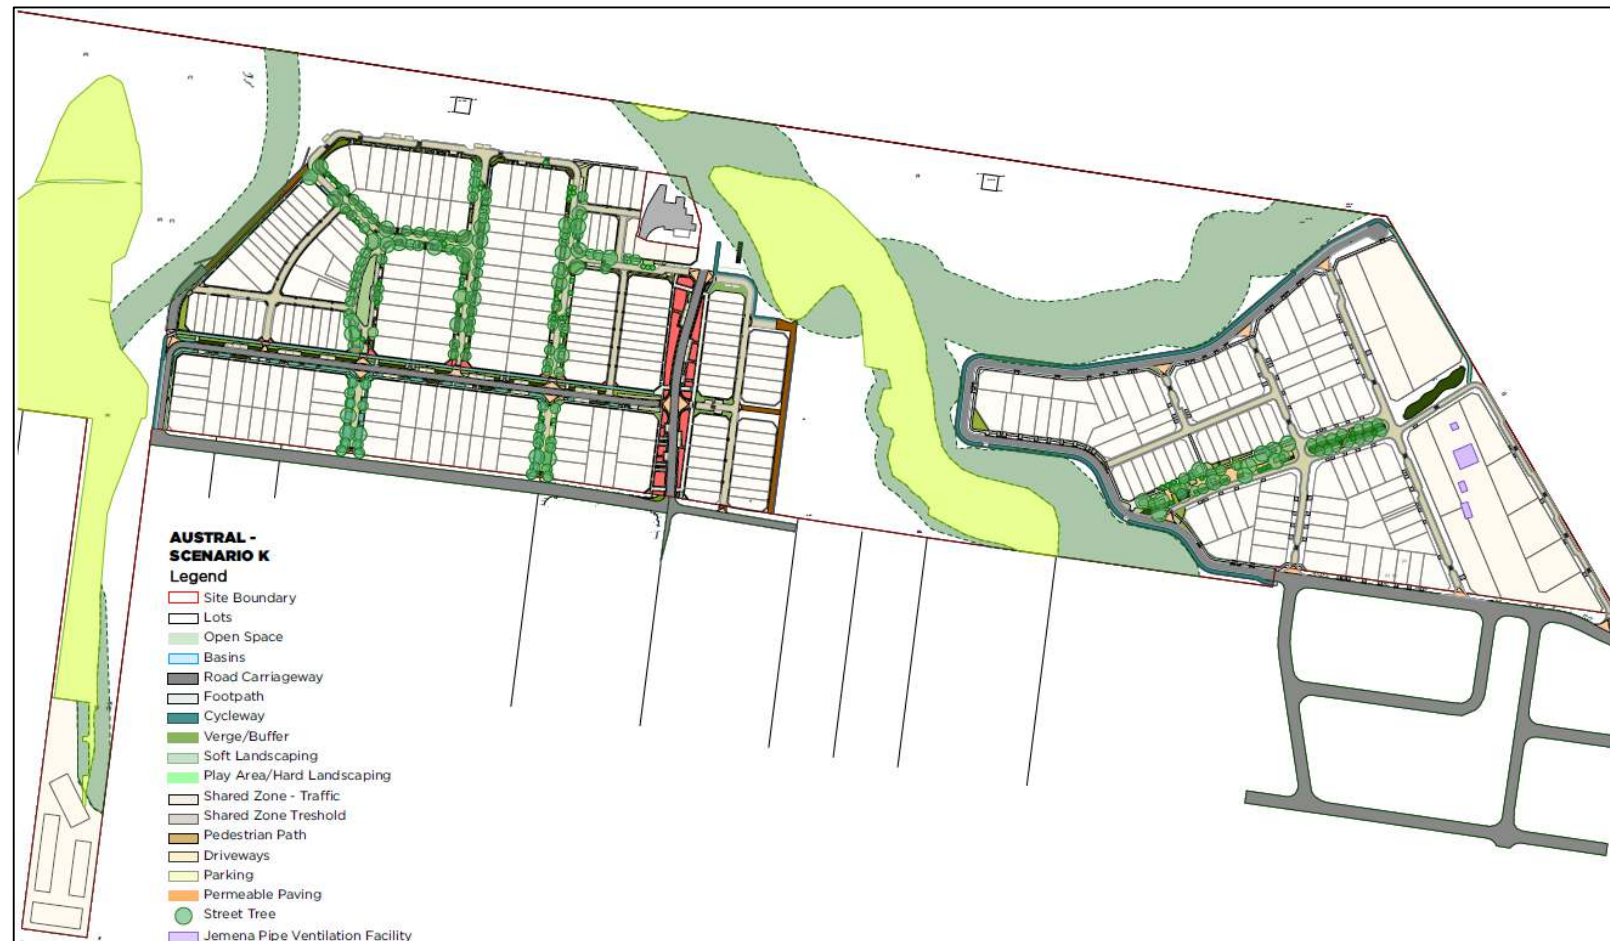
**Figure 1: Master Plan**

Land adjacent to the northern site boundary and electricity pylons shall be retained in their current layout. Land along the Jemena gas easement in the eastern part of the site shall be developed as large lots with Jemena pipe ventilation facilities incorporated.

The master plan for the proposed development is shown in Figure 1 on the following page.

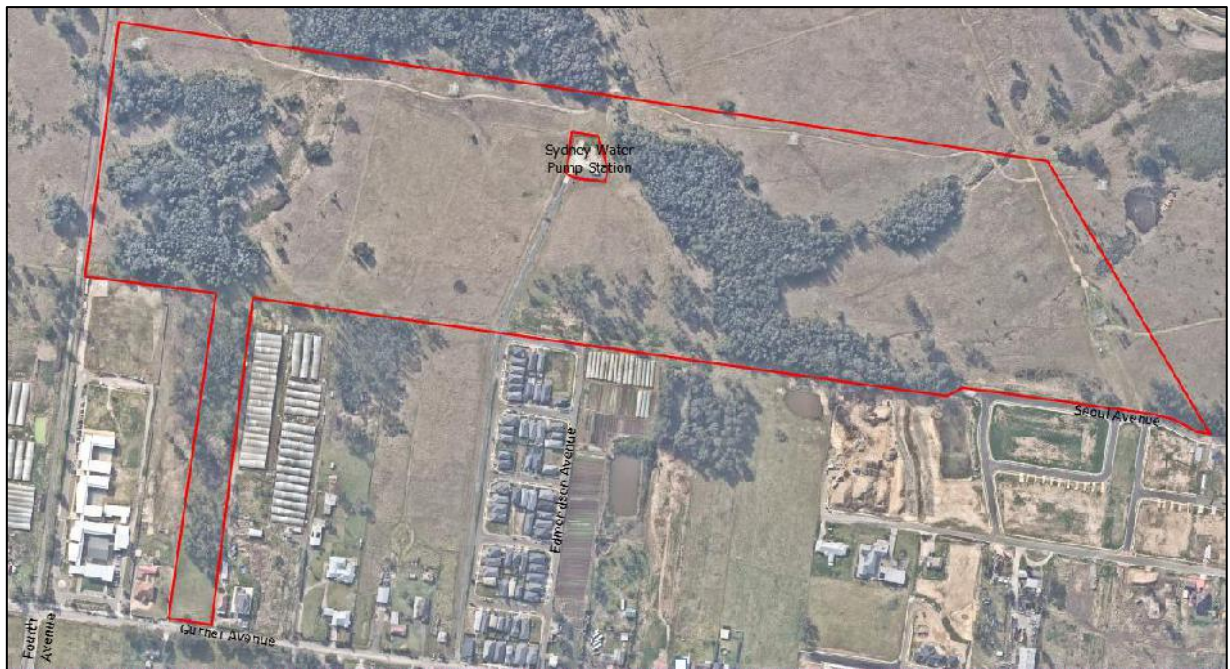
Figure 1: Site Location

The site is currently accessible via the northern end of Edmondson Avenue (main entrance), the eastern corner (Seoul Avenue) as well as more rarely used entrances in the southern strip, on Gurner Avenue and along the TransGrid access road. The site boundary is shown on Figure 1 below.
