**PRELIMINARY GEOTECHNICAL AND
CONTAMINATION ASSESSMENT**

**KAMIRA COURT, VILLAWOOD
URBAN RENEWAL PROJECTS**

**MAJOR PROJECTS DIRECTORATE
OF HOUSING NSW**

Project 45789

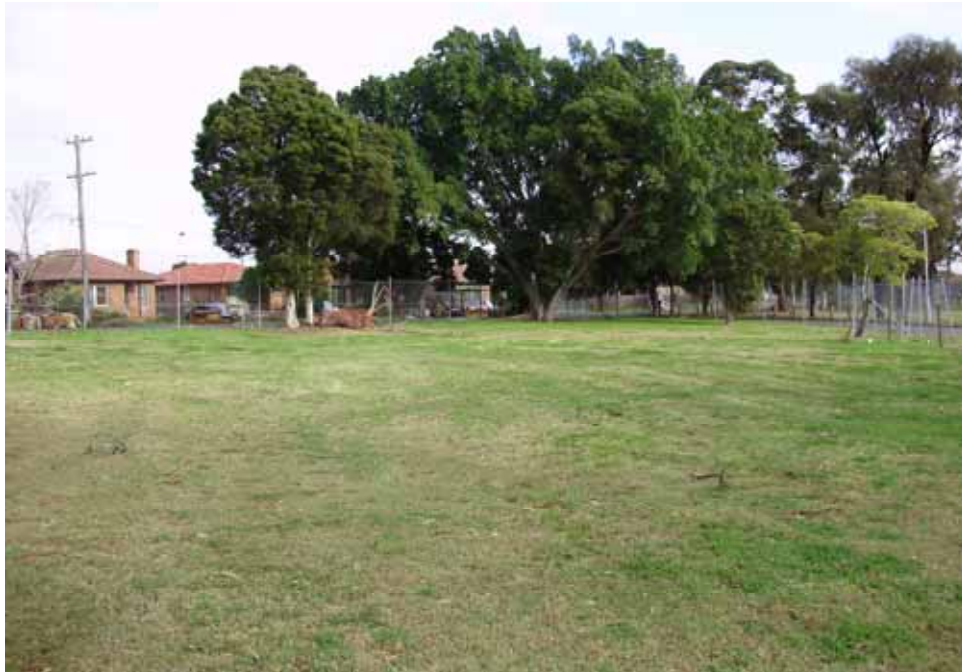
PHOTO 1: View on Lot 136 D.P. 16186 and Lot 39 D.P. 202006 in NW direction

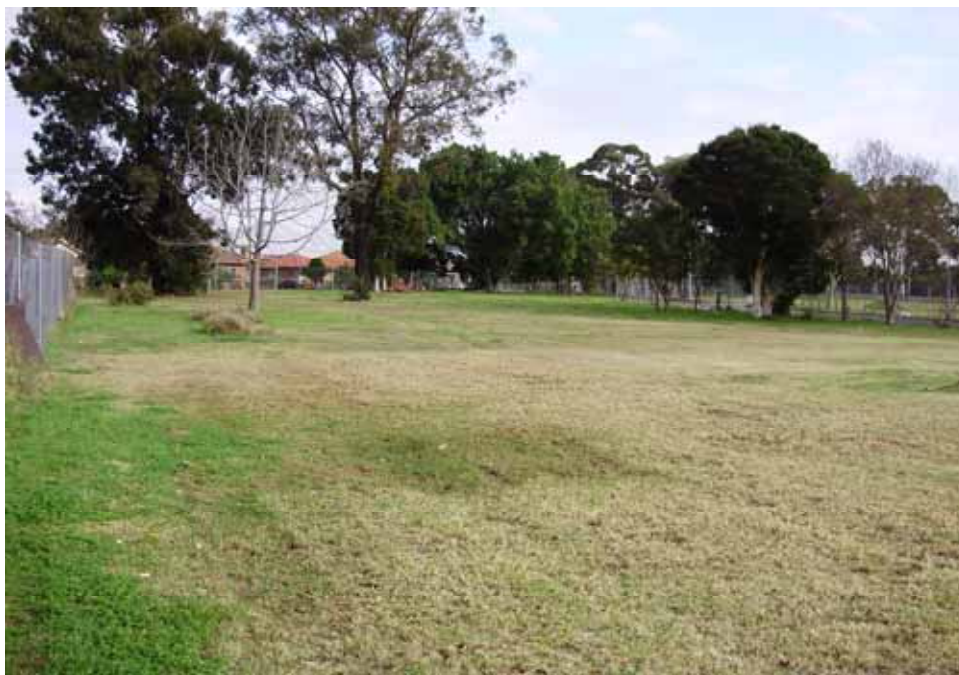
PHOTO 2: View on Lot 38 D.P. 202006 in WNW direction

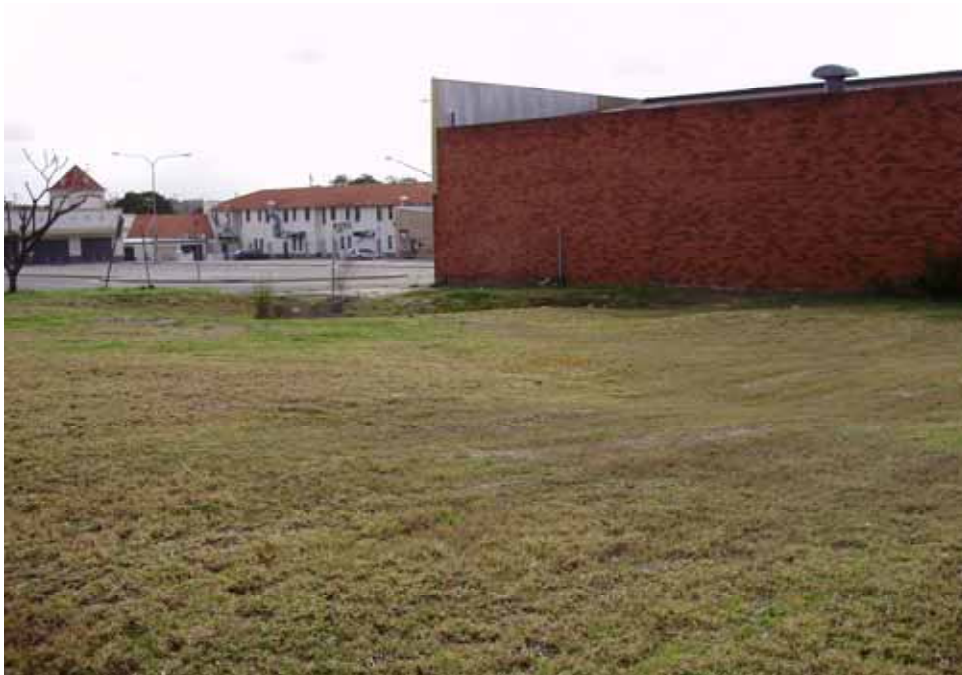
Test pits TP1 – TP 8 were generally located within the building footprint of previous structures. During the site inspection a significant unevenness of the ground level was noted around test pit TP4 as shown in Photo 3, Plate 2 in Appendix B. Similar conditions were noted at test pit TP7.

PHOTO 3: Eastern boundary of Lot 38 D.P. 202006, location of test pit TP 4

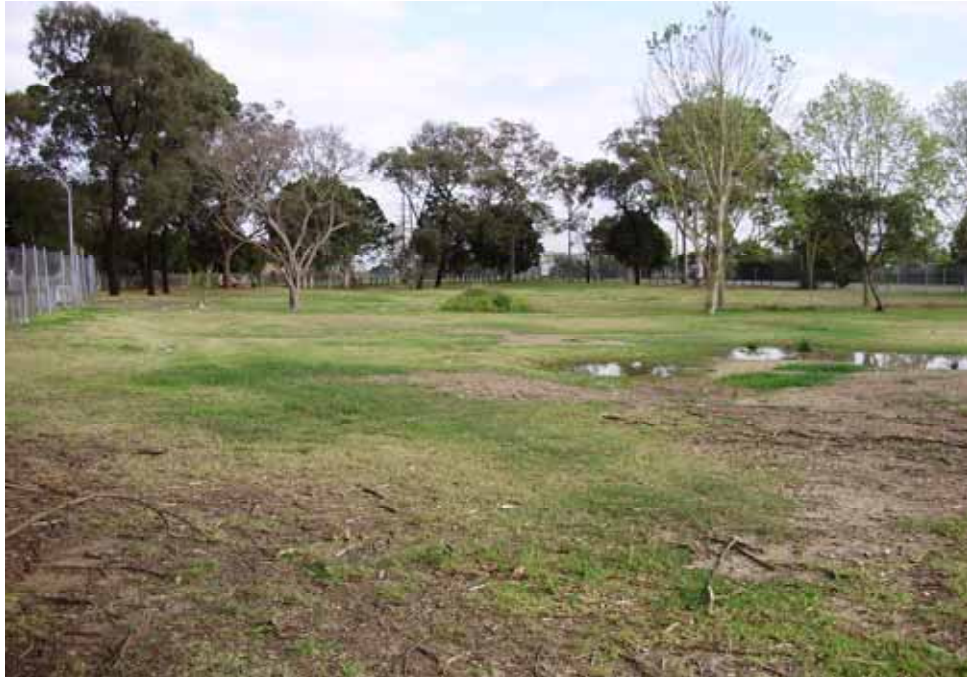
PHOTO 4: View on Lot 37 D.P. 202006 in W direction; Stockpile location

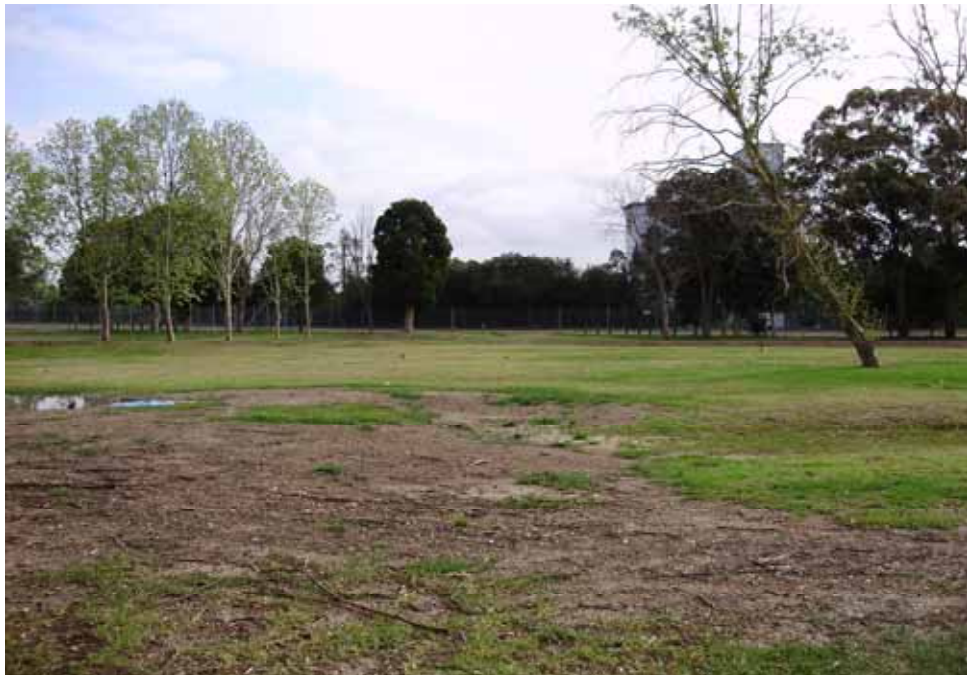
PHOTO 5: View on Lot 37 D.P. 202006 in NW direction

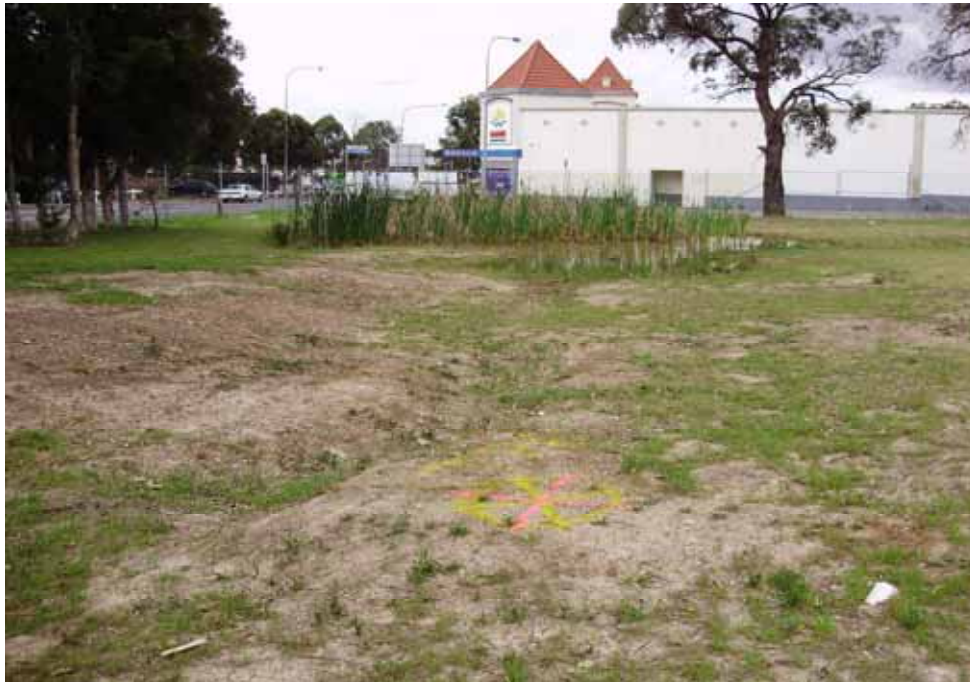
PHOTO 6: View on Lot 37 D.P. 202006 in NE direction, location of test pit TP 6

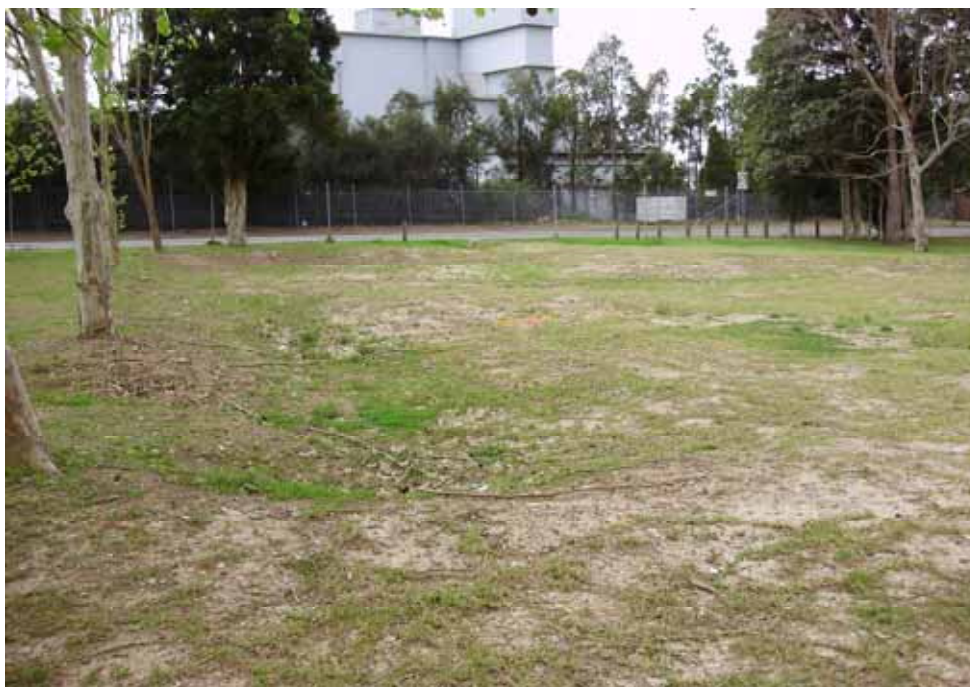
Minor groundwater seepage was intercepted at test pit TP 7 at a depth of approximately 4.6 m. Regional groundwater would be anticipated to be contained within the shale. At the north-east of Lot 37 there is a small a surface water pond. As discussed in Section 6.4, the site is situated within a low-lying floodplain and may be affected by local overland flooding in terms of local runoff and it can be presumed that the surface water body is caused by local runoff. This area is, according to the survey of test pit TP 6, likely to be the lowest location of the site.

PHOTO 7: View on Lot 37 D.P. 202006 in N direction, location of test pit TP 7

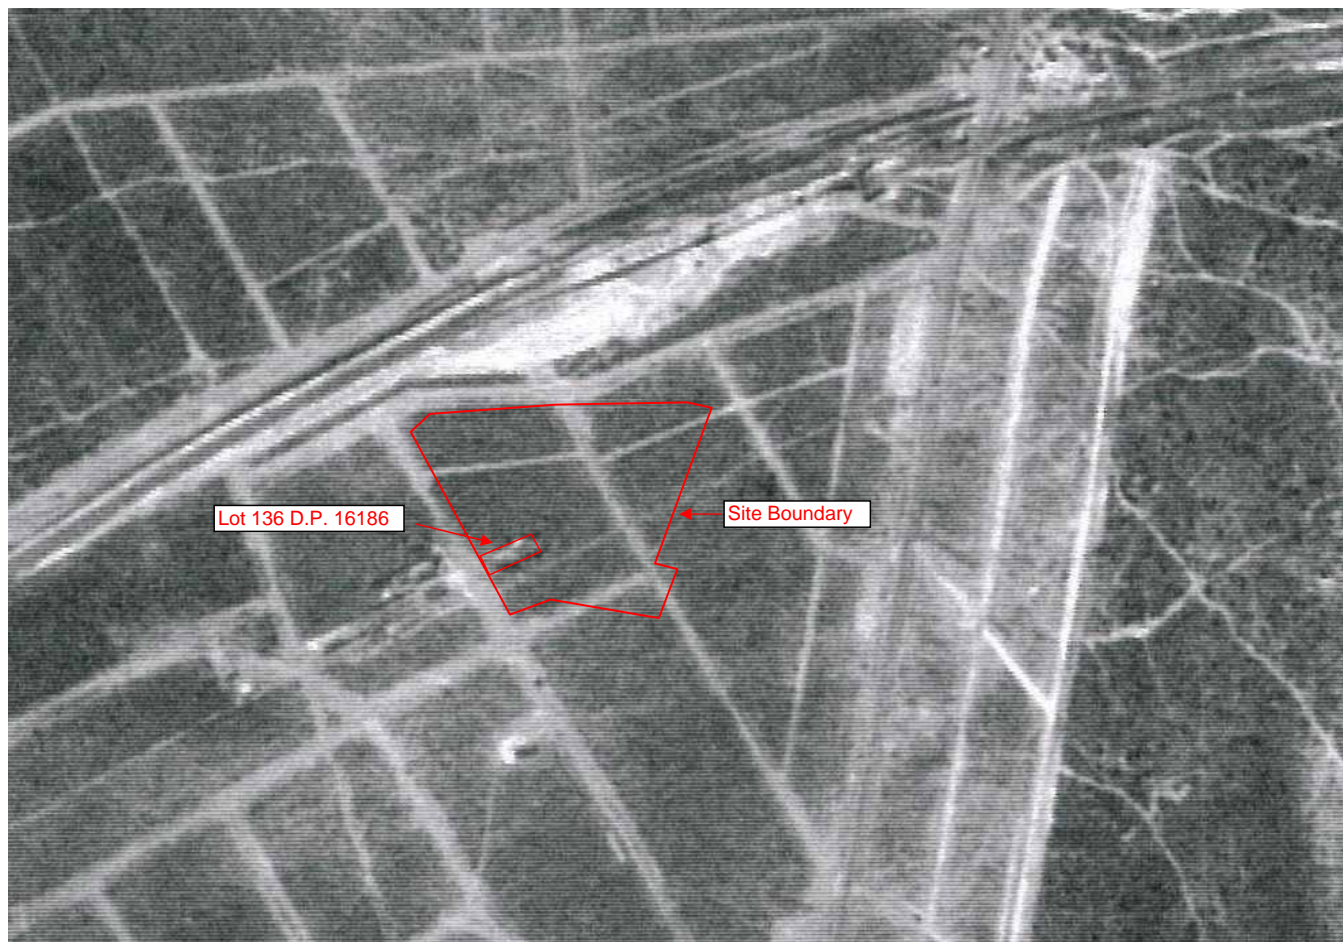
Aerial Photograph 1928
Preliminary Geotechnical and Contamination Assessment
Kamira Court, Villawood NSW 2163

1928 – Plate 1 shows two structures on Lot 136 in D.P. 16186. The building in the west of Lot 136 had the size typical of a residential house. The building in the east is smaller. The photograph shows the development of the first residential houses in Kamira Avenue, Villawood.

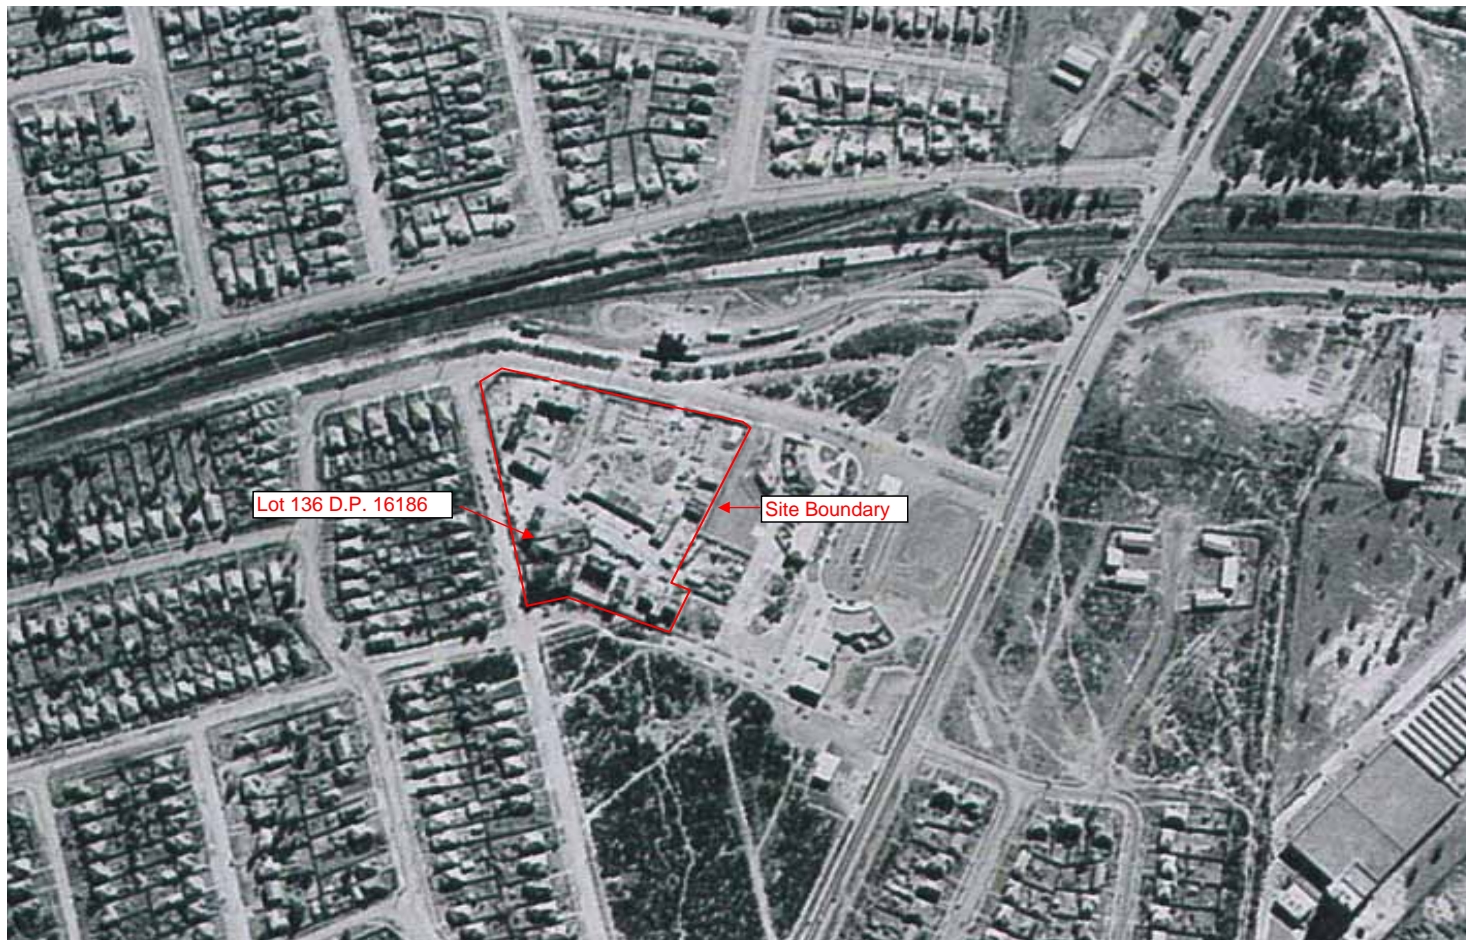
Aerial Photograph 1961
Preliminary Geotechnical and Contamination Assessment
Kamira Court, Villawood NSW 2163

1961 – Plate 4 shows a significant amount of new structures on Lot 37 – Lot 39. Considering that the Housing Commission of New South Wales owned Lot 37 – Lot 39 since 1947 it appears likely that the buildings were for residential purposes

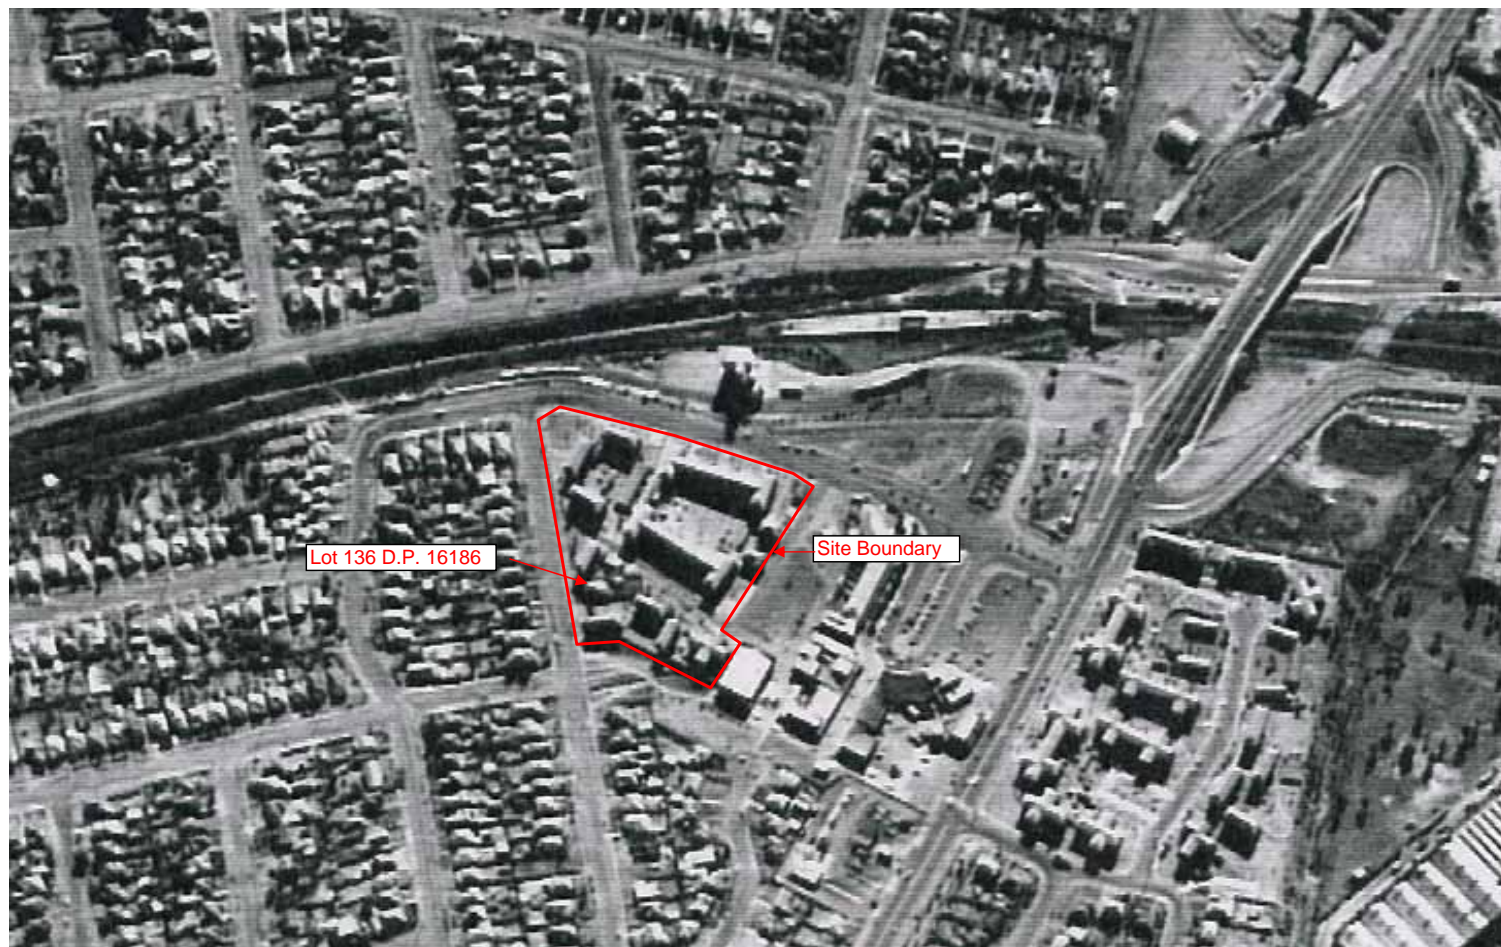
Plate
5

Aerial Photograph 1970
Preliminary Geotechnical and Contamination Assessment
Kamira Court, Villawood NSW 2163

Reference to the aerial photograph of 1928 (Plate 5, Appendix C) shows that the land was probably used for residential purposes. It appears likely to have maintained a residential use through to 1973 when the Housing Commission became the owner.

The marking of the land boundary of Lot 136 D.P. 16186 and the two buildings appear to be still present (Plate 5, Appendix C).

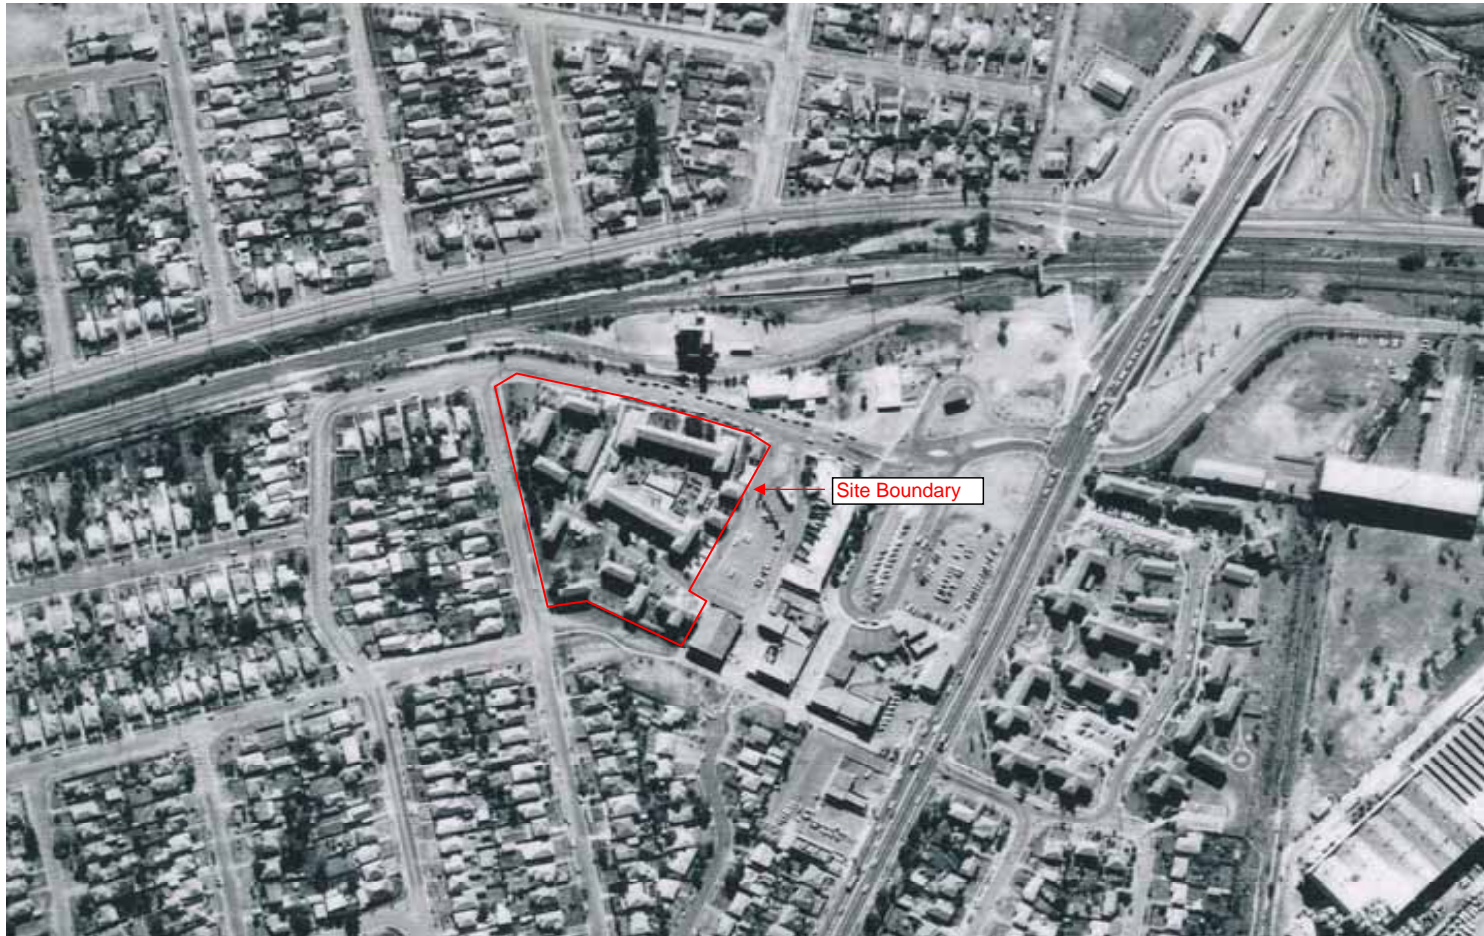
Aerial Photograph 1978
Preliminary Geotechnical and Contamination Assessment
Kamira Court, Villawood NSW 2163

1978 – Plate 6 shows that a total of 14 buildings had been constructed on Lot 37 – Lot 39. The site also comprised remnant stands of trees, car parks and a landscaped area between the two main buildings in the north and south of Lot 37. The two buildings previously identified on Lot 136 in D.P. 18186 have been demolished and removed and Lot 136 appears to be undeveloped.
