Report on
Detailed Site (Contamination) Investigation

Proposed Residential Development
Kamira Court, Villawood

Project 86819.01
March 2020

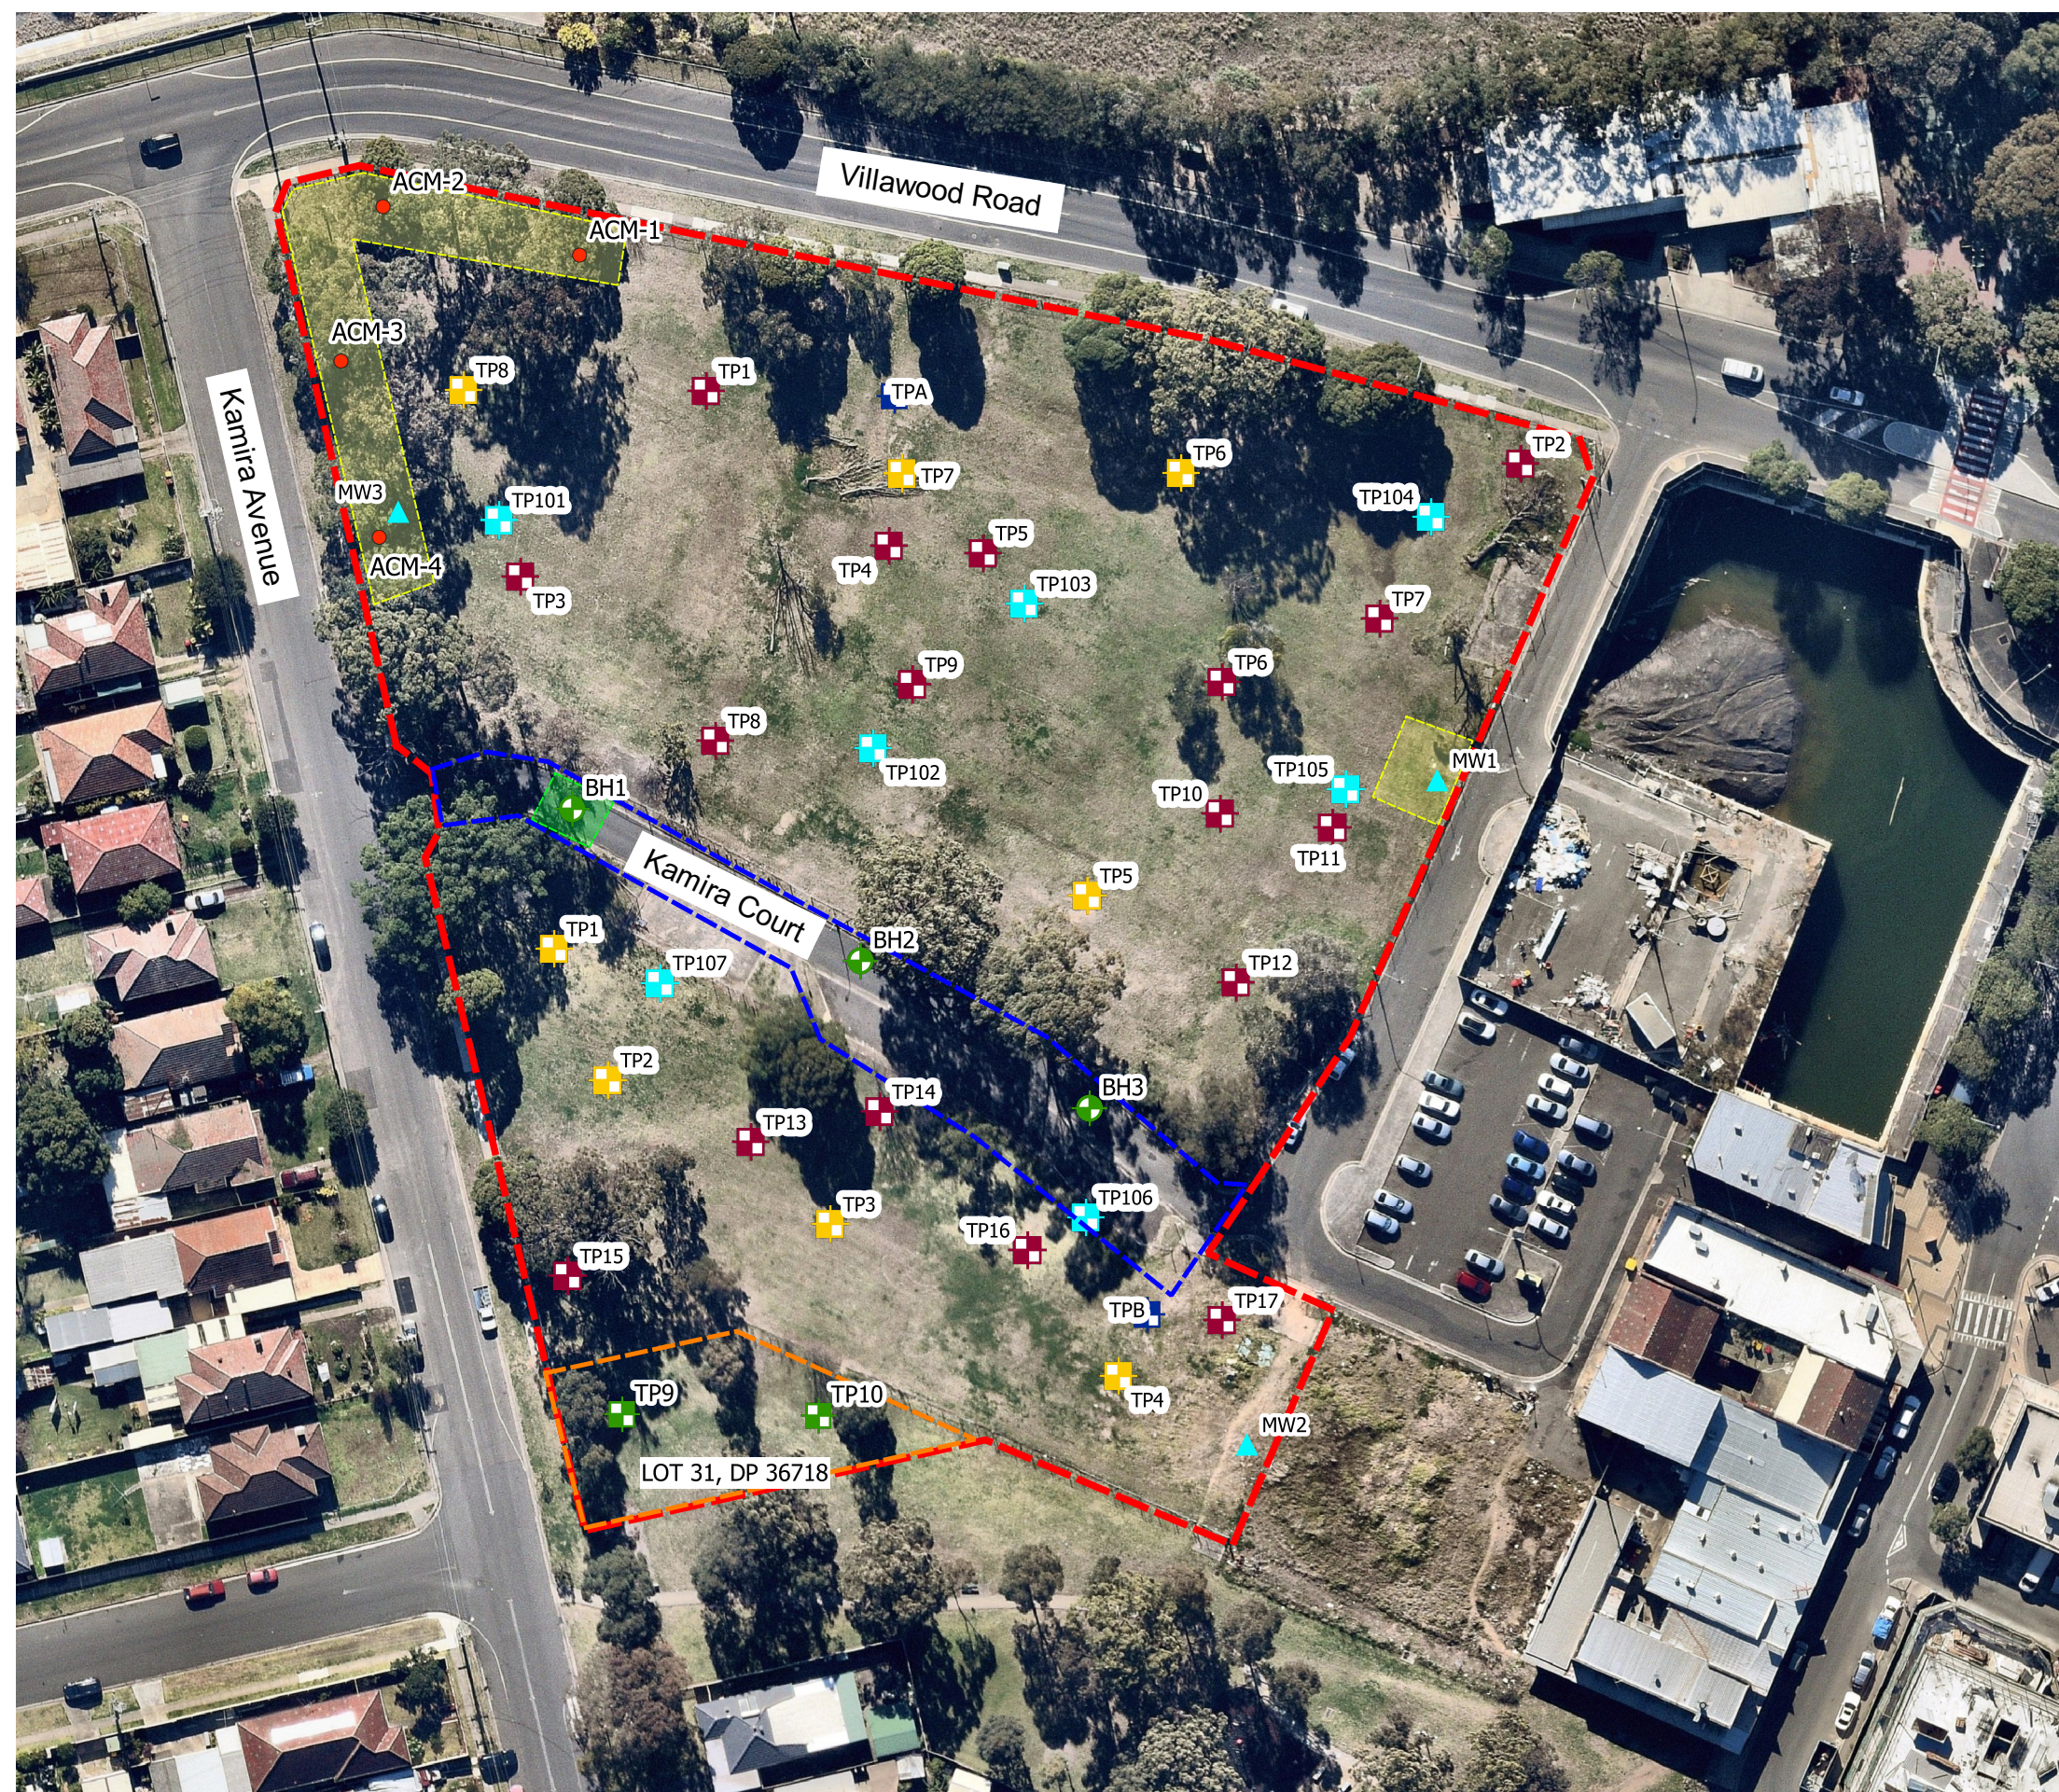
- ▬ Site Boundary
- ▬ Part Kamira Court
- ▬ Part Lot 31, DP 36718
- Asbestos Finds
- CT1 Exceedances
- Asbestos Material Samples
- Test Pits (Previous Investigation, 2008)
- Test Pits (Previous Investigation, 2010)
- Test Pits (Previous Investigation, 2019)
- ▲ Groundwater Wells
- Borehole Locations
- Testpit Locations
- ENM Investigation Testpits

With the exception of soils from beneath Kamira Court and limited asbestos finds (as shown in Drawing 2, Appendix A), the concentrations of the selected analytes in all soils were found to be within the SAC. The soils beneath Kamira Court reported exceedances of ecological based SAC, which may be managed by removing from site as part of bulk excavation works (for basements) or relocating in areas not exposed to proposed landscaping.

With the exception of the asbestos detected at MW1 in shallow soils, the remainder of the asbestos finds were observed on the ground surface, localised in the north west corner of the site (as shown in Drawing 2, Appendix A). It is considered possible that the materials may have been fly tipped on the site. However, based upon the presence of anthropogenic materials, including building rubble commonly associated with ACM it is possible that additional ACM is present in soils between test locations and other un-observed parts of the site. Soils impacted with ACM are to be waste classified for off-site disposal. In the areas where surficial asbestos was identified, the contamination risk may potentially be managed via a process of 'emu picking' visible ACM, followed by a surface clearance by a suitability qualified consultant or hygienist.

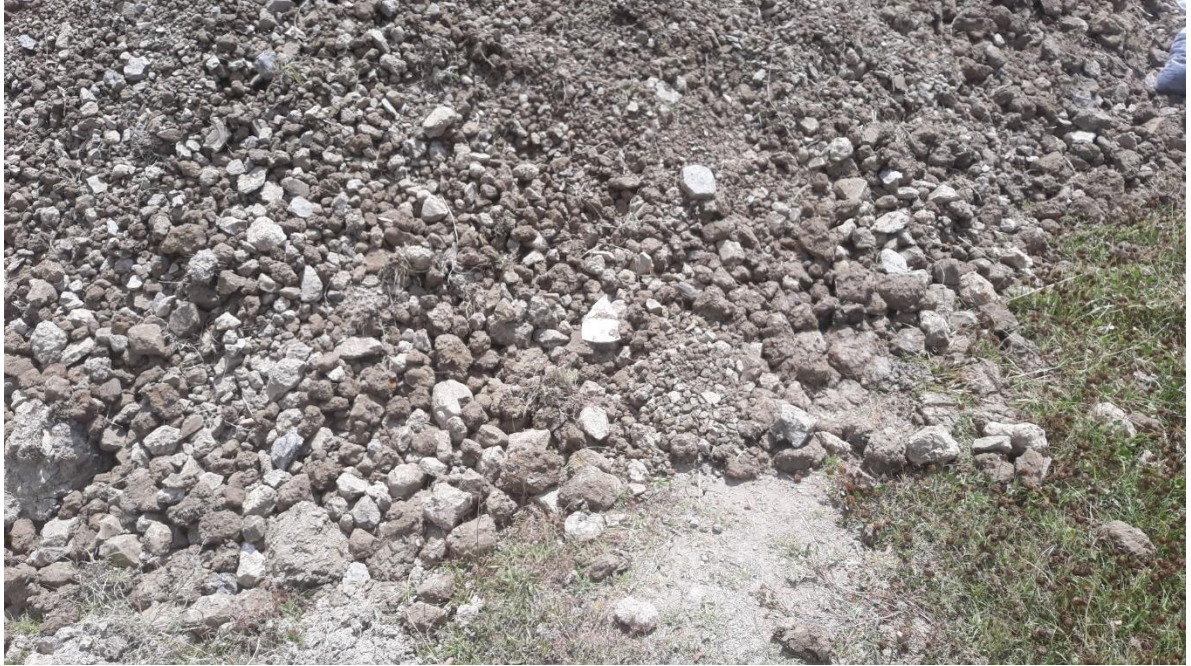
Photo 5: SPA additional anthropogenics in passing fraction (plastic & concrete)

It is also noted that the ENM Order does not allow for processing of material. Sieving may be seen as a method of processing and should be avoided if compliance with the ENM Order is sought. A method of manually removing large anthropogenics may be an appropriate method of managing the soils as an alternative. Again, this should be completed and assessed in small batches as recommended above.

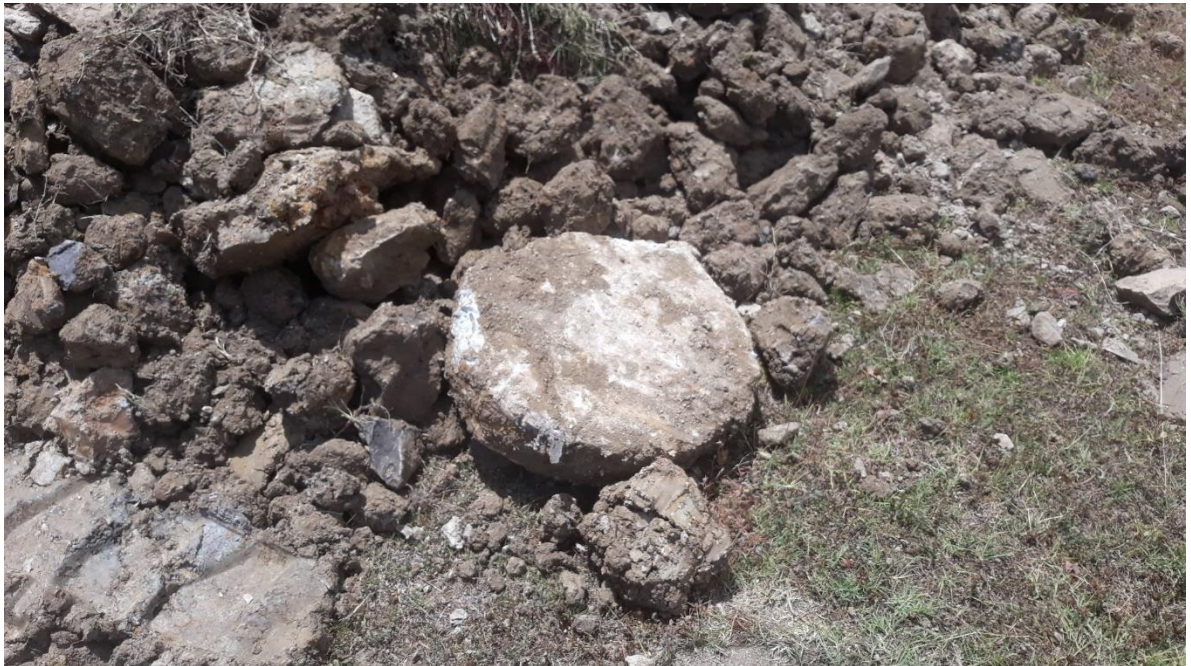
Photo 6: SPA larger anthropogenics in retained fraction

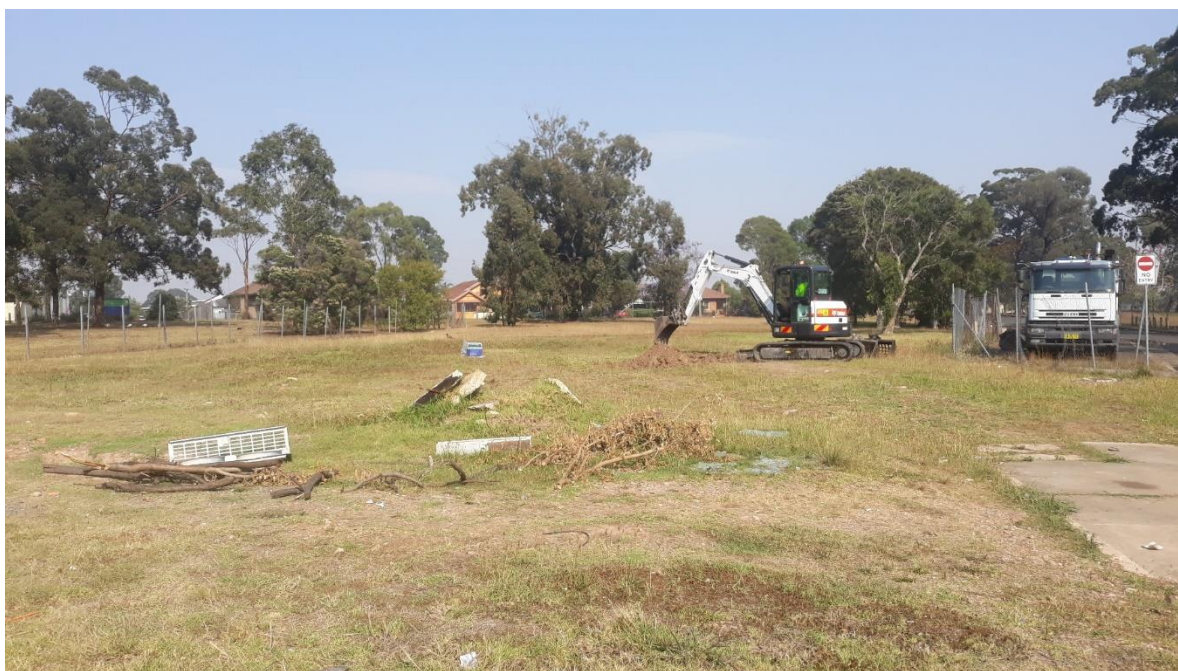
At the time of sampling, the site was observed to consist of two portions of vacant land bisected by Kamira Court. The northern portion of the site was fenced-off and bound by Villawood Road, Kamira Avenue and Kamira Court, and the southern portion was bound by Kamira Avenue, Kamira Court, an open public park / path to the south and vacant land at the rear of the commercial buildings to the east. The ground surface in both portions comprised open grassed areas with minimal tree cover and minor amounts of anthropogenic material, possibly fly tipped, visible on the surface.

Photo 11: Southern portion of site, fly tipped waste

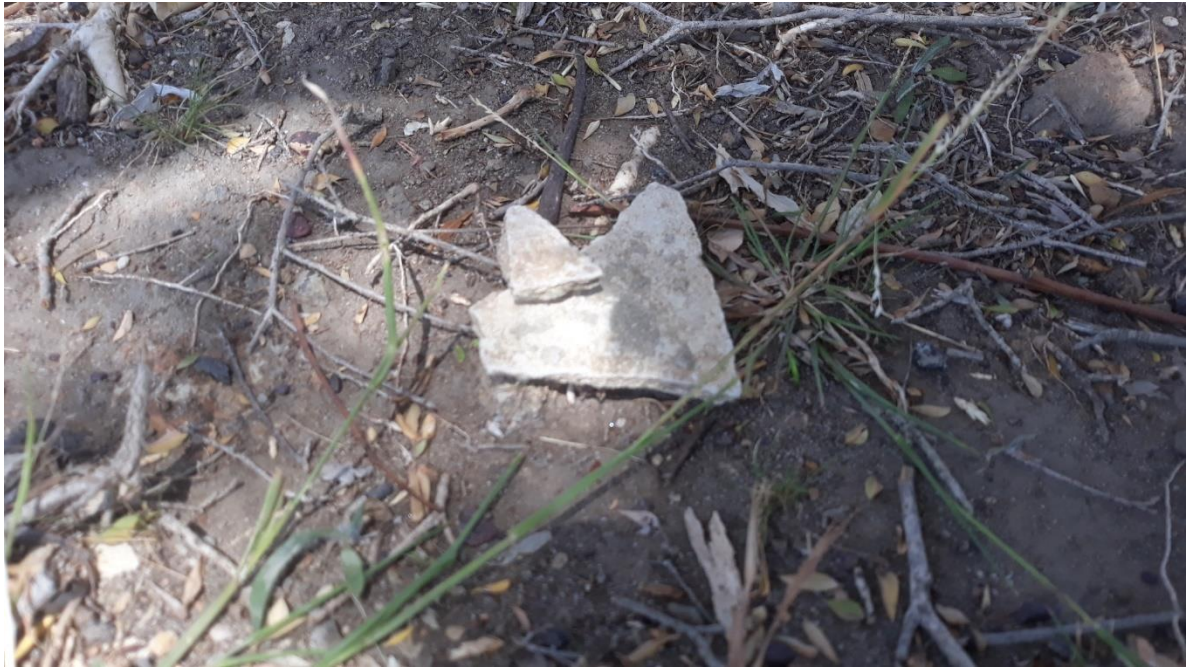
Fragments of potential asbestos containing material (ACM-1 to ACM-4) were observed at the ground surface in the north-west portion of the site, close to the boundary fence. The source of the fragments is not known, however, given the proximity to the boundary fence, it is possible that the fragments were introduced from outside the site. Laboratory analysis on one of the samples (ACM-2) confirmed the presence of asbestos. Based upon the similarity of the fragments the remaining samples are presumed to contain asbestos.

Photo 13: Surficial ACM fragments ACM-2

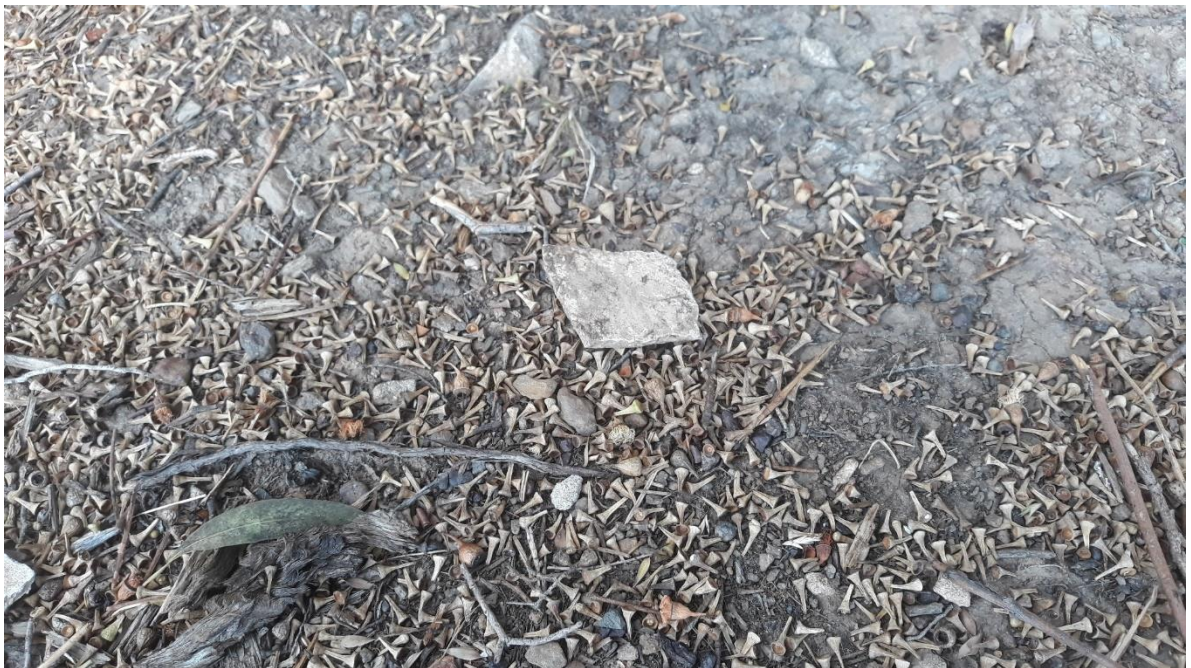
Photo 14: Surficial ACM fragment ACM-3
