Additional Geotechnical Investigation

28 Elizabeth Street, Liverpool NSW

E24175.G04 26 October 2021

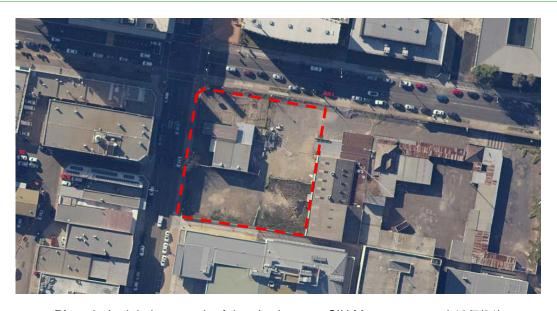
Plate 1: Aerial photograph of the site (source: SIX Maps, accessed 13/7/21)

The site identification details and associated information are presented in **Table 2-1** below while the site locality is shown on **Figure 1**. An aerial photograph of the site is presented in **Plate 1** below. The site conditions appeared to be similar to the previous GI dated 2019. Therefore the site descriptions from the previous GI report has been reproduced.

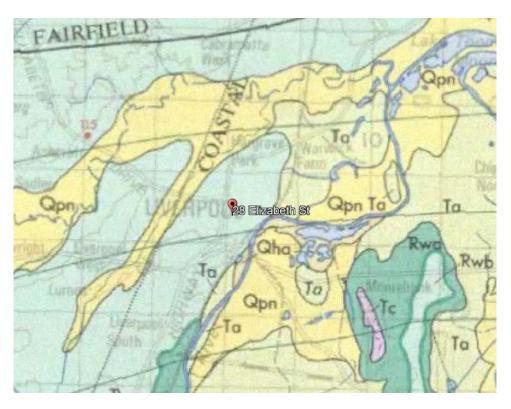
Plate 2: Excerpt of geological map showing location of site.

Attribute	Description
Topography	The site is generally flat and level with site surface levels between RL 13.96m at the north-eastern end and RL 13.08m at the south western end.
Regional Geology	Information on regional sub-surface conditions, referenced from the Department of Mineral Resources Geological Map Penrith 1:100,000 Geological Series Sheet 9030 (DMR 1991) indicates the site is underlain by Bringelly Shale. Bringelly Shale typically comprises shale, carbonaceous claystone, claystone, laminite, fine to medium-grained lithic sandstone, rare coal and tuff.

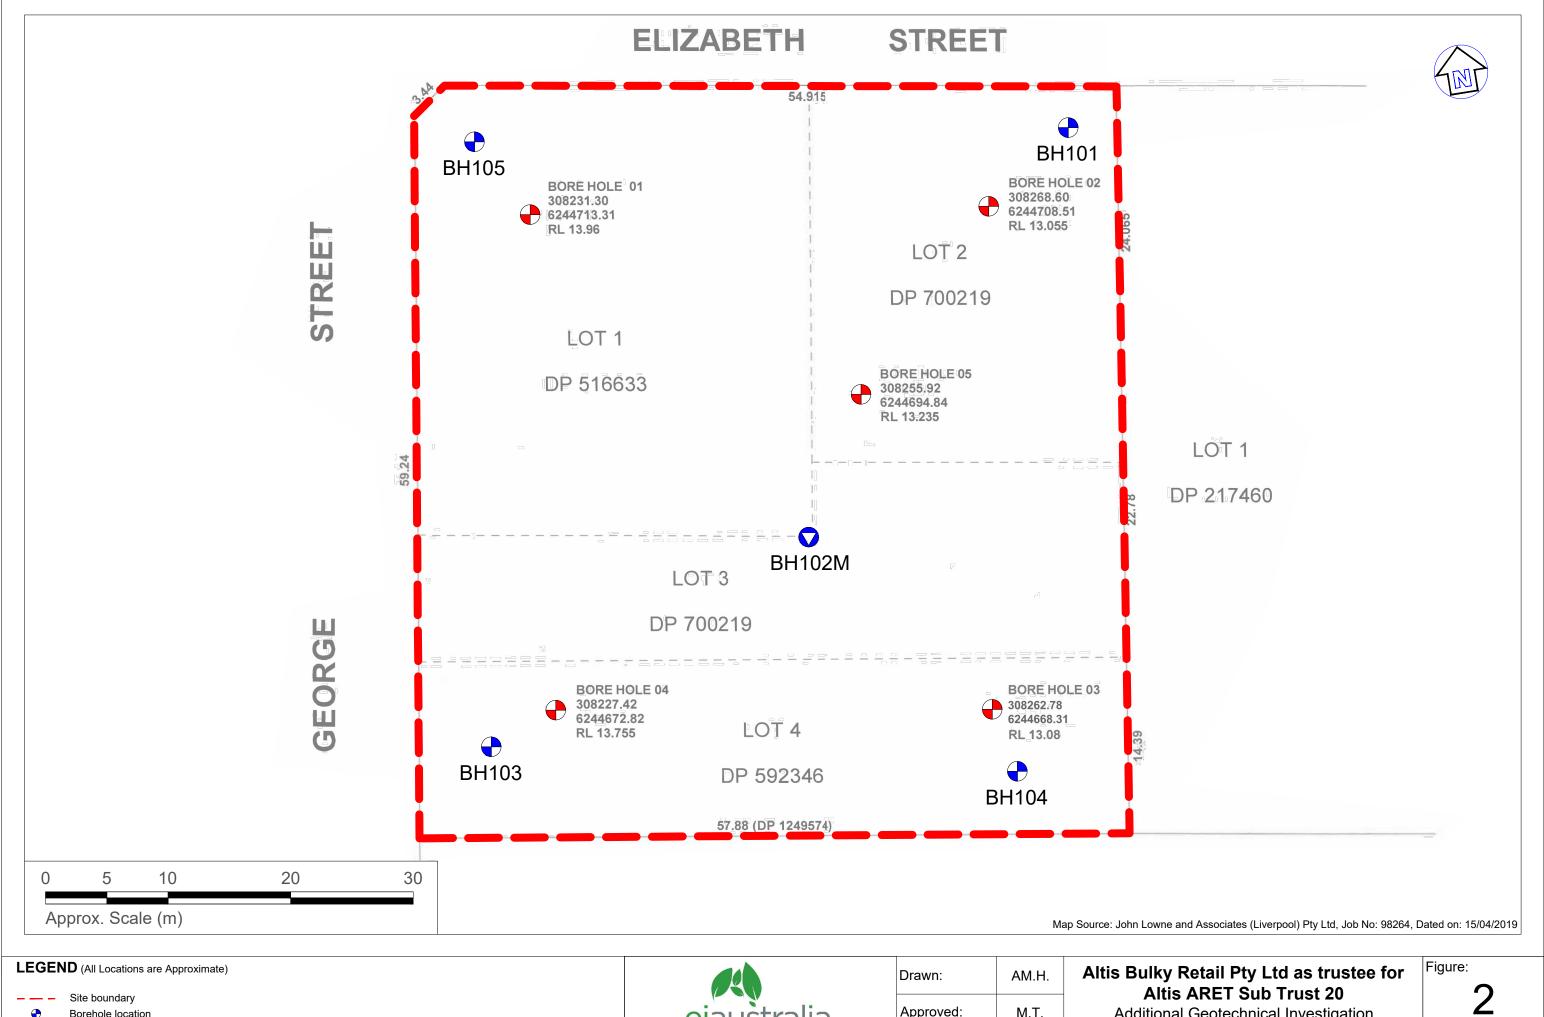
Figure 2 Borehole Location Plan

Borehole/monitoring well location

Additional Geotechnical Investigation 28 Elizabeth Street, Liverpool NSW **Borehole Location Plan**

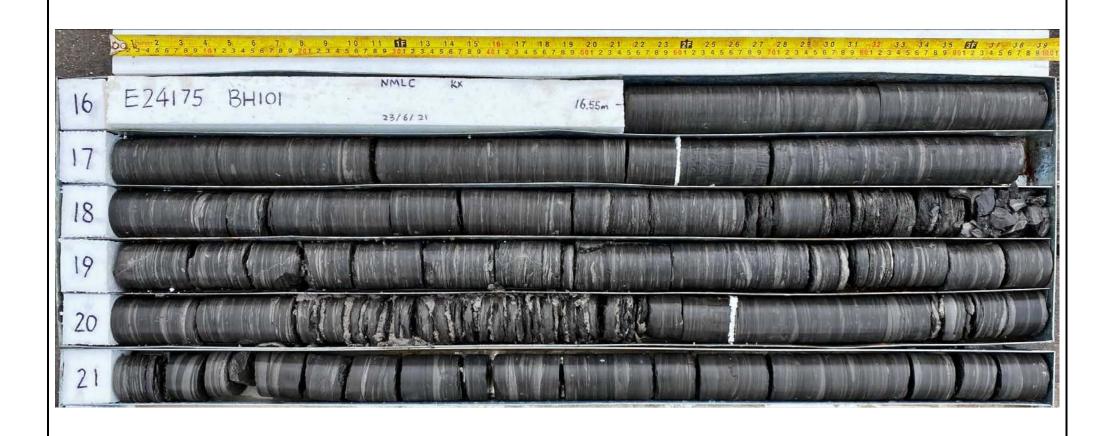
BOREHOLE LOG

Project Proposed Development Sheet 1 of 4 Location 28 Elizabeth Street, Liverpool NSW **Date Started** 24/06/2021 Position Refer to Figure 2 **Date Completed** 24/06/2021 Job No. E24175.G04 Date 24/06/2021 Logged By KX Client Altis Bulky Retail Pty Ltd as trustee for Altis ARET Sub Trust 20 Reviewed By MT Date 22/07/2021 **Drilling Contactor** BG Drilling Pty Ltd Surface RL ≈13.24 m AHD Drill Rig Hanjin DB 8D Inclination -90° Drilling Field Material Description Sampling MOISTURE CONDITION CONSISTENCY REL. DENSITY PENETRATION RESISTANCE GROUP SYMBOL RECOVERED STRUCTURE AND SAMPLE OR FIELD TEST GRAPHIC LOG ADDITIONAL OBSERVATIONS SOIL/ROCK MATERIAL DESCRIPTION METHOD DEPTH (metres) WATER DEPTH RL PAVEMENT FILL 13.21 ASPHALT; 30 mm thick. FILL: Gravelly SAND; fine to coarse grained, dark grey, fine to coarse, sub-angular to sub-rounded gravels, with clay. М RESIDUAL SOIL Silty CLAY; medium to high plasticity, pale brown-grey mottled red-brown. M (>PL) (St) 3 GWNE From 3.4 m, with fine to coarse, sub-angular to sub-rounded AD/ ironstone gravels. From 3.6 m, grading to extremely weathered material. BEDROCK SANDSTONE; fine to medium grained, pale grey-brown, very low strength, distinctly weathered. 5 8 SHALE; dark grey. 10 This borehole log should be read in conjunction with El Australia's accompanying standard notes.

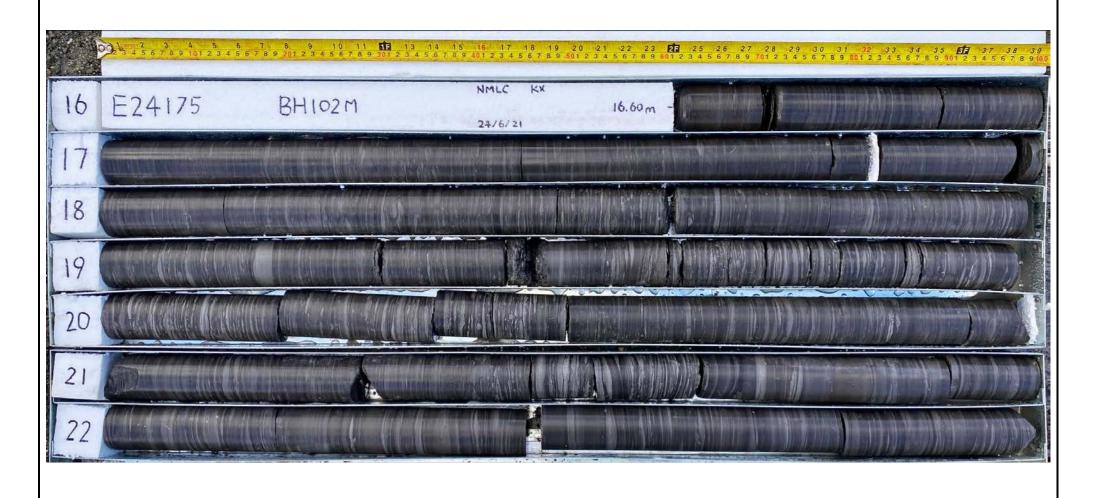
Surface RL ≈ 13.24m

Project Proposed Development Sheet 1 of 4 Location 28 Elizabeth Street, Liverpool NSW **Date Started** 24/06/2021 Position Refer to Figure 2 **Date Completed** 25/06/2021 Job No. E24175.G04 Logged By KX Date 24/06/2021 Client Altis Bulky Retail Pty Ltd as trustee for Altis ARET Sub Trust 20 Reviewed By MT Date 22/07/2021 **Drilling Contactor** BG Drilling Pty Ltd Surface RL ≈13.08 m AHD Drill Rig Hanjin DB 8D Inclination -90° Drilling Field Material Description Sampling MOISTURE CONDITION CONSISTENCY REL. DENSITY PENETRATION RESISTANCE GROUP SYMBOL RECOVERED STRUCTURE AND ADDITIONAL OBSERVATIONS SAMPLE OR FIELD TEST GRAPHIC LOG SOIL/ROCK MATERIAL DESCRIPTION DEPTH (metres) WATER DEPTH RL 13.08 FILL: Silty SAND; fine grained, dark brown, with gravels and brick fragments, with clay. М RESIDUAL SOIL Silty CLAY; high plasticity, grey mottled red. M (>PL) (St) AD/T 3 From 3.5 m, grading to extremely weathered material. SANDSTONE; pale grey, very low strength, distinctly weathered, with ironstaining. BEDROCK 5 7.70 5.38 WB SHALE; dark grey. 8 9 This borehole log should be read in conjunction with El Australia's accompanying standard notes.

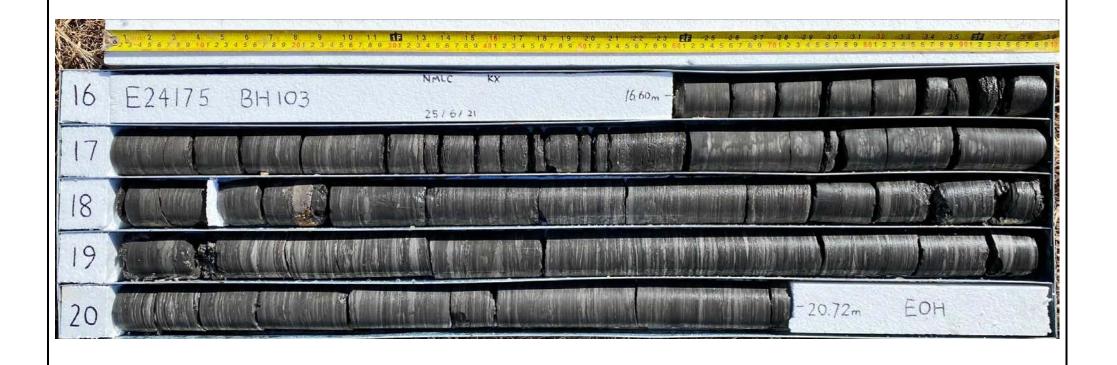
Surface RL ≈ 13.08m

Project Proposed Development Sheet 1 of 4 Location 28 Elizabeth Street, Liverpool NSW **Date Started** 25/06/2021 Position Refer to Figure 2 **Date Completed** 25/06/2021 Job No. E24175.G04 Logged By KX Date 25/06/2021 Client Altis Bulky Retail Pty Ltd as trustee for Altis ARET Sub Trust 20 Reviewed By MT Date 22/07/2021 **Drilling Contactor** BG Drilling Pty Ltd Surface RL ≈13.76 m AHD Drill Rig Hanjin DB 8D Inclination -90° Drilling Field Material Description Sampling MOISTURE CONDITION CONSISTENCY REL. DENSITY PENETRATION RESISTANCE GROUP SYMBOL RECOVERED STRUCTURE AND SAMPLE OR FIELD TEST GRAPHIC LOG ADDITIONAL OBSERVATIONS SOIL/ROCK MATERIAL DESCRIPTION DEPTH (metres) WATER DEPTH RL 13.76 FILL: gravelly SAND; fine to coarse grained, dark grey, fine to coarse, sub-angular to sub-rounded gravels. FILL М RESIDUAL SOIL Silty CLAY; medium plasticity, brown mottled pale grey. 2.00 11.76 From 2.0 m, pale grey mottled red-brown, with fine, sub-angular to sub-rounded ironstone gravels, fine grained sand. 3 (St) 3.70 10.06 AD/T From 3.7 m, pale grey-brown. 5 From 6.0 m, grading to extremely weathered material. BEDROCK SANDSTONE; brown, very low strength, distinctly weathered, with shale. 7.70 6.06 SHALE; dark grey. 8 9 10 This borehole log should be read in conjunction with El Australia's accompanying standard notes.

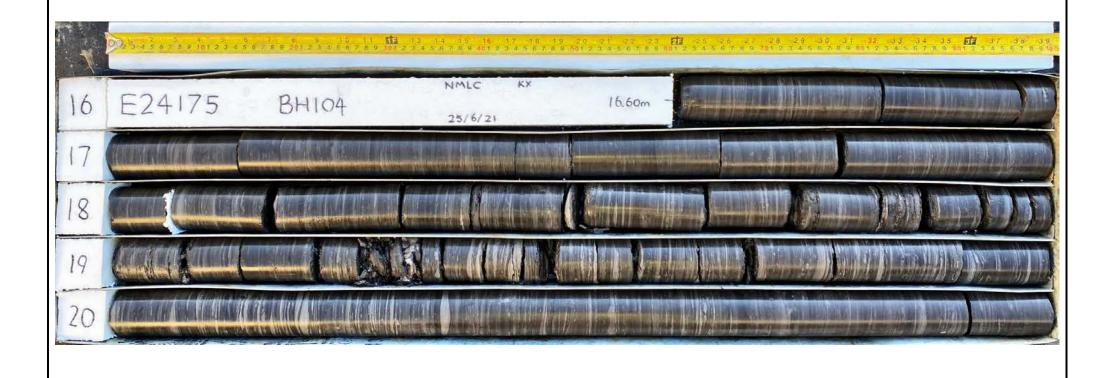
Surface RL ≈ 13.76m

Project Proposed Development Sheet 1 of 4 Location 28 Elizabeth Street, Liverpool NSW **Date Started** 28/06/2021 Position Refer to Figure 2 **Date Completed** 28/06/2021 Job No. E24175.G04 Logged By KX Date 28/06/2021 Client Altis Bulky Retail Pty Ltd as trustee for Altis ARET Sub Trust 20 Reviewed By MT Date 22/07/2021 **Drilling Contactor** BG Drilling Pty Ltd Surface RL ≈13.96 m AHD Drill Rig Hanjin DB 8D Inclination -90° Drilling Field Material Description Sampling MOISTURE CONDITION CONSISTENCY REL. DENSITY PENETRATION RESISTANCE GROUP SYMBO RECOVERED STRUCTURE AND SAMPLE OR FIELD TEST GRAPHIC LOG ADDITIONAL OBSERVATIONS SOIL/ROCK MATERIAL DESCRIPTION METHOD DEPTH (metres) WATER DEPTH RL Б PAVEMENT CONCRETE; 120 mm thick. 0.12 13.84 FILL FILL: Silty SAND; medium to coarse grained, orange-brown, trace ash. FILL: Silty CLAY; low plasticity, dark brown, with sand, trace gravels. М RESIDUAL SOIL Silty CLAY; medium plasticity, grey mottled red. AD/T (St) 3 3.20 10.76 From 3.2 m, grey, with ironstone bands, grading to extremely weathered material. **4.80** 9.16 BEDROCK SHALE; dark grey, very low strength, distinctly weathered. From 5.5 m, dark grey. WB 8 9 This borehole log should be read in conjunction with El Australia's accompanying standard notes.

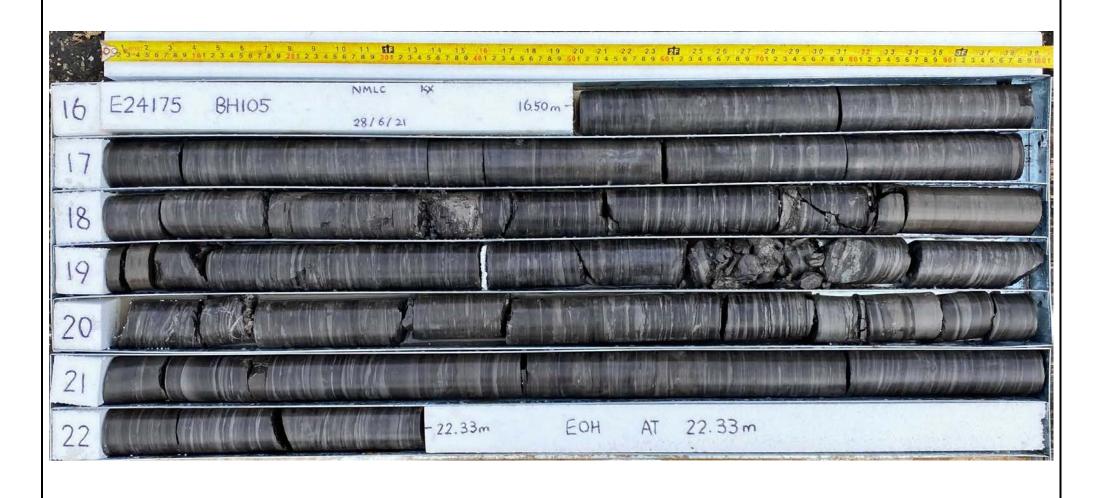
Surface RL ≈ 13.96m
