**Acid Sulfate Soil
Management Plan**

28 Elizabeth Street, Liverpool NSW

Report Title: Acid Sulfate Soil Management Plan

Report No: E24175.E14_Rev0

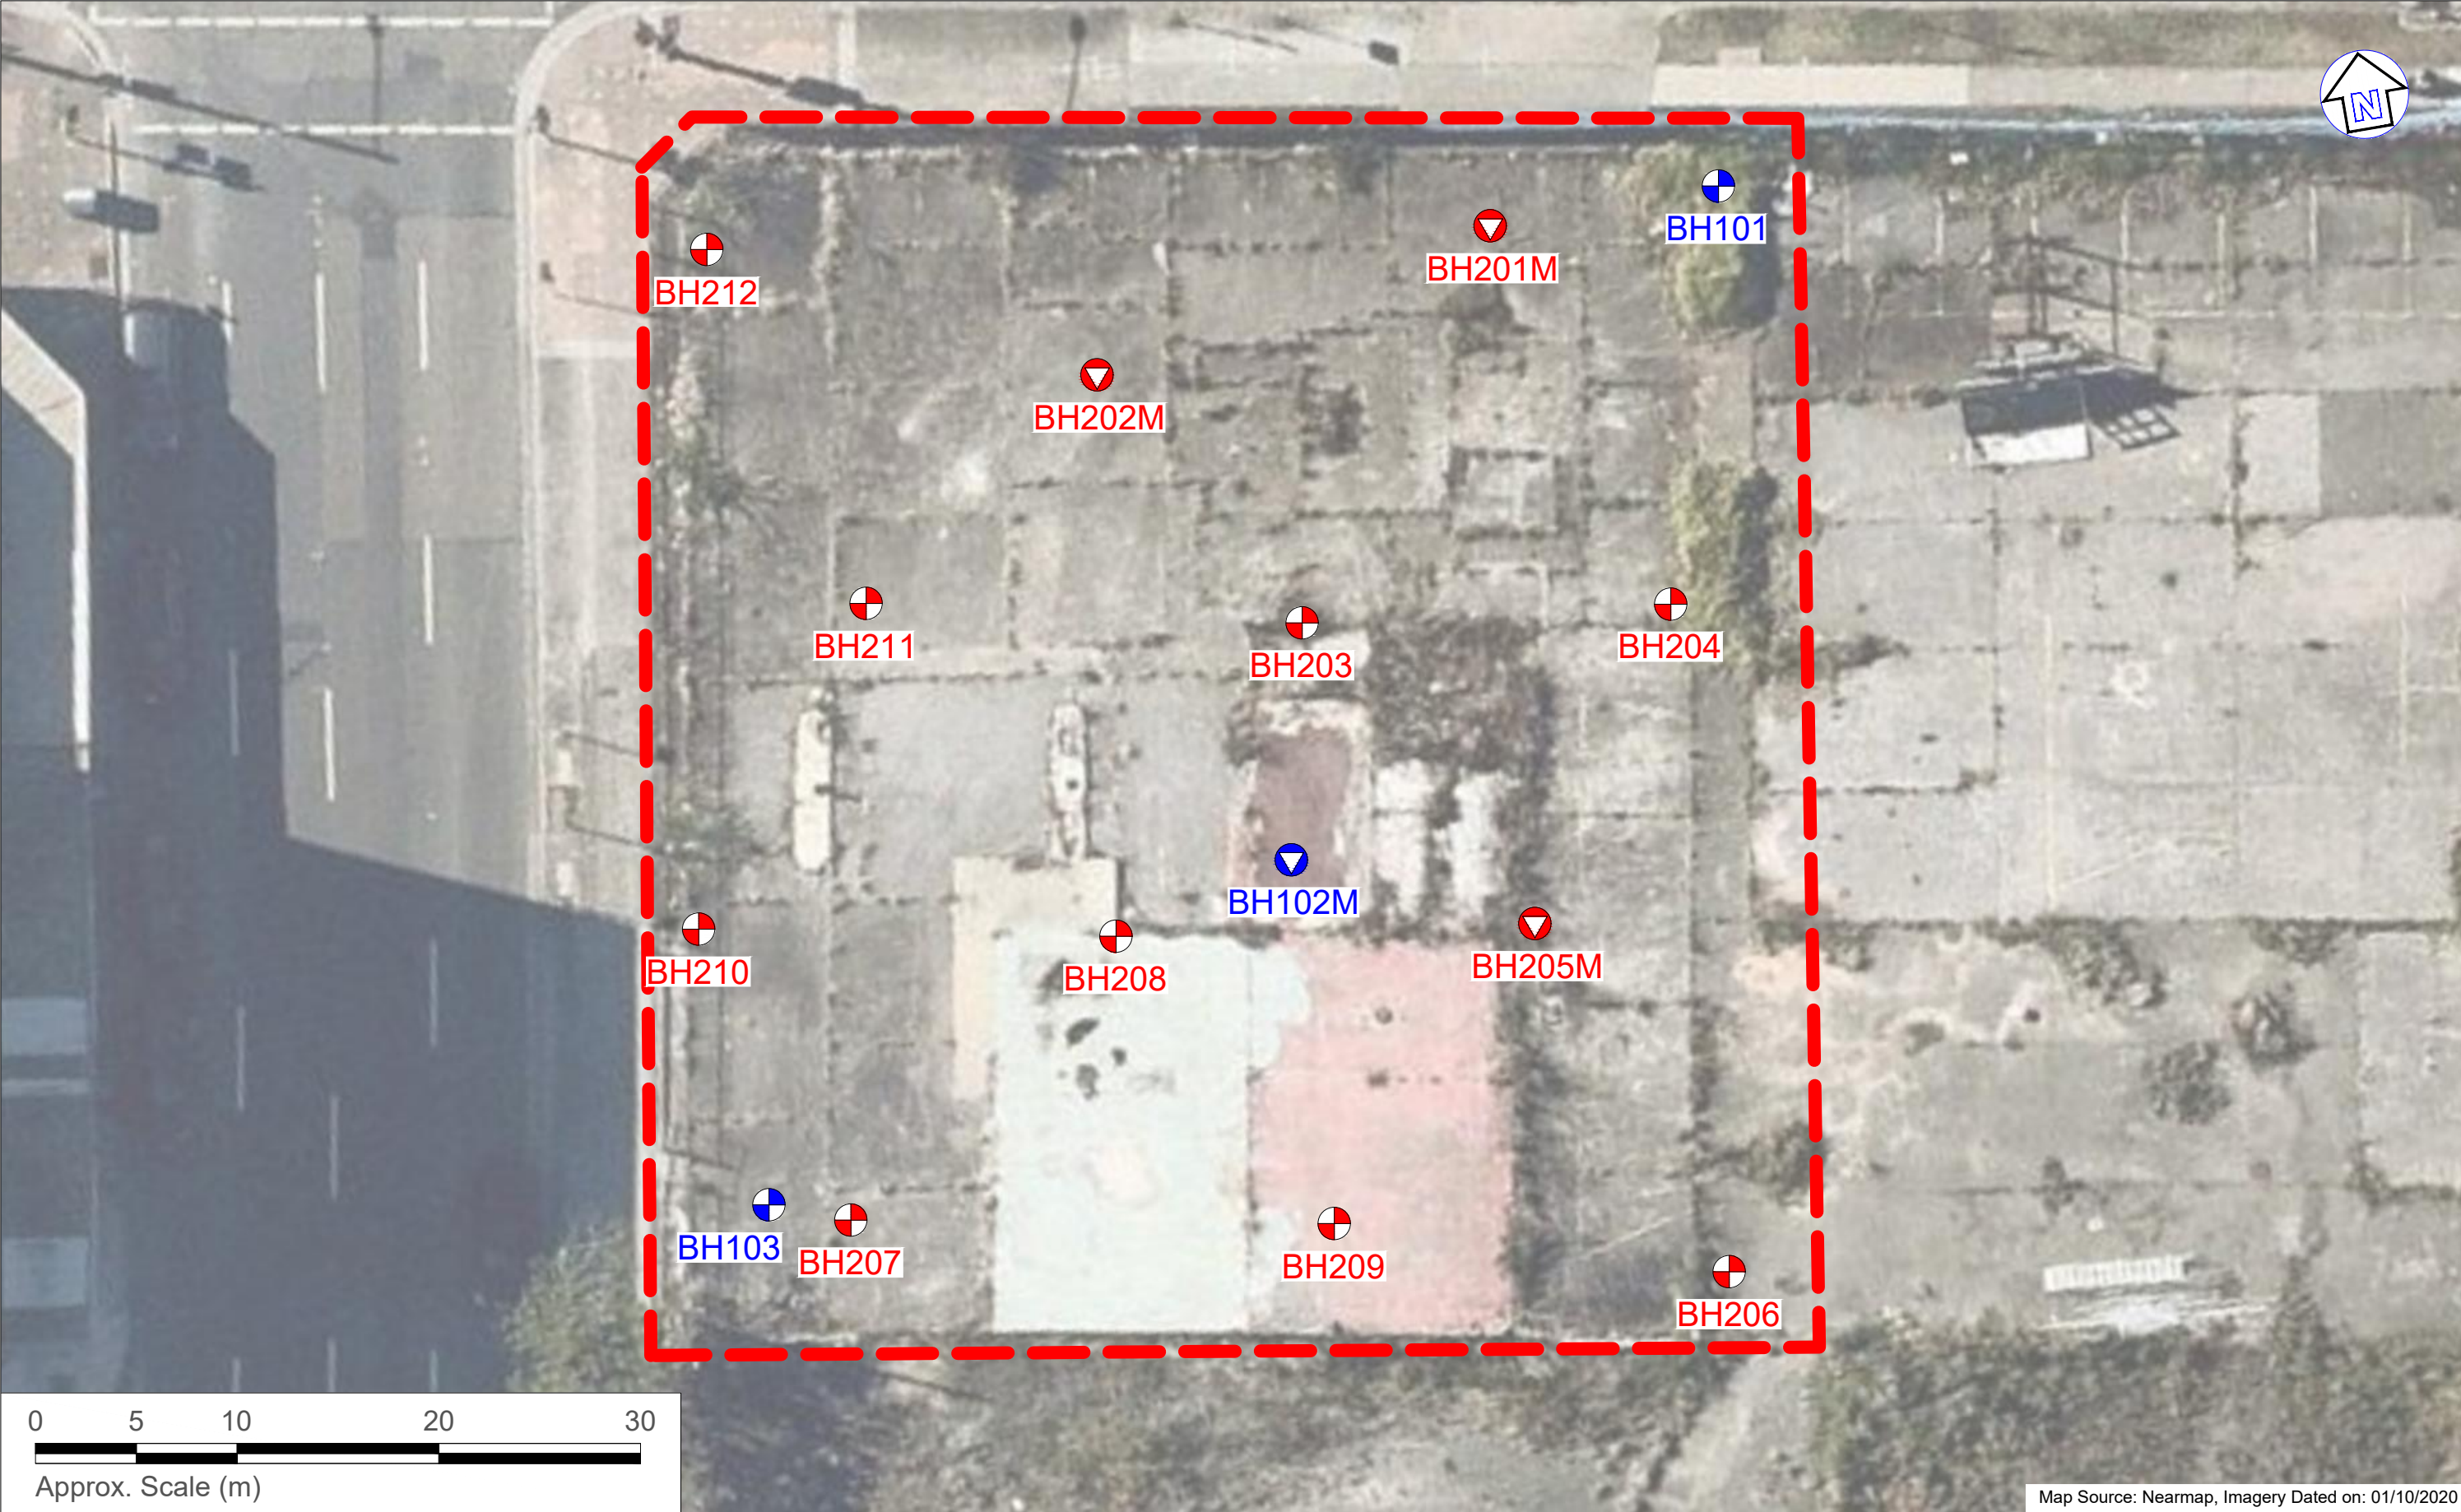
LEGEND (All Locations are Approximate)

- Site boundary
- ⊕ Borehole location
- ⊕ Borehole/monitoring well location
- ⊕ Previous borehole location (EI, 2020)
- ⊕ Previous borehole/monitoring well location (EI, 2020)

A sub-surface inspection and associated soil sampling was conducted at two borehole locations (BH101 and BH103) on 23 June 2021. Borehole locations onsite are presented in **Figure 2**. Intrusive investigation was performed by the use of a track mounted drill rig (Hanjin DB 8D) fitted with solid flight augers. Boreholes were extended to a maximum depth of 16.6mBGL (target depth exceeded). Soil samples were collected at approximately 0.5 m intervals in the natural, silty clay material. Sulfurous odours were not observed at either sampling location. Detailed borehole logs pertaining to this additional ASS investigation are presented in **Appendix D**.
