Remediation Action Plan

28 Elizabeth Street, Liverpool NSW

Report Title: Remediation Action Plan, 28 Elizabeth Street, Liverpool NSW

Report No: E24175.E06_Rev0

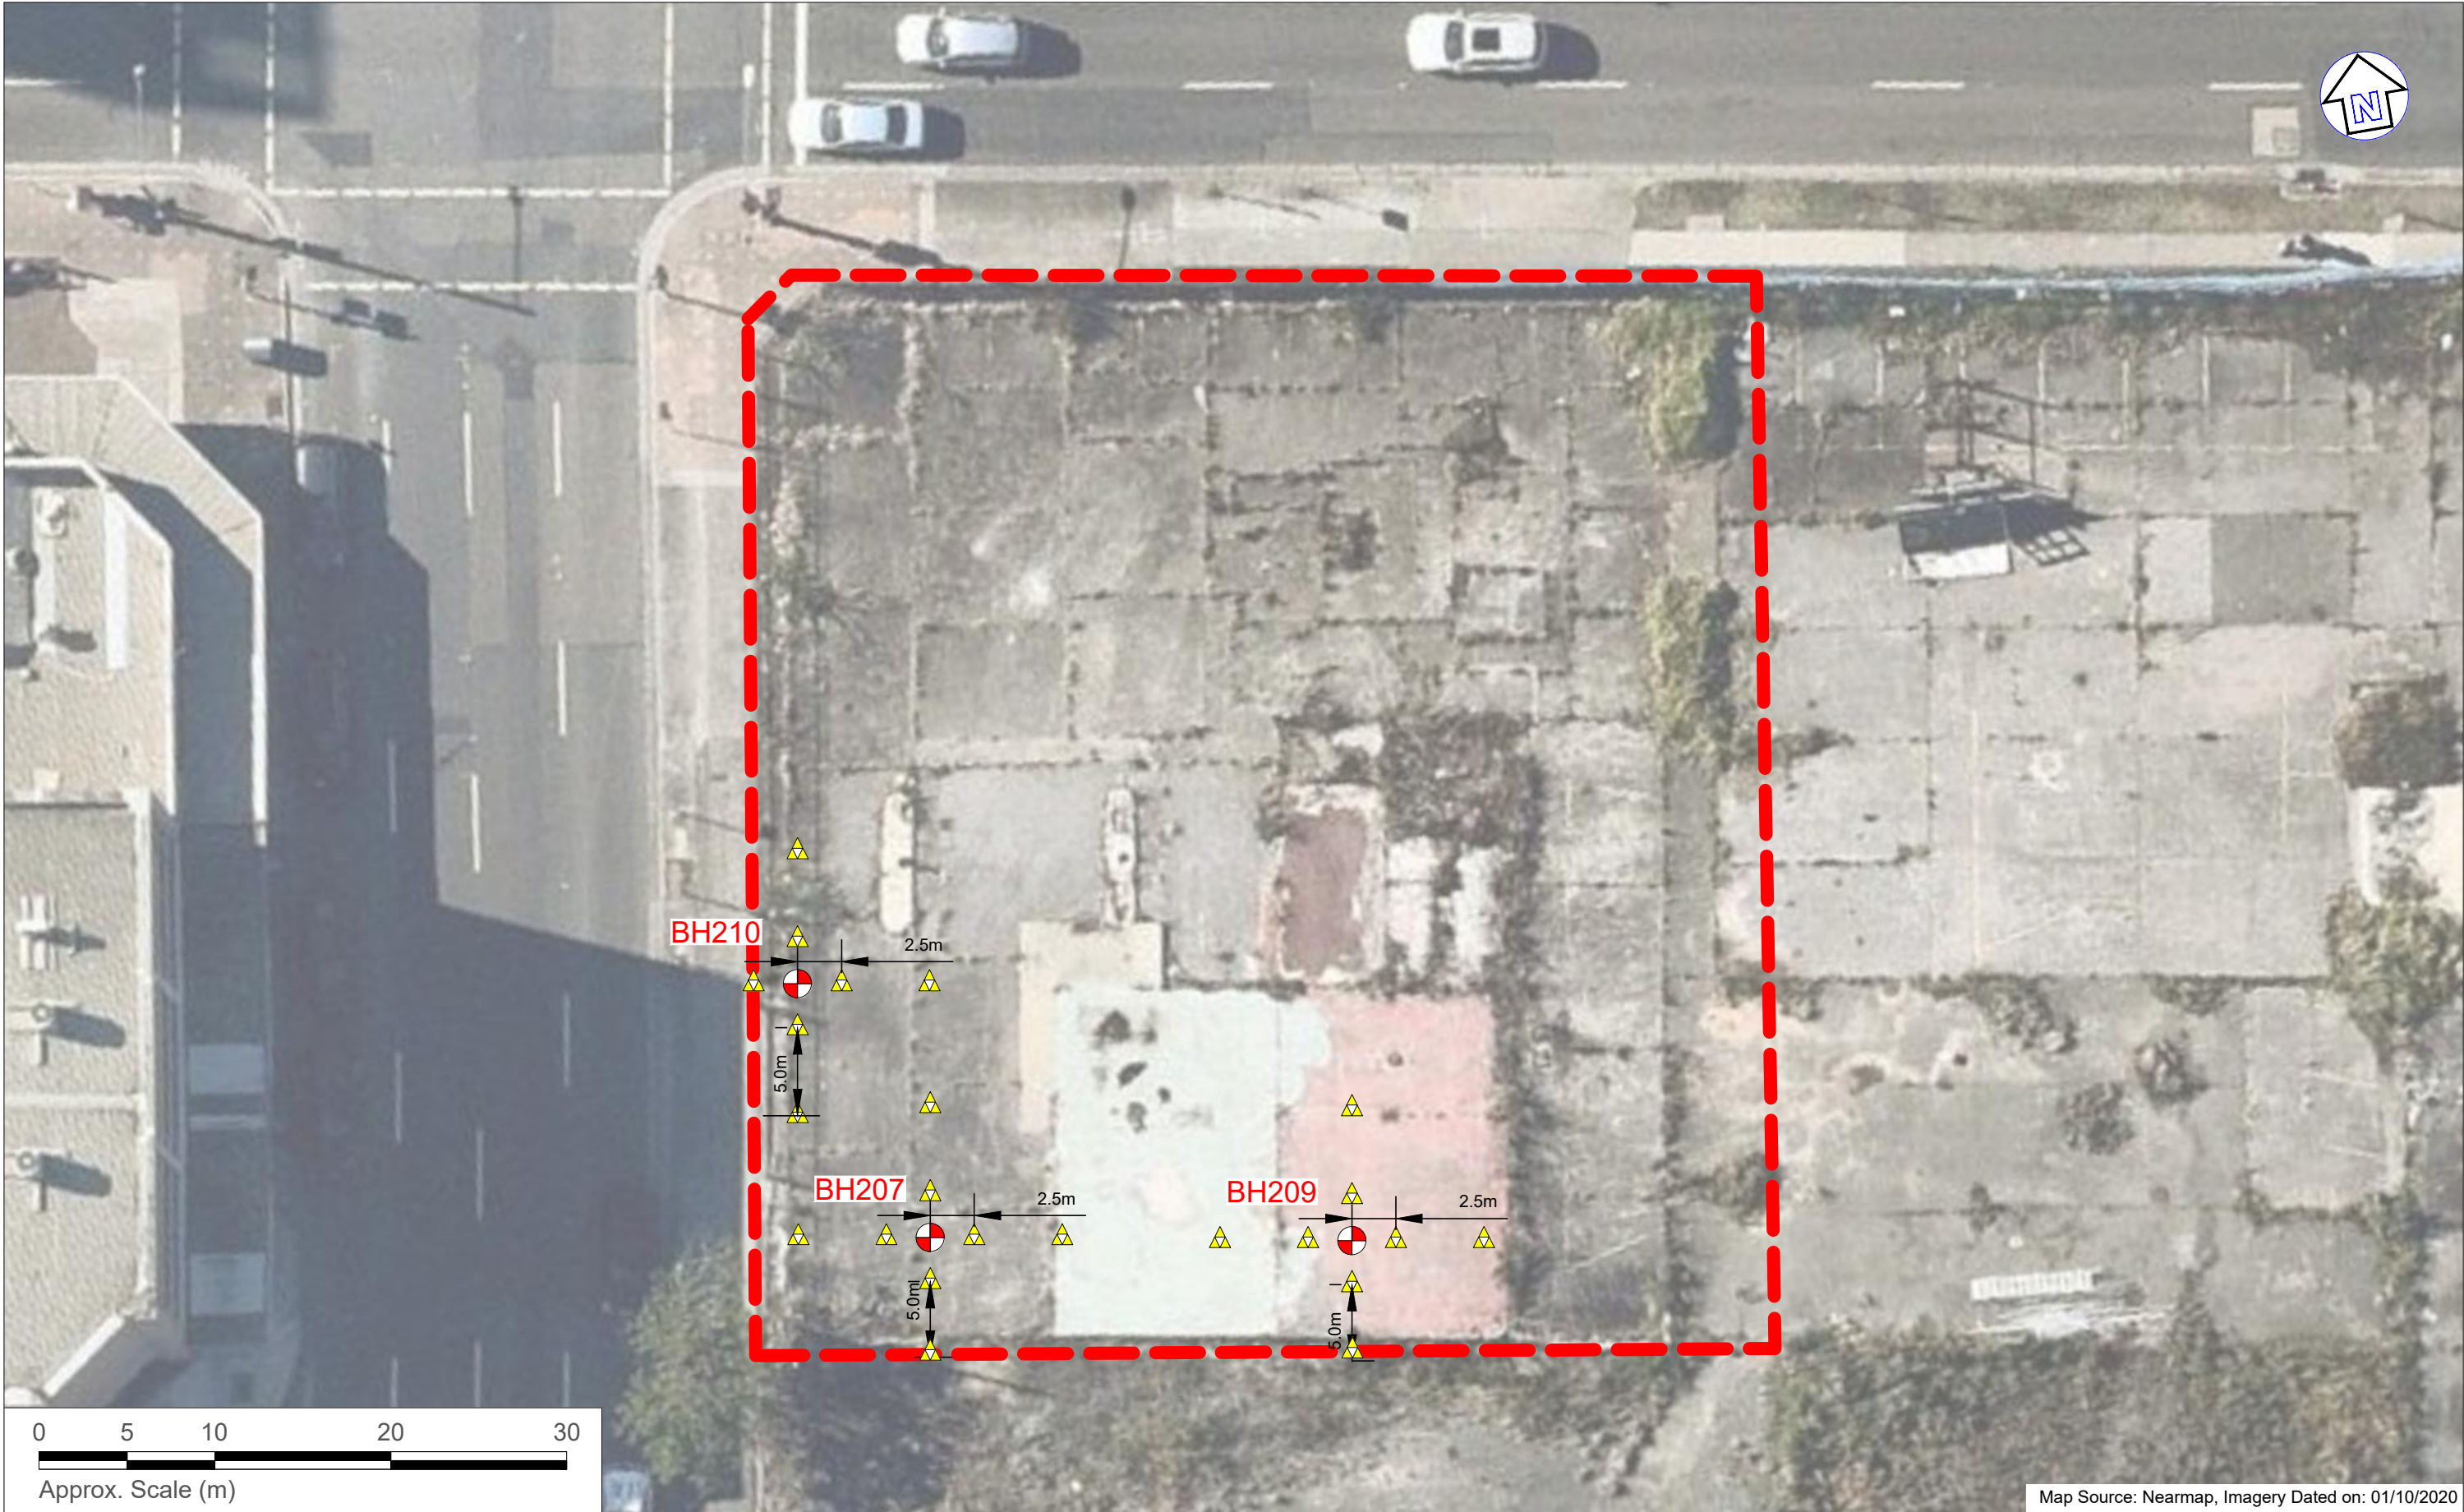
- Site boundary
- Previous borehole location (EI, 2020)
- Proposed delineation sampling location
