WEED MANAGEMENT PLAN

BLUE MOUNTAINS CITY COUNCIL

168 Hawkesbury Road, Springwood, NSW, 2777

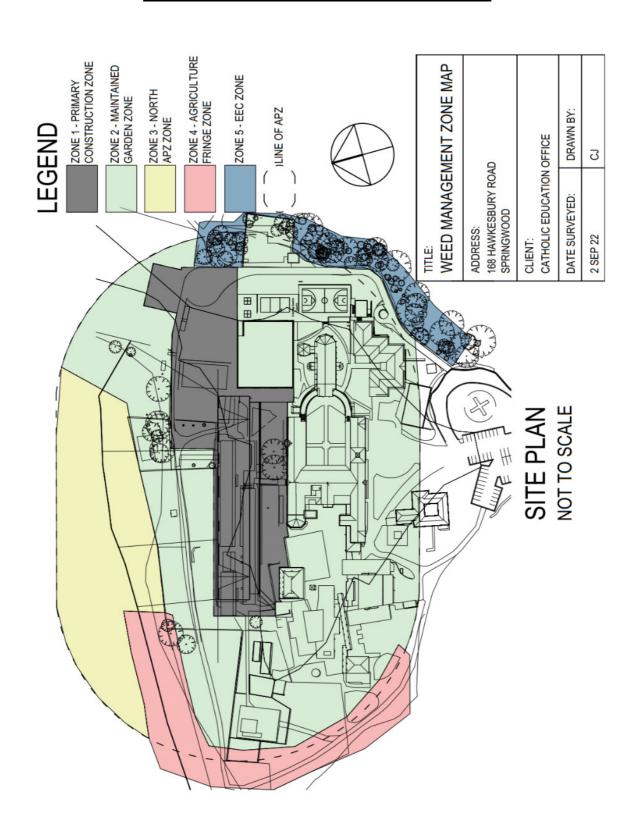
APPENDIX 1 – SITE MAP / WEED ZONES

For purposes of weed management the site has been broken into 5 sections. These sections have been labelled "Zone 1 - Primary Construction Zone", "Zone 2 – Maintained Garden Zone", "Zone 3 – North APZ Zone", "Zone 4 – Agriculture Fringe Zone", and "Zone 5 – Endangered Ecological Community Zone".

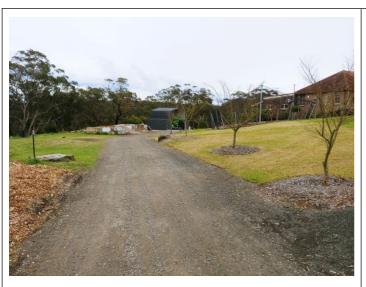
As most of this area is made up of turf areas, either mowed or grazed, the weed levels in this area are fairly minimal (see Photos #1, 2, & 3).

Photo 1 – Indicative maintained garden area

Turf areas should continue to be maintained as previously, with careful attention paid to the interface between this area and the surrounding bush. Escaped *Cenchrus clandestinum* (Kikuyu) and *Cynodon dactylon* (Couch) remain the largest weed threat for this zone, and ample evidence can be seen of these species making their way into the surrounding bush areas.

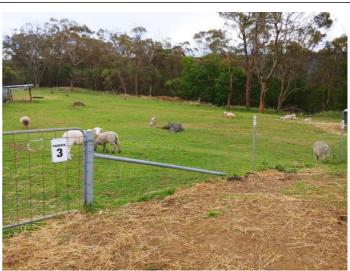
Photo 2 – Indicative maintained garden area

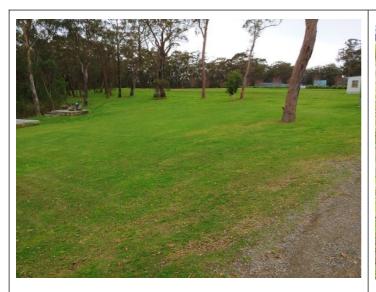
Photo 3 – Indicative maintained garden area

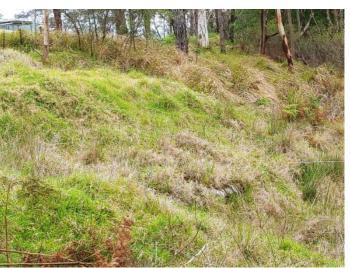
Escaped *Cenchrus clandestinum* (Kikuyu) and *Cynodon dactylon* (Couch) remain the largest weed threat for this zone (see Photo #4), and ample evidence can be seen of these species making their way downslope into the creek area. The cliff cutting off the areas below is currently the only line of defence in this zone, and should be assisted with further sediment, stabilisation and replanting works.

Photo 4 – North APZ Zone Kikuyu

Non-woody and trailing/climbing weeds in this area should be hand-slashed to a manageable level, retaining sufficient foliage for poison intake, and then sprayed as per the treatment methods outlined. Species that are resistant to foliar spray should be carefully removed by hand, paying particular attention to slope stability and erosion control.

At a minimum, following spraying of the grass weed species, this area should have sediment control fences installed and maintained in perpetuity.

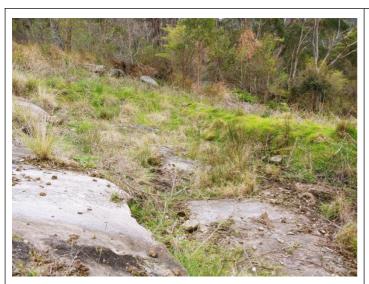
There is some evidence of previous slope stabilisation and sediment control measures may have been put in place, though these have not been maintained. Notably an area near the top of the slope appears as though it may have, at one time, been prepared as a formal sediment trap (see Photo #5). Investigating whether this area can be re-designed and constructed for the purpose of directing water and seed flows into it would be highly beneficial for mitigating the weed infestation process in this zone.

Photo 5 – Possible previous sediment trap

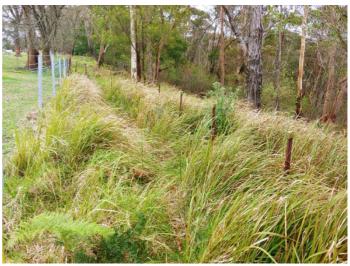
Photo 6 – Possible previous sediment control

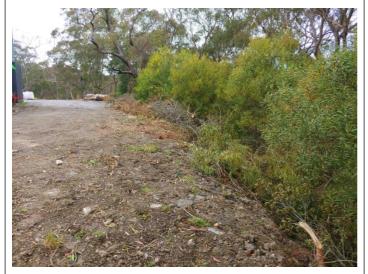
This area has been identified as a separate zone primarily as a result of the unique situation faced below the agricultural areas of the college. Animal feed may contain many weed seeds, and the embankments behind the kayak storage shed has been used as a garden waste dump (see Photos #7 & 8).

Garden waste dumping poses the greatest future threat to this zone. Tree and shrub cuttings, as well as grass clippings, have routinely been tipped off the edge of the fill area, that the shed sits on. It is recommended that this garden waste be cleared and disposed of at the local waste management facility. It is further recommended that an ongoing waste storage and disposal system be instituted, and adhered to, to minimise the threats of future weed infestation.

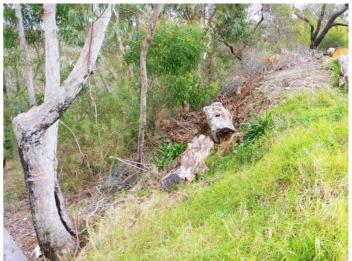
Photo 8 – Agriculture shed embankment used for dumping garden waste

The slope of the shed fill area is steep, and bears no evidence of existing native seed stock. It is recommended that erosion and sediment control fencing be placed along the contours, and at the base, of the slope, and planting of soil stabilising native species (e.g Grevillea x gaudichaudii) be planted across the entirety of the slope.

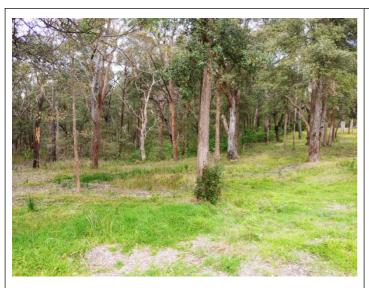
This area consists mostly of existing Syncarpia glomulifera trees, with a few assorted species interspersed. The ground and shrub stratum has largely been removed to accommodate the required Asset Protection Zones (see Photos #9 & 10). The remaining stubble bears only small evidence of weed infestation, at this stage. However the transition areas display evidence of weed creep and, if weed reduction measures are not put in place and soil light exposure not reduced, will result in total infestation of the area.

- Photo 9 - Endangered Ecological Community transition zone

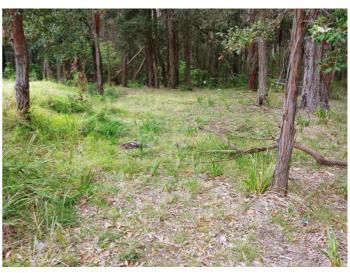
Escaped *Cenchrus clandestinum* (Kikuyu) and *Cynodon dactylon* (Couch) remain the largest weed threat for this zone (see Photo #10).

- Photo 10 - Endangered Ecological Community transition zone

Non-woody and trailing/climbing weeds in this area should be hand-slashed to a manageable level, retaining sufficient foliage for poison intake, and then sprayed as per the treatment methods outlined. Species that are resistant to foliar spray should be carefully removed by hand, paying particular attention to the protection and retention of species which are indicative of the Endangered Ecological Community.

Planting should follow weed reduction, with the aim of minimising overland sheet flows, and soil light penetration. All plantings carried out should be consistent with the Endangered Ecological Community e.g. *Blechnum cartilagineum* (Gristle Fern), *Dianella caerulea* (Flax Lily), *Lomandra longifolia* (Spiny Mat Rush), *Pteridium esculentum* (Bracken).

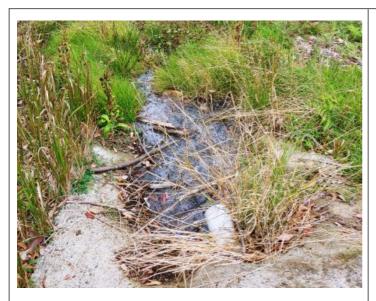
Within this zone there are a number of stormwater outlet pipes, that empty into the surrounding bushland (see Photos #11 & 12). Whilst there is no great weed infestation associated with these pipes at this time, there is evidence of weed encroachment beginning to appear. This is probably a result of the clearing associated with the required Asset Protection Zones. As with many areas on this site a small number of precautionary measures, taken early, have the potential to minimise future threat. In this instance it is recommended that the client investigate whether the installation of constructed sediment traps would be a viable method of limiting future weed threat relating to these pipes.

- Photo 11 – Stormwater pipes directed into bushland

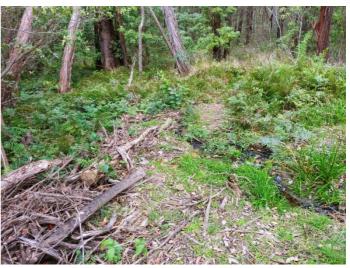
- Photo 12 – Stormwater overflow heading into bush

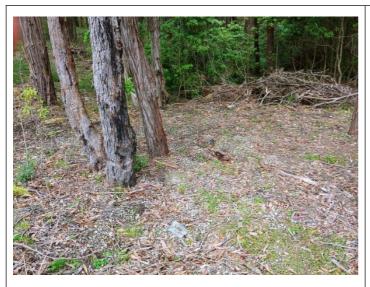
Sheet flows of rainwater across the cleared areas has resulted in sheet erosion of soil, potentially bringing with it water borne seeds into this area (see photo #13).

- Photo 13 - Endangered Ecological Community sheet flows following APZ clearing

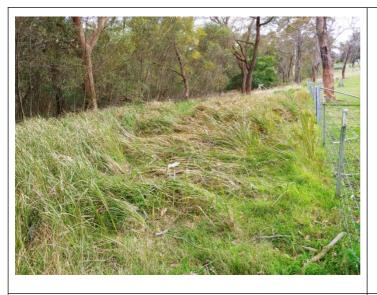
In is noted that previous plantings of *Imperata cylindrica* (Bladey Grass) in other areas of the site have been largely successful for either stopping or slowing down the weed infestation process (see Photo #15), and planting should be investigated and carried out as soon as weed species are removed in this area. Soil stabilising native species (e.g. Grevillea x gaudichaudii) should be utilised in all steeply sloping sections of this area. All planting design should be mindful of the fact that this area is a bushfire Asset Protection Zone, and recommendations within the Bushfire report should be adhered to.

- Photo 15 – Successful *Imperata* planting

The areas, outside the fence, that interface between the agriculture areas and the bush, show a moderate grass weed threat. It is noted however that previous plantings of Imperata cylindrica (Bladey Grass) have been largely successful in slowing and stopping weed infestation. Following weed removal it is recommended that this regime of Imperata planting be followed for all transition areas.
