# Statement of Heritage Impact

**168 Hawkesbury Road Springwood  
St Columba's College**

## Proposal: Classroom Block

Prepared on 3 Dec 2021(Rev)

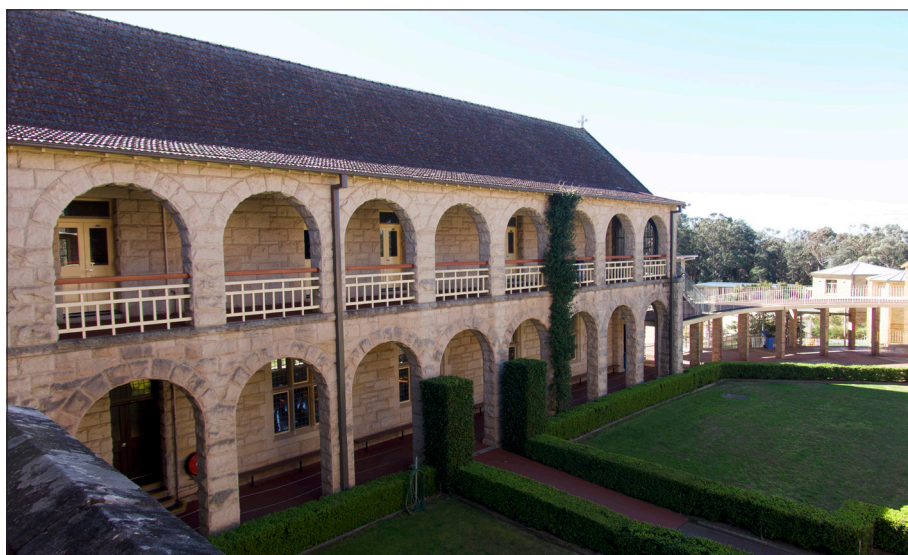
The arcade to the north wing of the Main Building, completed in 1934.

The arcade became incorporated into a colonnade around the central courtyard and is an integral part of the character of the building.

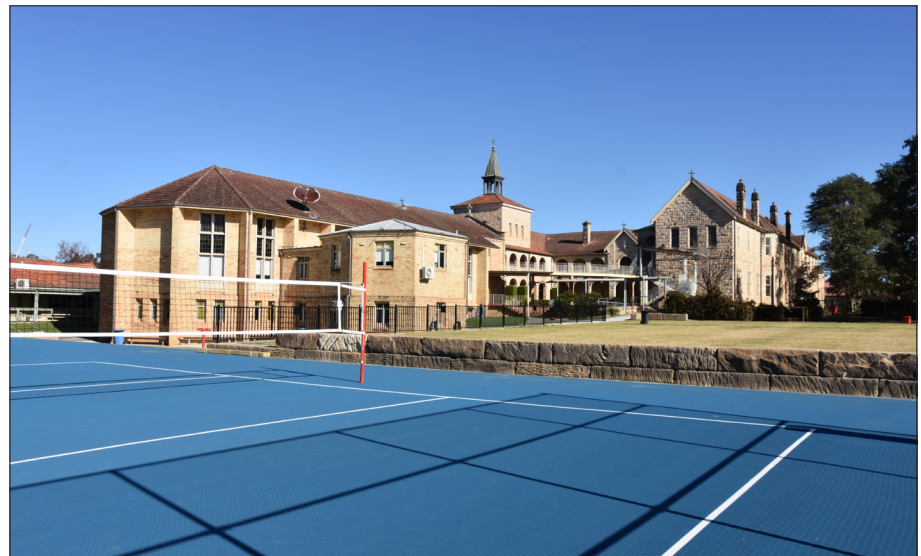
View to the Library showing the brick fin butress and brick piers and the apsidal side chapel. The Library is a good example of late 20C ecclesiastical architecture.

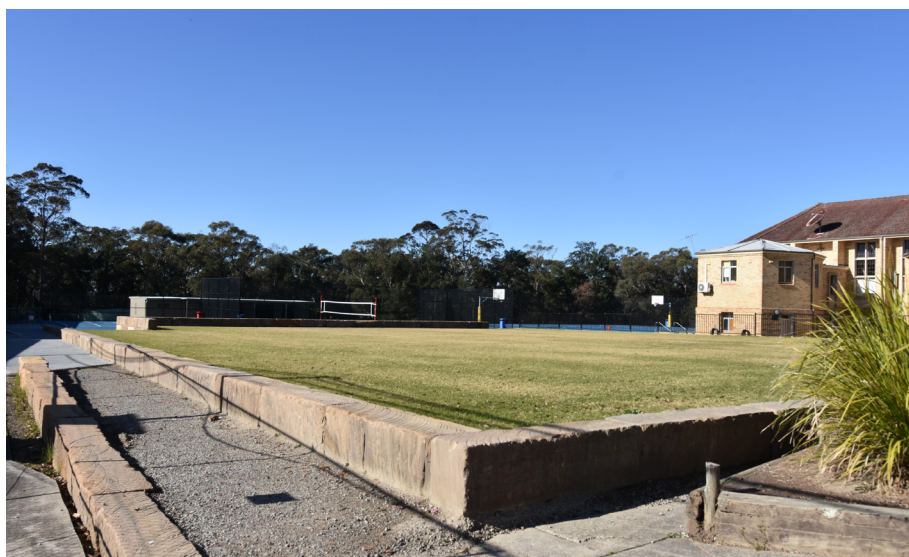
Photo 2: Views to the north and east of the Library the new site accommodating basketball, volleyball, handball courts and grassed area provides expanded curtilage and views to the bushland.

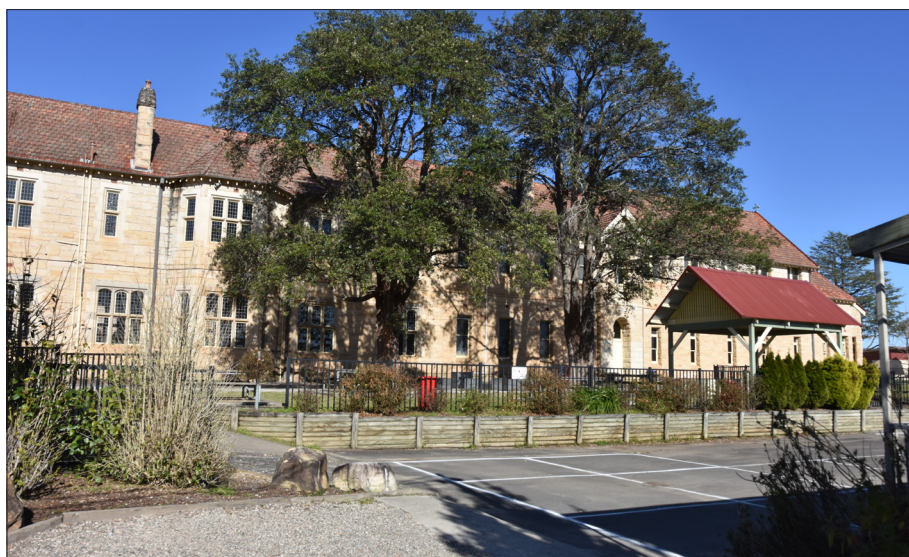
Photo 3: The landscaped garden to the north of the Main Building, contains a mix of landscaped elements which detracts from the heritage buildings. The two mature trees to be retained.

It was noted that the landscaping to the north of the main building provides a good setting to appreciate the Northern façade of the Main building and provides a meaningful separation between the existing demountable buildings and the heritage item. While the garden is assessed as of low significance, the Turpentine trees appear to be significant (subject to arboriculture advice) in contributing positively to the setting of the main building. If the trees are proposed for removal, suitable replacement trees should be included in the landscape plans. A sensitive landscape setting will allow for the appreciation of the main building and the drama room to the north and will allow for a respectful curtilage between the heritage buildings and the new development.

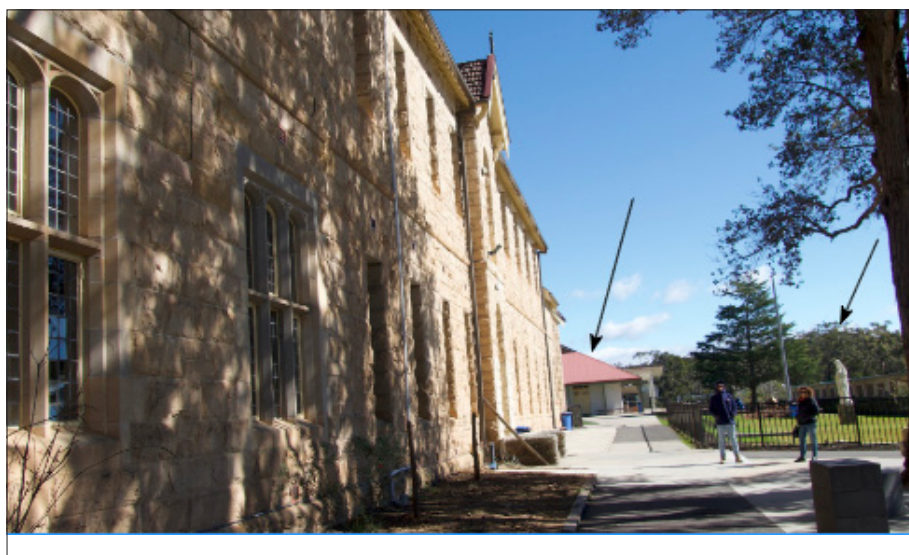
Photo 4: View corridor from east to west and visa versa and some district views to and from the grounds.

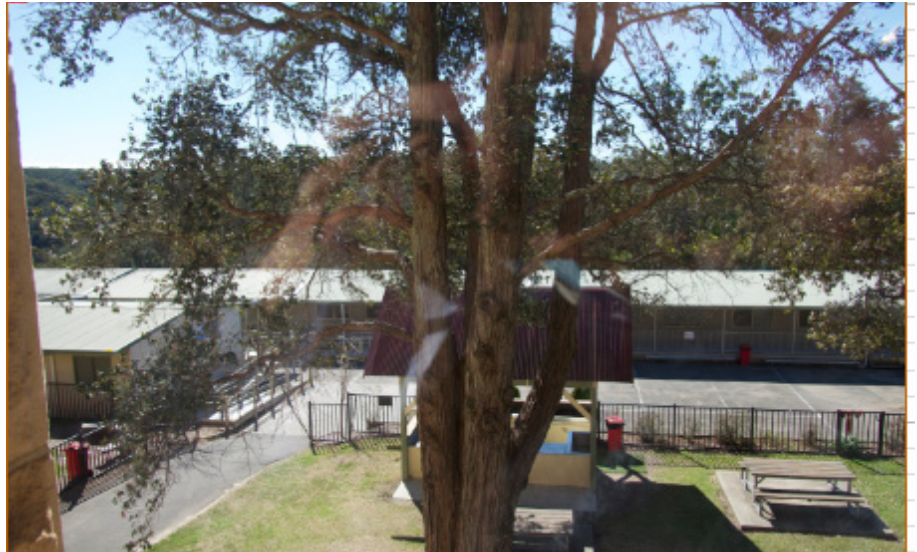
Photo 5: View from the Main Building to the landscaped garden and view to the demountable showing ramp and grassed area.

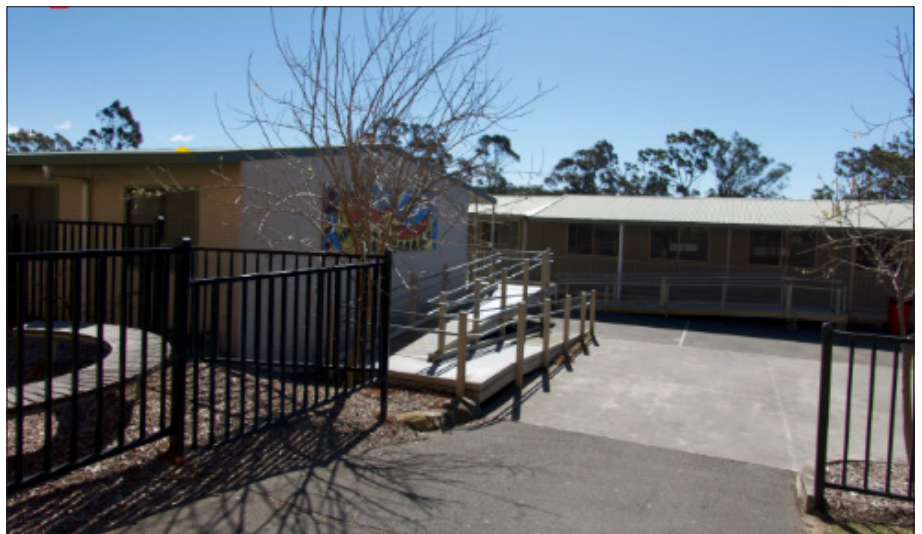
Photo 6: The views to the demountable from the Main Building are not aesthetically pleasing. The mix of landscaped elements are detracting. District views are available above that of the roof height line.

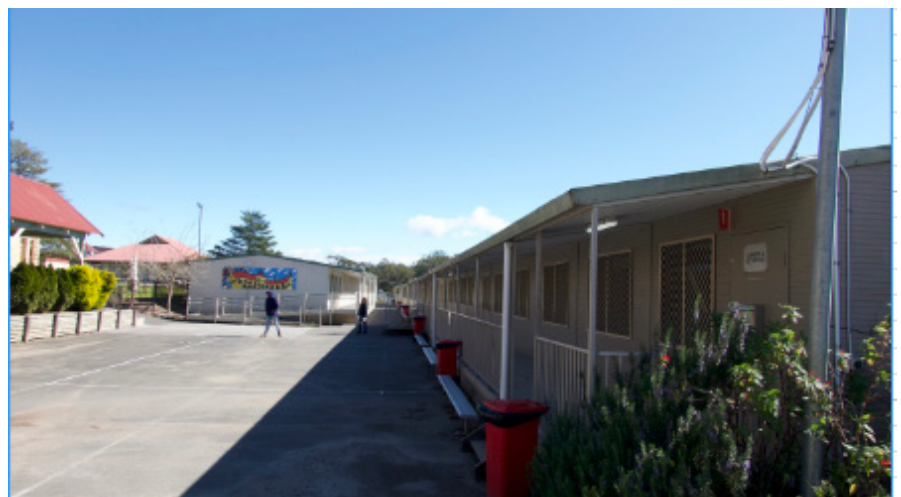
Photo 7: View corridors are evidenced, from east to west and vice versa and some district views to and from the grounds.

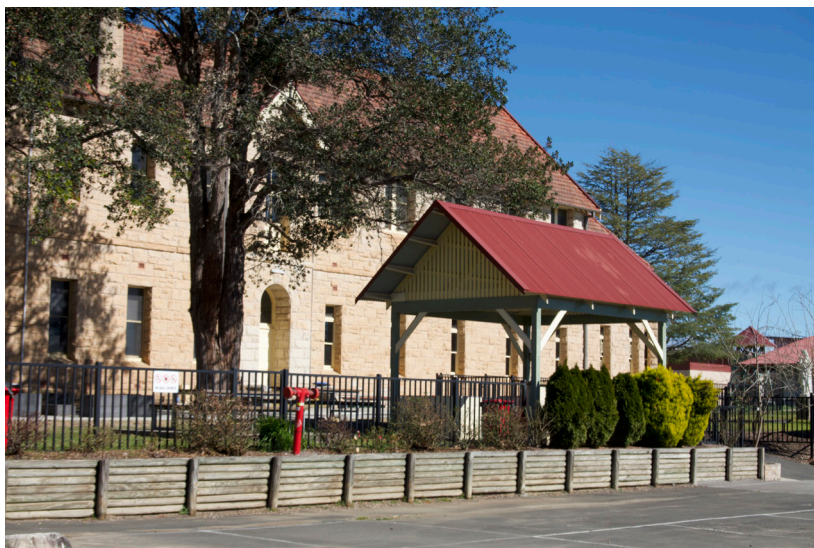
Photo 8: South view to the Main Building and mix of detracting building elements, materials and levels.

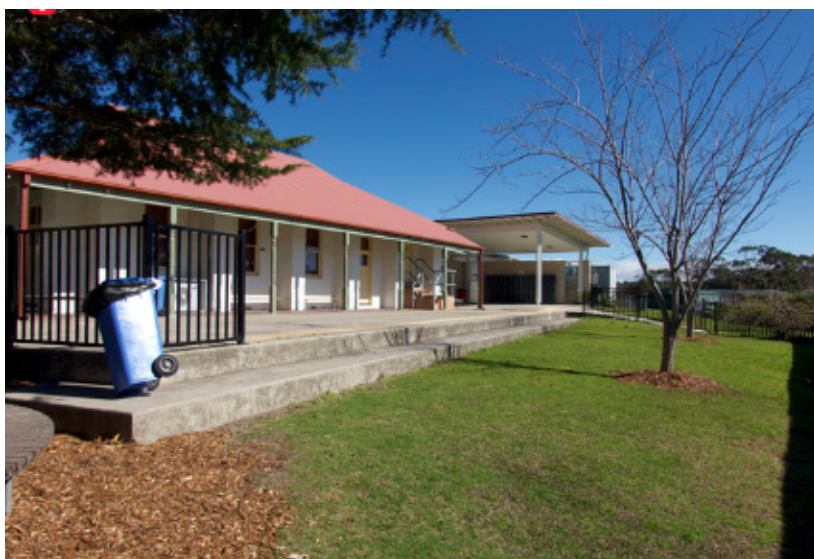
Photo 9: The setting to the Drama Room includes a podium though the building cannot be fully experienced due to lack of curtilage.

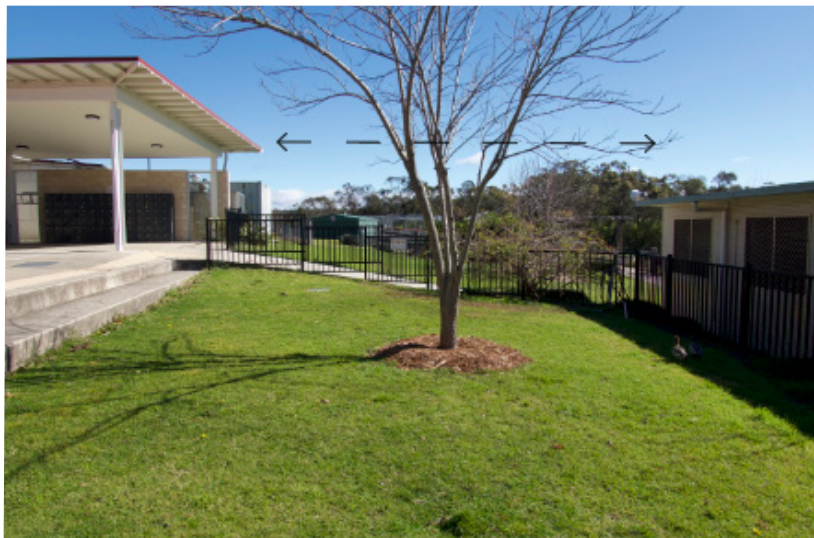
Photo 10: View corridor from east to west.  
The Drama Room connected to the demountable by a ramp and is detracting.

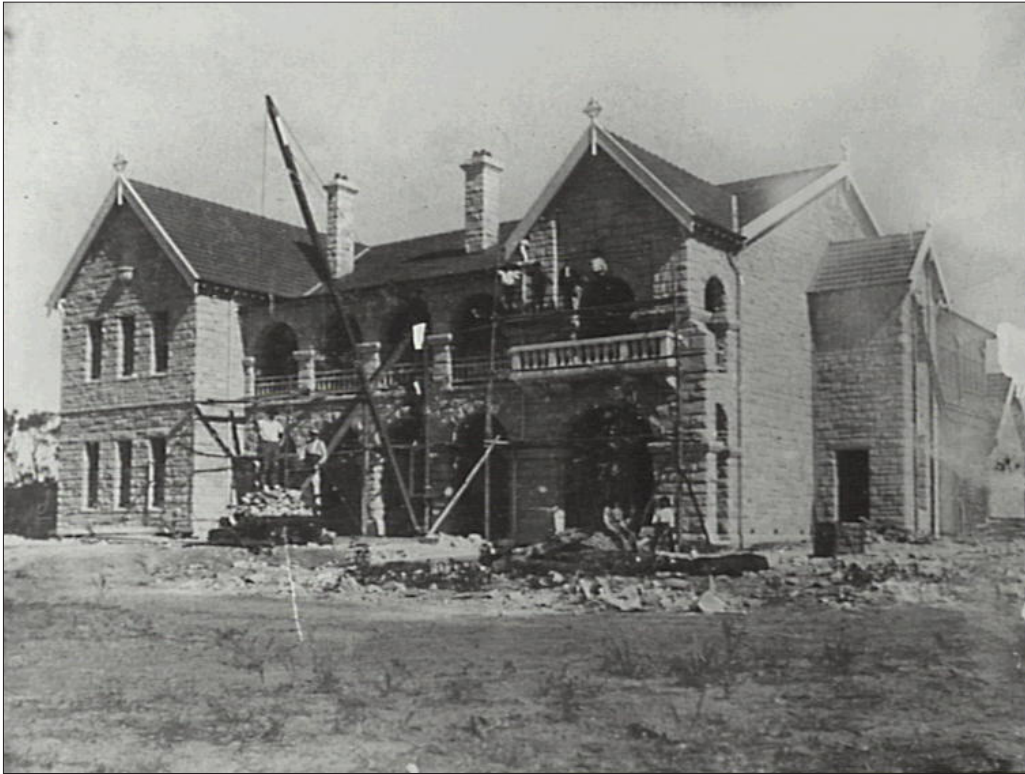
First section St Columba's Colleghe in process of building. Foundation stone laid and blessed by Cardinal Moran 6 January 1909. Blessed and opened by Cardinal Moran 4 October 1909. First 26 Students 1910. Photograph dated 1909

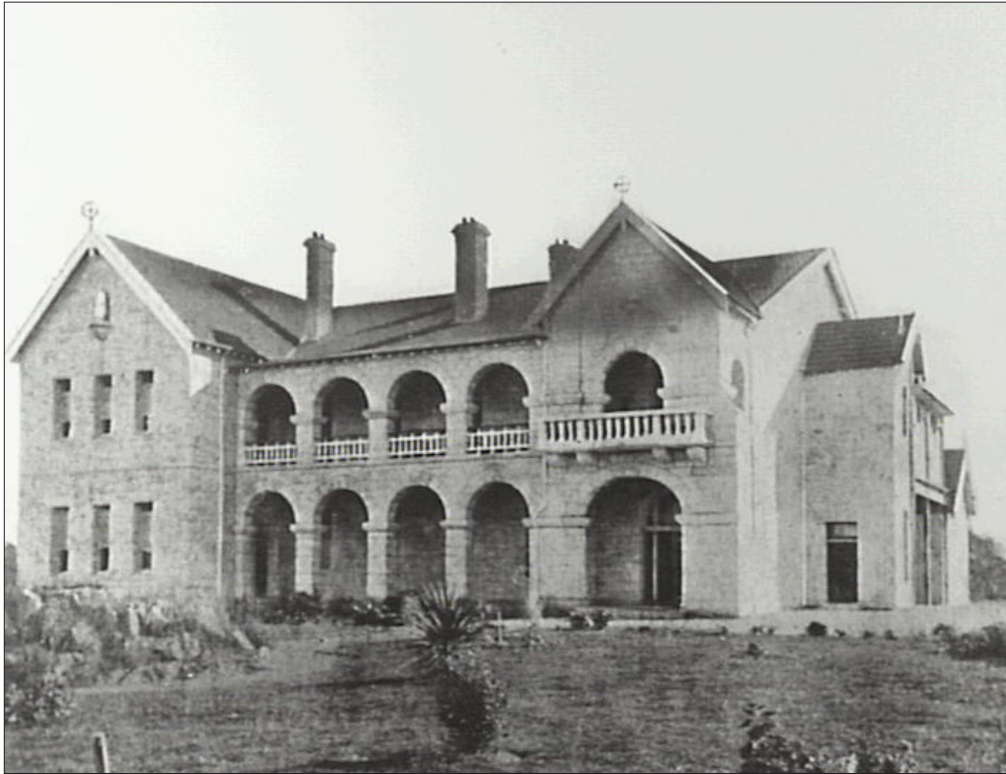
Completed first section of college, built in sandstone. Photograph dated 1909.

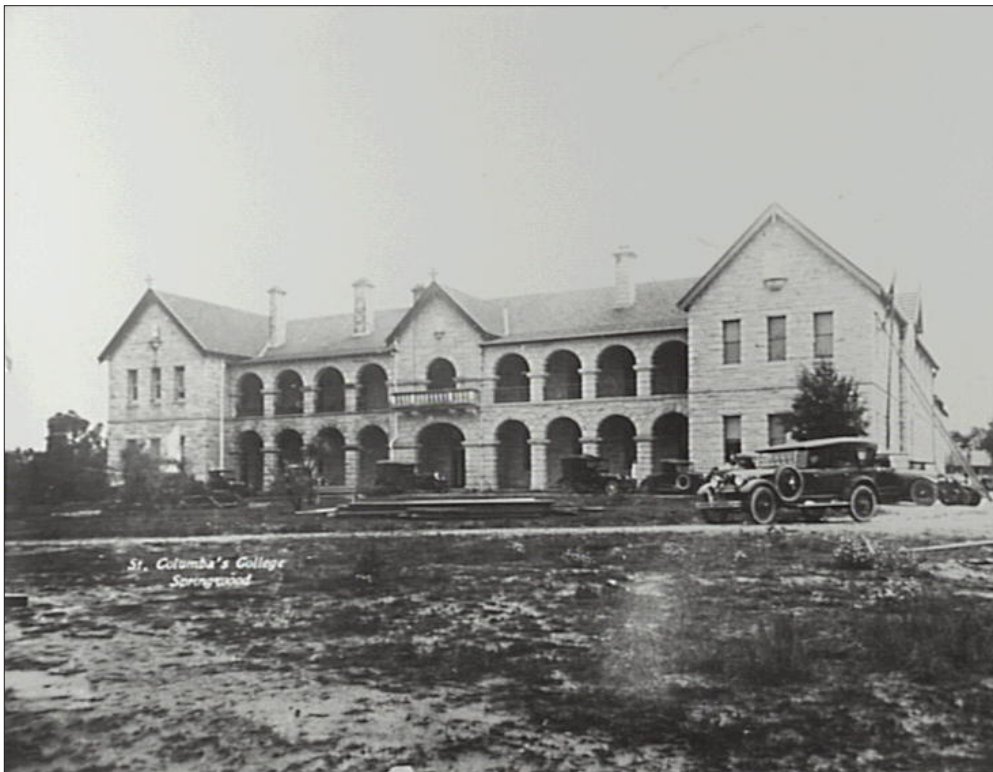
Extensions to St Columba's Chapel, Dormitory and Classroom 1923. Front view showing, as well, a number of cars of the day.

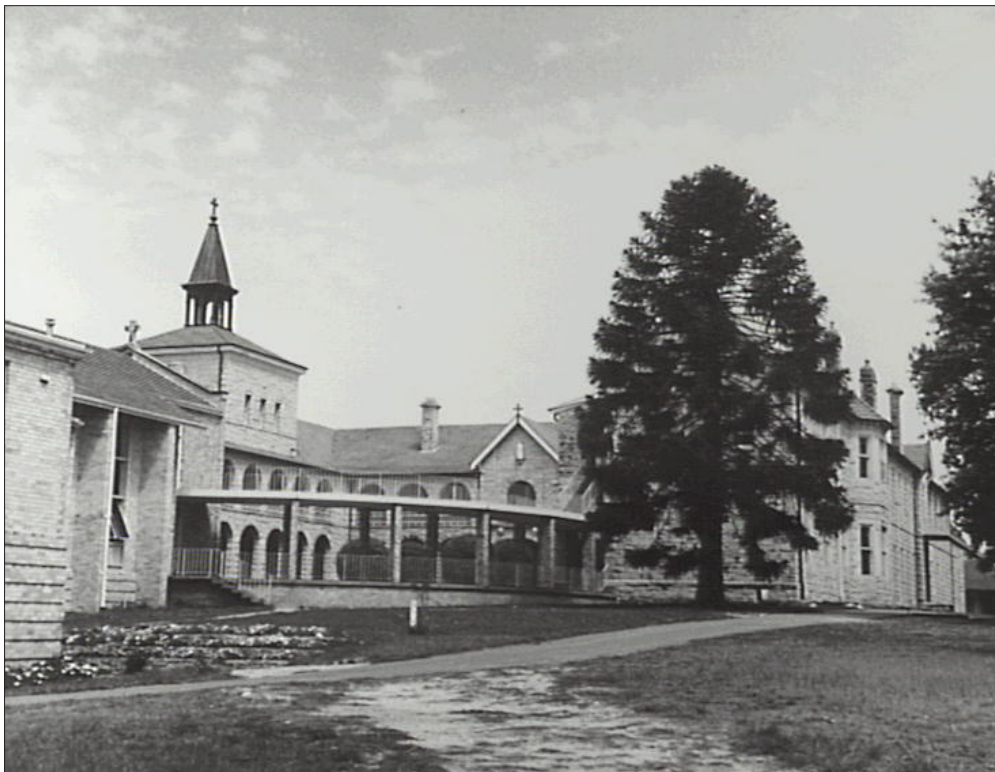
New Wing 1958; New Chapel 1960; more information back of picture. Photograph dated 1958

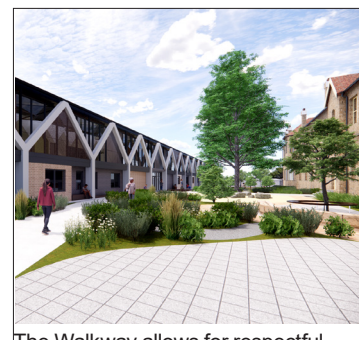
The Walkway allows for respectful separation between the buildings

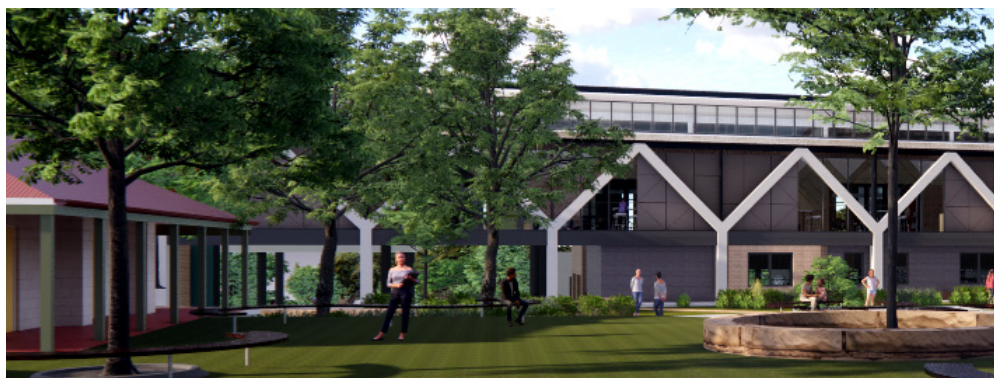
The contemporary colonnade opens up to the west end and provides expanded curtilage to the Drama Room

The ground floor comprises the covered outdoor learning area and to the west of the building the outdoor area increase in size accommodating the COLA area and features columns that allow slot views to and from the Drama Room, the Main Building and the bushland beyond. The covered outdoor learning area to the front of the Drama School provides for an expanded curtilage to the heritage building, improved connectivity and visual links that activate the setting.

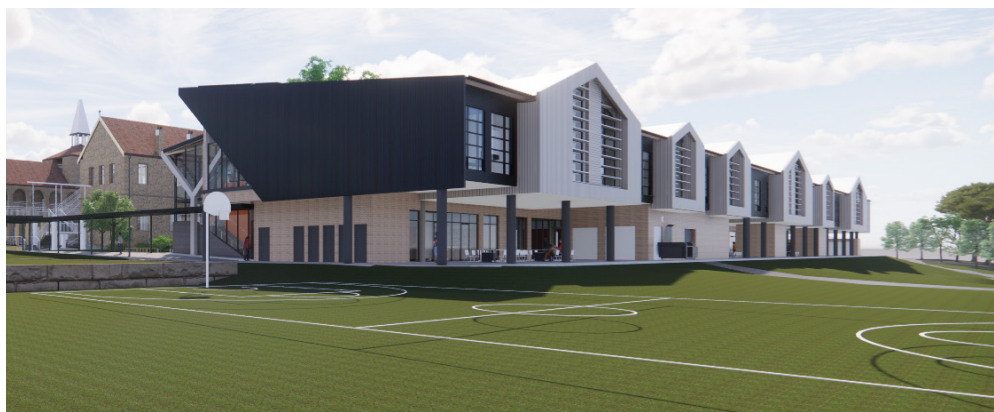
The north facing facade includes expansive window that furnishes the run of classrooms with natural light and enables extensive views to the bushland.

The gabled ends are to the first floor only, in all 3 x large and 3 x small and are glazed and comprise rectangle windows which are recessed and accentuated by deep reveals. The gabled ends, referencing the Main Building gabled roof and breakfronts, project slightly over the ground floor and between the gables the wall is punctuated with a series of rectangular shaped windows that overall create a facade that activates the frontage. The north facing orientation furnishes the run of classrooms with natural light, is energy efficient and enables extensive views to the bushland.

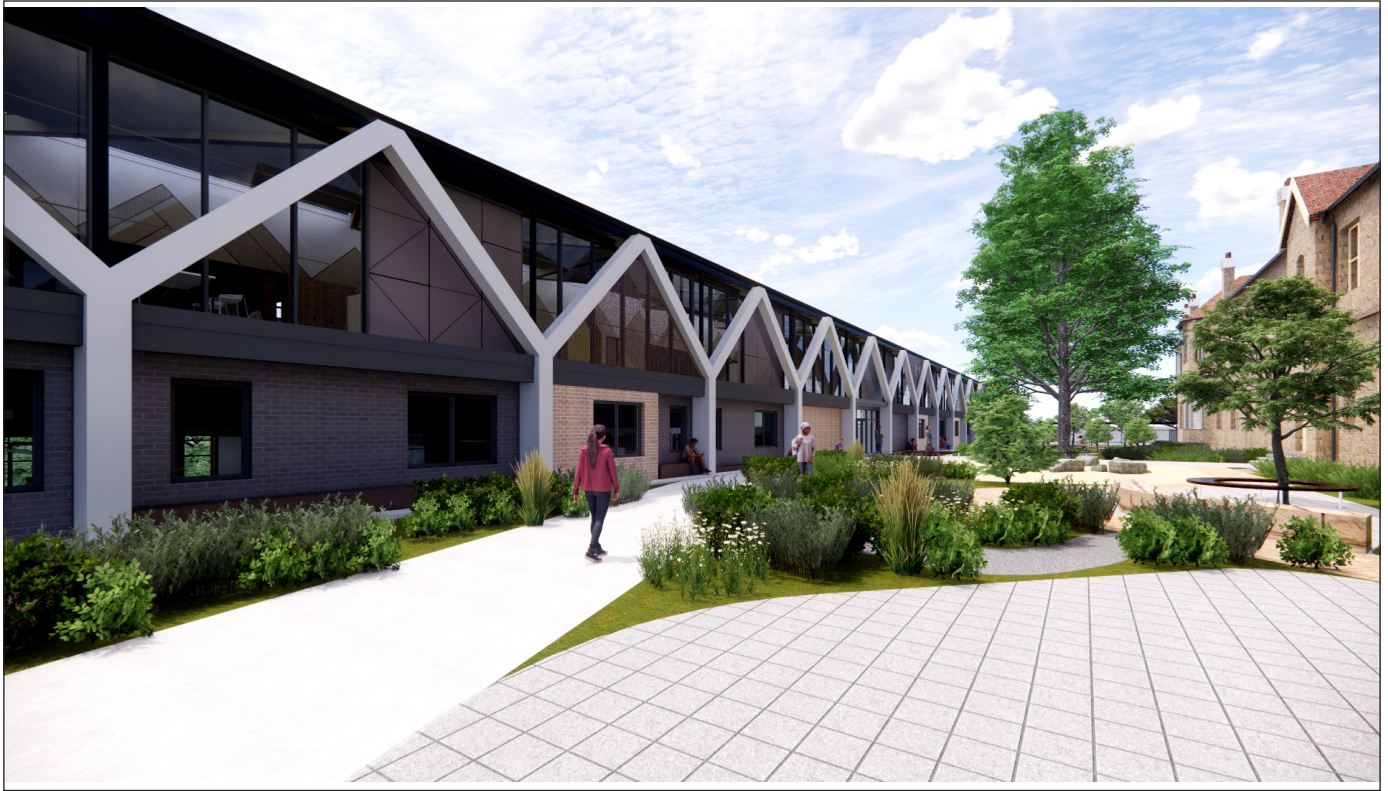
Perspective- View of walkway looking east.  
Alleanza Architecture

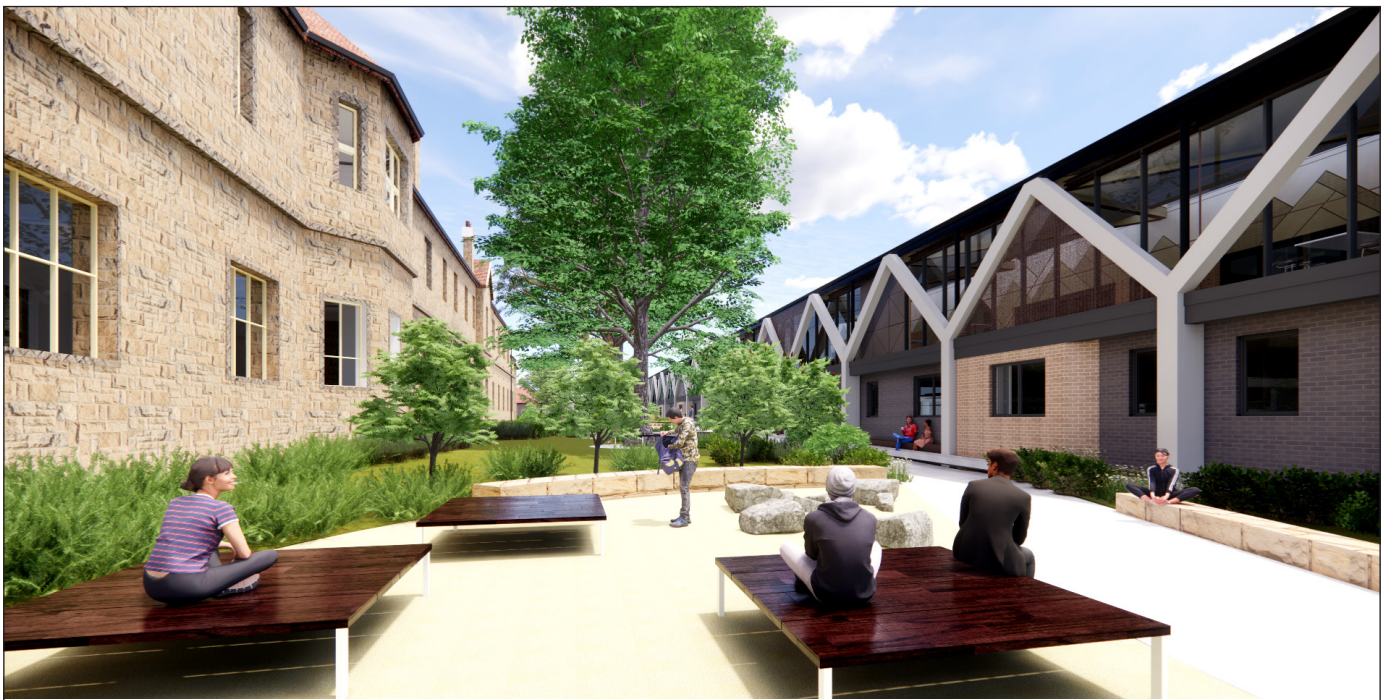
Perspective- View of walkway looking west.  
Alleanza Architecture

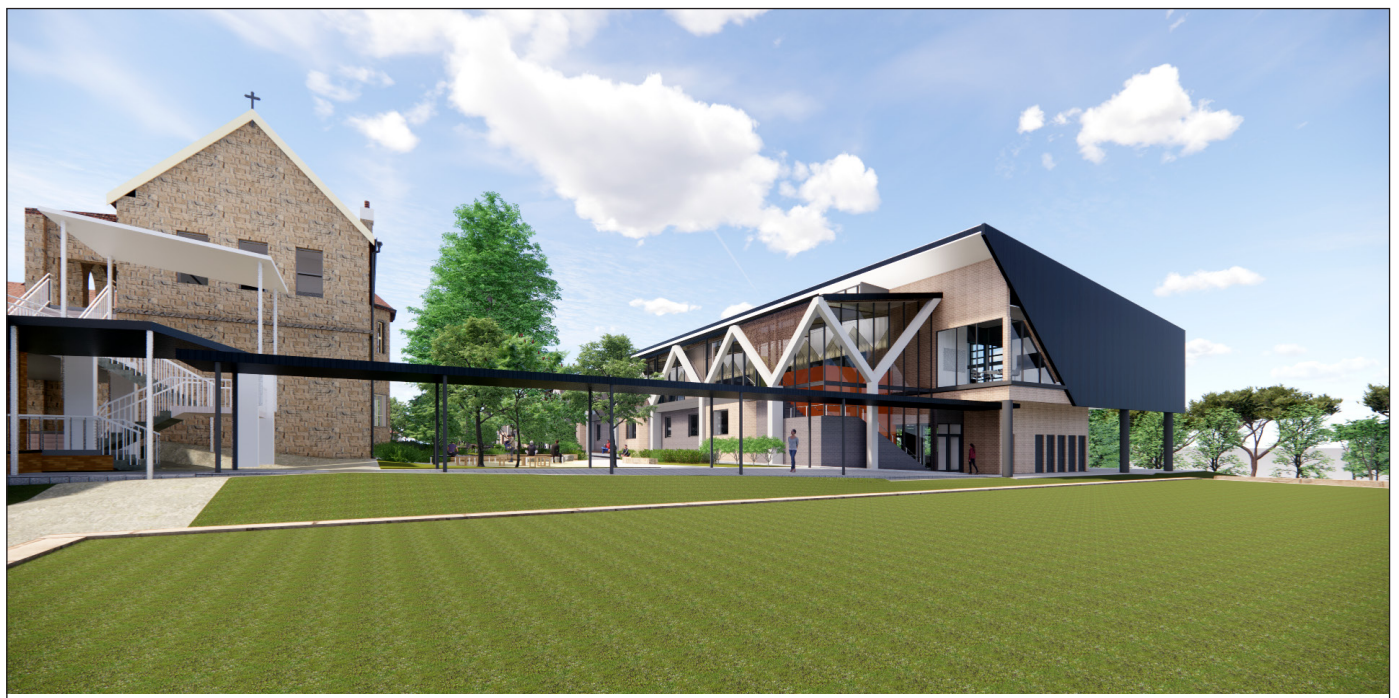
Perspective- View of walkway to Library  
Alleanza Architecture

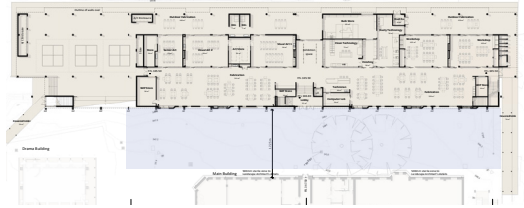
<p>The walkway extends west and terminates opposite the Drama Room where the area opens up by means of the covered outdoor learning space and allows the curtilage to the Drama Room to be expanded. As such the 1930s building can be interpreted and be fully experienced in the round whilst working in unison with the Proposed Building.</p>

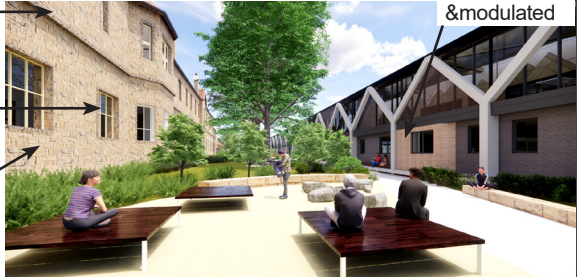
<p>Viewing west, the Main Buildings series of modulated windows, bays and gables are reflected in the contemporary interpretation of the Proposed Building.</p> <p>Material colour is light coloured and masonry (brick)</p>

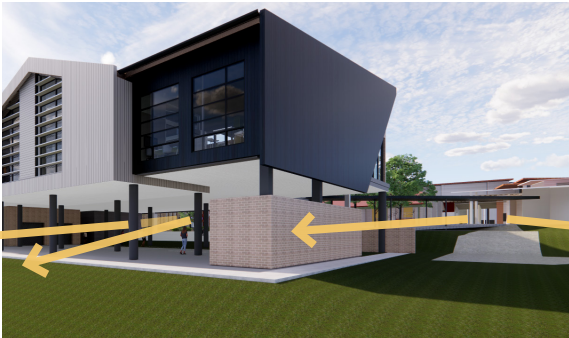
<p>The colonnade to the north of the Proposed Building provides a visual corridor providing district views - east and west. Slot views are available on ground floor provided by the outdoor sheltered area.</p>

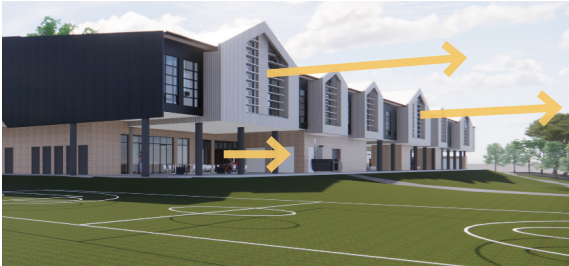
<p>District views are enabled from the Proposed Building's first floor. The boundaries to the Quadrangle sited between the Main Building and the Drama Room is further defined and framed by the Proposed Building, enhances the setting and results in dynamic views between the buildings.</p>

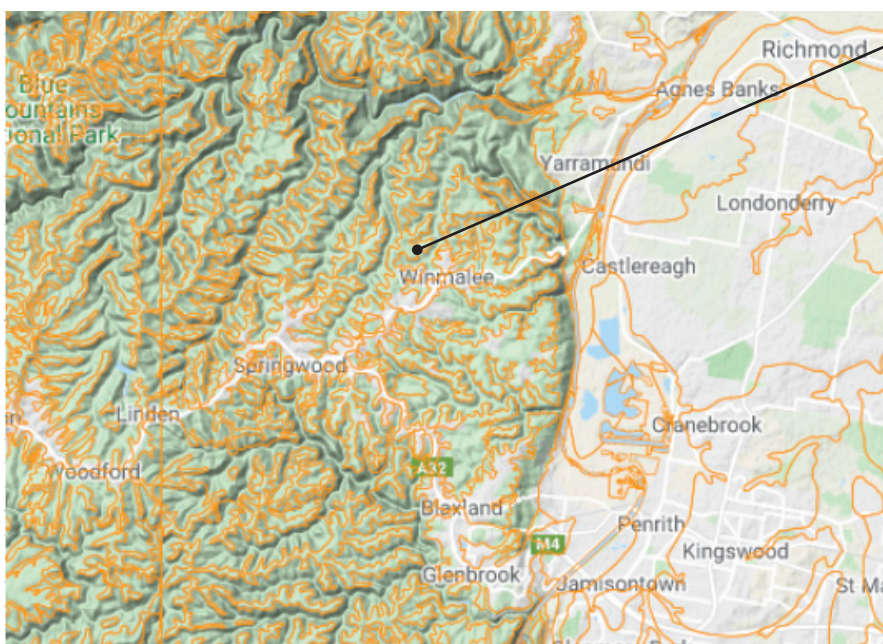
Geographical Profile of NSW  
Extract of Faulconbridge  
Source: NSW Planning Industry & Environment  
Espade Database

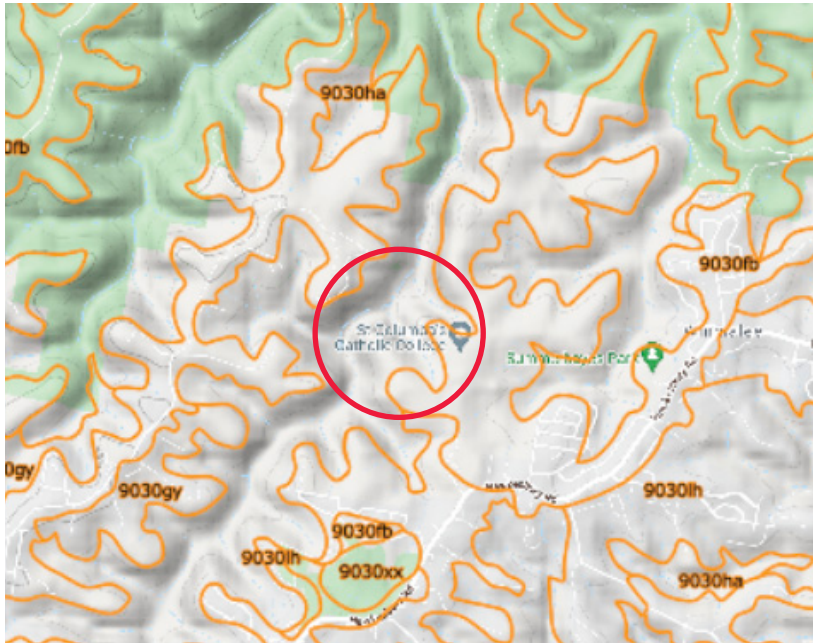
ESpade Geological map for the Springwood area, showing zones of varying geological/landscape qualities. Subject site circled

The geological map locates the subject site as containing or being in close proximity to three geological profiles, some that have relevance for the subject site's former characteristics before development.

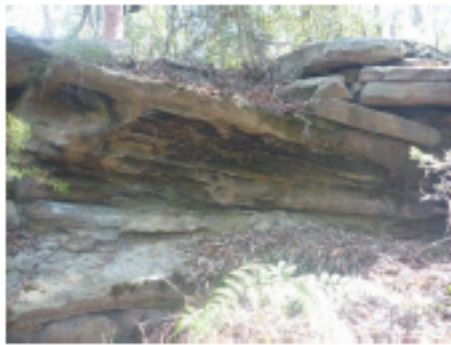
Figure 3.3 Site 4 shelter. (Source: GML 2013)

Sites 4 and 5 (both shelters with deposit) were relocated during the field inspection. The inspection demonstrated that Site 4 remained relatively undisturbed (Figure 3.4). However, the sandstone of the shelter was cracked in some places, possibly due to heat from past fires, and the roof was degrading. Some areas within the shelter were demonstrating exfoliation of the sandstone, with the sandstone being quite fragile along the drip line (Figure 3.5). Although the shelter was originally recorded as containing artefacts, no artefacts were located within the shelter of Site 4 during the 2013 inspection.

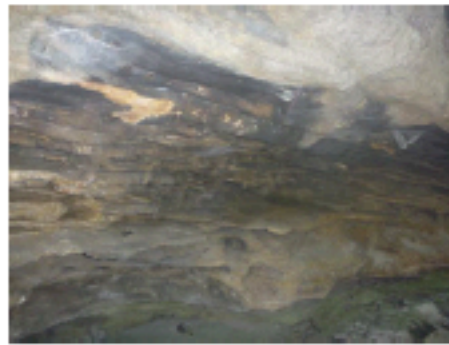
Figure 3.4 Site 4 shelter carbon staining and exfoliation of sandstone along shelter roof. (Source: GML 2013)

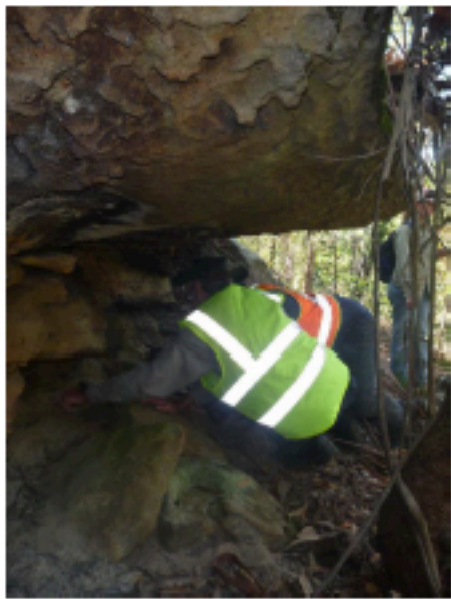
Figure 3.5 Site 5, lower shelter with Aboriginal representatives. (Source: GML 2013)
