Report on
Geotechnical Investigation

Rocla Site - Proposed Development
158-164 Old Bathurst Road, Emu Plains

Prepared for
Penrith City Council

Project 200309.02
January 2024

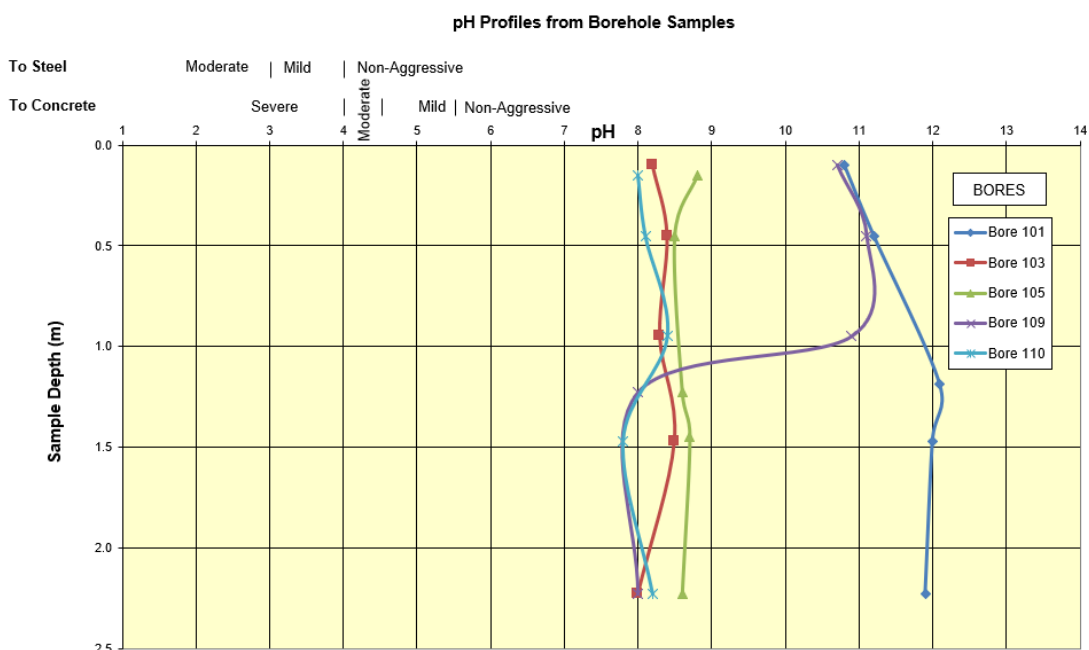
Figure 3: Vertical pH Profiles

The results show that the samples tested indicate the ground conditions are non-aggressive to concrete and steel with reference to AS2159. The pH profiles with depth are shown in Figure 3.
