Geotechnical Investigation

160 Lord Sheffield Circuit, Penrith NSW

Report Title: Geotechnical Investigation, 160 Lord Sheffield Circuit, Penrith NSW

Report No: E25358.G03_Rev1

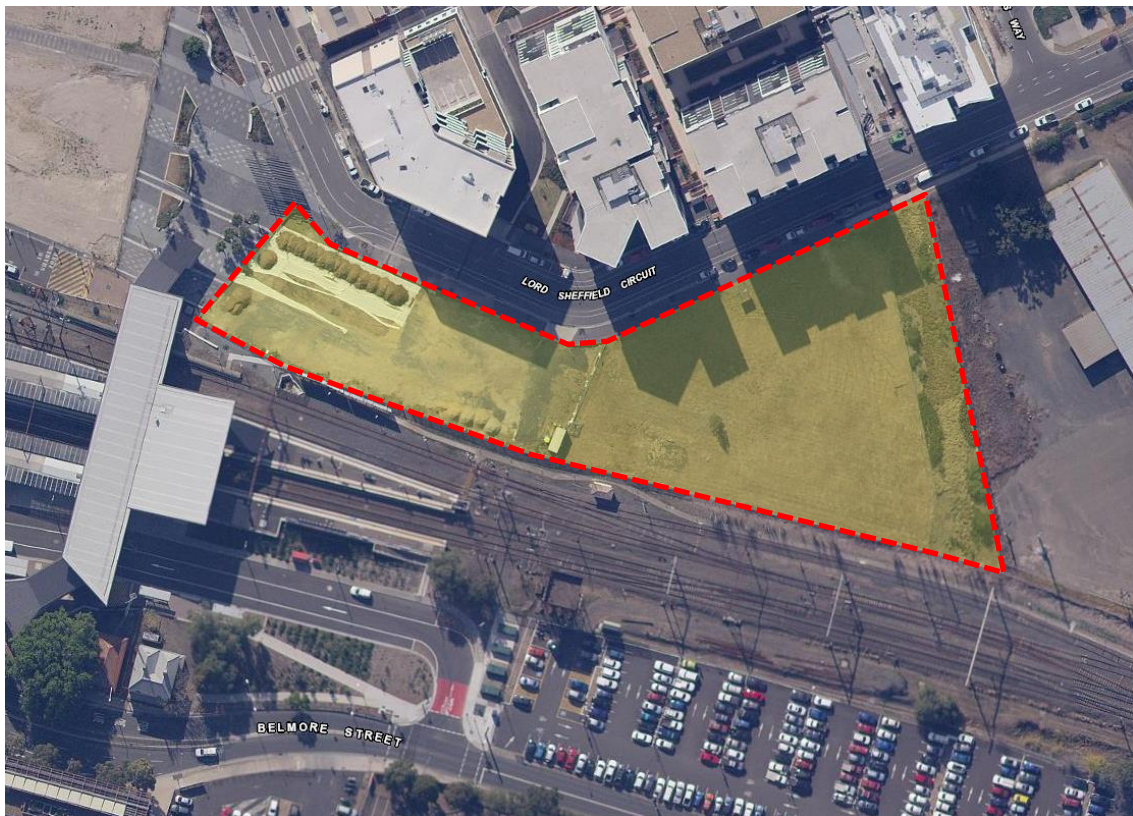
Plate 1: Aerial photograph of the site (source: SIX Maps, accessed 3/11/22)

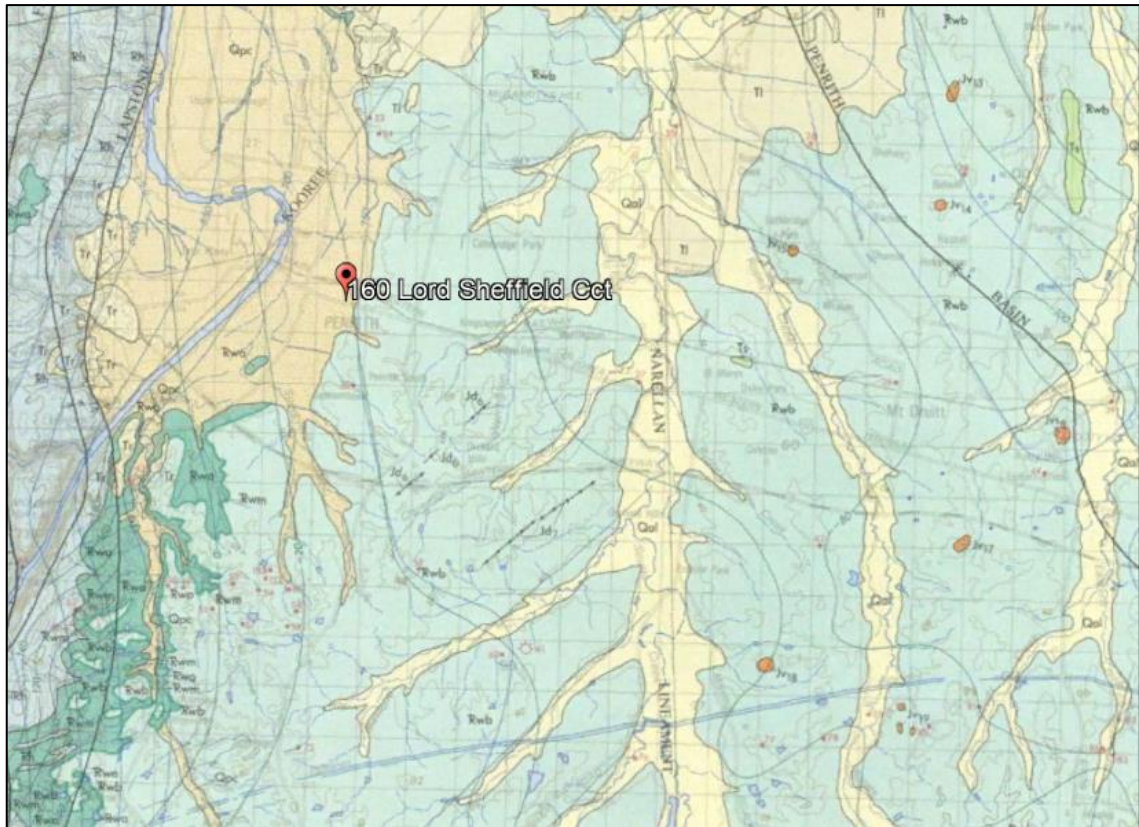
Plate 2: Excerpt of geological map showing location of site.

Attribute	Description
Topography	The site is located on the south side of Lord Sheffield Circuit within almost flat topography.
Regional Geology	Information on regional sub-surface conditions, referenced from the Department of Mineral Resources Geological Map Penrith 1:100,000 Geological Series Sheet 9030 (DMR 1991) indicates the site to be underlain by gravel, sand, silt and clay. This is underlain by Bringelly Shale, consisting of shale, carbonaceous claystone, laminate, lithic sandstone and rare coal.

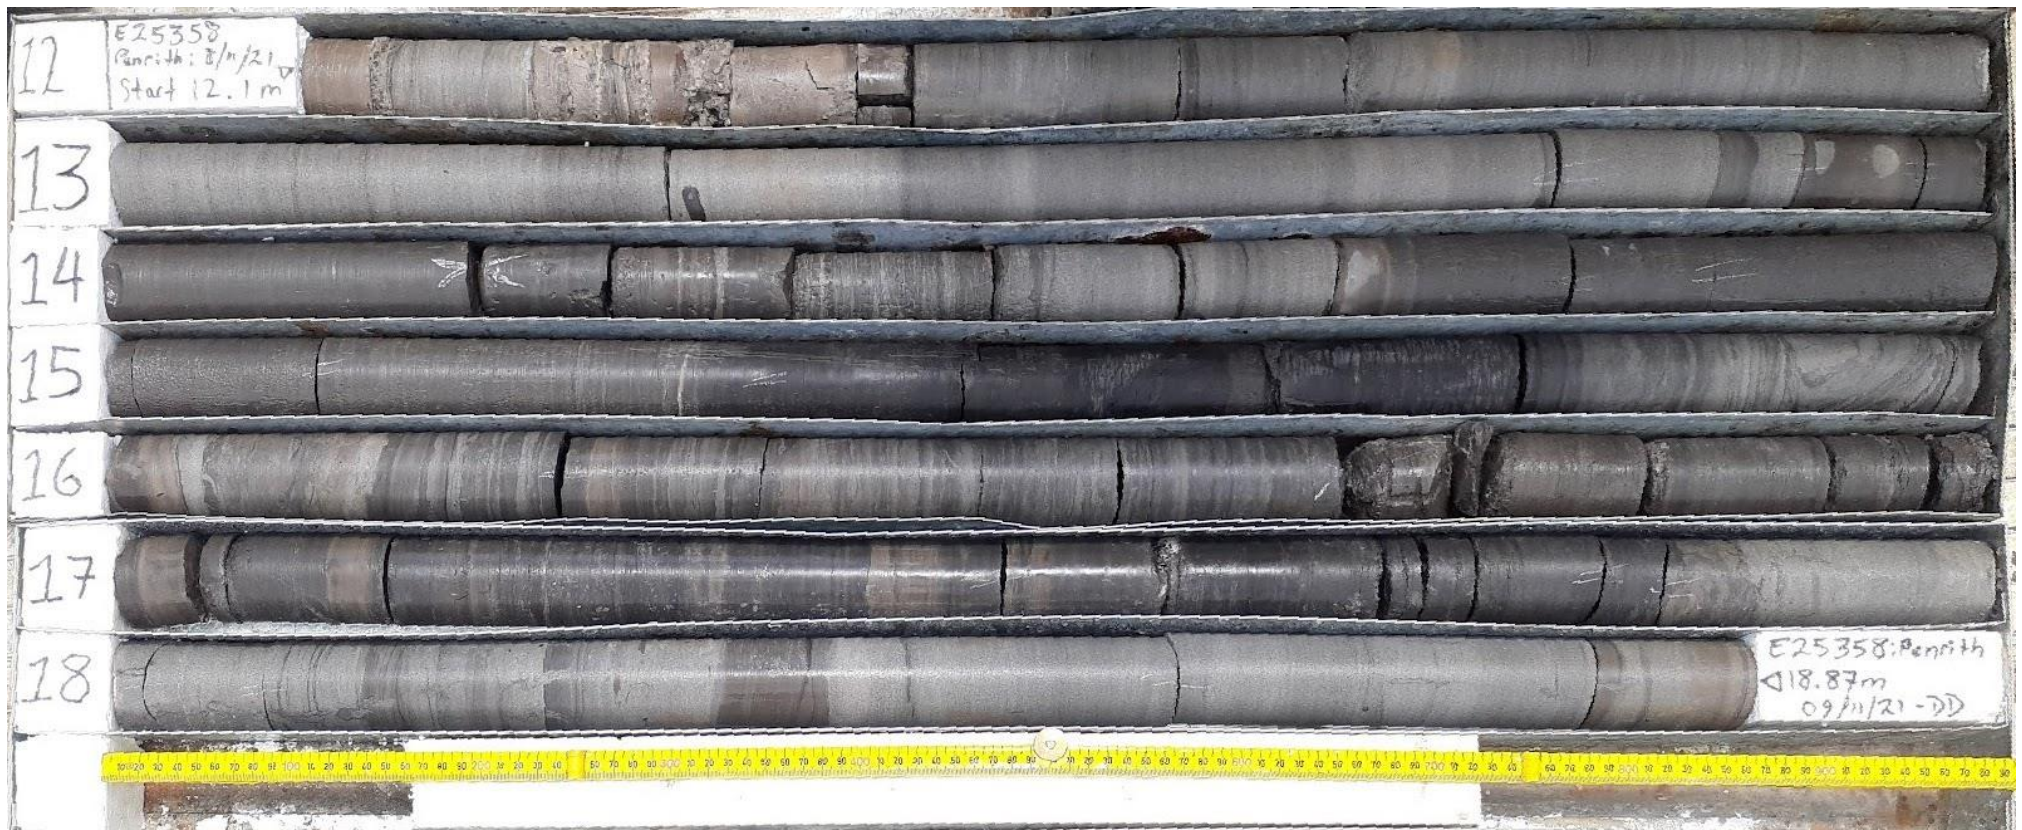
CORE PHOTOGRAPH OF BOREHOLE: BH1

Project	Proposed Development	Depth Range	12.1m to 18.87m BEGL		
Location	160 Lord Sheffield Circuit, Penrith NSW	Contractor	Geosense Drilling Engineers Pty Ltd		
Position	Refer to Figure 2	Drill Rig	Comacchio Geo 205		
Job No.	E25358.G03	Logged	DD	Date	08 / 11 / 2021
Client	Urban Apartments Pty Ltd	Box	1-2 of 2	Checked	SR Date 03 / 02 / 2022

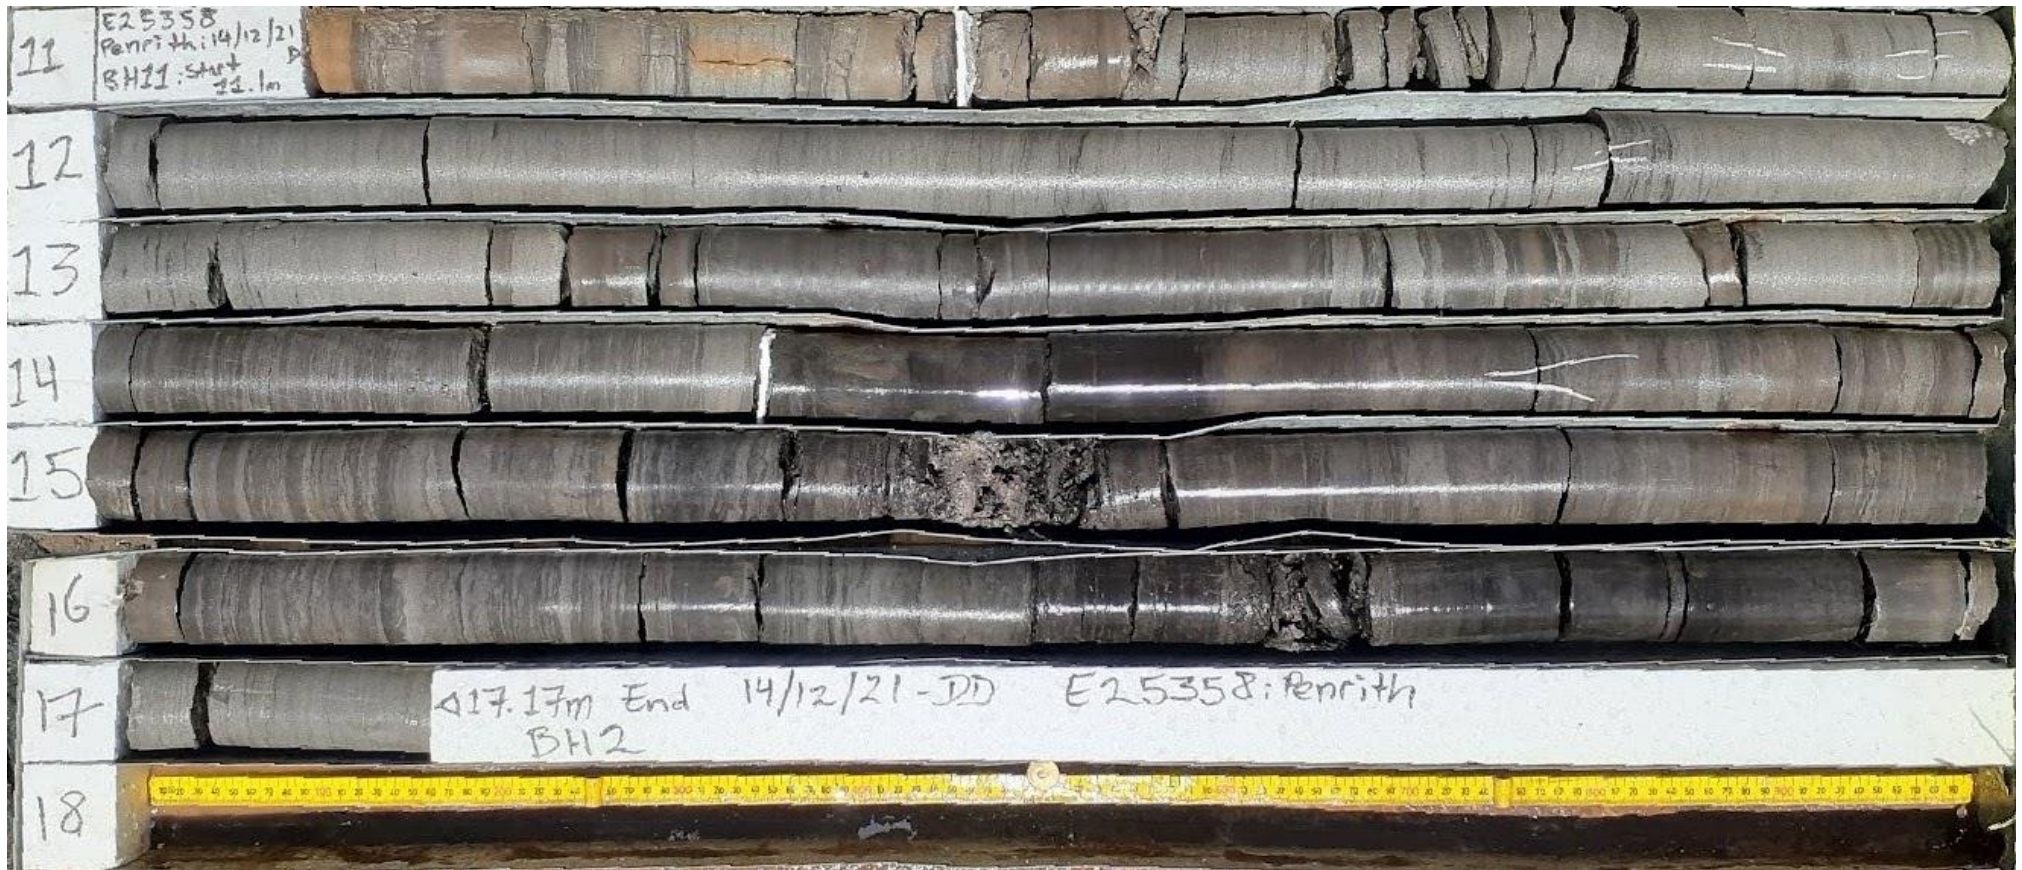
CORE PHOTOGRAPH OF BOREHOLE: BH2

Project	Proposed Development	Depth Range	11.1m to 17.17m BEGL	
Location	160 Lord Sheffield Circuit, Penrith NSW	Contractor	Geosense Drilling Engineers Pty Ltd	
Position	Refer to Figure 2	Drill Rig	Comacchio Geo 205	
Job No.	E25358.G03	Logged	DD	Date 13 / 12 / 2021
Client	Urban Apartments Pty Ltd	Box	1-2 of 2	Checked SR Date 03 / 02 / 2022
Surface RL		≈ 27.40 m AHD		
Inclination		-90°

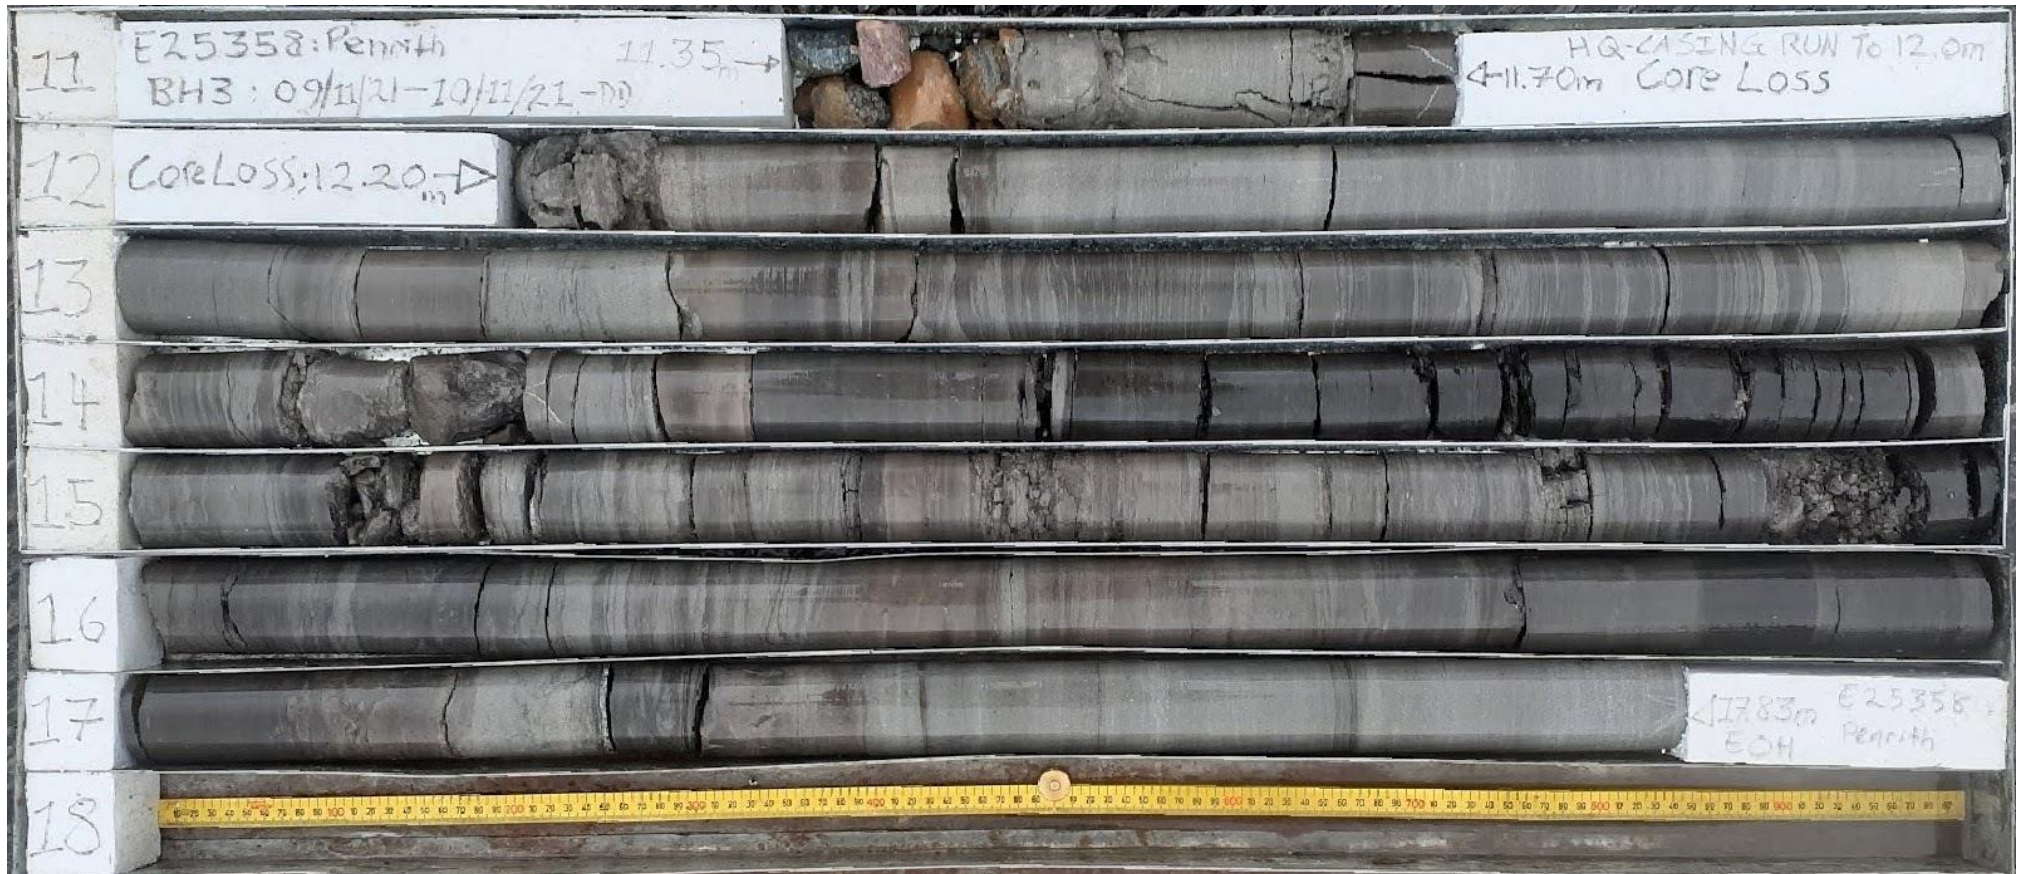
CORE PHOTOGRAPH OF BOREHOLE: BH3

Project	Proposed Development	Depth Range	11.35m to 17.83m BEGL		
Location	160 Lord Sheffield Circuit, Penrith NSW	Contractor	Geosense Drilling Engineers Pty Ltd		
Position	Refer to Figure 2	Drill Rig	Comacchio Geo 205		
Job No.	E25358.G03	Logged	DD	Date	09 / 11 / 2021
Client	Urban Apartments Pty Ltd	Box	1-2 of 2	Checked	SR Date 03 / 02 / 2022

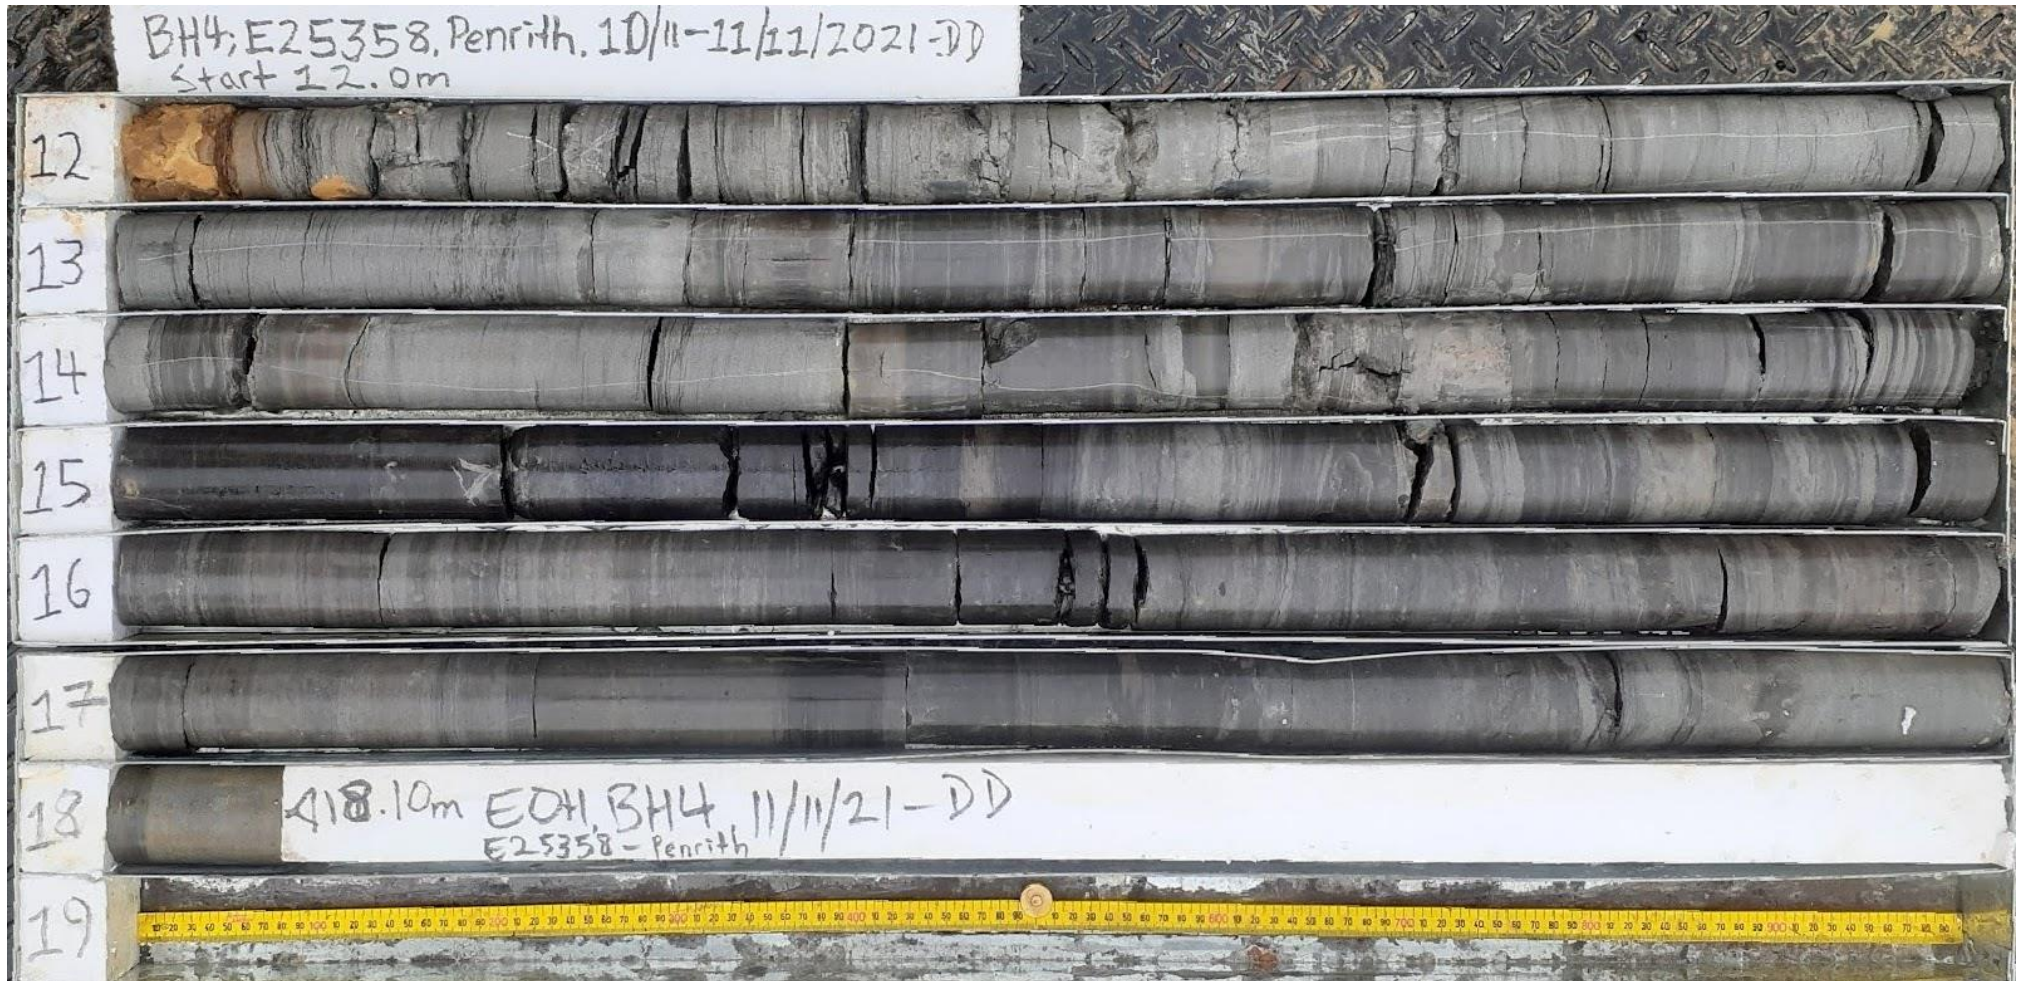
CORE PHOTOGRAPH OF BOREHOLE: BH4M

Project	Proposed Development	Depth Range	11.2m to 18.1m BEGL	
Location	160 Lord Sheffield Circuit, Penrith NSW	Contractor	Geosense Drilling Engineers Pty Ltd	
Position	Refer to Figure 2	Drill Rig	Comacchio Geo 205	
Job No.	E25358.G03	Logged	DD	Date 10 / 11 / 2021
Client	Urban Apartments Pty Ltd	Box	1-2 of 2	Checked SR Date 03 / 02 / 2022
		Surface RL	≈ 27.60 m AHD	
		Inclination	-90°

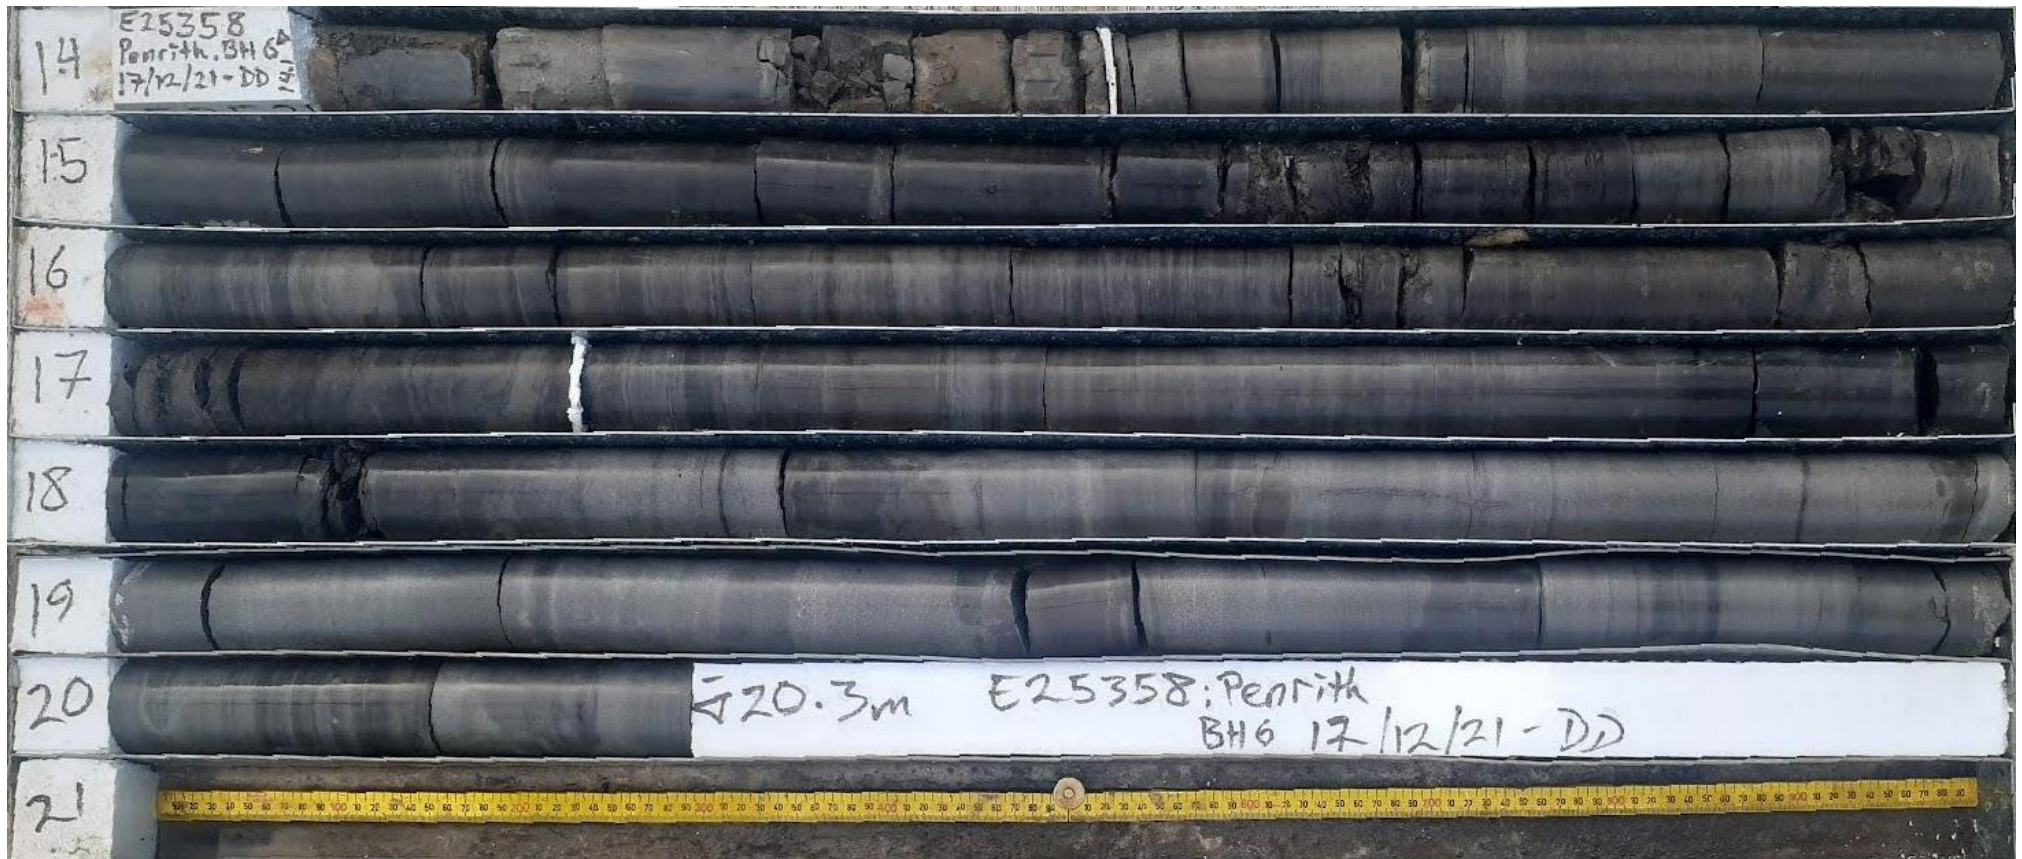
CORE PHOTOGRAPH OF BOREHOLE: BH6

Project	Proposed Development	Depth Range	14.1m to 20.3m BEGL	
Location	160 Lord Sheffield Circuit, Penrith NSW	Contractor	Geosense Drilling Engineers Pty Ltd	
Position	Refer to Figure 2	Drill Rig	Comacchio Geo 205	
Job No.	E25358.G03	Logged	DD	Date 17 / 12 / 2021
Client	Urban Apartments Pty Ltd	Box	1-2 of 2	Checked SR Date 03 / 02 / 2022
