# ARBORICULTURAL IMPACT ASSESSMENT

## Bonnyrigg Living Communities Project: Subdivision Stages 12 & 13

**LGA:** Fairfield City Council  
**Date:** 17 October 2022  
**Revision:** A  
**Job No:** E938

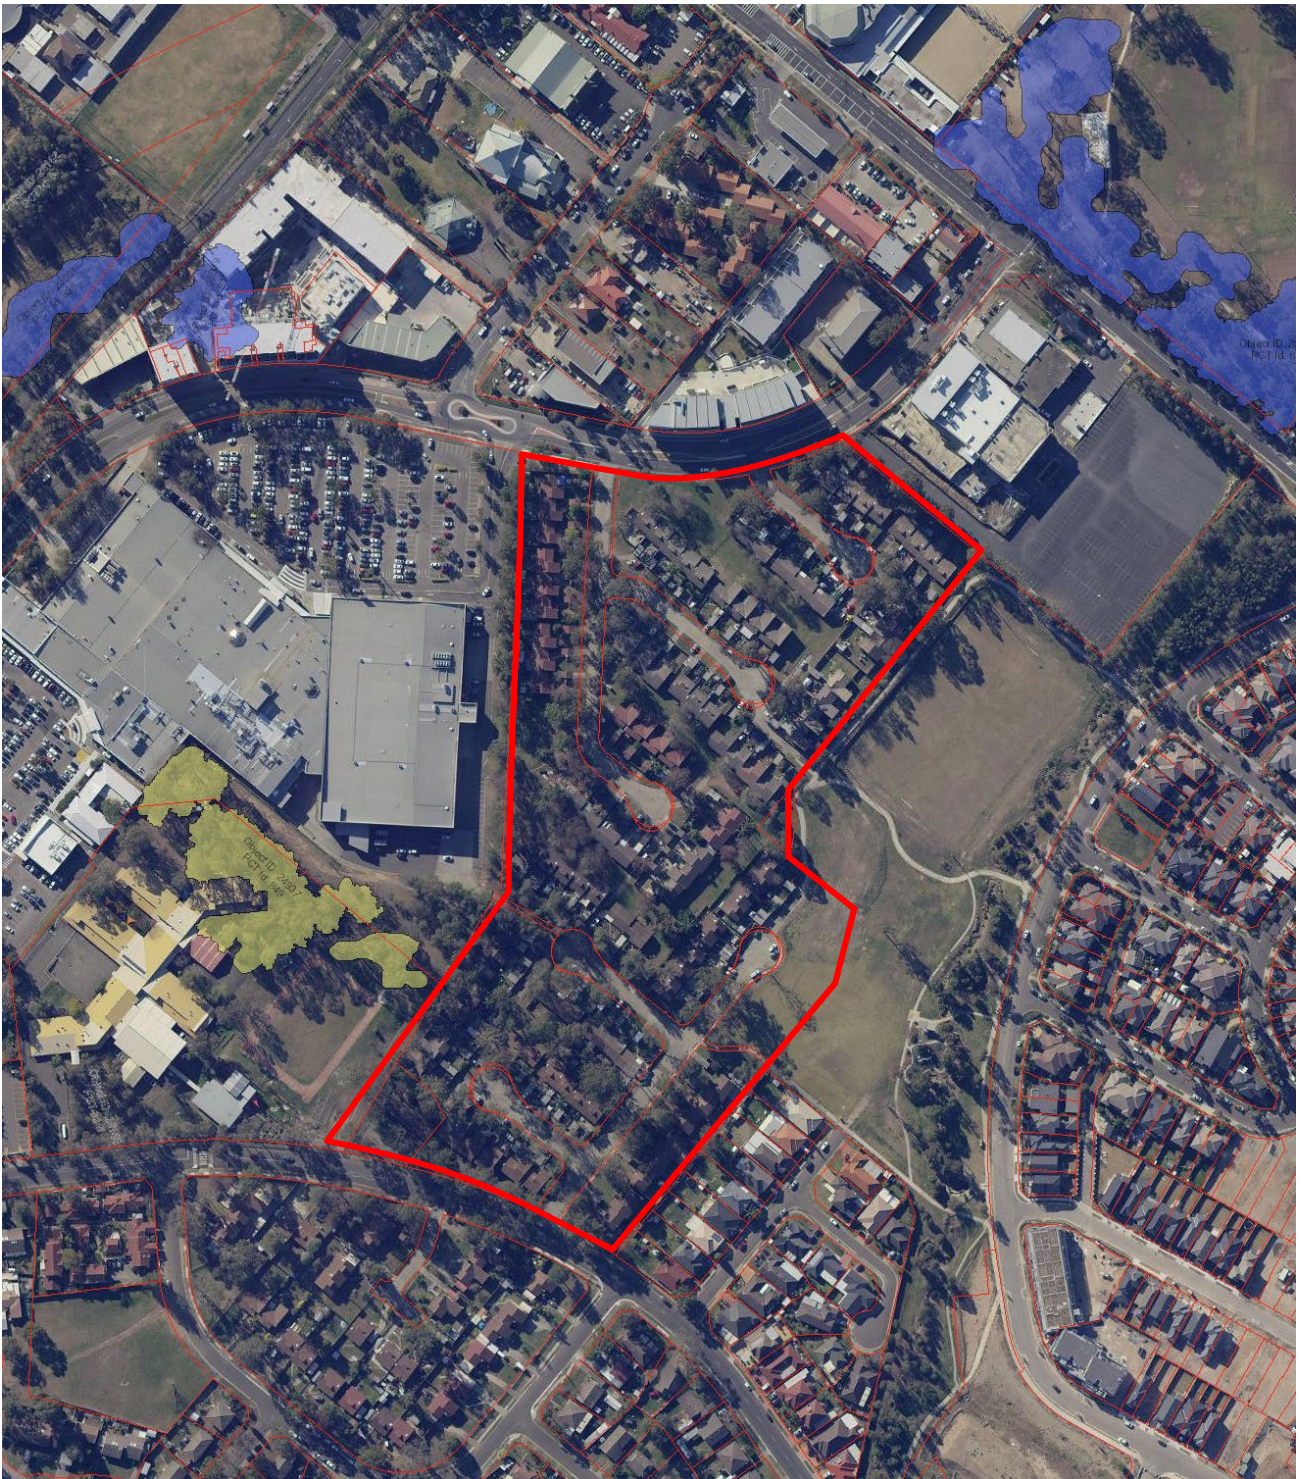
**Figure 5** - Sydney Metropolitan Vegetation Map extract showing the extent of PCT No. 835 (highlighted purple) and PCT No. 849 (highlighted yellow) within proximity to the subject site (outlined red).

Of relevance to the subject site, it is noted that these communities are represented by Plant Community Type (PCT) Nos. 835 (*River-Flat Eucalypt Forest*) and 849 (*Cumberland Plain Woodland*) under the Sydney Metropolitan Vegetation Map 2016. An excerpt from this mapping is provided within **Figure 5** below which shows the extent of these PCTs within proximity to the proposed development area. It is noted that mapped PCT areas do not occur within the subject site.
