# Geotechnical Investigation Report

**Proposed Yiribana Logistics Estate West  
771 – 797 Mamre Road, Kemps Creek NSW 2178**

**The GPT Group**

**15955-GR-1-1**

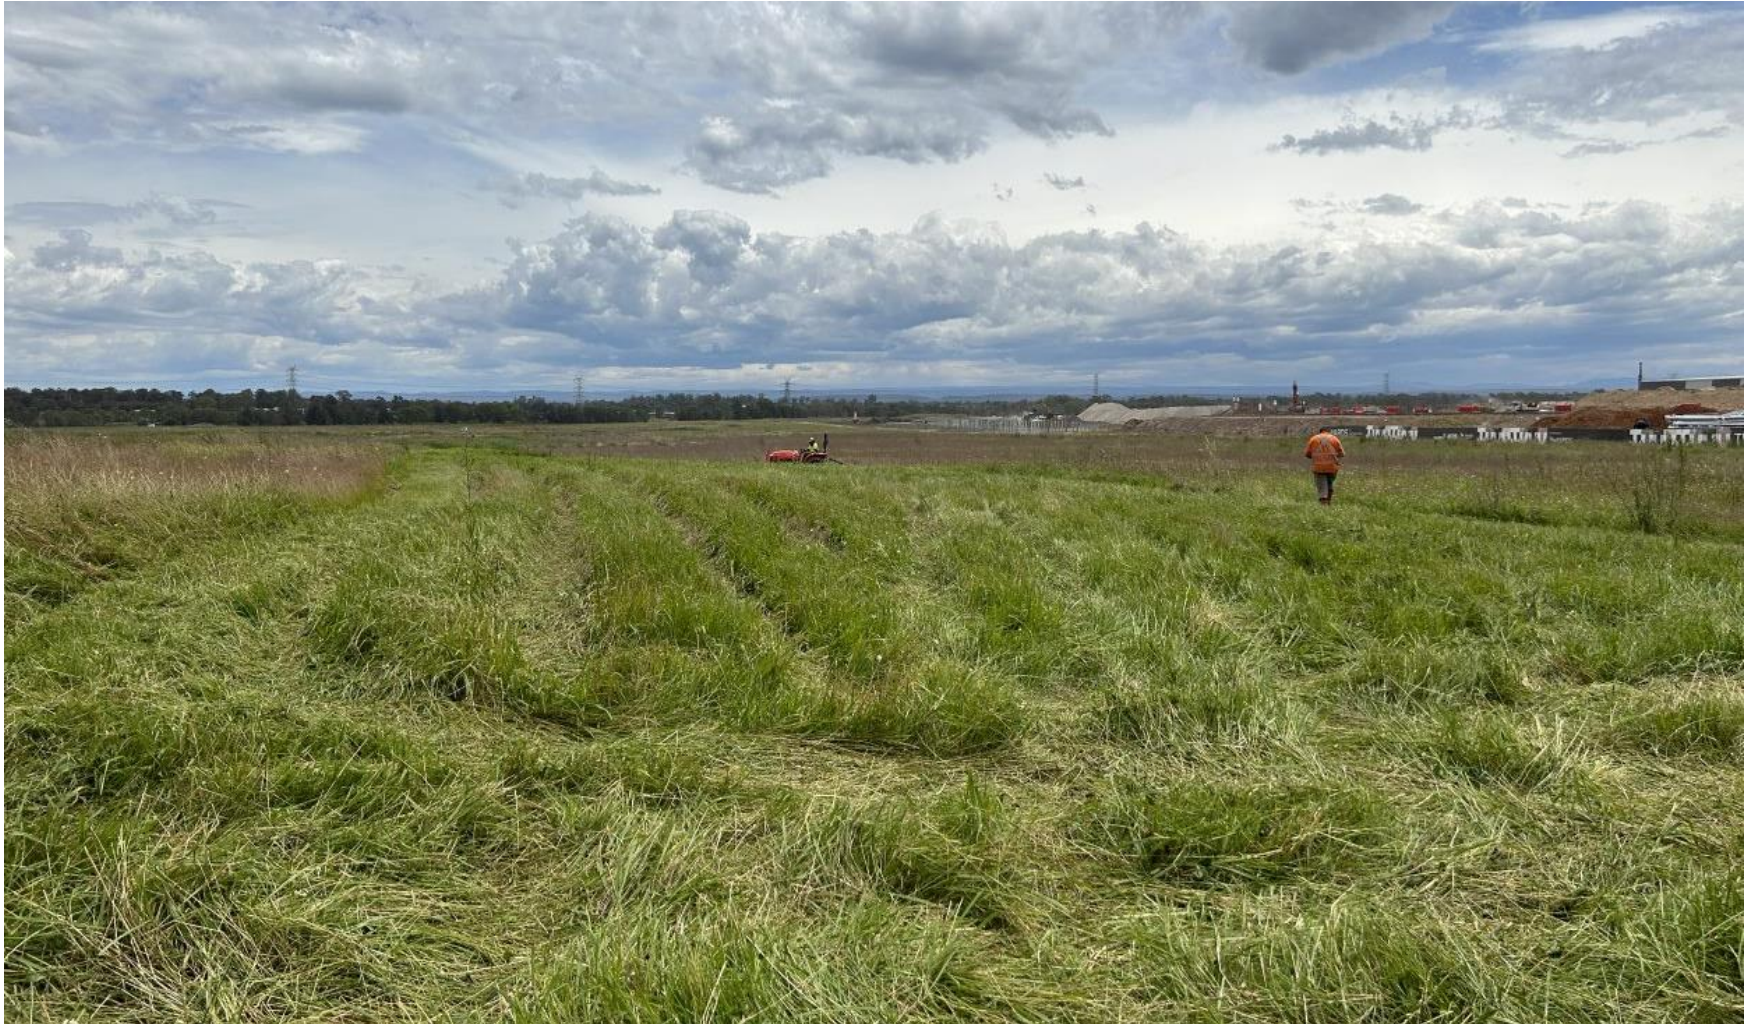
**Photo 1 - General view of the northern portion of the Site, looking west**

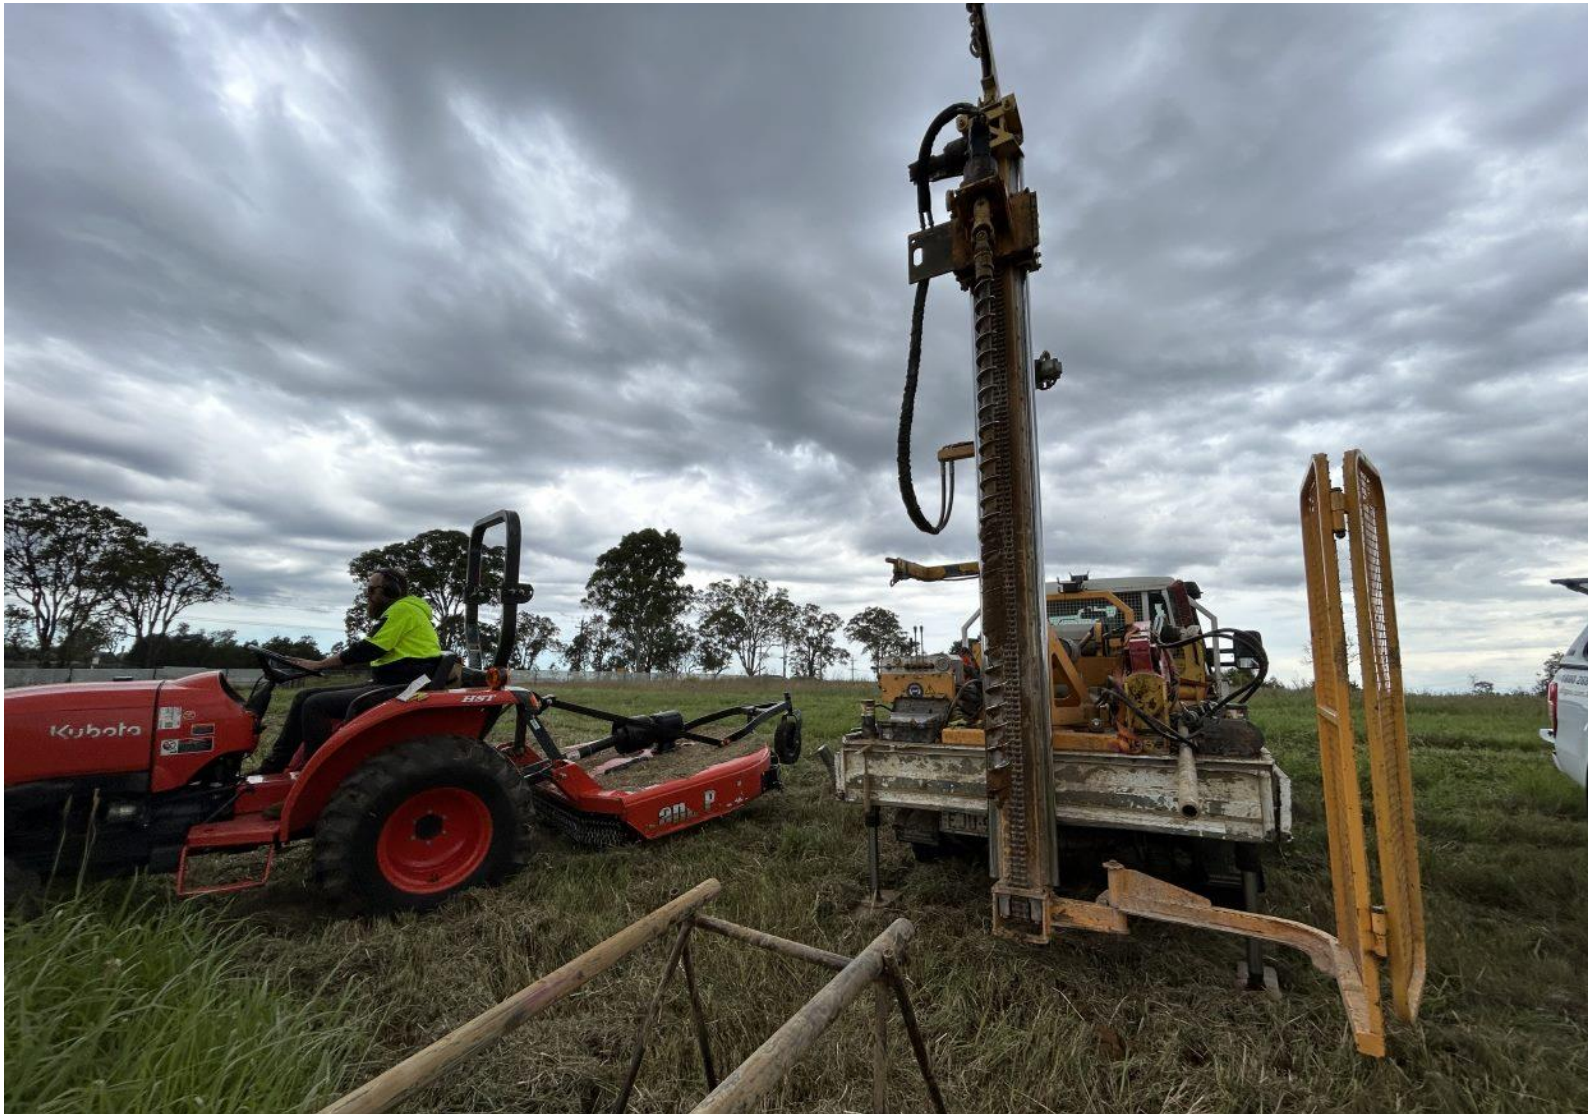
Photo 2 - Borehole BH01 drilling rig setup
