Our Ref: PSM4815-004L Rev3

**RE: RESIDENTIAL DEVELOPMENT, EDMONDSON PARK SOUTH – RESULTS OF GEOTECHNICAL INVESTIGATION**

This letter presents the results of the geotechnical investigation undertaken by PSM for the proposed residential development in Edmondson Park South. This work has been undertaken in accordance with our proposal, PSM4815-001L Rev1, dated 29 June 2022.

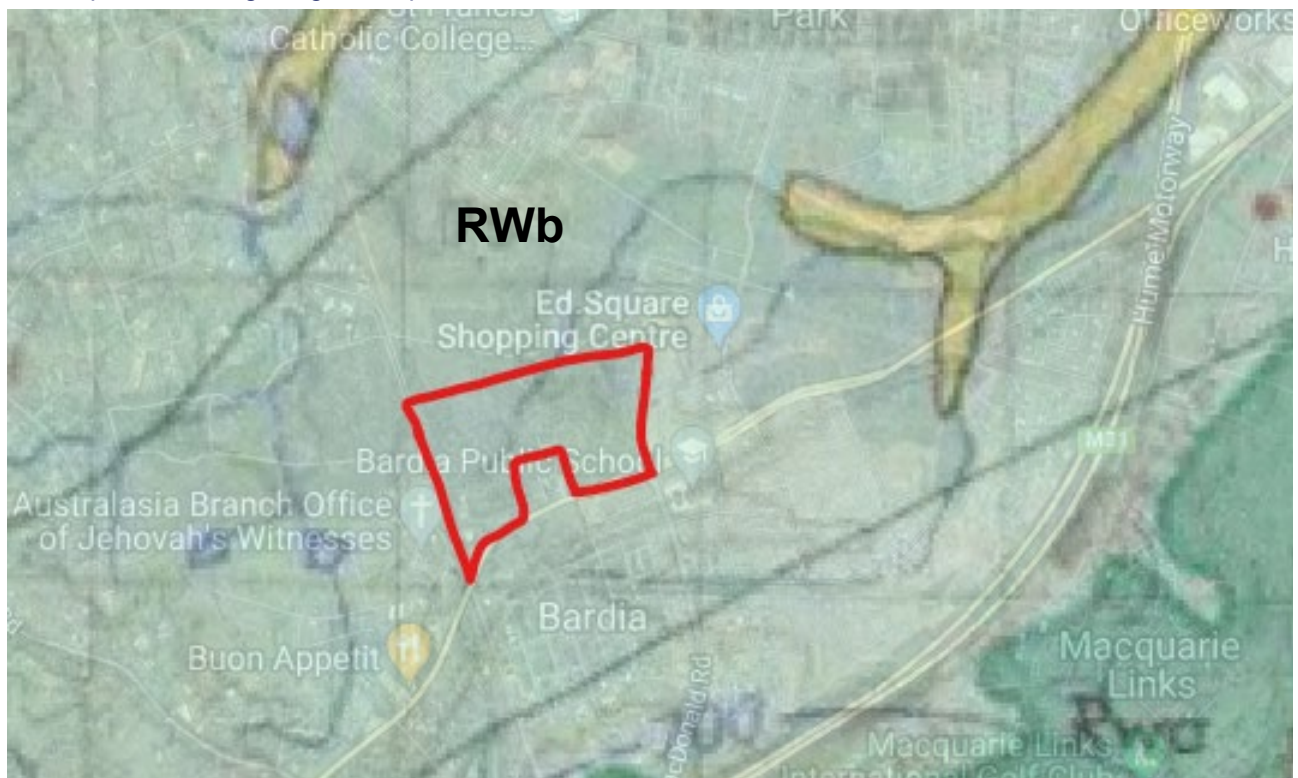
- (Rwb) Bringelly Shale of the Wianamatta Group comprising of Shale, carbonaceous claystone, claystone, laminate, fine to medium grained sandstone, rare coal and tuff.

**Inset 2 - 1:100,000 Penrith Geological Map (approximate site boundaries in red)**

Inset 2 presents the geological map of the site.

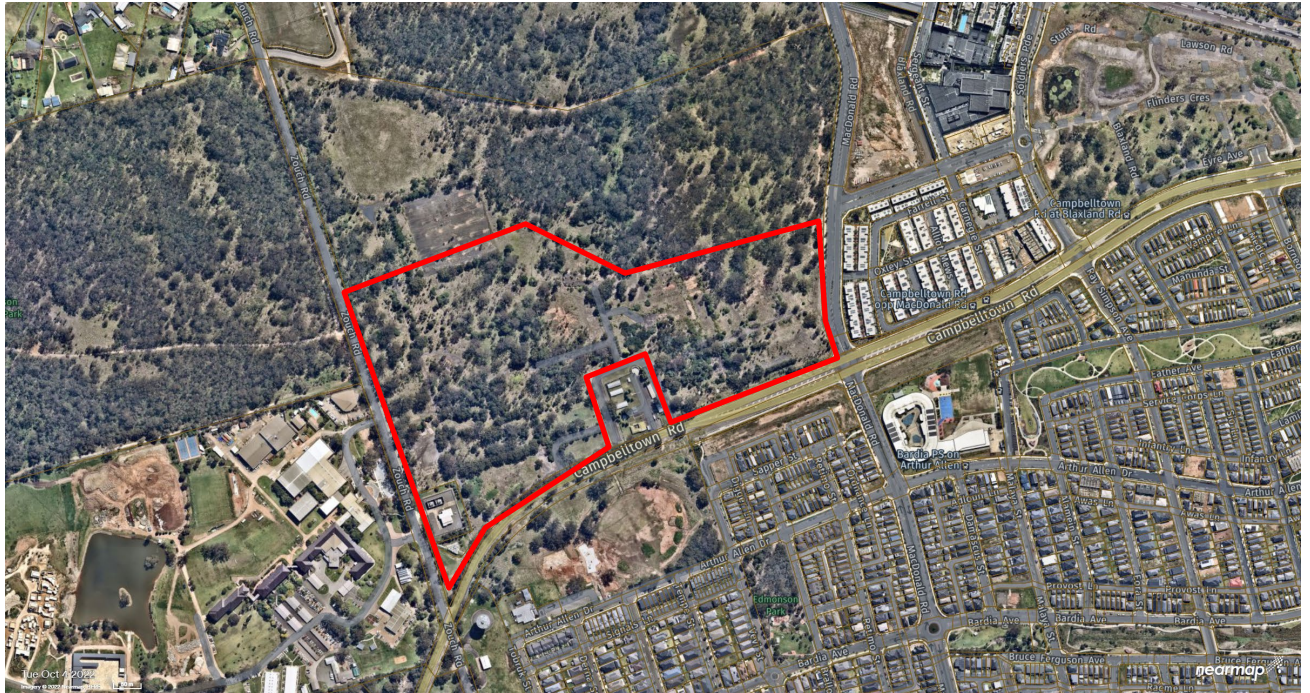
- The Site was historically used as an army barracks until early 2010. The buildings were then demolished except for the Bardia Barracks which remain as part of a separate Lot
- No significant changes to the land use were observed from 2010 to present
- The existing site comprises:
  - Vegetated area (grass, shrubs and trees)
  - Building slabs and wall remnants from the old barracks
  - Paved road.

**Inset 3 - Nearmap aerial image in Oct 2022**

Inset 3 presents a recent nearmap image of the Site.

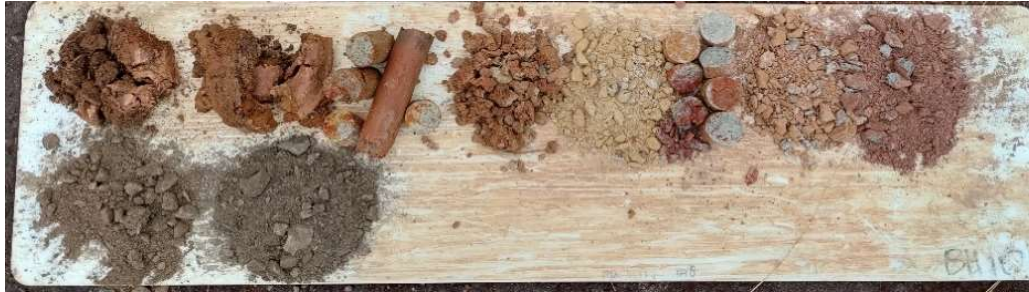
Photo 5 : Typical soil cutting profile (BH14)

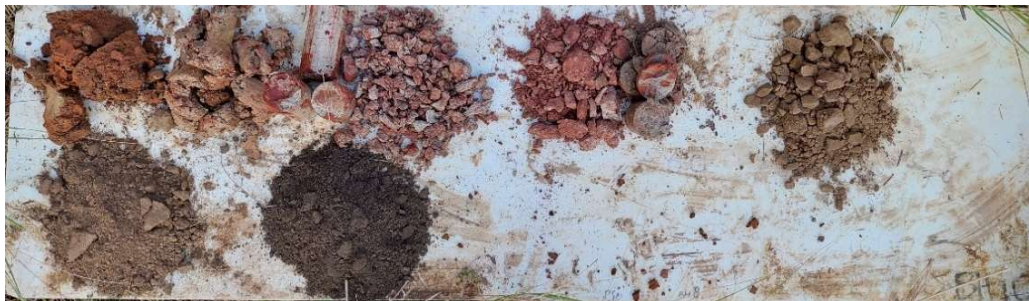
Photo 6 : Typical soil cutting profile (BH17)

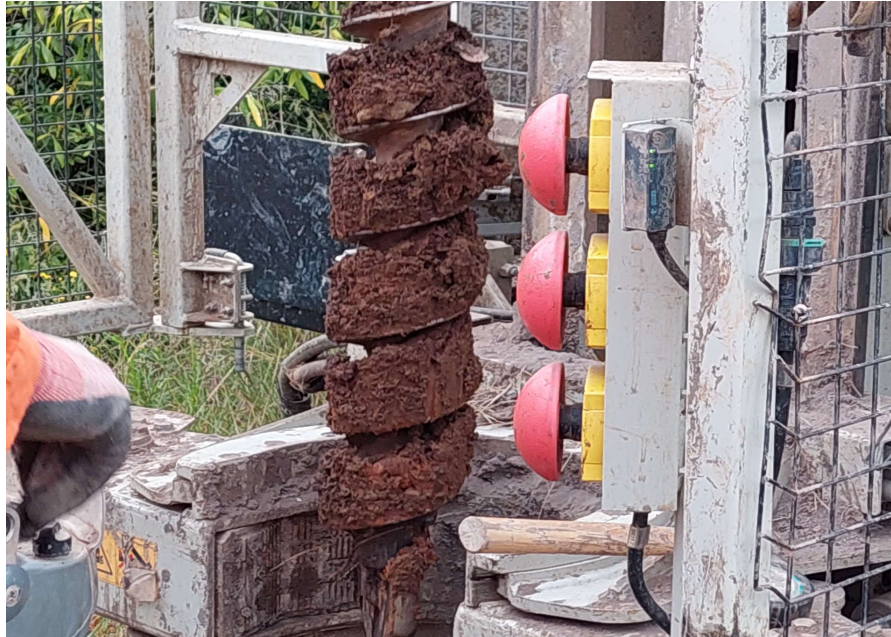
Photo 7 : Typical Natural Clay Sample

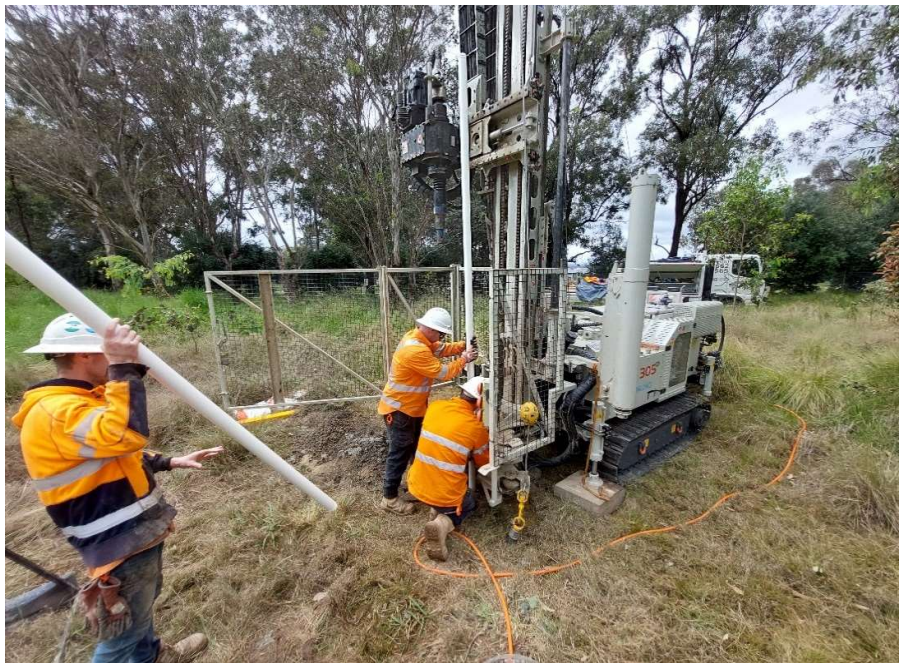
Photo 8 : Typical piezometer installation process

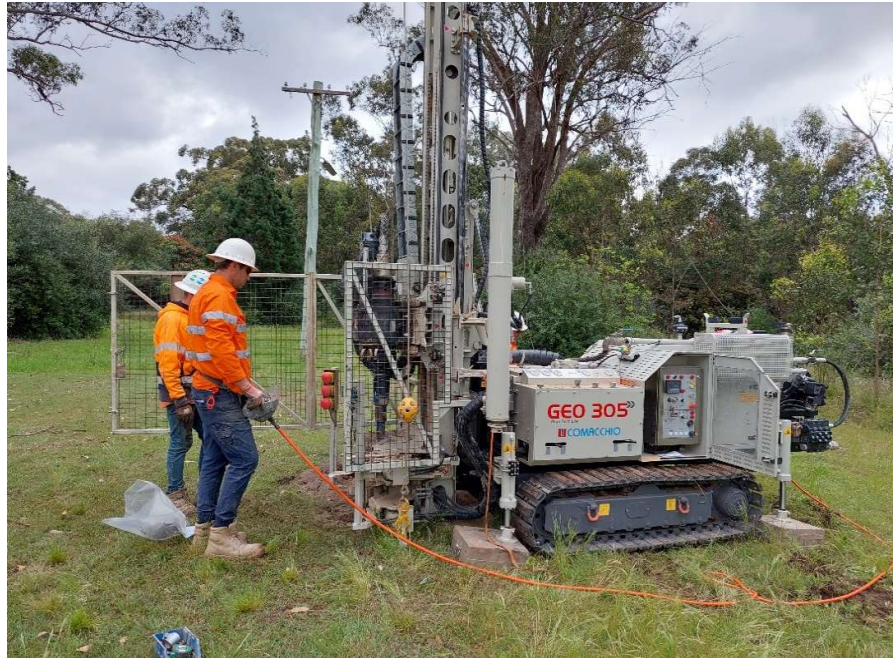
Photo 9 : 5.5t track mounted drill rig typical setup

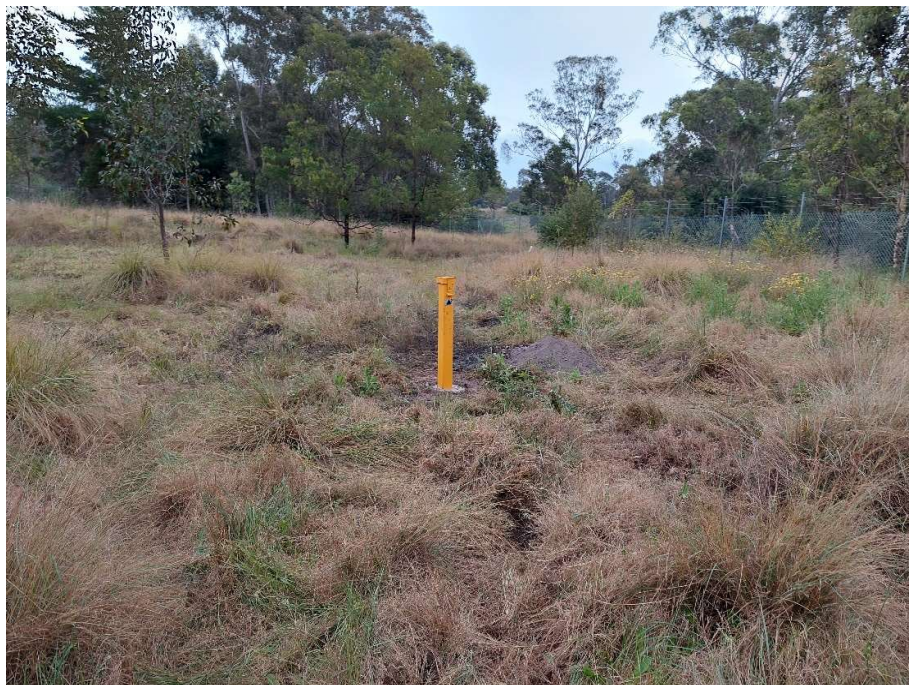
Photo 10 : Typical piezometer installation process

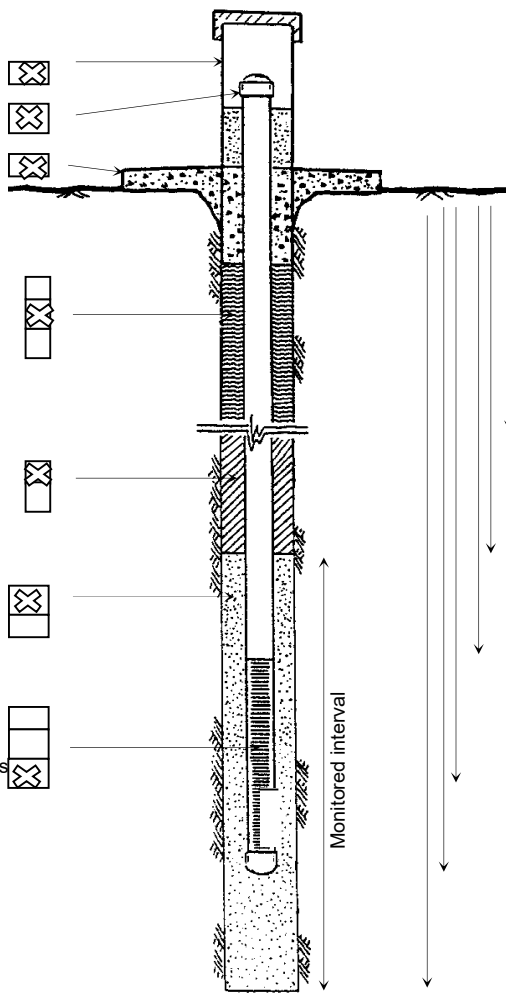
Height of stickup (m)	<u>1.1</u>
PVC cap	<input checked="" type="checkbox"/>		Diameter of PVC (mm)	<u>50</u>
Concrete collar	<input checked="" type="checkbox"/>			
Back fill type: Cement bentonite Soil None	<input checked="" type="checkbox"/>		Depth to top of seal	<u>5.5m</u>
Seal: Bentonite pellets Other	<input checked="" type="checkbox"/>		Depth to top of gravel pack	<u>6.5m</u>
Gravel type: 2-5mm gravel Other	<input checked="" type="checkbox"/>		Depth to top of screen	<u>7.0m</u>
Perforation type: Drill holes Hack saw cuts 40um machine slots	<input checked="" type="checkbox"/>		Depth to base of screen	<u>10.0m</u>
			Depth to base of piezo	<u>10.0m</u>
			Depth to base of gravel	<u>10.0m</u>

COMMENTS: Water table encountered at 8.0m

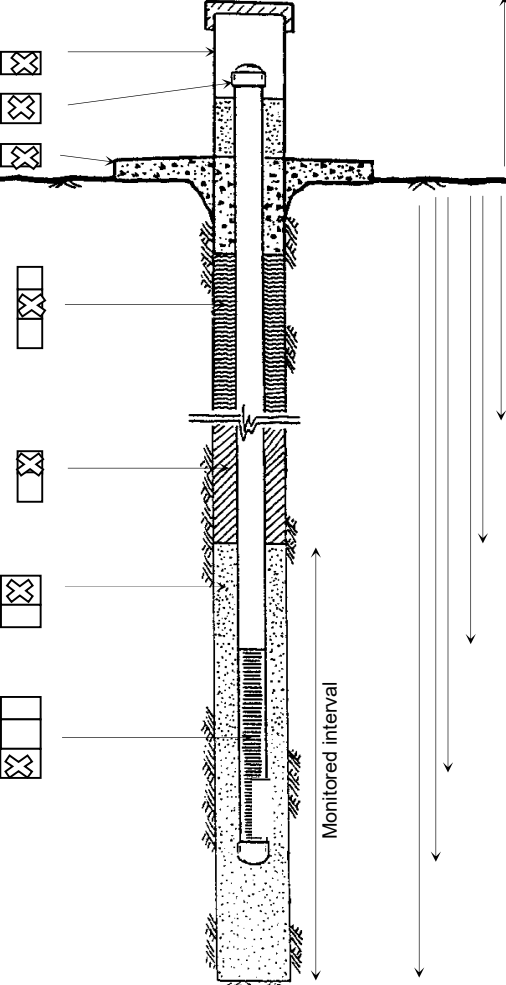
Height of stickup (m)	<u>1.1</u>
PVC cap	<input checked="" type="checkbox"/>		Diameter of PVC (mm)	<u>50</u>
Concrete collar	<input checked="" type="checkbox"/>			
Back fill type: Cement bentonite Soil None	<input checked="" type="checkbox"/>		Depth to top of seal	<u>7.4m</u>
Seal: Bentonite pellets Other	<input checked="" type="checkbox"/>		Depth to top of gravel pack	<u>8.4m</u>
Gravel type: 2-5mm gravel Other	<input checked="" type="checkbox"/>		Depth to top of screen	<u>9.0m</u>
Perforation type: Drill holes Hack saw cuts 40um machine slots	<input checked="" type="checkbox"/>		Depth to base of screen	<u>12.0m</u>
			Depth to base of piezo	<u>12.0m</u>
			Depth to base of gravel	<u>12.0m</u>

COMMENTS: Water table encountered at 10.0m

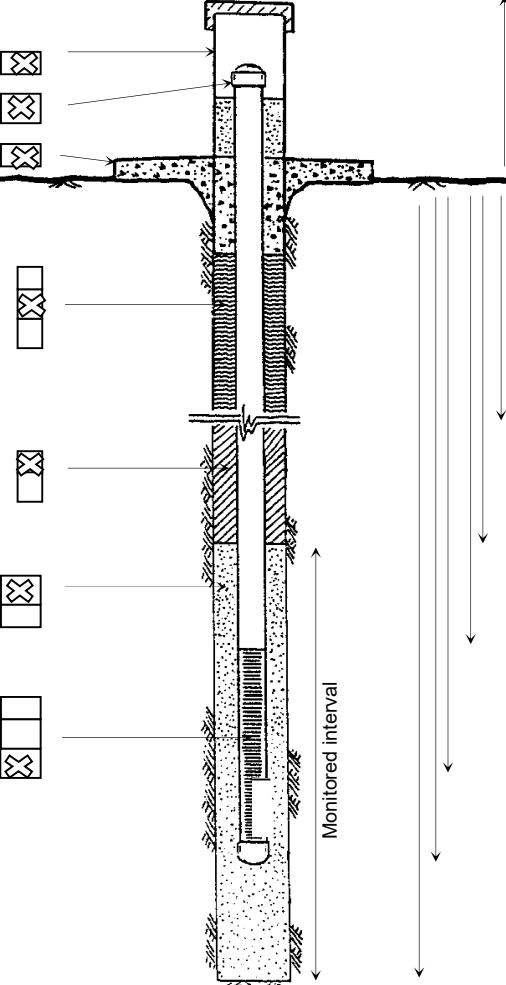
Height of stickup (m)	<u>1.1</u>
PVC cap	<input checked="" type="checkbox"/>		Diameter of PVC (mm)	<u>50</u>
Concrete collar	<input checked="" type="checkbox"/>			
Back fill type: Cement bentonite Soil None	<input checked="" type="checkbox"/>		Depth to top of seal	<u>7.5m</u>
Seal: Bentonite pellets Other	<input checked="" type="checkbox"/>		Depth to top of gravel pack	<u>8.5m</u>
Gravel type: 2-5mm gravel Other	<input checked="" type="checkbox"/>		Depth to top of screen	<u>9.1m</u>
Perforation type: Drill holes Hack saw cuts 40um machine slots	<input checked="" type="checkbox"/>		Depth to base of screen	<u>12.1m</u>
			Depth to base of piezo	<u>12.1m</u>
			Depth to base of gravel	<u>12.1m</u>

COMMENTS: Water table encountered at 10.0m
