Edmondson Park, Precinct 3, Lot 3

Remedial Action Plan
Campbelltown Road, Edmondson Park NSW

16 February 2023

63325/ 149,764 (Rev 0)

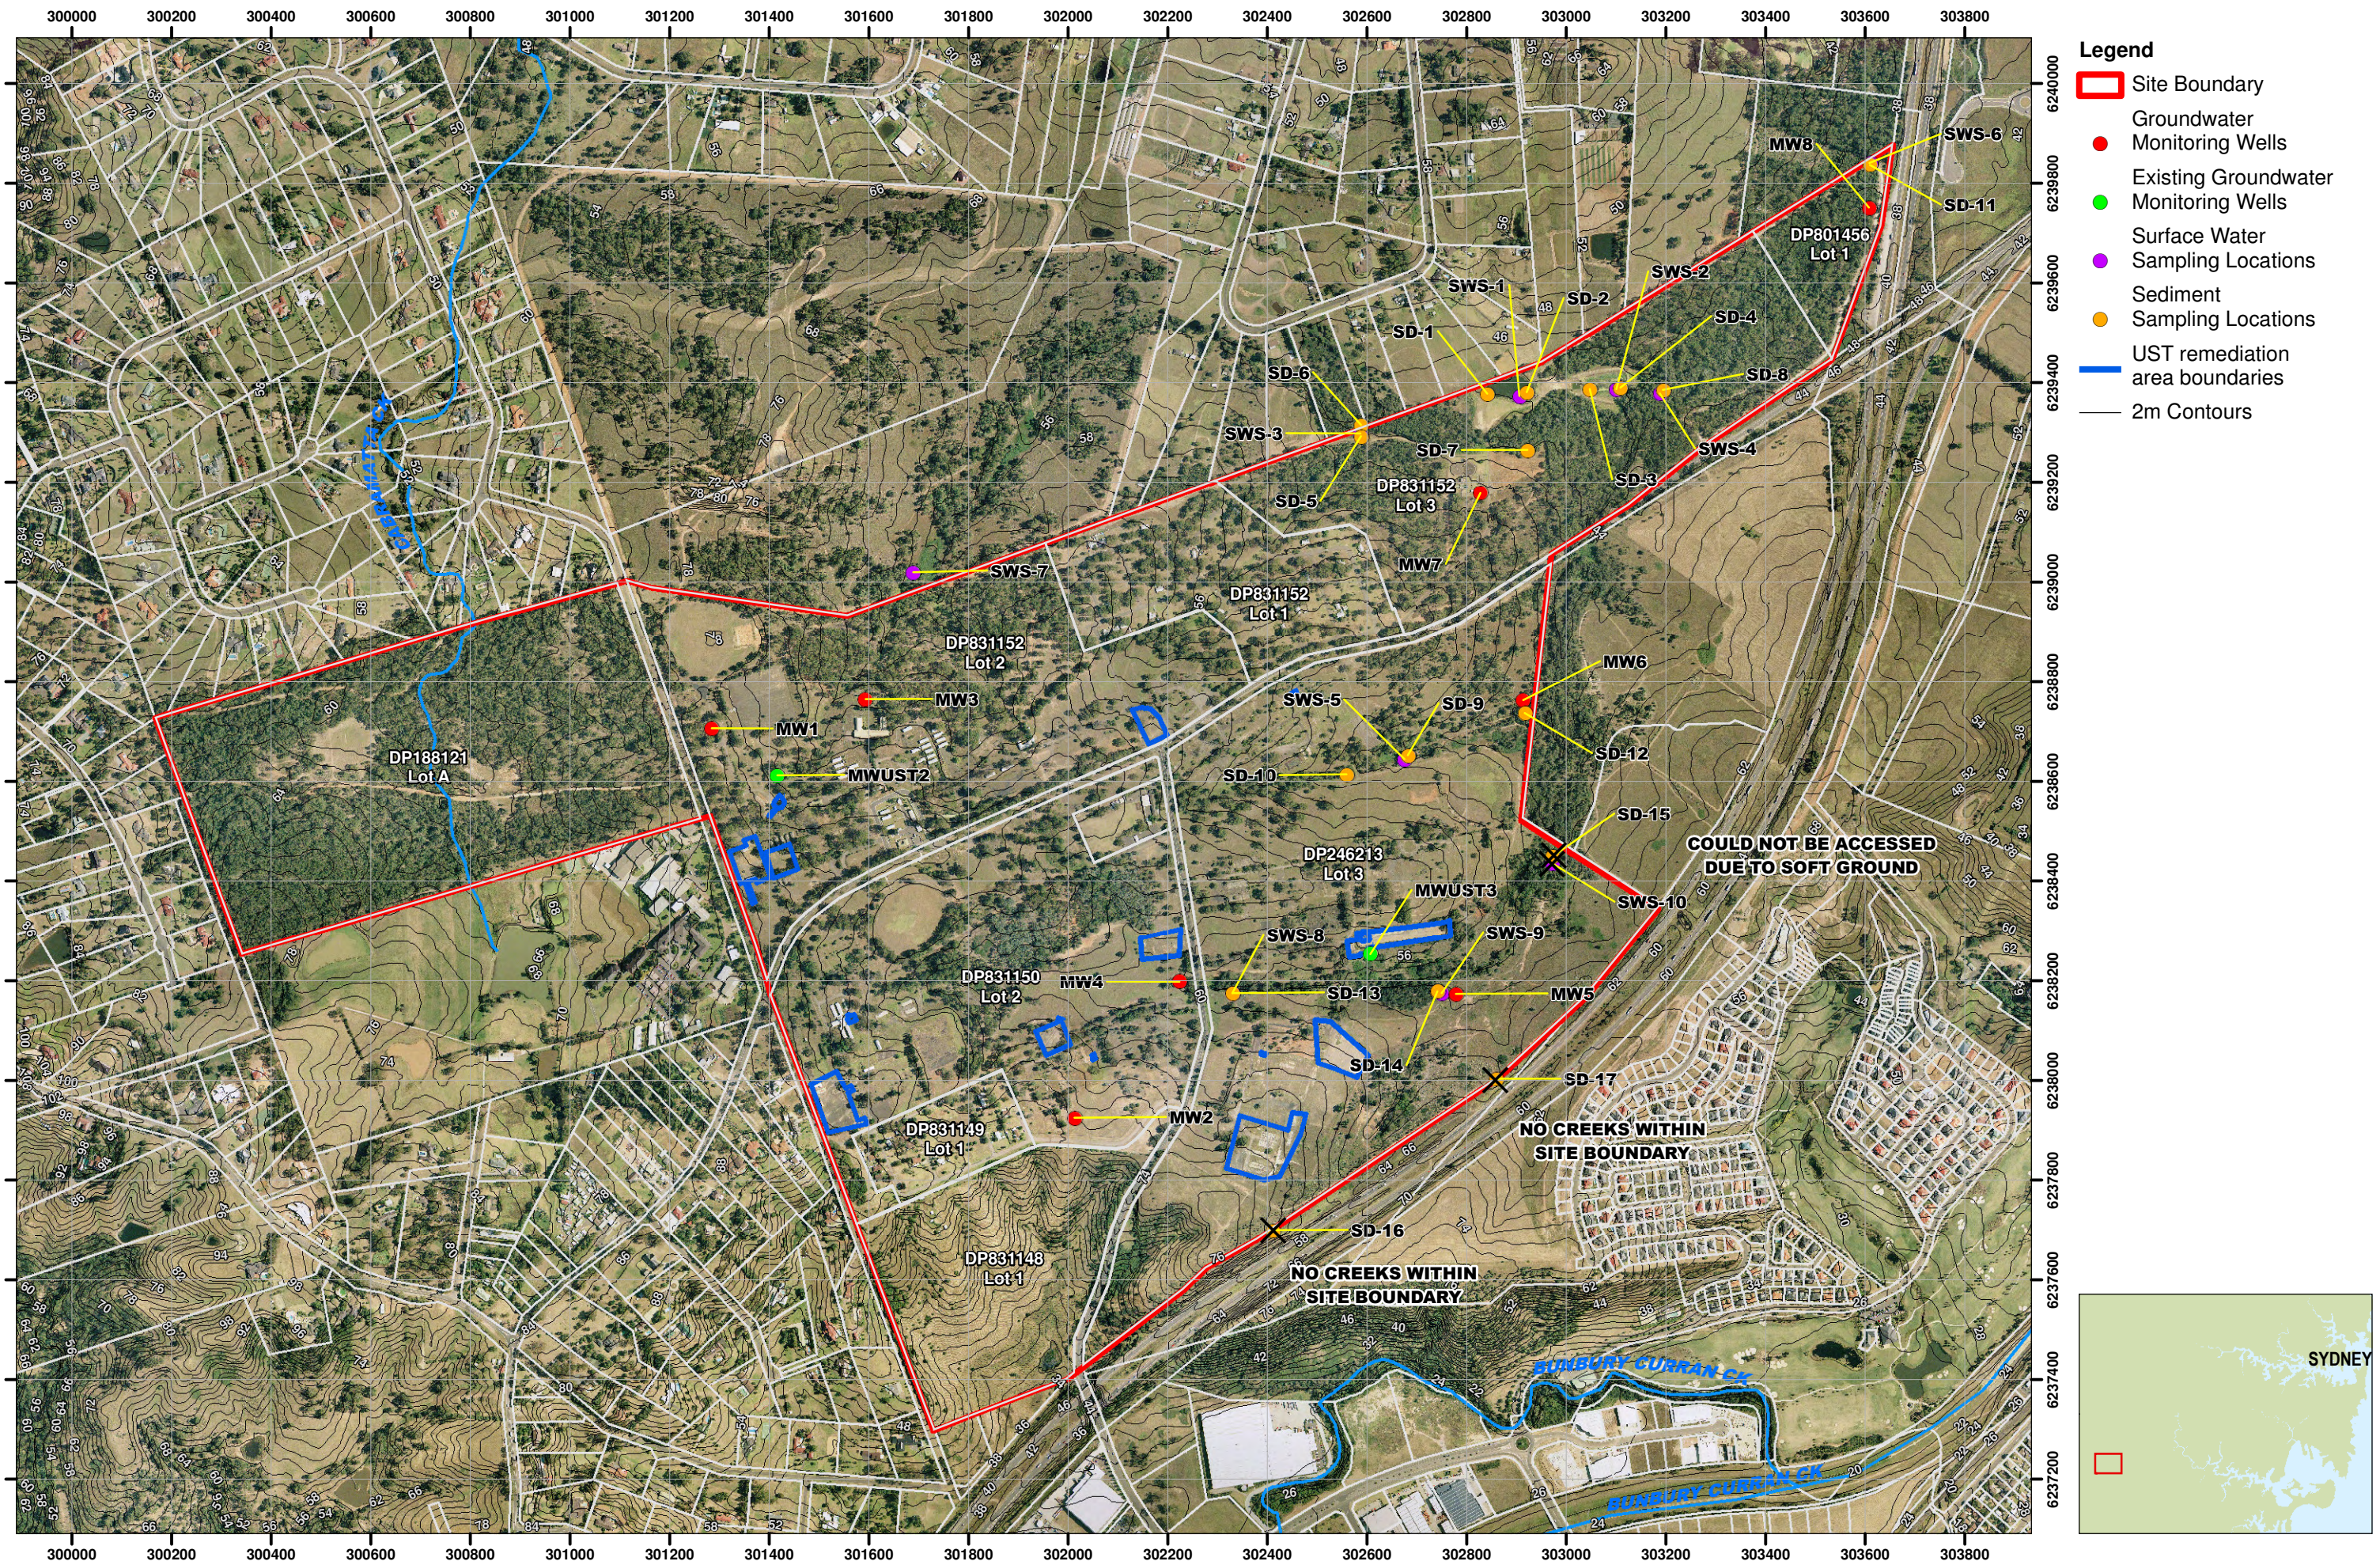
Figure 3

Groundwater, Surface Water and Sediment Locations

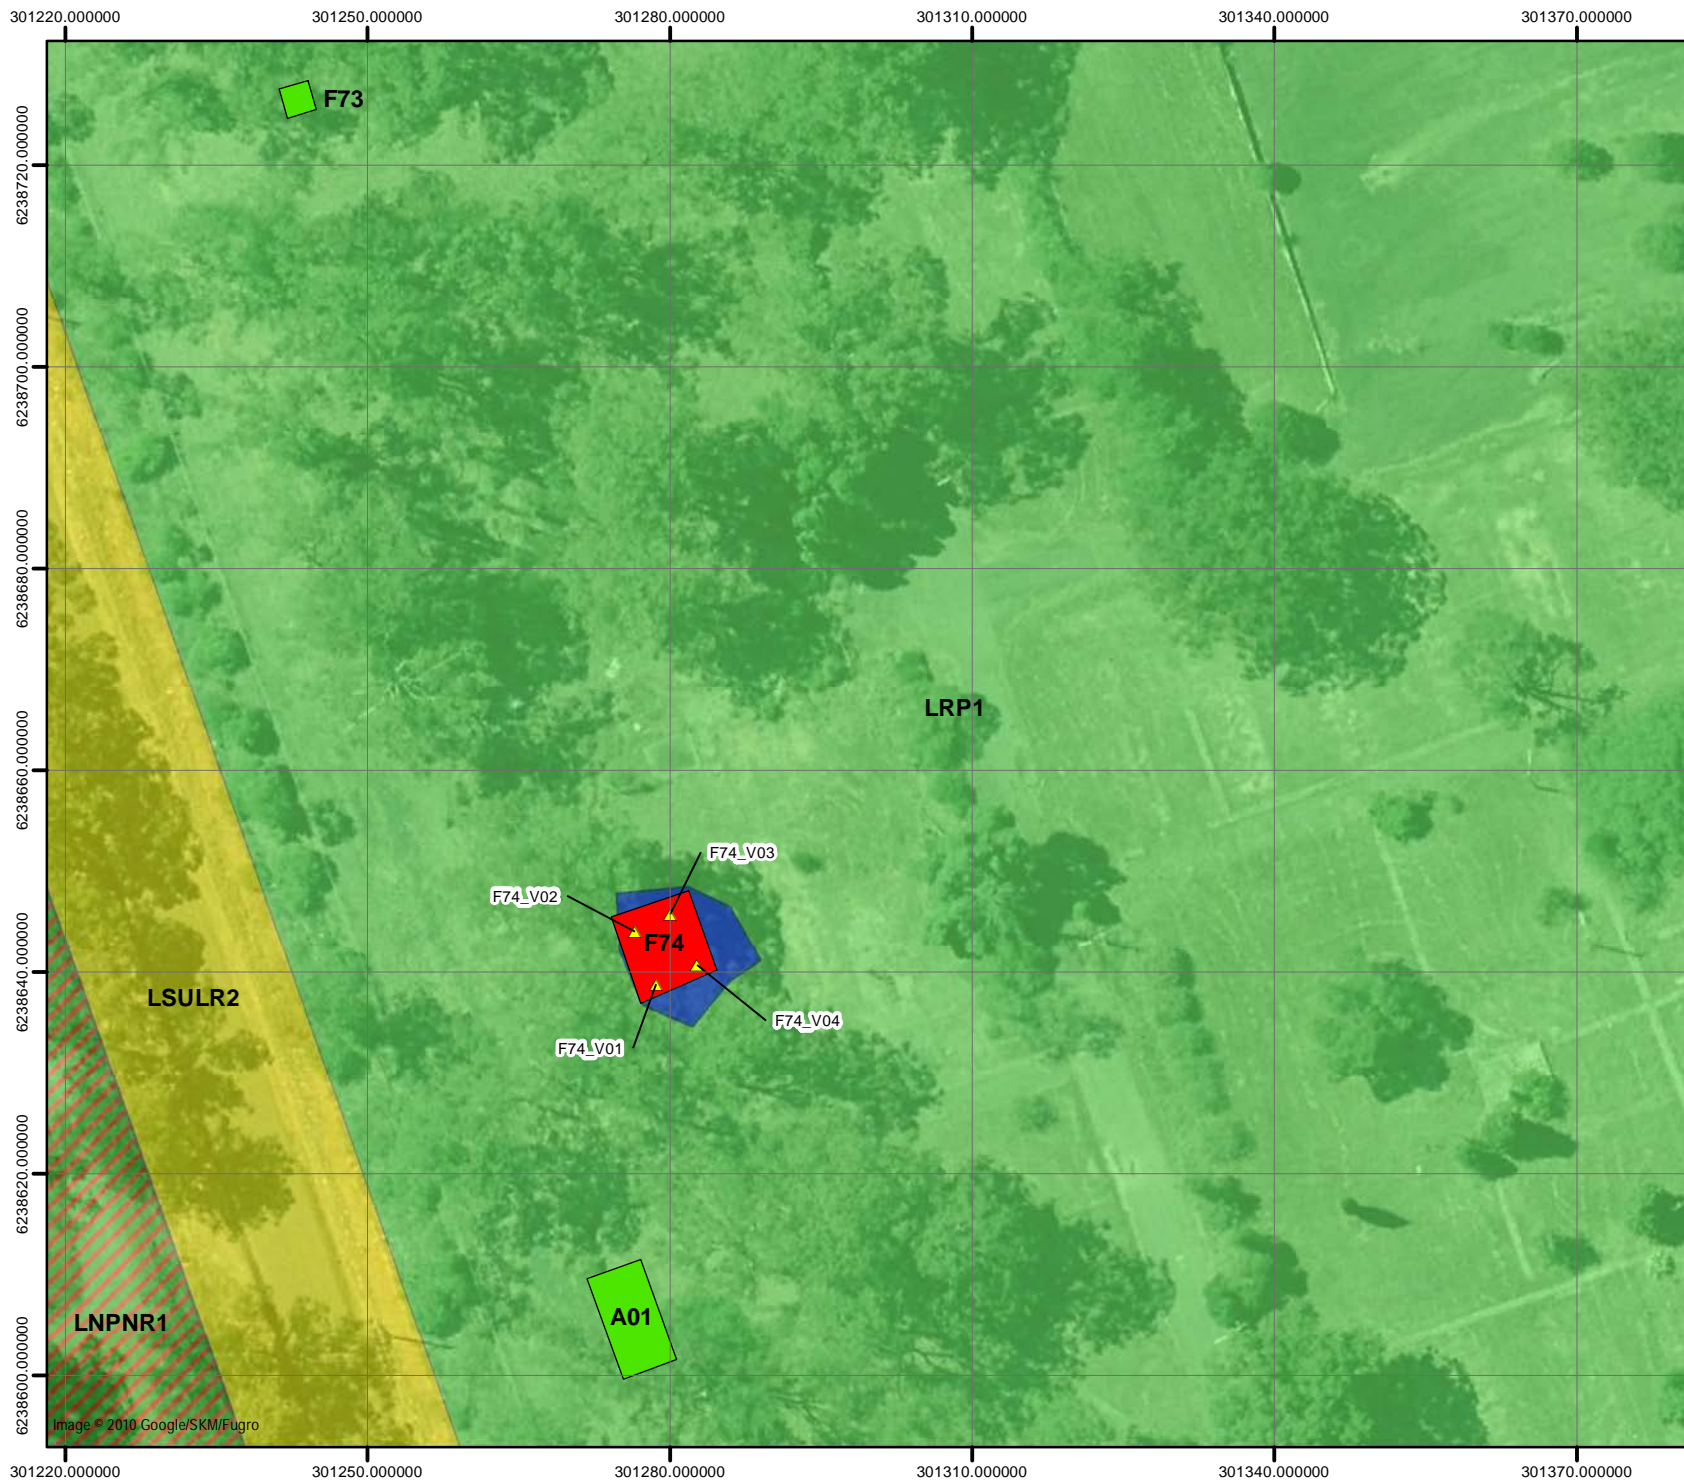
Figure 10

Location of Demolished Building Footprints and Validation Samples- A01, F73 and F74, within subsite LRP1
