**PRELIMINARY SITE INVESTIGATION  
PREPARED FOR  
SHINE MOTOR CORPORATION PTY LTD  
8 NOONAN ROAD, INGLEBURN NSW 2565**

**Report No:** 241071\_PSI\_Rev4  
September 2024  
(Released: 12 September 2024)

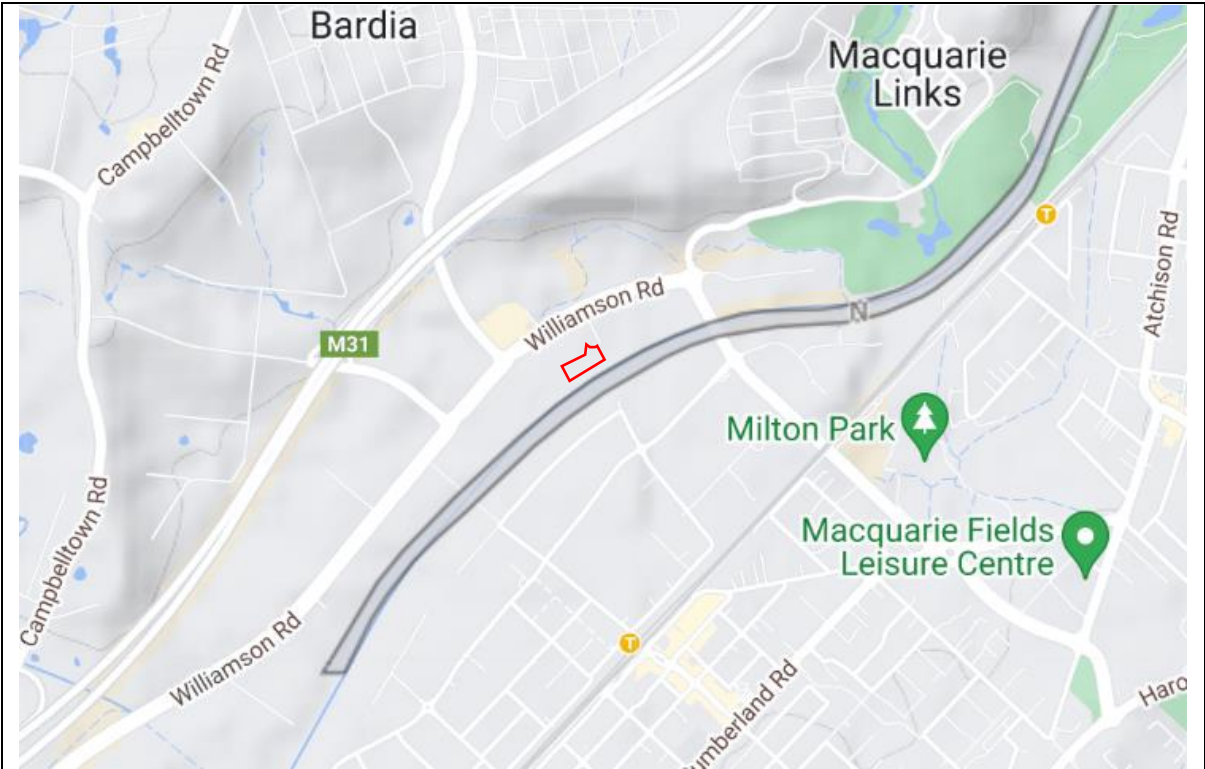
Figure 3-1: eSpade Acid Sulfate Soil Risk Mapping

The CSIRO eSpade interactive web portal shows the subject site is not located on land that is at risk from acid sulfate soil (ASS), thus the site has *very low* risk from ASS (see Figure 3-1 below).

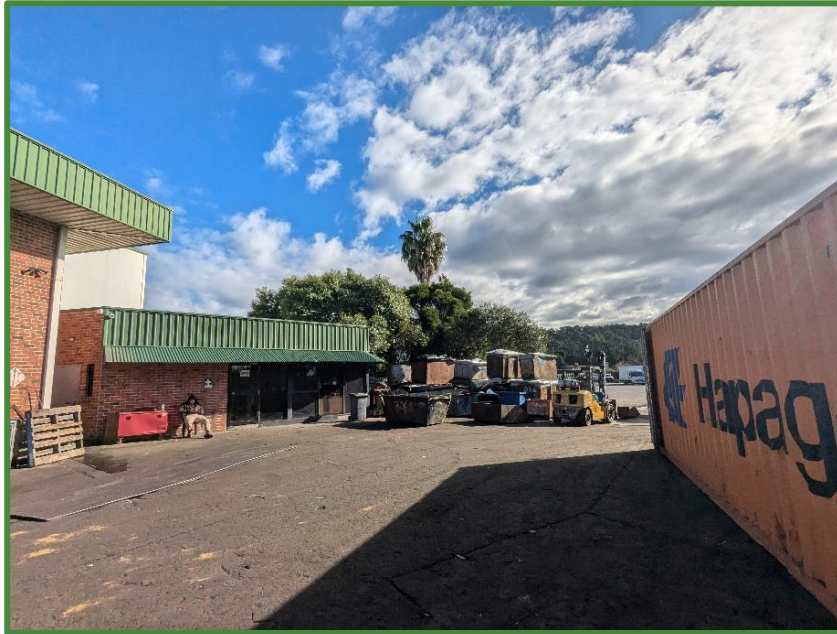
**Photograph 3:** Northeastern aspect of the facility. Office building A, access gateway, and storage container visible. Multiple skip bin/storage vessels visible along northern gateway.

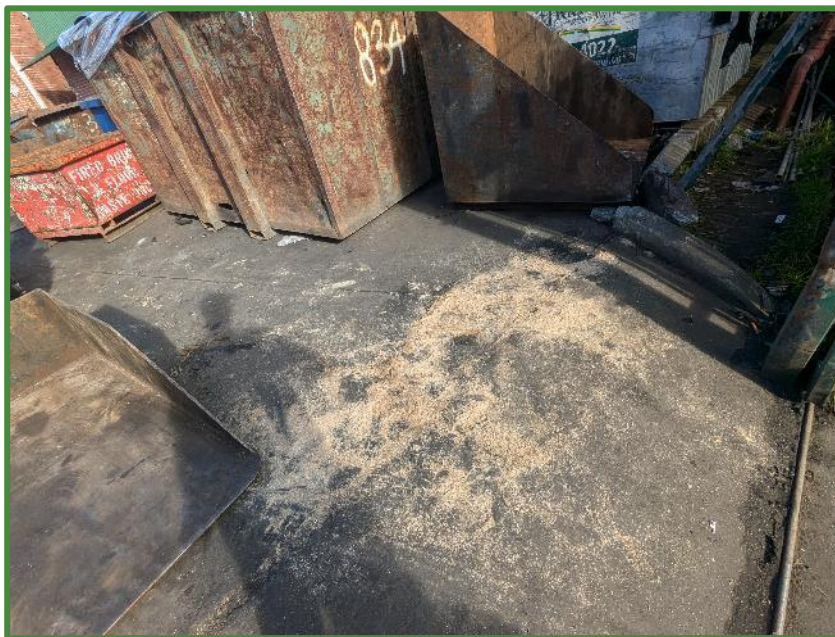
**Photograph 5:** Hardstand along entrance driveway. Sand/sawdust used to contain/prevent mobility of spillage visible. Various stored skip bins visible in background (viewer facing northwest).

Sediment was observed across the hardstand throughout the facility to control vehicle oil spills. During rain events, these sediments which highly likely contain petroleum oils, would be collected by stormwater and enter into the Site's stormwater drains and exit into Bunbury Creek, below the Site.

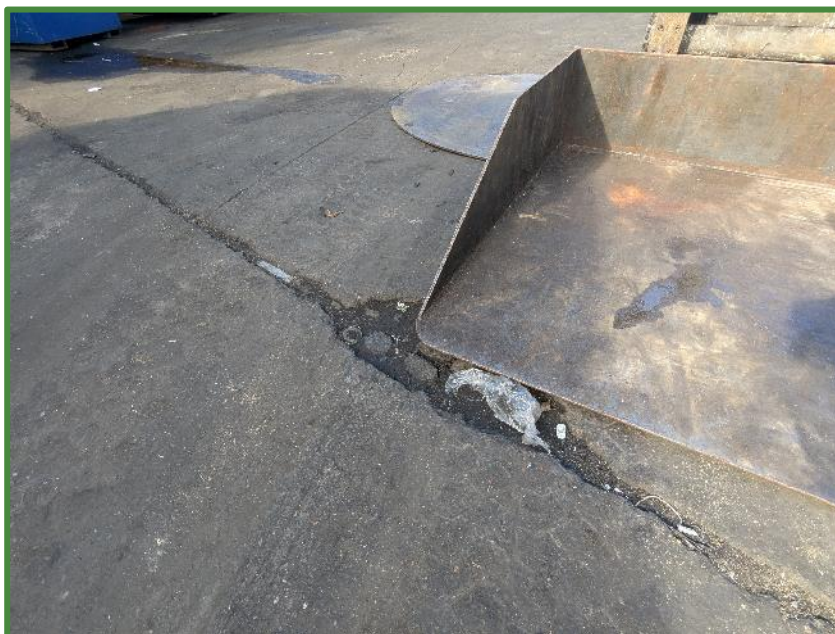
**Photograph 6:** Hardstand along driveway entry, visibly worn from use (viewer facing southwest).

The site is mostly covered in concrete hardstand, with exposed soil present on the eastern boundary due to the stormwater easement. It was noted during our site visit that some areas of hardstand are worn or cracked from repetitive vehicle use, primarily at the Site's entrance from Noonan Road. Overall, the hardstand's condition is considered as good.

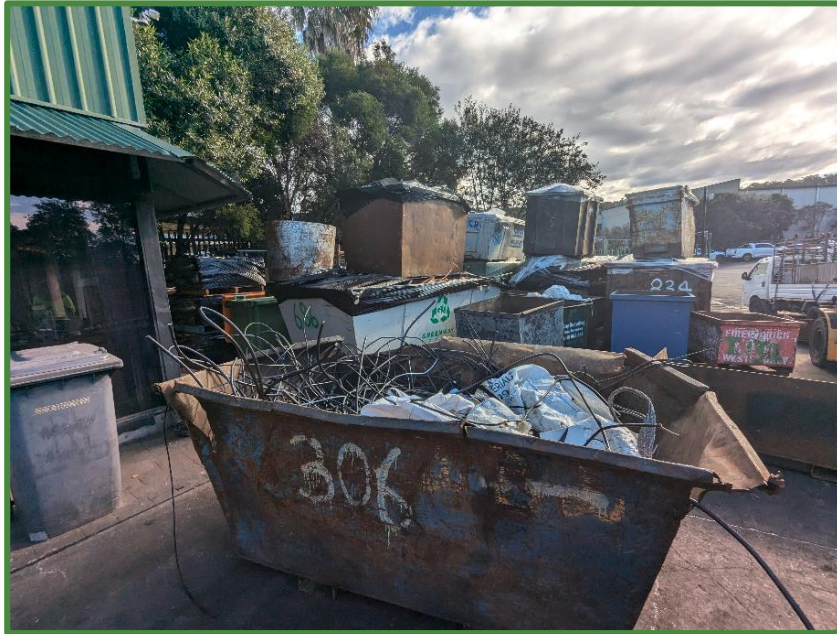
**Photograph 7:** Close up of various bins along northern boundary of site next to office complex. Skip bin with wiring visible (viewer facing north).

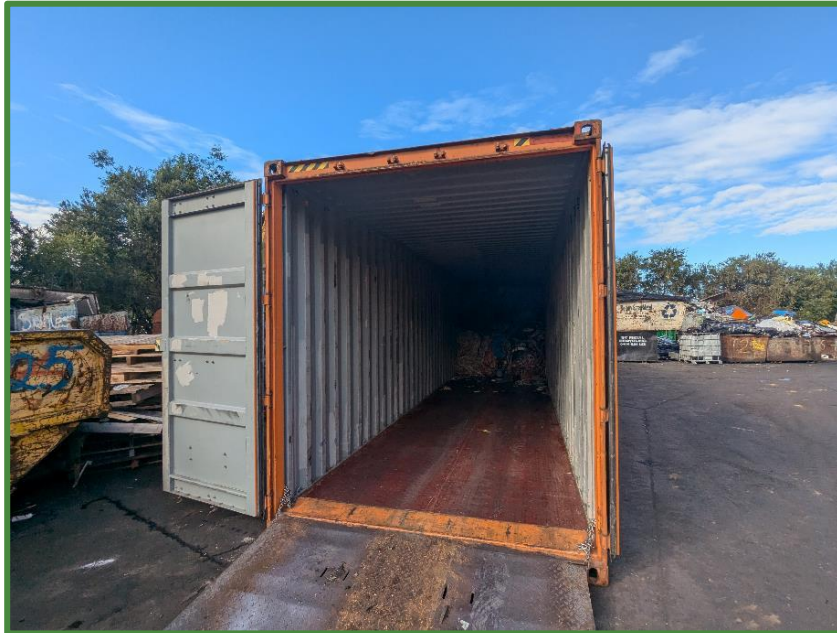
**Photograph 9:** Empty shipping container at the Site's northeastern aspect. Mostly empty. Pallets, skip bins and IBCs visible in background (viewer facing S).

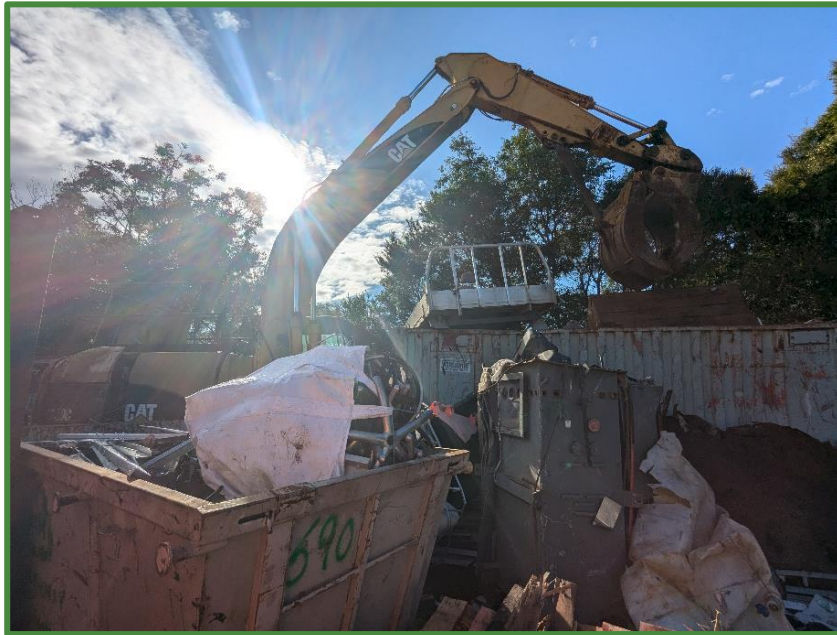
**Photograph 10:** CAT Excavator stored on the eastern boundary of the site (behind storage container). Skip bin with various metal waste, and a disused water coolant system visible (viewer facing East).

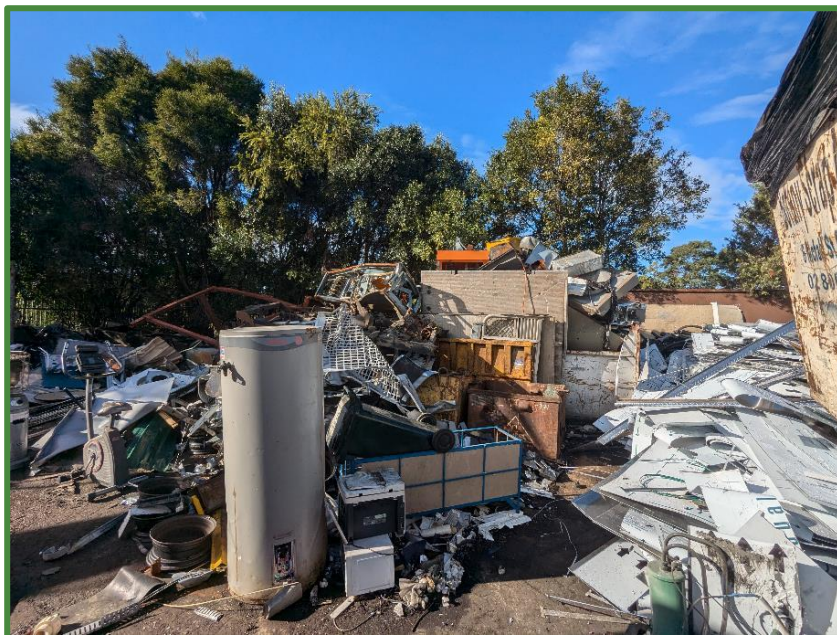
**Photograph 11:** Eastern corner aspect of the site. Temporary storage of various materials in corner of facility (water cooler, heater, bedframe, drawers, wheels, paper, cardboard etc.) (viewer facing East).

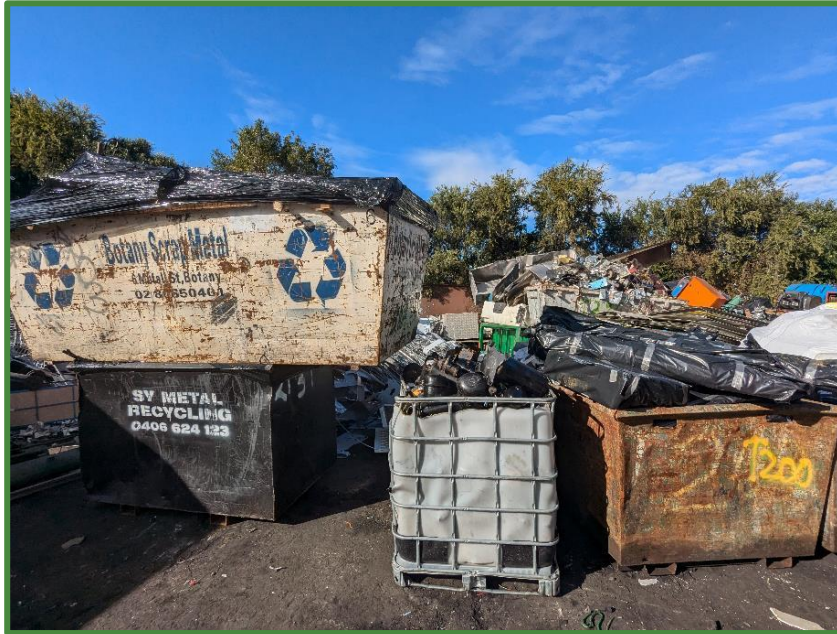
**Photograph 12:** Scrap metal skip bins along southern boundary of site. Empty IBC with various components stored on top (viewer facing South).

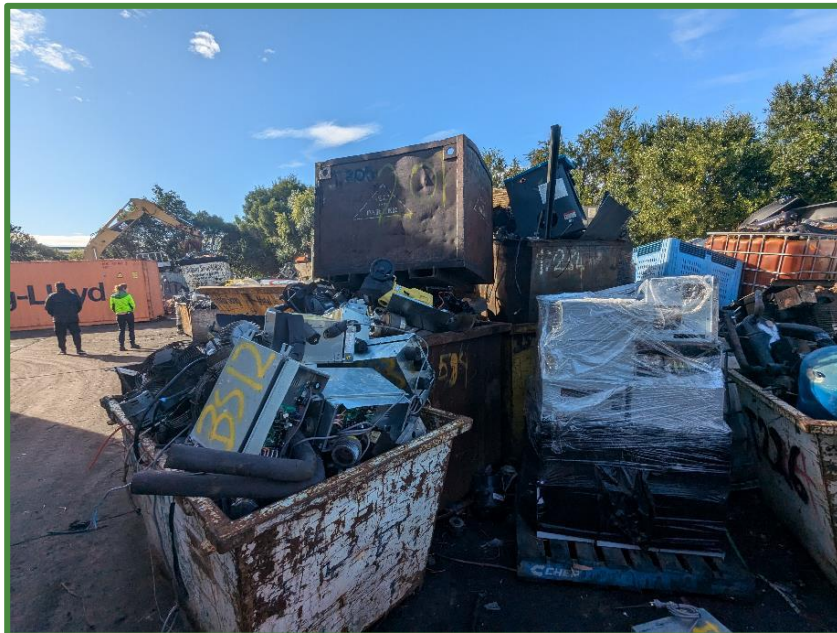
**Photograph 13:** Skip bins with various metal wastes stored. Pallet with radiators stacked visible in centre. Excavator and container visible in background (viewer facing East).

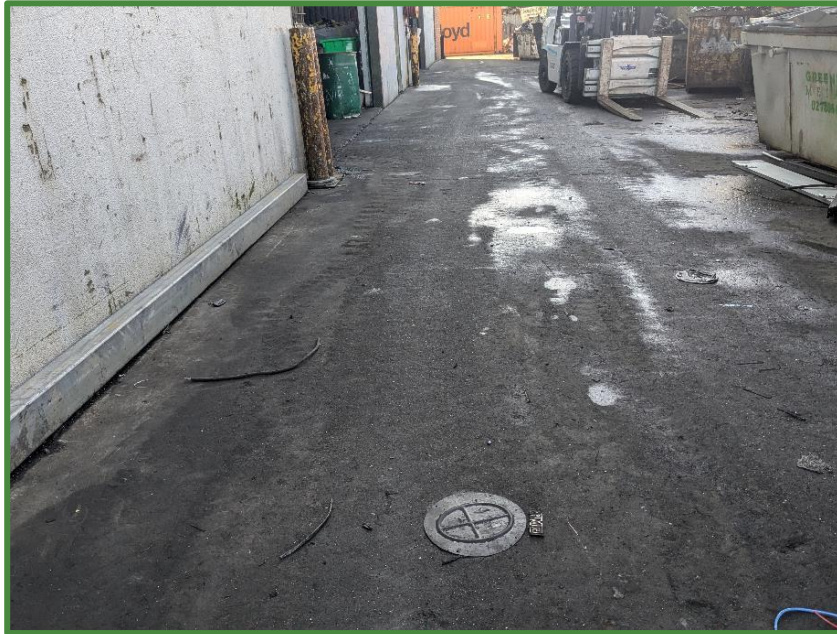
**Photograph 14:** Hardstand along southern aspect of site. Wall of metal works warehouse to left. Forklift visible to right. Storage container visible in background (viewer facing northeast).

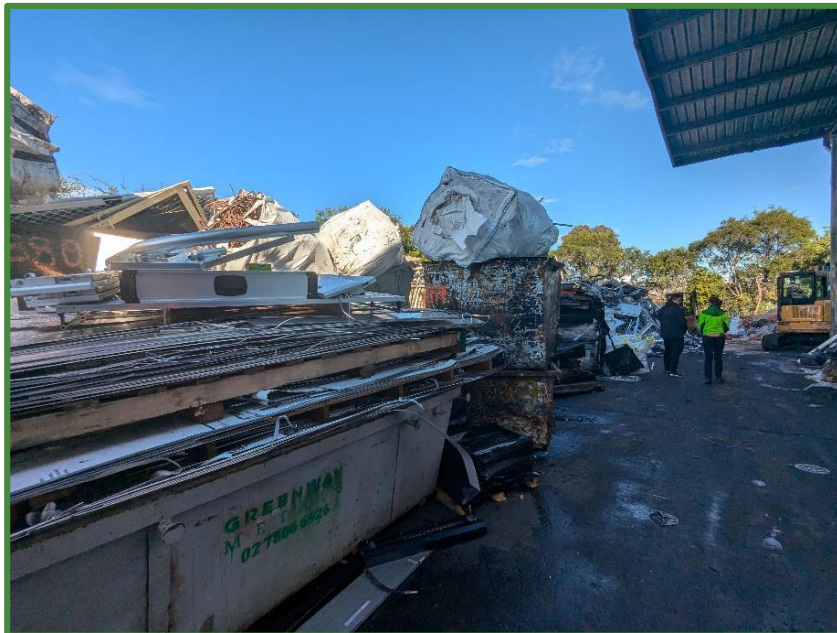
**Photograph 15:** Various external metal storage along southern boundary of site. Awning of mechanical area visible (right). Second excavator visible in background (viewer facing southwest).

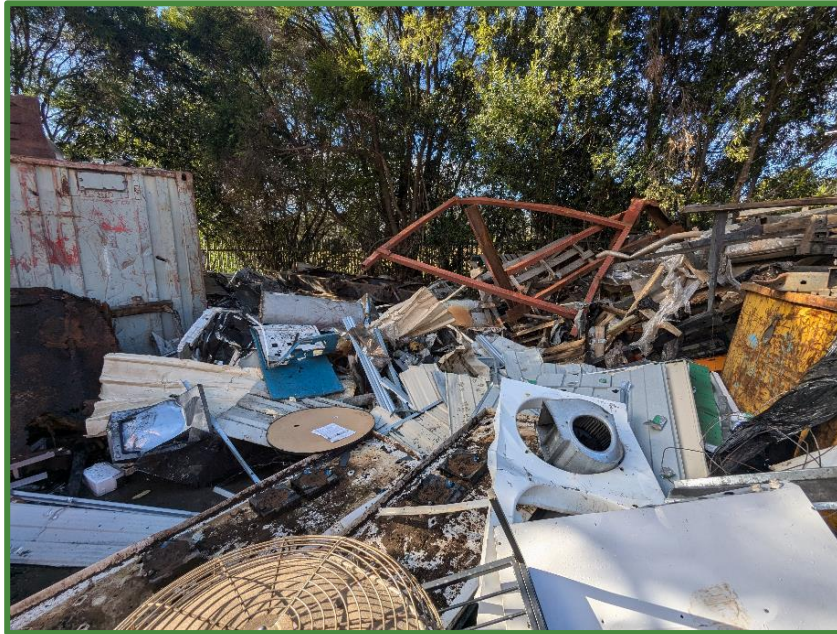
**Photograph 16:** External stockpile of various metal waste along southern boundary of site (viewer facing South).

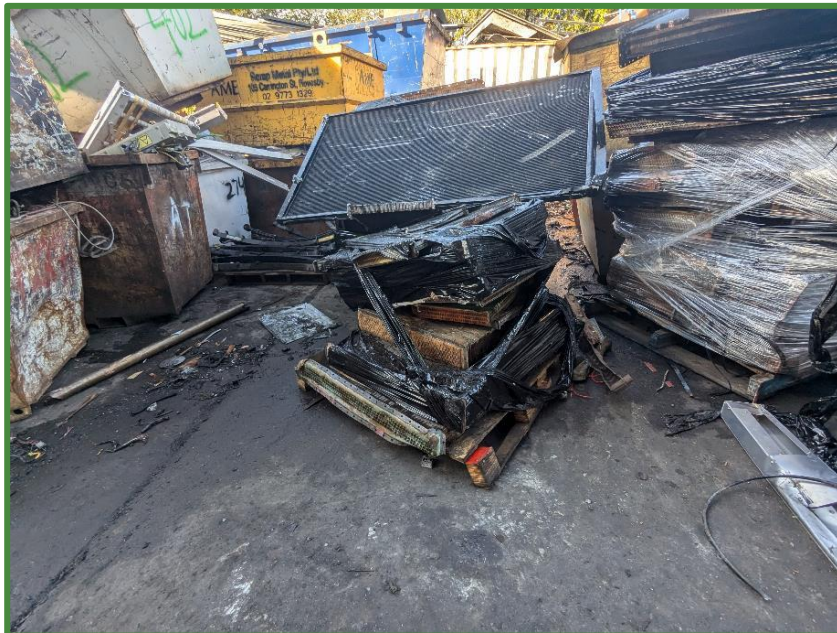
**Photograph 17:** Significantly worn pallets with radiators along southern boundary. Skip bins with various metal waste in background.

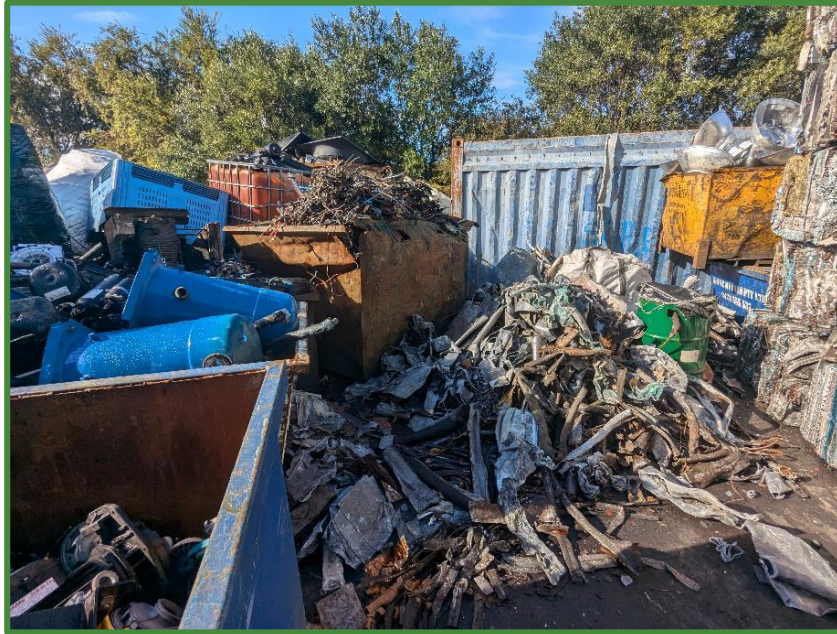
**Photograph 18:** Stockpile of metal materials stored on floor along southern aspect of facility. Skip bin with sorted wire visible. Skip bin with stripped car components visible (left). Stained red empty IBC visible. Stacked baled metal materials visible (right) (viewer facing South).

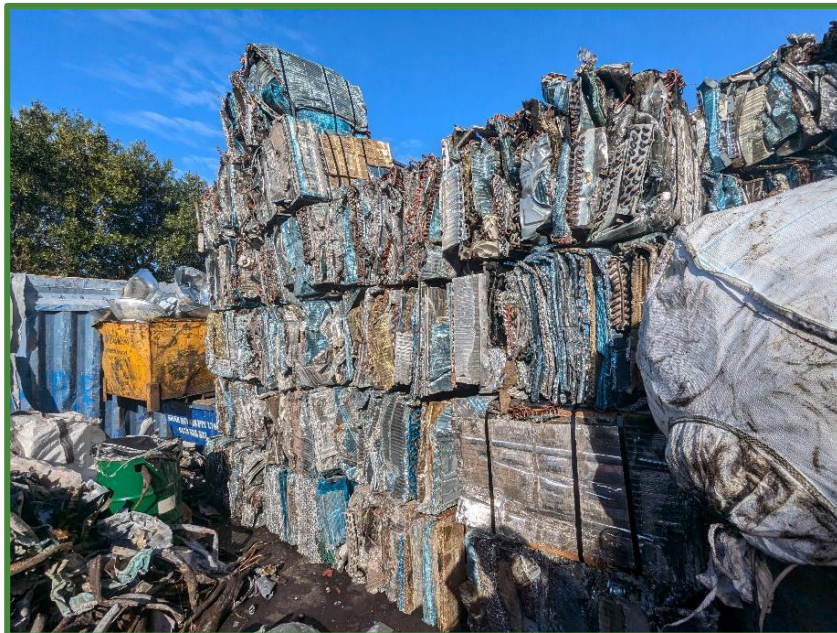
**Photograph 19:** Storage of stacked and baled metal materials (viewer facing southwest).

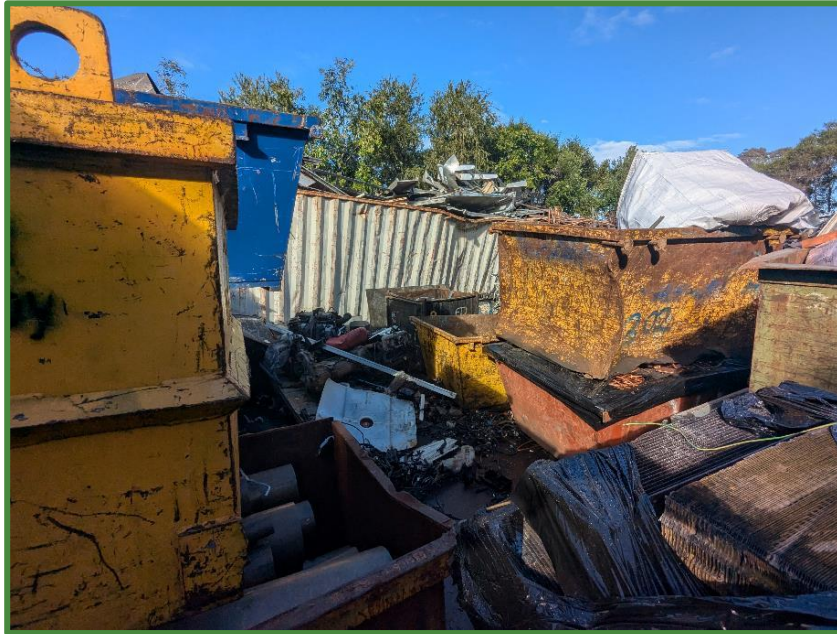
**Photograph 20:** Further storage of metal materials within skip bins and on hardstand along southern boundary of site. Copper cables visible within skip bin (right).

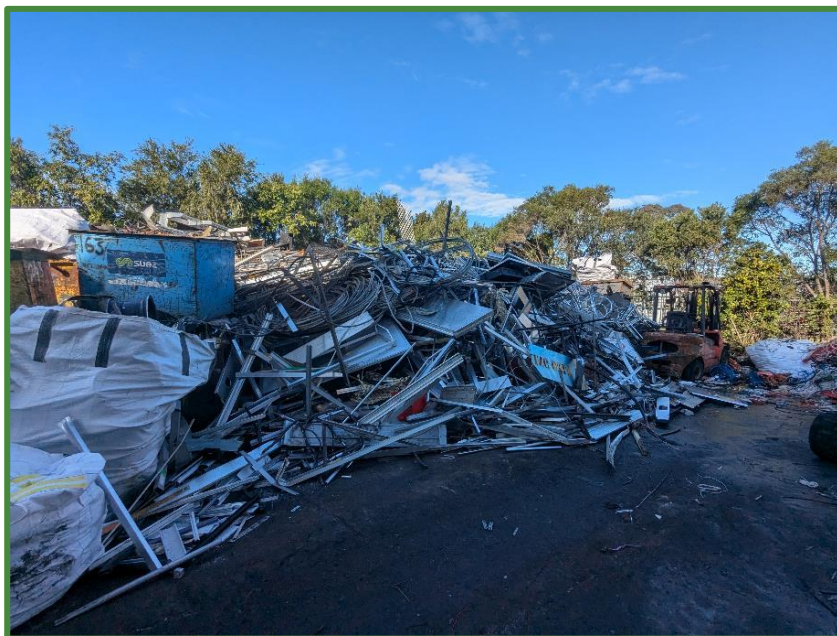
**Photograph 21:** External aluminium stockpile in Site's southwest aspect. Forklift visible (viewer facing southwest).

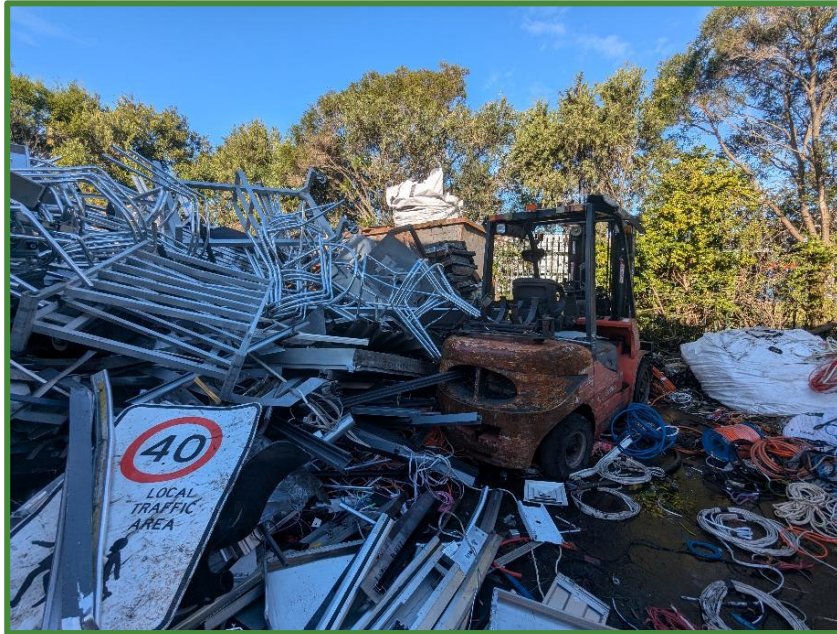
**Photograph 22:** Disused forklift in Site's southwest aspect. Aluminium stockpile on LHS of image. Wiring from stockpile is visible to the right (viewer facing West).

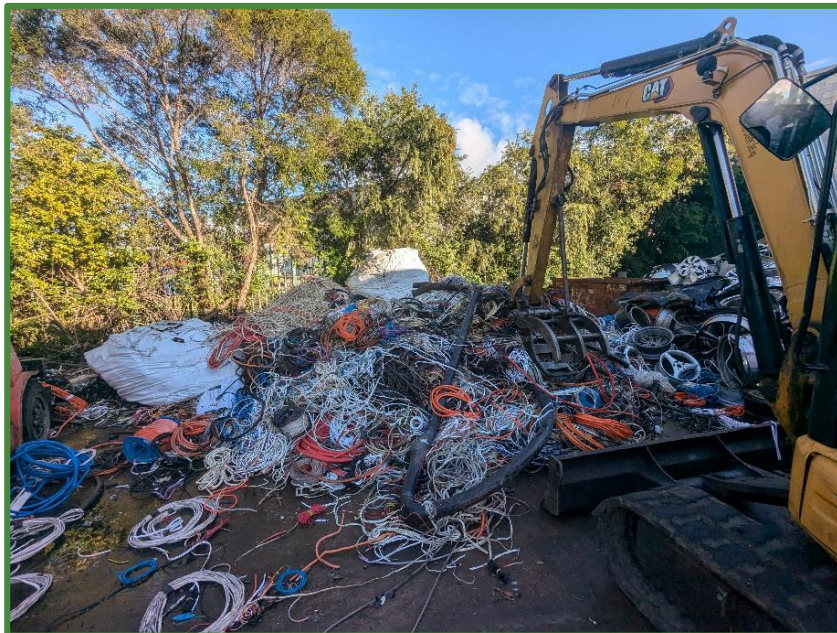
**Photograph 23:** Sorted wire stockpile in western aspect of site. Second CAT loader visible (right). Wheel stockpile visible in background (viewer facing W).

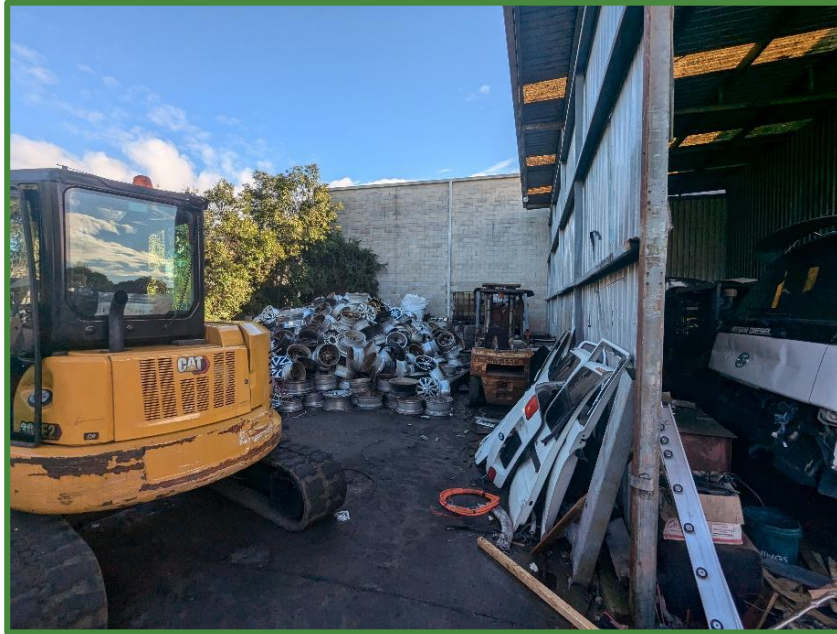
**Photograph 24:** Wheel stockpile in NW aspect of site. Three (3) IBCs against wall of adjoining building. Stripped car parts visible against steel wall of mechanical area. Forklift visible in background (viewer facing NW).

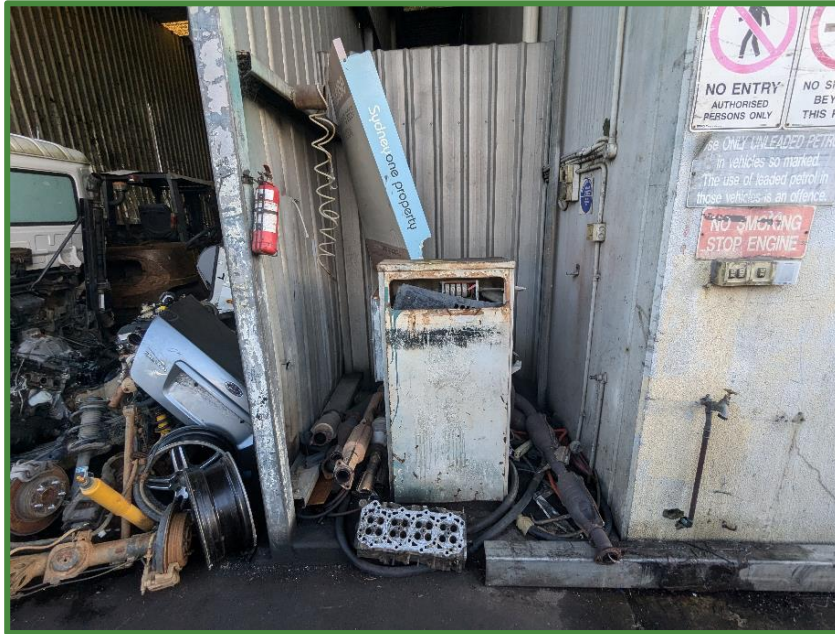
**Photograph 26:** Remains of an abandoned petrol bowser. The Water/oil separator pump system is located in the narrow room directly behind the aluminium fence. (viewer facing North).

**Note:** Information regarding the use of this bowser to fuel vehicles during past site usage, along with the location of the fuel tank (presumably underground) was not able to be procured during our visit.

The historical use and storage of fuels at the site during previous operations poses a high risk of environmental contamination to groundwater, surface water and soils. This contamination may occur through loss of integrity of UST, or its associated underground pipes, leading to fuel leaking into the soil and entering groundwater beneath the site. Further, as the site is not bunded, historical spills that may have occurred during vehicle refuelling could have entered the stormwater or into soils from gaps in the hardstand.

Further investigation regarding the location of the UST and its potential environmental contamination is highly recommended.

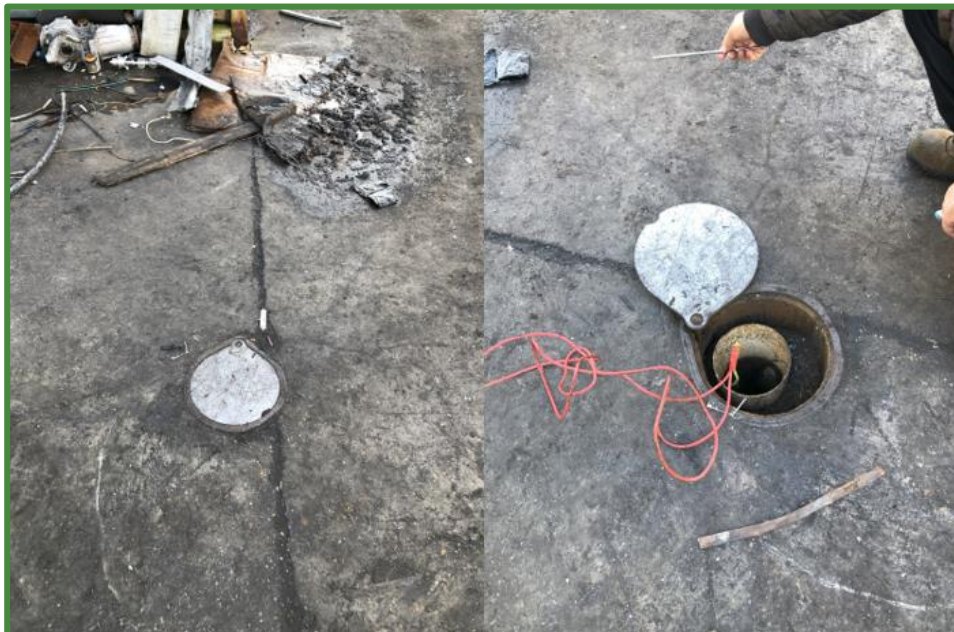
**Photograph 27:** Earthing cables that were located a few metres west of the bowser. These are attached to tanker trucks during refuelling to prevent discharge of static electricity causing a potential fire.

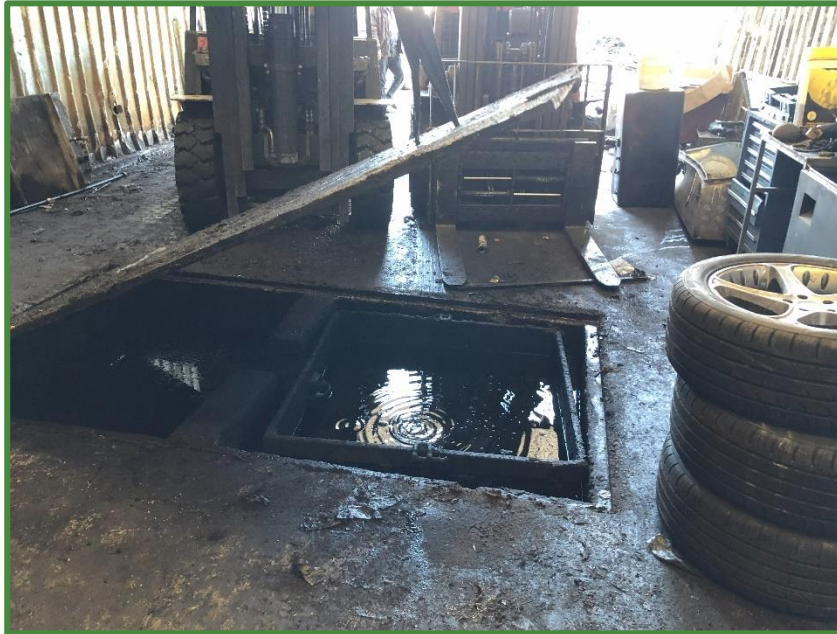
**Photograph 28:** The pit used to collect waste oil from engines. The pit is covered by a steel plate with slits to allow the oil to collect in the bucket located beneath.

A detailed site investigation (DSI) is considered warranted to determine if contamination of the Site's soils has occurred due to historical site activities, especially from the oil collection pit area and from the potential UST. Use of ground penetrating radar is recommended to help locate the UST, most likely located beneath the Site's western handstand area.

One (1) underground pit is contained beneath the mechanical area that captures oil drained from vehicle parts and engines. If the integrity of the pit is not regularly and properly maintained, contamination from motor oils may occur finding pathways through cracks/seams to enter the environment (soils/groundwater). Contamination of the environment through the pit system is uncertain. Further investigation regarding these pits and their potential environmental impacts is recommended.

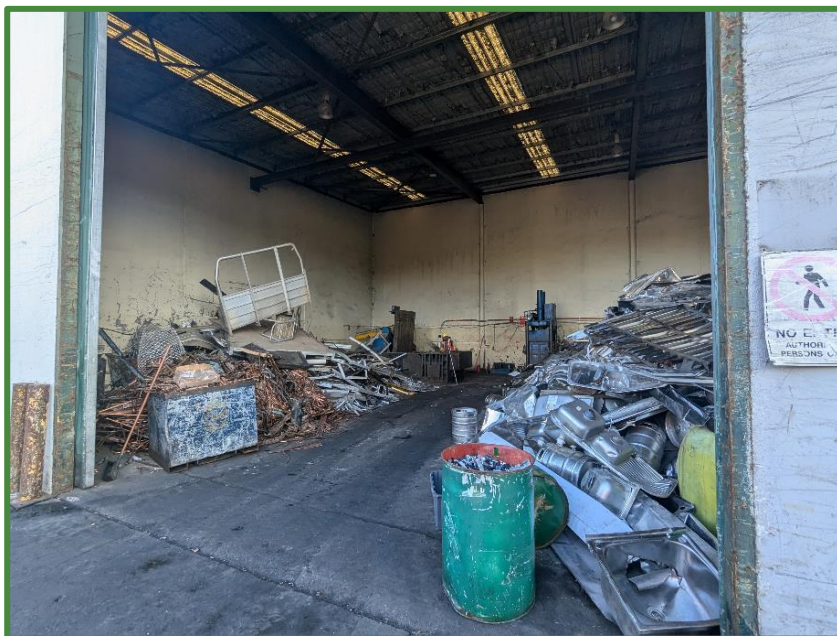
**Photograph 29:** Left access roller door of metal workshop area. Sorted copper storage visible (left). Steel storage stockpile visible (right). Baler visible (back right) viewer (viewer facing NE).

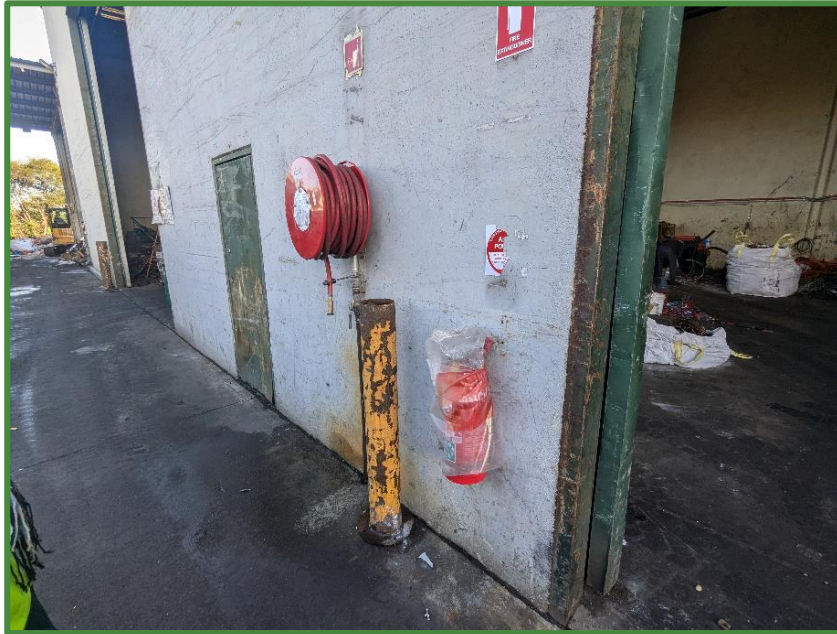
**Photograph 30:** Central aspect of metalworks building. Firefighting equipment visible affixed to external wall (viewer facing NW).

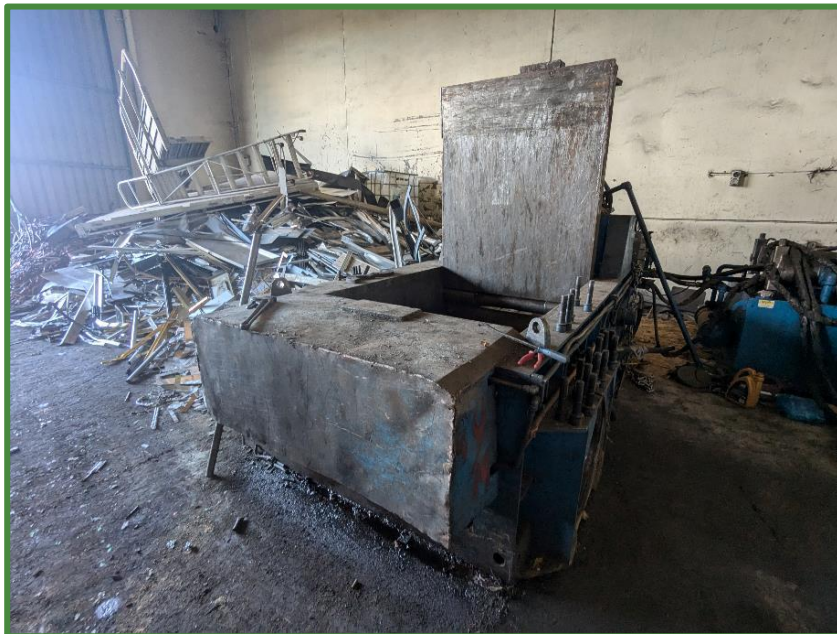
**Photograph 31:** Metal baler within metalworks building (not operational during visit). Note probable loss of hydraulic oil beneath the baler. An aluminium stockpile is visible in background. Hydraulic pump is visible to the right. Sand across floor visible along western wall of building (viewer facing southwest).

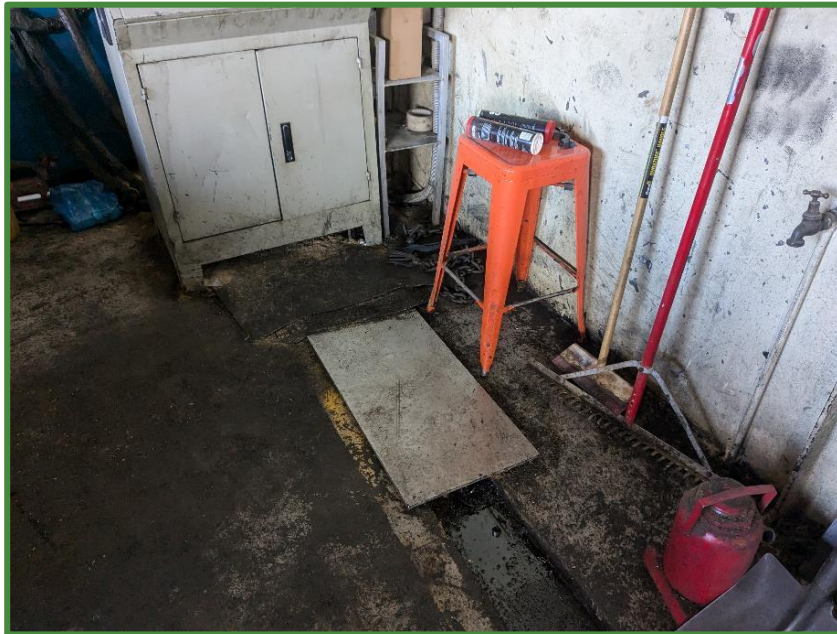
**Photograph 32:** Northwestern corner of the metalworks building. Note the open drain. This collects fluids along the building's northern boundary. Storage cabinet in corner (contents unknown).

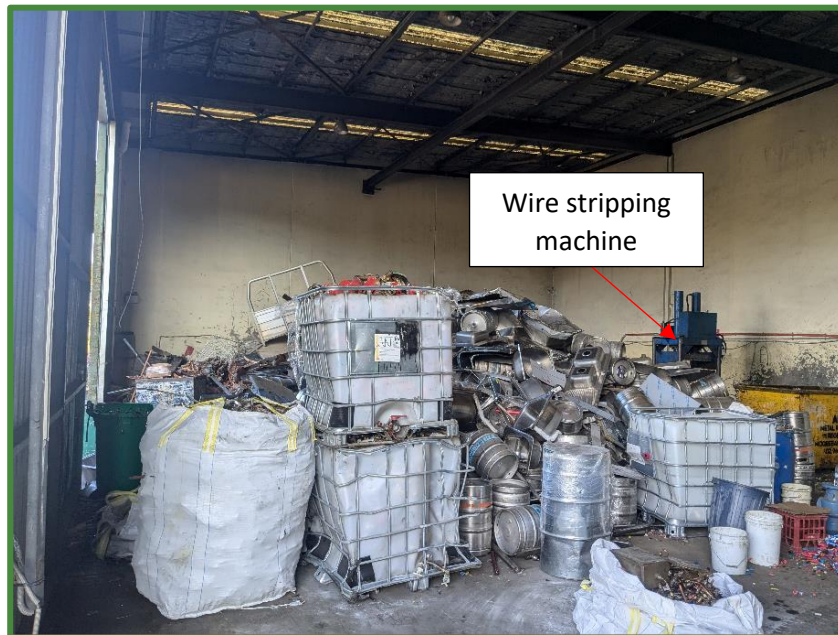
**Photograph 34:** Steel stockpile in centre of metal works building. Two (2) empty IBCs visible. Wire stripper visible in background. Large bag of sorted metal material visible (facing West).

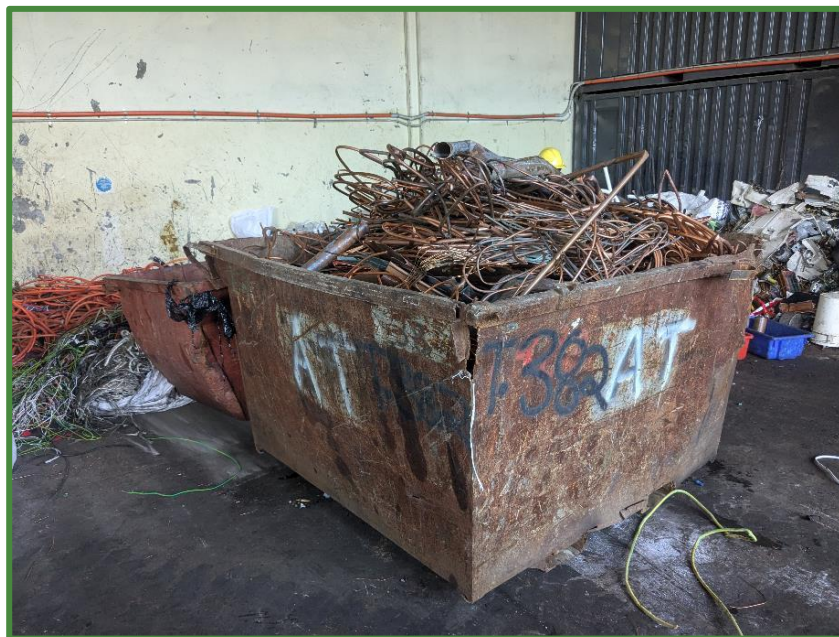
**Photograph 35:** Bin of stripped copper within metal works building (facing northeast).

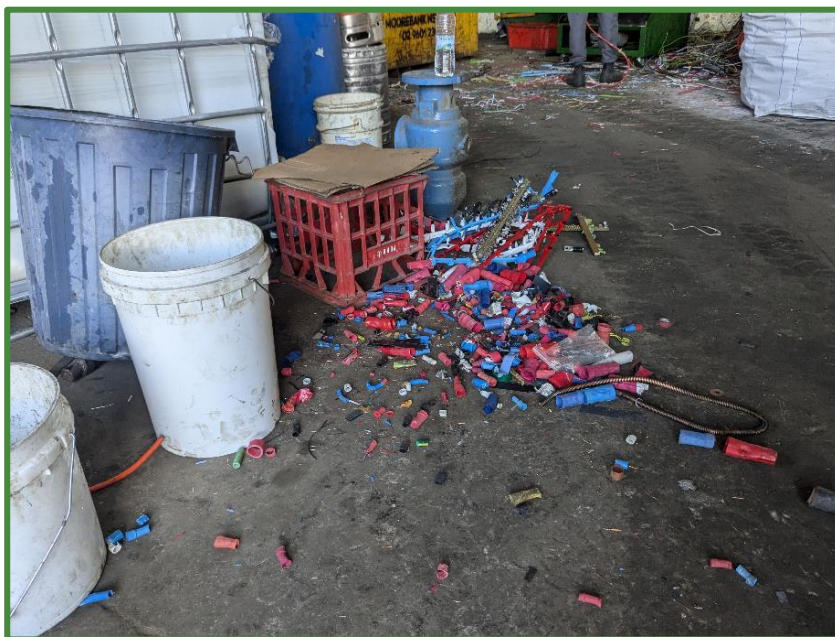
**Photograph 36:** Sorted plastics area sourced from stripped wires and other scrap metal goods. Plastics are sent to landfill (facing E).

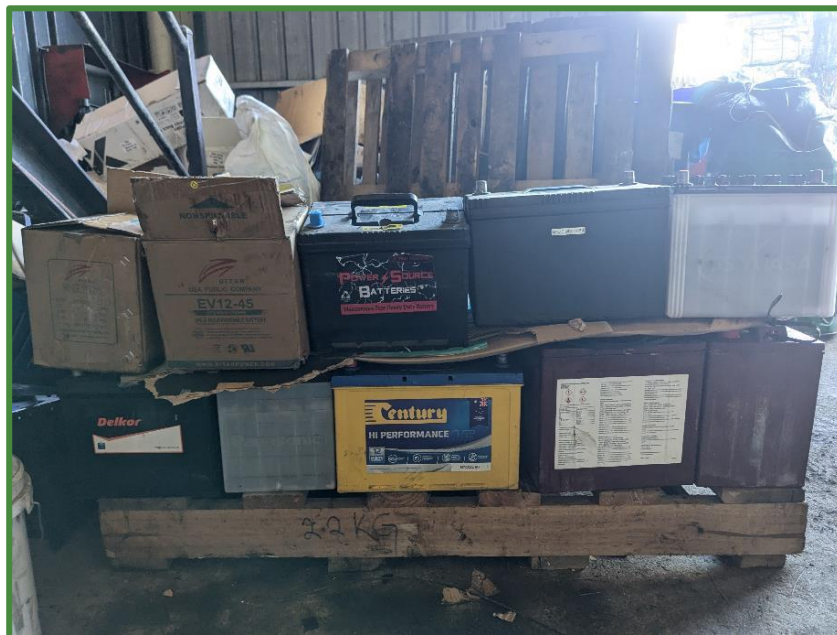
**Photograph 38:** Lead-acid batteries stored on pallet within metal works building. Batteries are sent for off-site for recycling (viewer facing SE).

Lead-acid batteries were stored in minor quantities on pallets in the sorting building. It is recommended that these batteries are stored within a bunded area to minimise potential contamination risk.

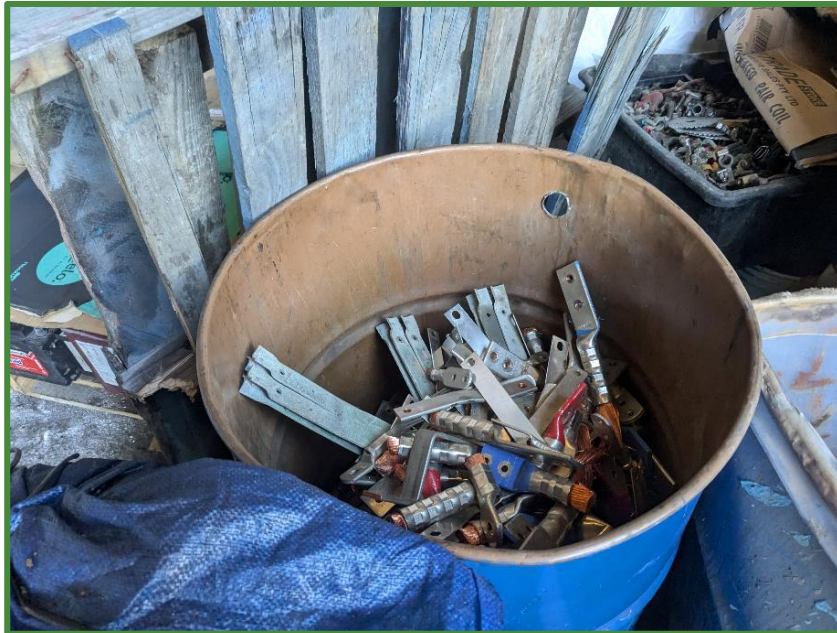
**Photograph 40:** Steel drum housing sorted metal components.

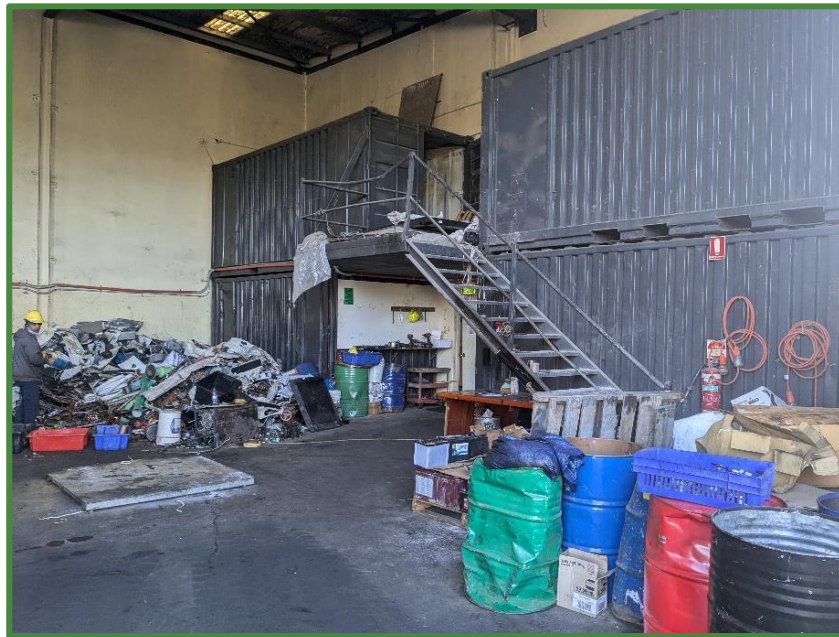
**Photograph 42:** Mezzanine area within metal works building. Four (4) container rooms utilised for storage are visible. Unsorted metal is visible in background (viewer facing N).
