Cabramatta East Precinct Development Remedial Action Plan

Moon Investments Pty Ltd

Report

11 July 2023

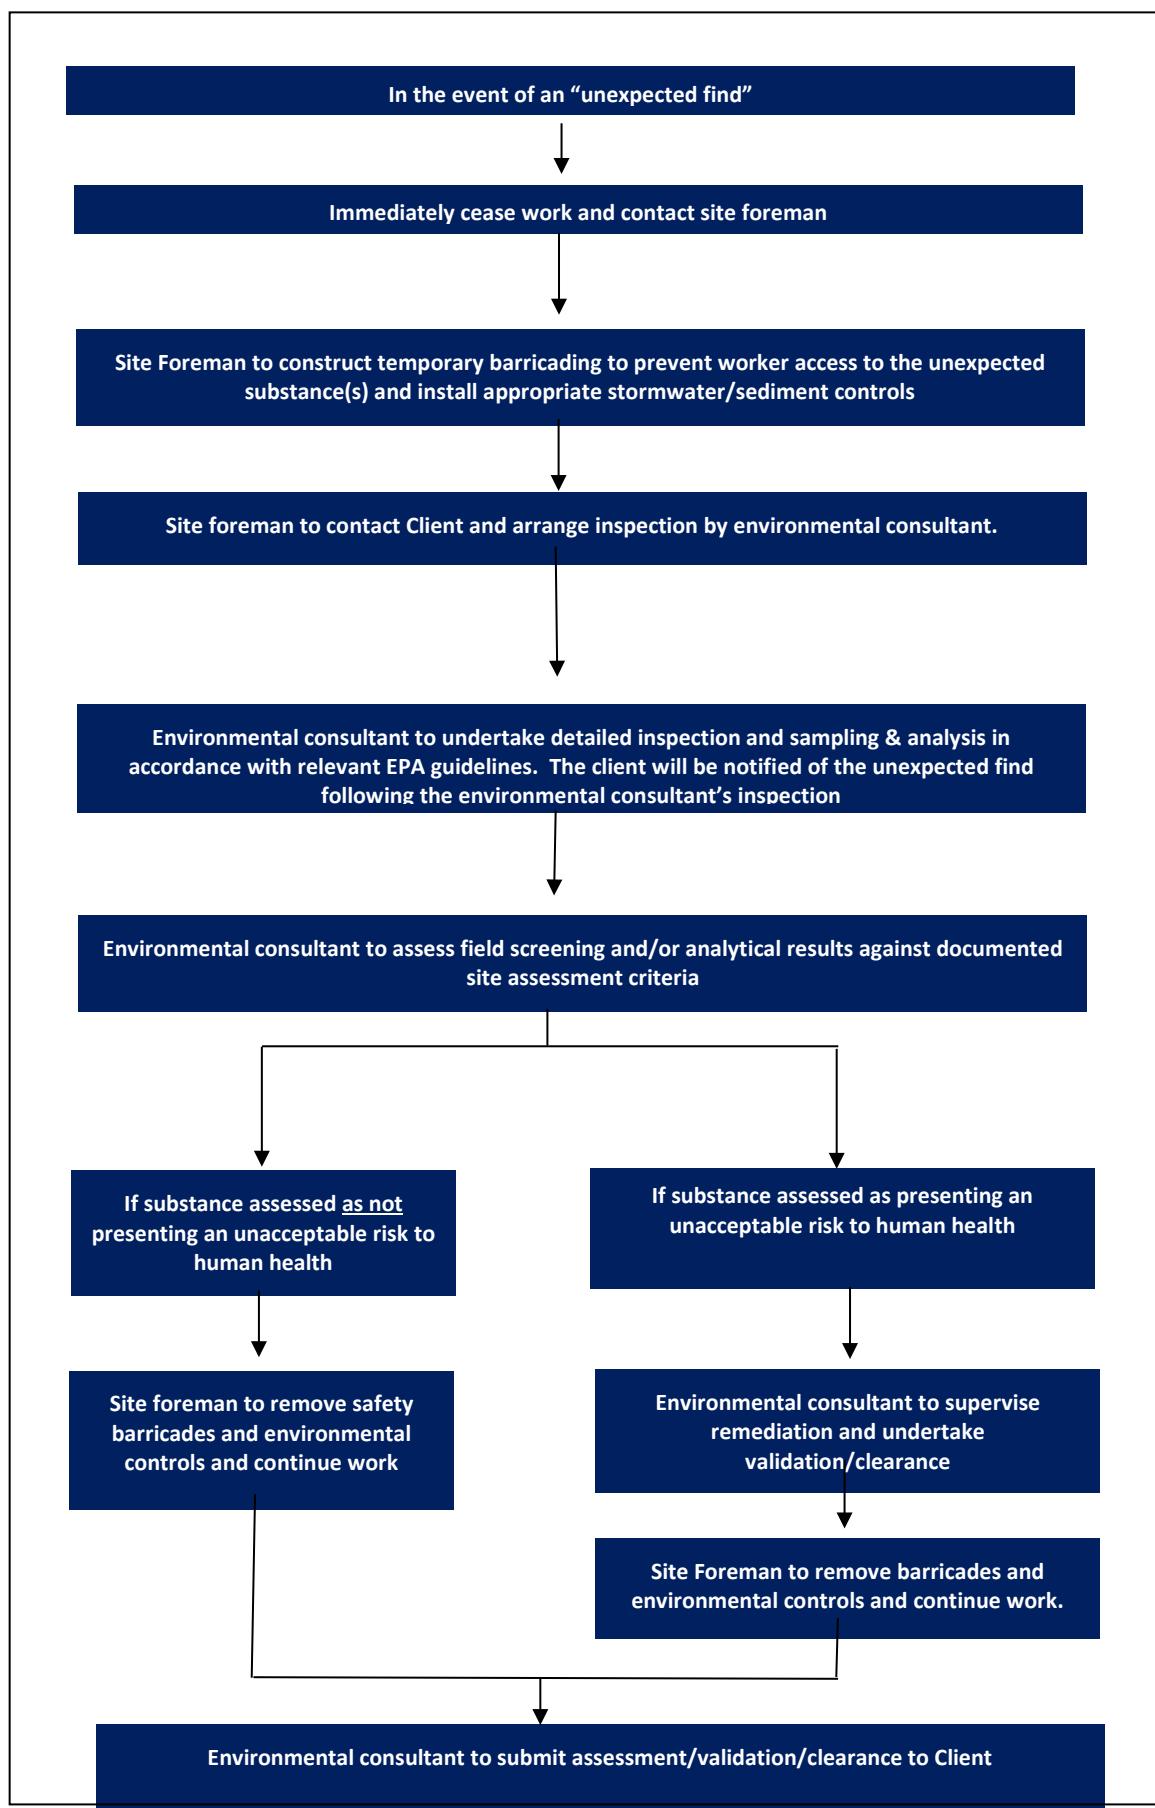
Figure 9.1: Unexpected Finds Protocol

As a precautionary measure to ensure the protection of the workforce and surrounding community, should any of the abovementioned substances (or any other unexpected potentially hazardous substance) be identified, the procedure summarised in **Figure 9.1** is to be followed.

The sampling strategy for each “unexpected find” shall be designed by a suitably qualified environmental consultant. The strategy will, however, be aimed at determining the nature of the substance – that is, is it hazardous and, if so, is it at concentrations which pose an unacceptable risk to human health or the environment.

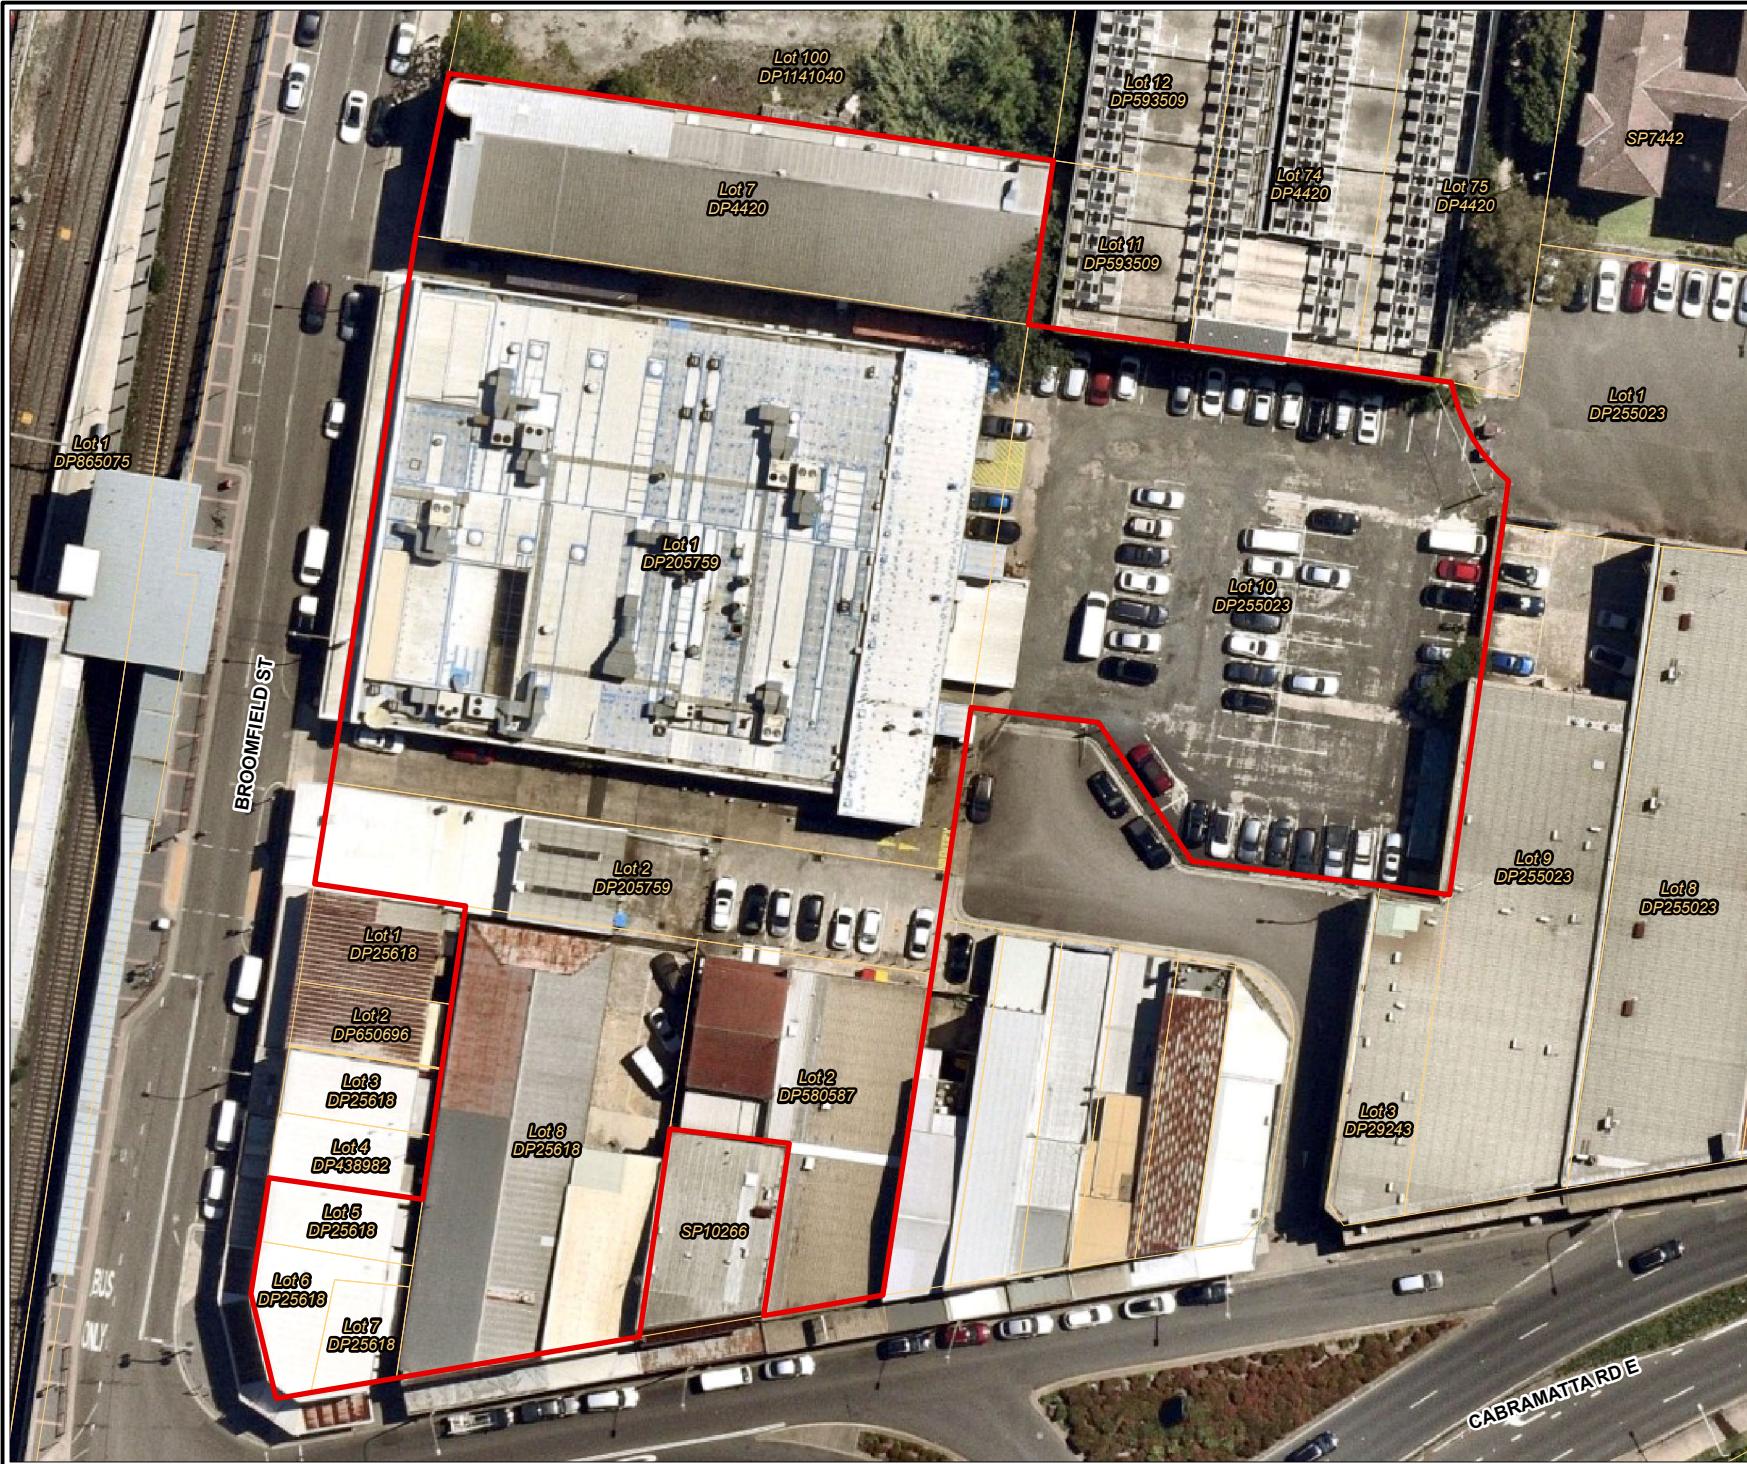
FIGURE 1

SITE LOCATION

JBS&G Australia Pty Ltd (JBS&G) was engaged by Moon Investments Pty Ltd (the client) to produce a Remedial Action Plan (RAP) for land located at 76-86 Broomfield Street and 139 & 147-151 Cabramatta Road East, Cabramatta NSW (the site), legally identified as Lot 7 Section E in Deposited Plan (DP) 4420, Lots 1 & 2 DP 205759, Lot 10 DP 255023, Lots 5 to 8 DP 25618 and Lot 2 DP 580587. The combined total area of the site is approximately 0.8 hectares. The site location and layout are presented on **Figure 1** and **Figure 2**, respectively.

The site location is shown on **Figure 1**. The site layout and associated cadastral boundaries are shown on **Figure 2**. The site details are summarised in **Table 2.1** and described in detail in the following sections.

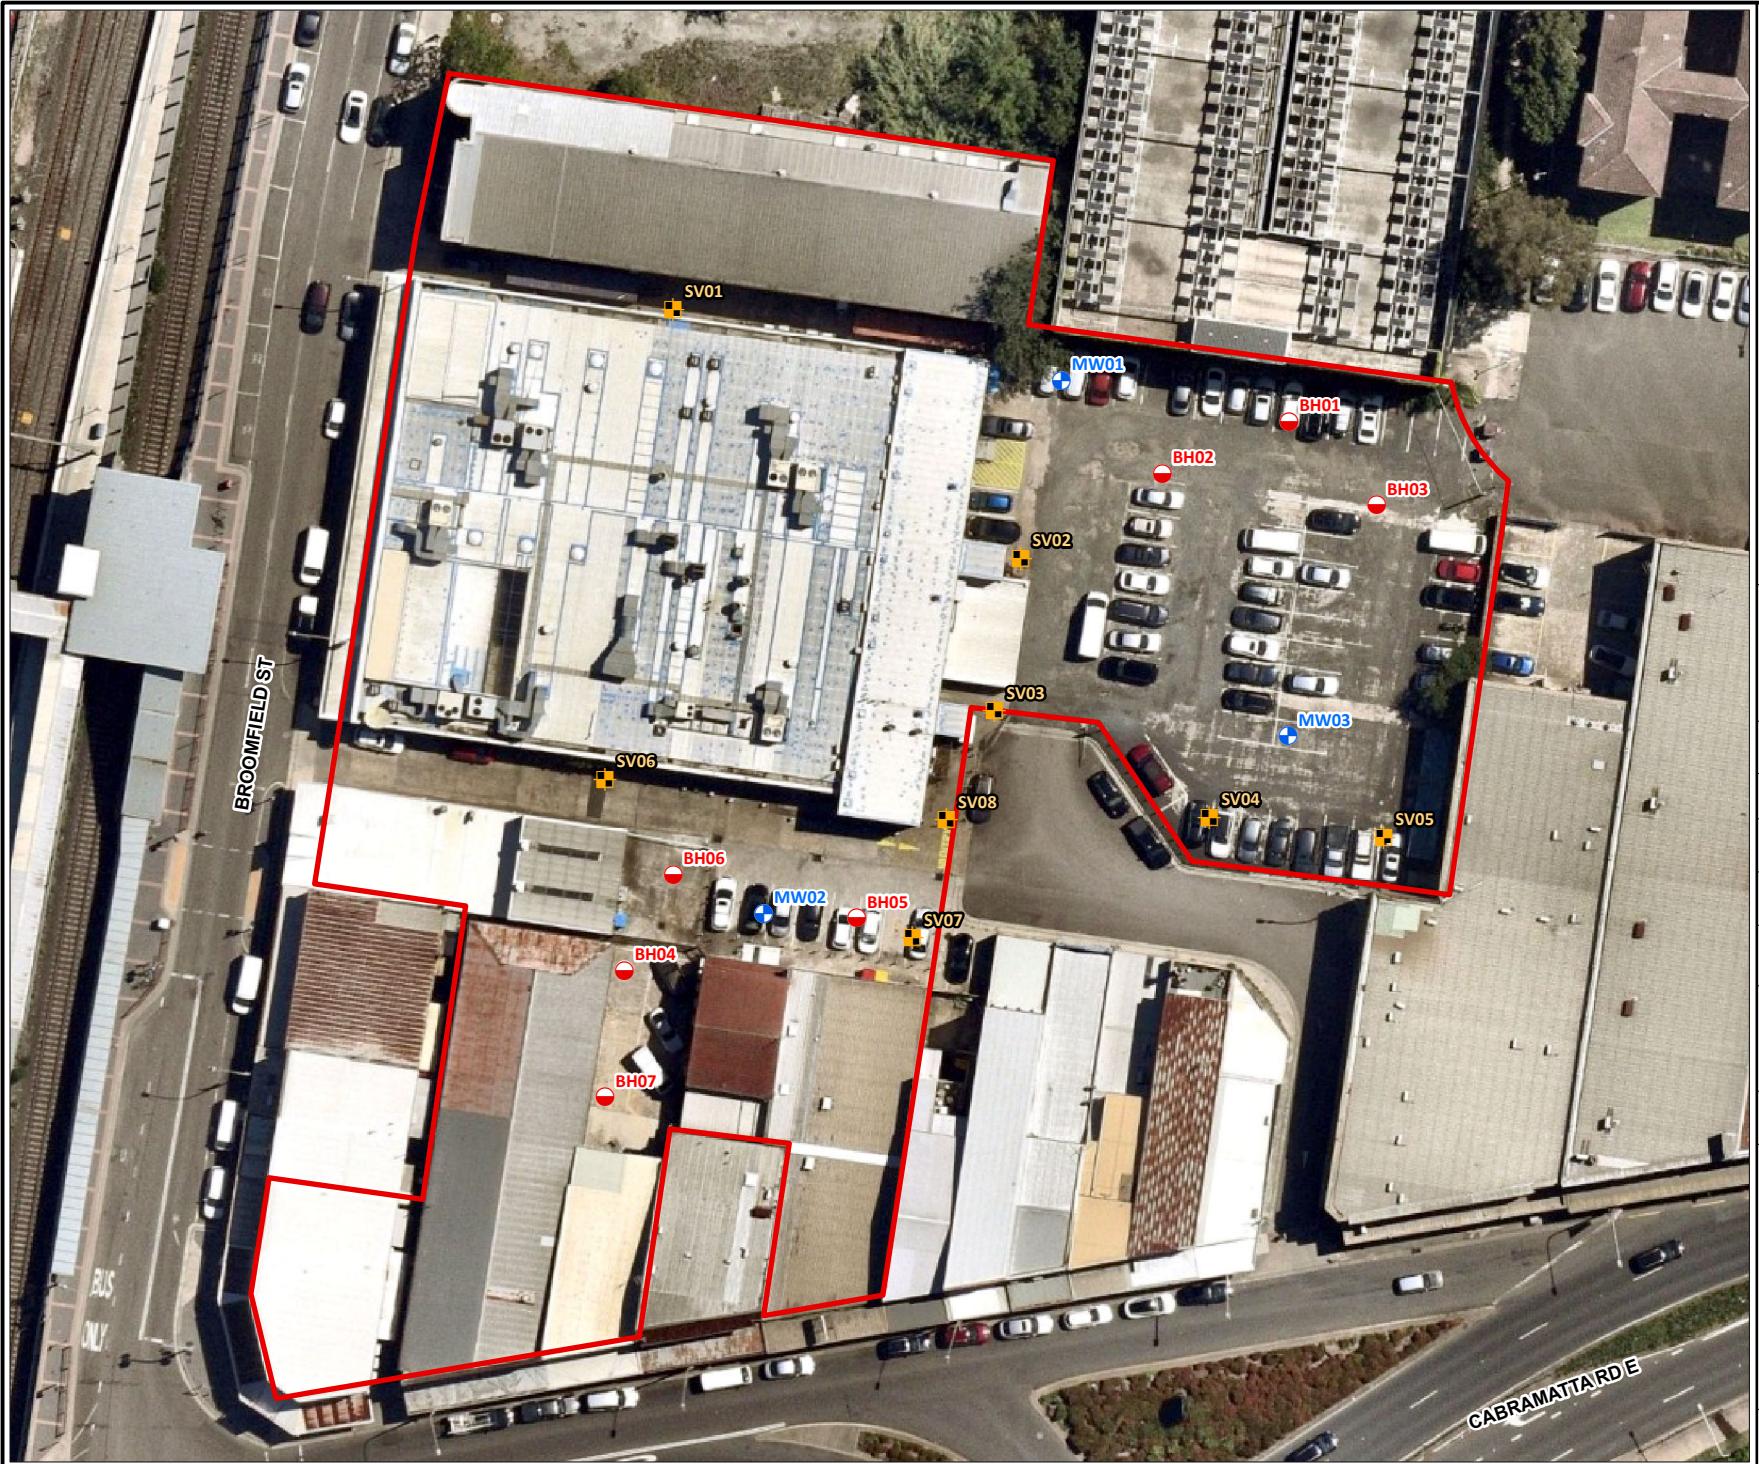
FIGURE 3

- Approximate Site Boundary
- Sample Locations (JBS&G, 2023)
- Borehole
- Monitoring Well
- Soil Vapour

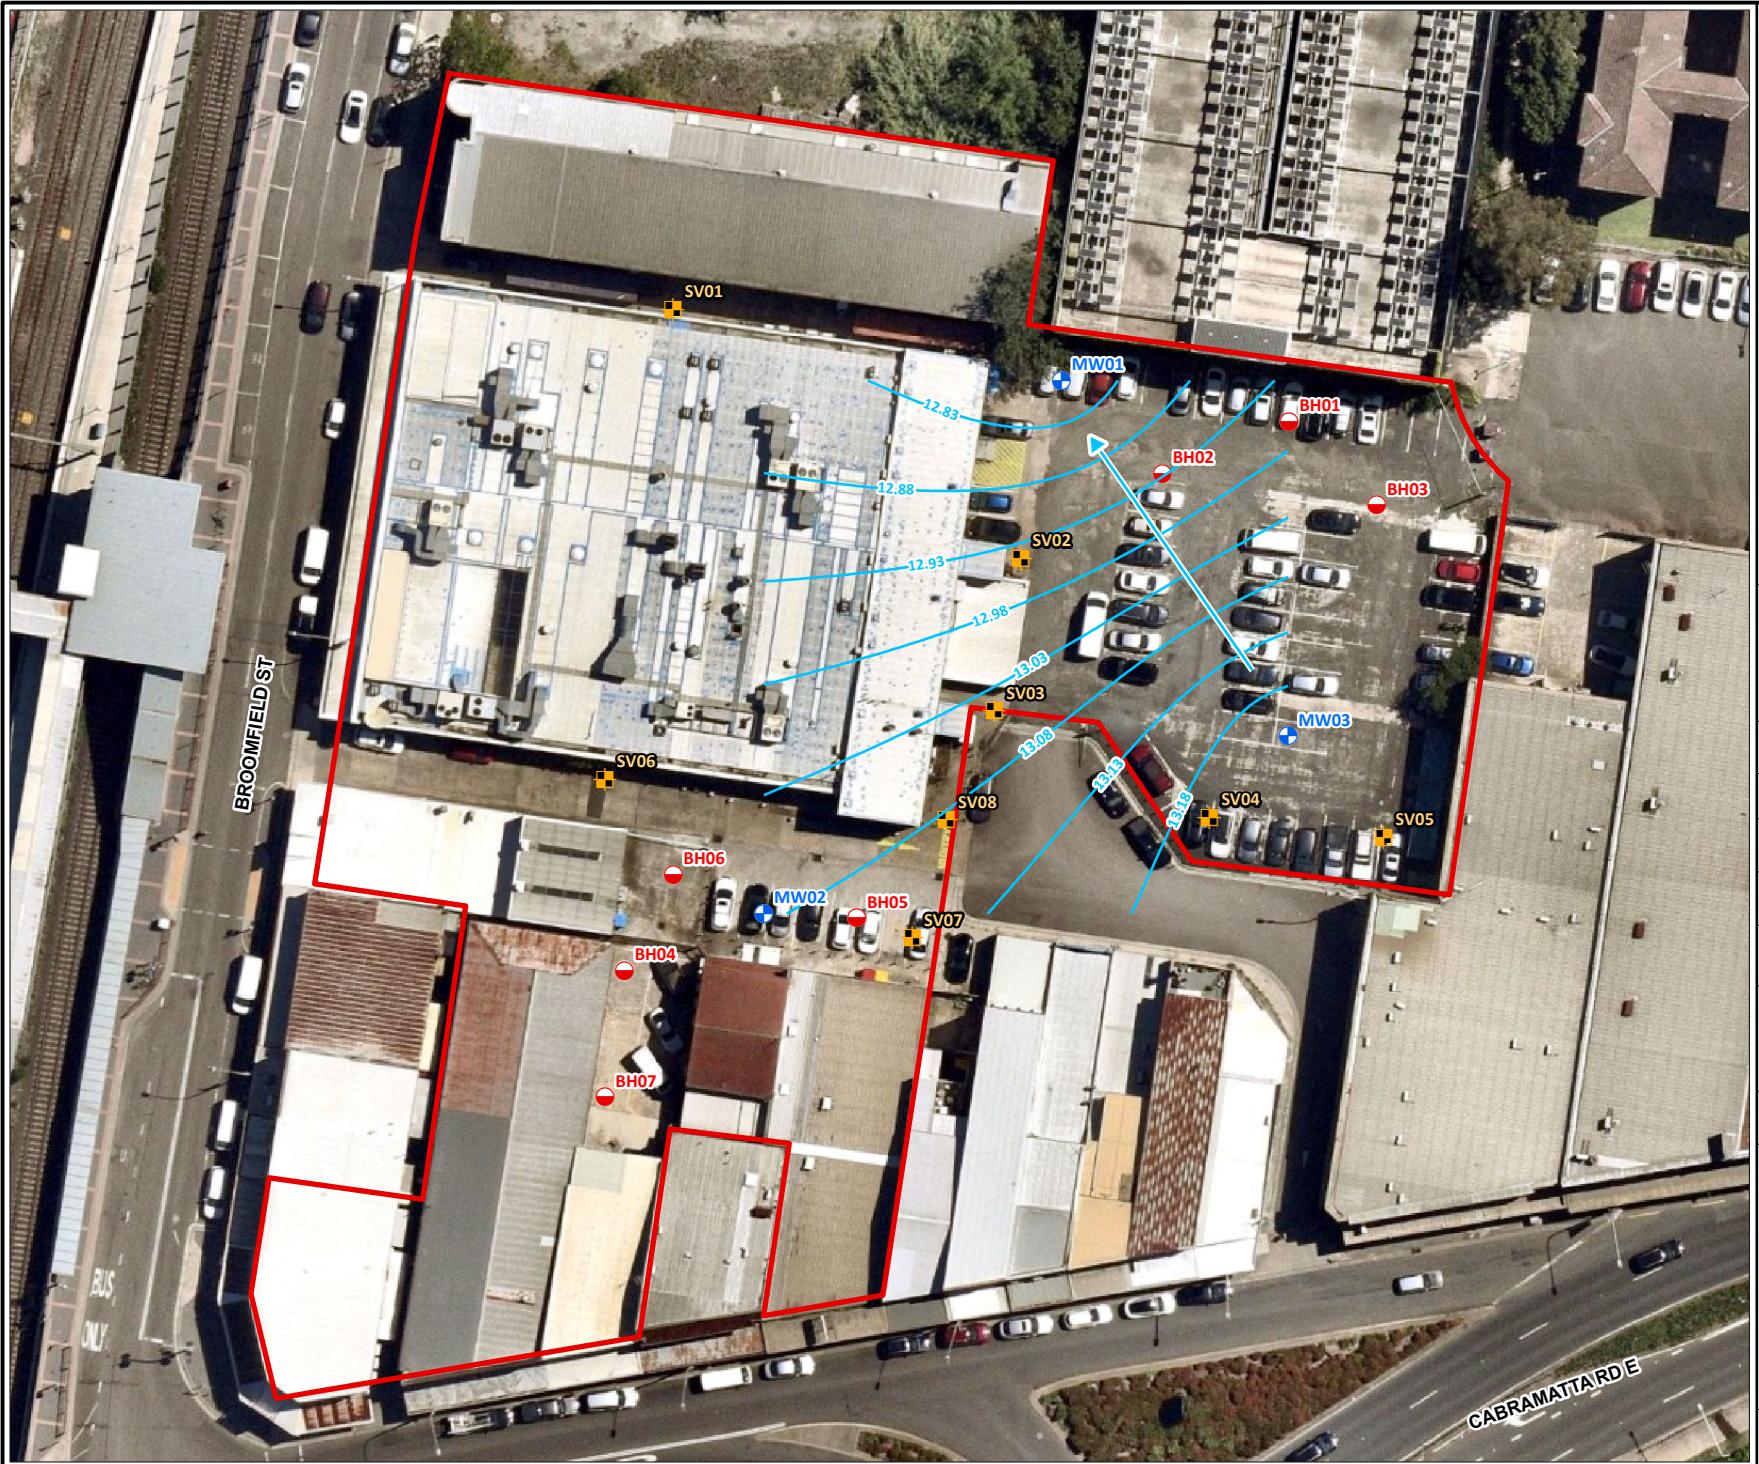
SAMPLE LOCATIONS

- Approximate Site Boundary
- Inferred Ground Water Flow
- Standing Water Level (AHD)
- Sample Locations (JBS&G, 2023)
- Borehole
- Monitoring Well
- Soil Vapour

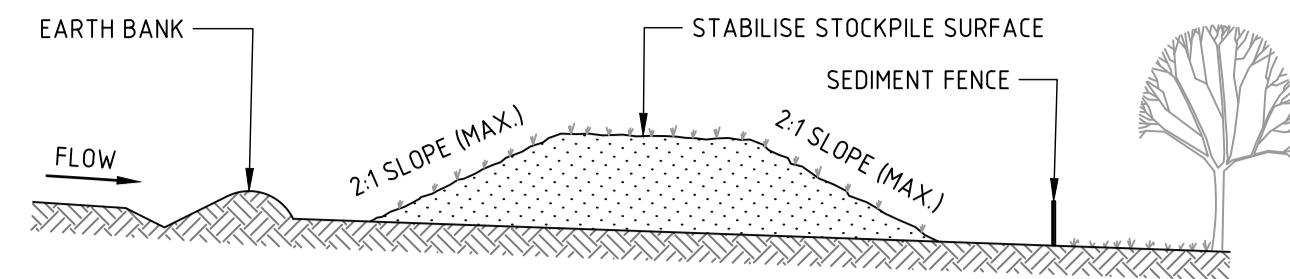
STOCKPILE

- PLACE STOCKPILES MORE THAN 2m (PREFERABLY 5m) FROM EXISTING VEGETATION, CONCENTRATED WATER FLOW, ROADS AND HAZARD AREAS.
- CONSTRUCT ON THE CONTOUR AS LOW, FLAT, ELONGATED MOUNDS.
- WHERE THERE IS SUFFICIENT AREA, TOPSOIL STOCKPILES SHALL BE LESS THAN 2m IN HEIGHT.
- WHERE THEY ARE TO BE IN PLACE FOR MORE THAN 10 DAYS, STABILISE FOLLOWING THE APPROVED SWMP OR ESCP TO REDUCE THE C-FACTOR TO LESS THAN 0.10.
- CONSTRUCT EARTH BANKS (STANDARD DRAWING 5-5) ON THE UPSLOPE SIDE TO DIVERT WATER AROUND STOCKPILES AND SEDIMENT FENCES (STANDARD DRAWING 6-8) 1 TO 2m DOWNSLOPE.

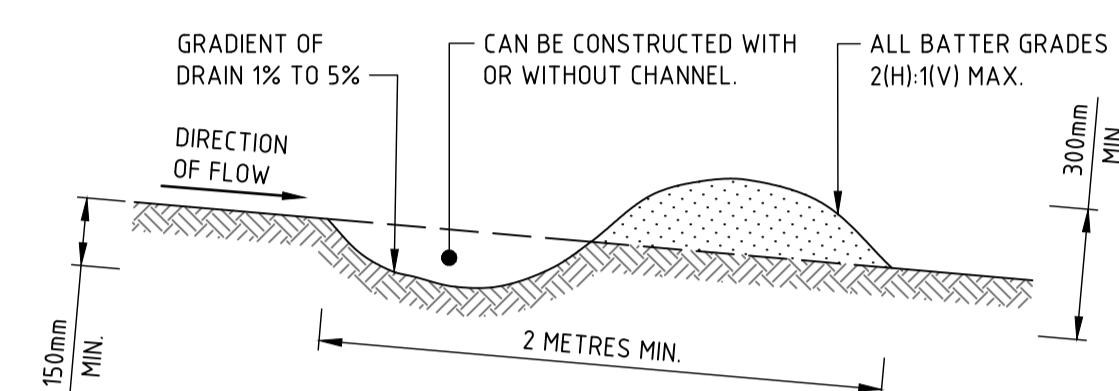
DRAINAGE SWALE - LOW FLOW

- BUILD WITH GRADIENTS BETWEEN 1 AND 5 PERCENT.
- AVOID REMOVING TREES AND SHRUBS IF POSSIBLE - WORK AROUND THEM.
- ENSURE THE STRUCTURES ARE FREE OF PROJECTIONS OR OTHER IRREGULARITIES THAT COULD IMPEDE WATER FLOW.
- BUILD THE DRAINS WITH CIRCULAR, PARABOLIC OR TRAPEZOIDAL CROSS SECTIONS, NOT V SHAPED.
- ENSURE THE BANKS ARE PROPERLY COMPAKTED TO PREVENT FAILURE.
- COMPLETE PERMANENT OR TEMPORARY STABILISATION WITHIN 10 DAYS OF CONSTRUCTION.

NOTE: ONLY TO BE USED AS TEMPORARY BANK
WHERE MAXIMUM UPSLOPE LENGTH IS 80 METRES.

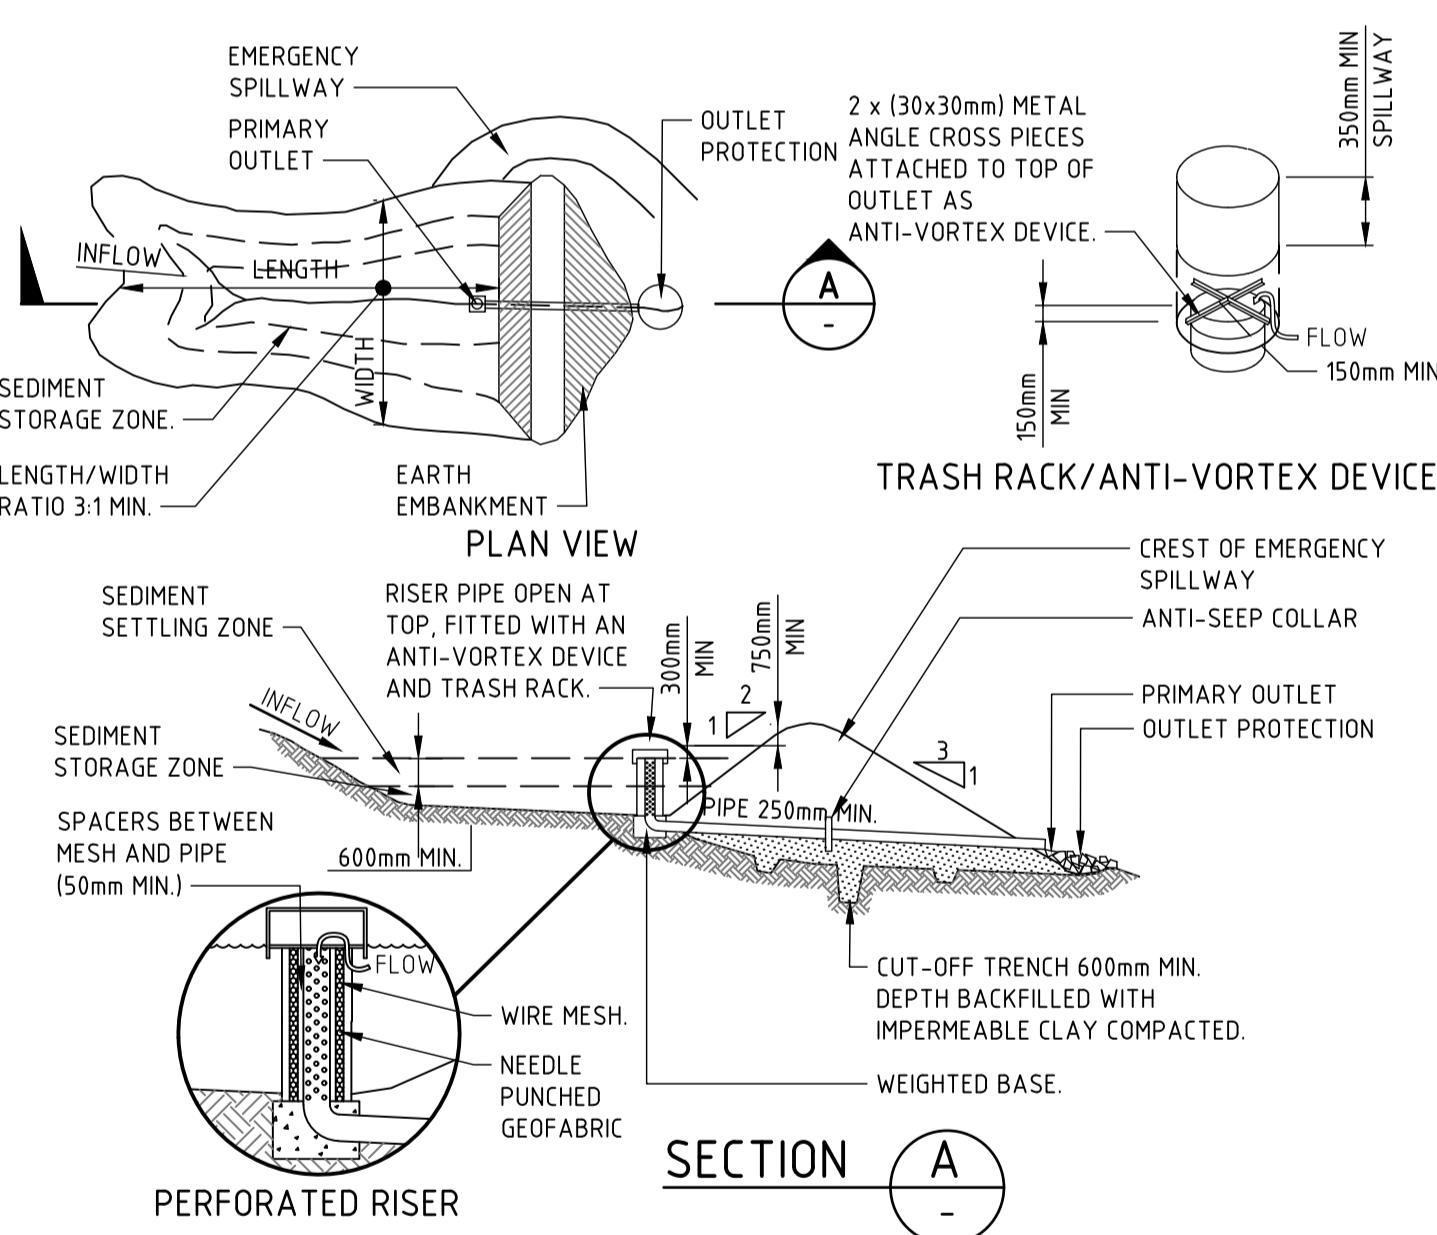
(APPLIES TO 'TYPE C' SOILS ONLY)
EARTH BASIN - DRY

- REMOVE ALL VEGETATION AND TOPSOIL FROM UNDER THE DAM WALL AND FROM WITHIN THE STORAGE AREA.
- FORM A CUT OFF TRENCH UNDER THE CENTRELINE OF THE EMBANKMENT 600mm DEEP AND 1200mm WIDE, EXTENDING TO A POINT ON THE WATERCOURSE WALL ABOVE THE RISER SILL LEVEL.

- PREPARE THE SITE UNDER THE EMBANKMENT BY RIPPING TO AT LEAST 100mm TO HELP BOND THE COMPAKTED FILL TO THE EXISTING SUBSTRATE.
- SPREAD THE FILL IN 100mm TO 150mm LAYERS AND COMPACT IT AT OPTIMUM MOISTURE CONTENT FOLLOWING THE SWMP.

- INSTALL THE PIPE OUTLET WITH SEEPAGE COLLARS AS SPECIFIED IN THE SWMP AND STANDARD DRAWING 6-3B.
- FORM BATTER GRADES AT 2(H:1)V UPSTREAM AND 3(H:1)V DOWNSTREAM OR AS SPECIFIED IN THE SWMP.

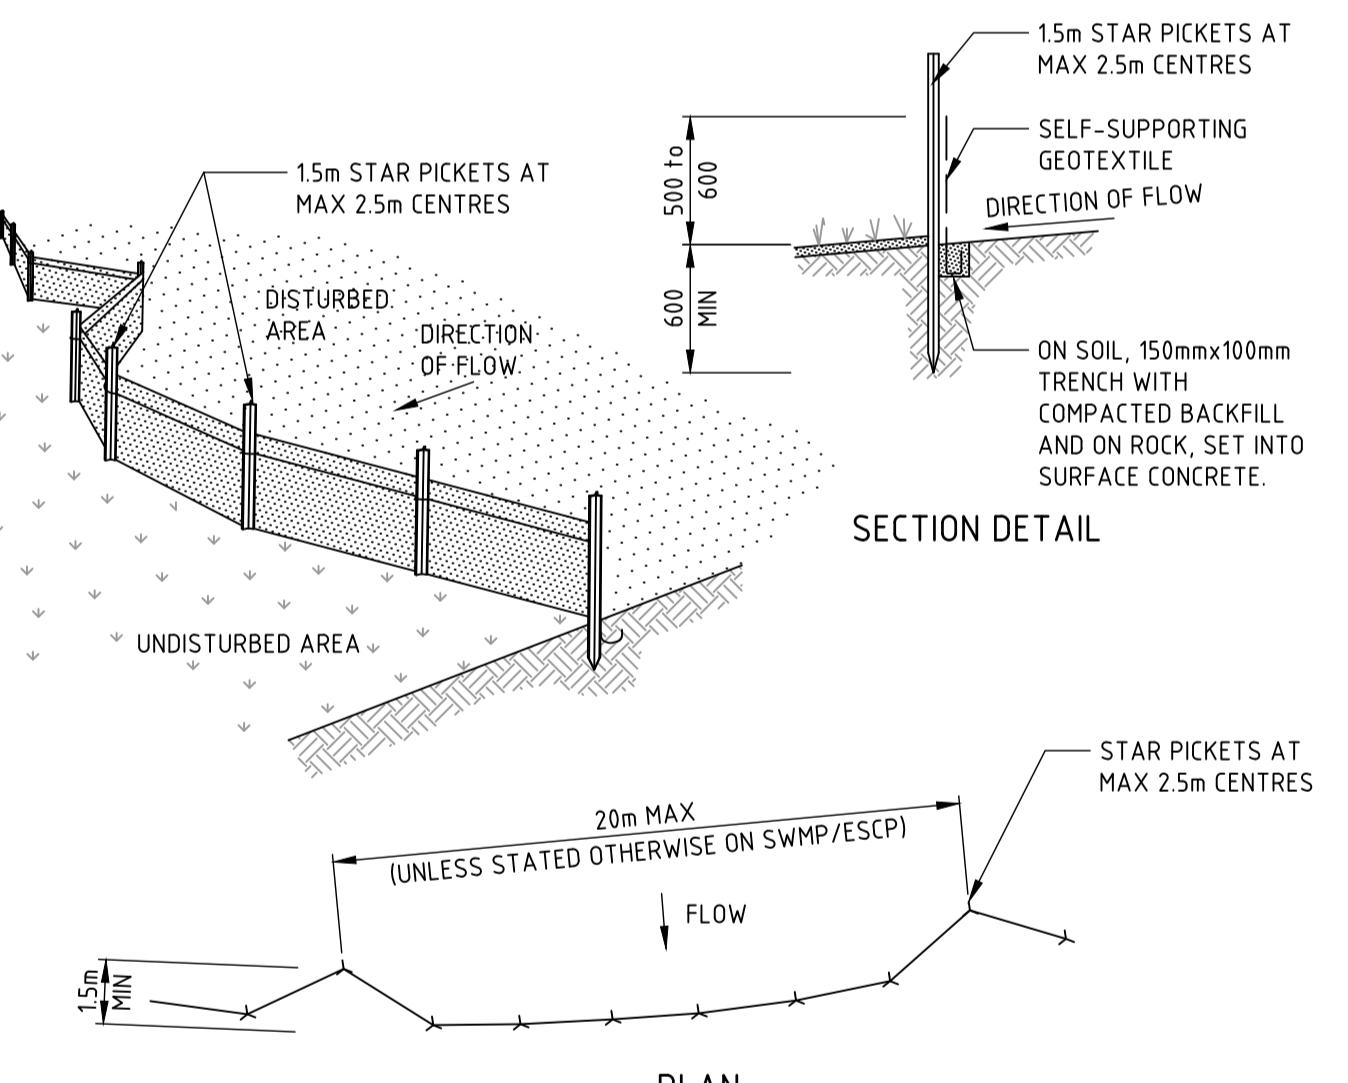
SEDIMENT FENCE

- CONSTRUCT SEDIMENT FENCES AS CLOSE AS POSSIBLE TO BE PARALLEL TO THE CONTOURS OF THE SITE, BUT WITH SMALL RETURNS AS SHOWN IN THE DRAWING TO LIMIT THE CATCHMENT AREA OF ANY ONE SECTION. THE CATCHMENT AREA SHOULD BE SMALL ENOUGH TO LIMIT WATER FLOW IF CONCENTRATED AT ONE POINT TO 50 LITRES PER SECOND IN THE DESIGN STORM EVENT, USUALLY THE 10-YEAR EVENT.

- FIX SELF-SUPPORTING GEOTEXTILE TO THE UPSLOPE SIDE OF THE POSTS ENSURING IT GOES TO THE BASE OF THE TRENCH. FIX THE GEOTEXTILE WITH WIRE TIES OR AS RECOMMENDED BY THE MANUFACTURER. ONLY USE GEOTEXTILE SPECIFICALLY PRODUCED FOR SEDIMENT FENCING. THE USE OF SHADE CLOTH FOR THIS PURPOSE IS NOT SATISFACTORY.

- JOIN SECTIONS OF FABRIC AT A SUPPORT POST WITH A 150mm OVERLAP.
- BACKFILL THE TRENCH OVER THE BASE OF THE FABRIC AND COMPACT IT THOROUGHLY OVER THE GEOTEXTILE.

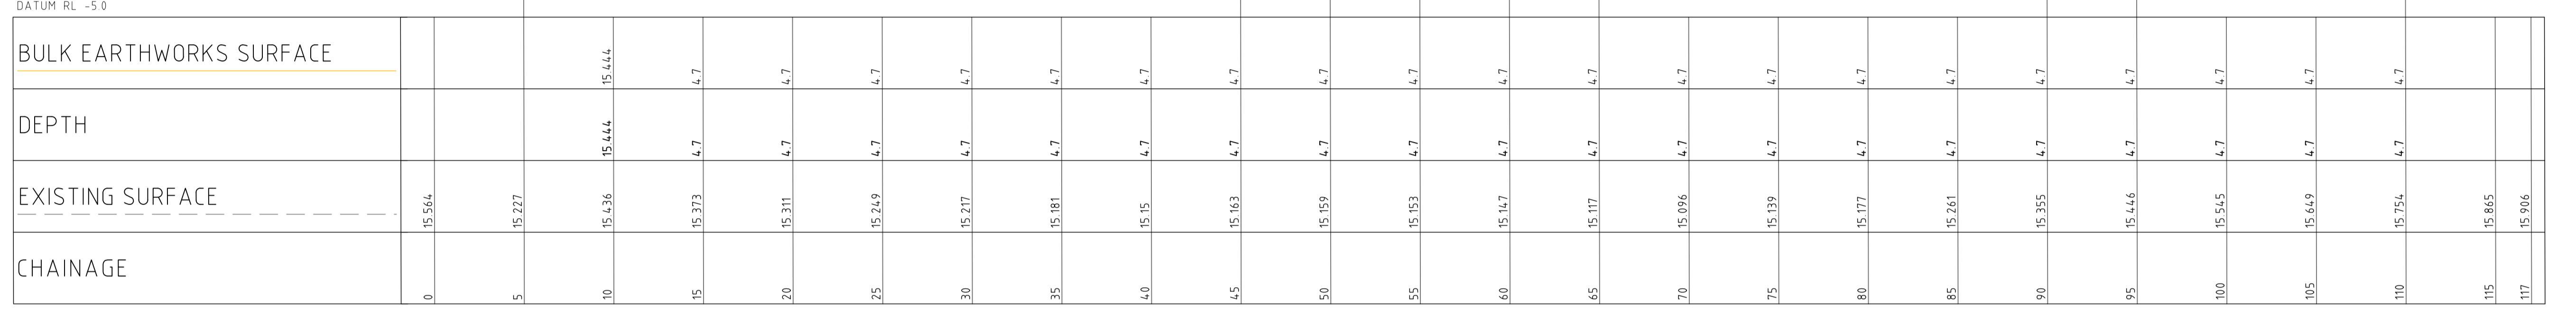
BULK EARTHWORKS B
HORIZONTAL SCALE 1:200@A1
VERTICAL SCALE 1:200@A1

LEGEND	
	DENOTES BULK CUT AREA
	DENOTES BULK FILL AREA
