DETAILED SITE INVESTIGATION REPORT

330 – 350 Eighth Avenue, Austral NSW

Woolworths Ltd – April 2023

Report reference: 2301008Rpt01FinalV01_21Apr23

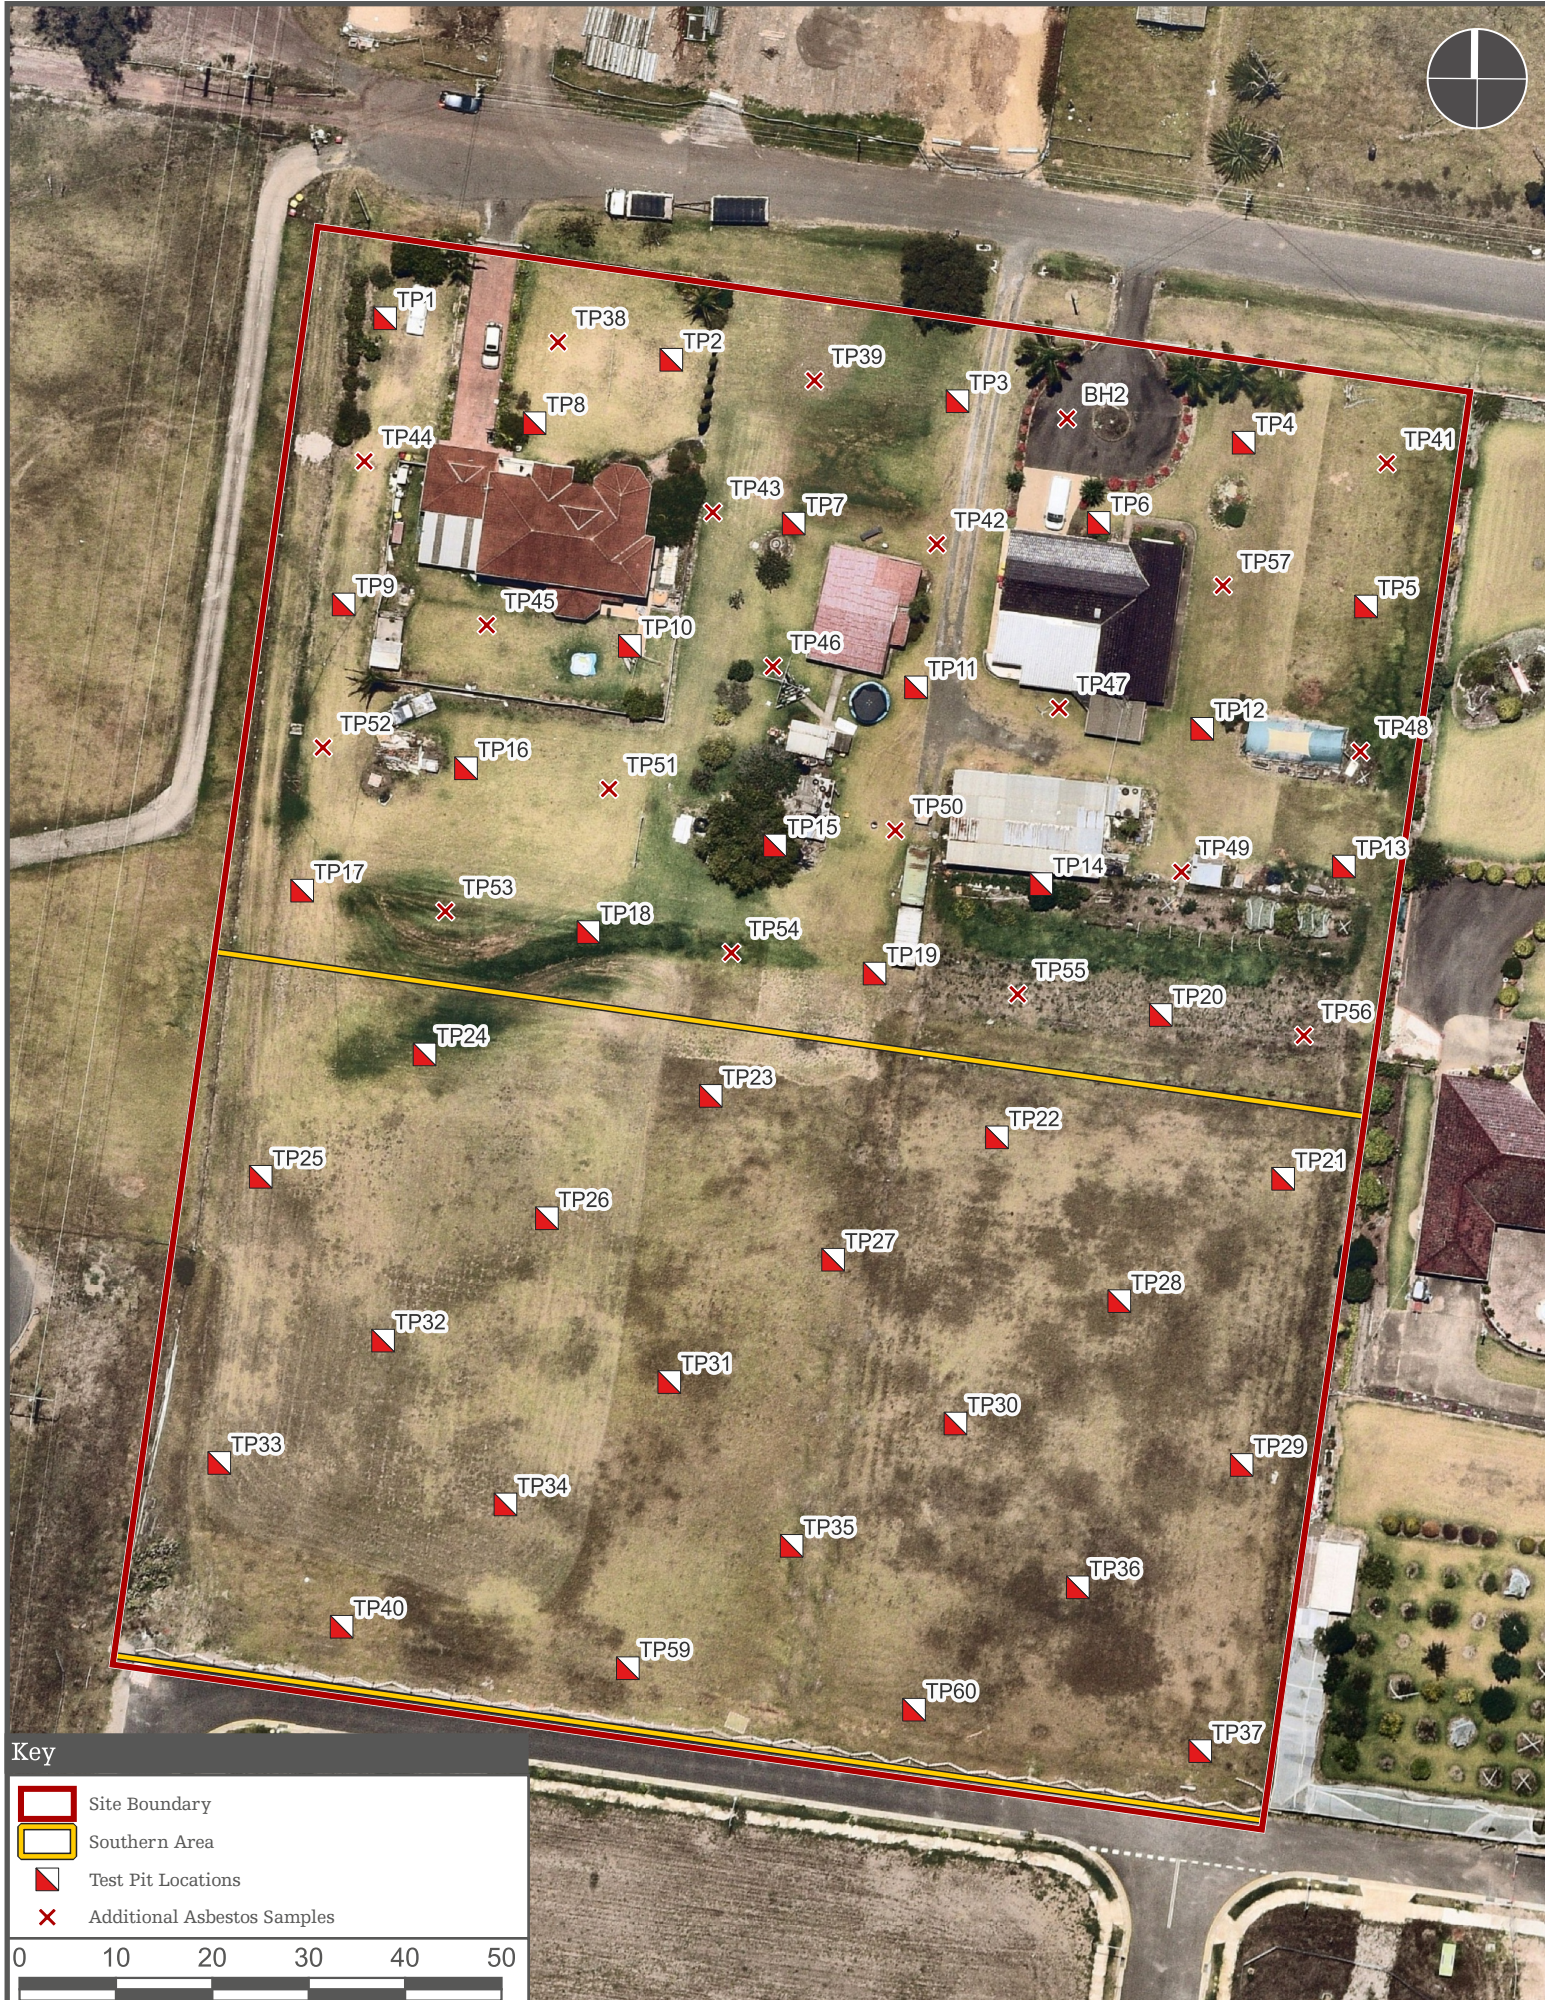
Figure 2

- Site Boundary
- Southern Area
- Test Pit Locations
- Additional Asbestos Samples

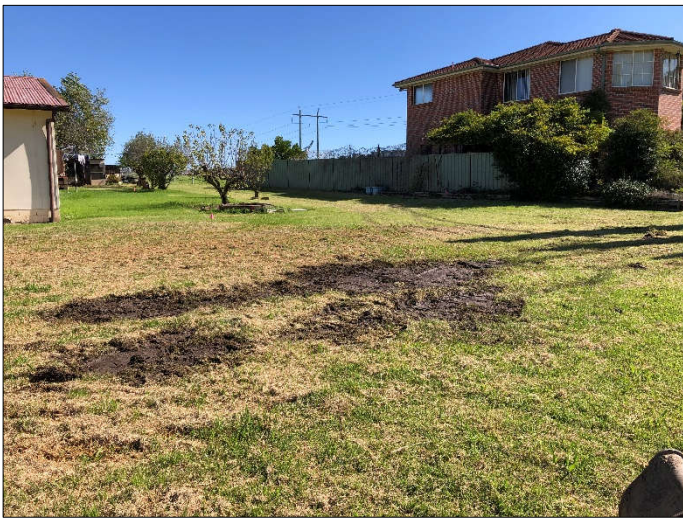
The area north of the central dwelling was water logged with water infiltrating testpits in this location at around 0.4 m. The water was suspected to be from a leaking water pipe or associated with the adjacent septic tank. The water was observed with slight sheen but no odour noted.

Plate 3 – View of water logged area in central northern portion of the site.

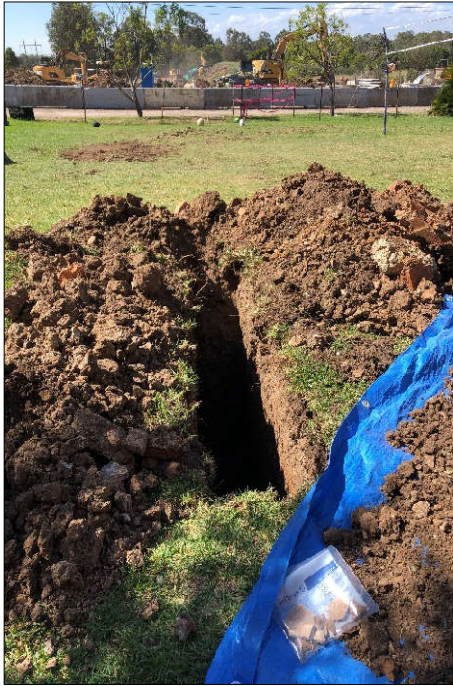
It is noted that potential ACM plaster cement fragments were identified in 10L bulk samples of fill from locations TP2, TP8 and TP13. These fragments were not similar to the fibrous fragment identified in TP15 and were noted to be similar to the bulk of the non-fibrous plaster cement fragments on the ground surface around location TP15. The fragment observed in TP13 (TP13/A1) was sent for laboratory analysis for asbestos identification and the results indicate the fragment did not contain asbestos.

Plate 7 – Fill excavated from TP8 with non-fibrous plaster fragments.

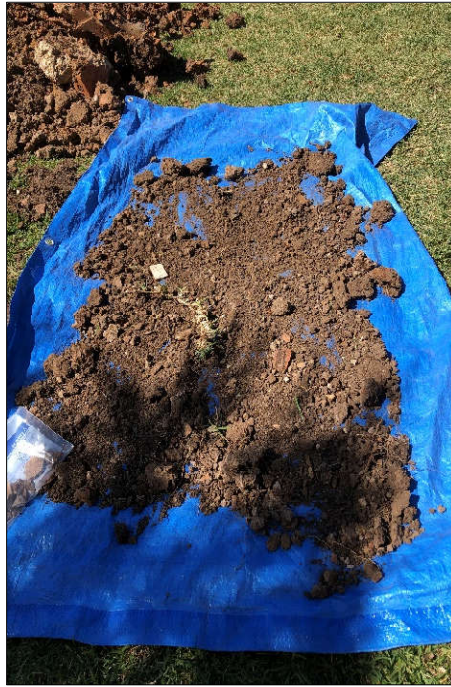
Plate 8 – Fill excavated from TP8 with non-fibrous plaster fragments.

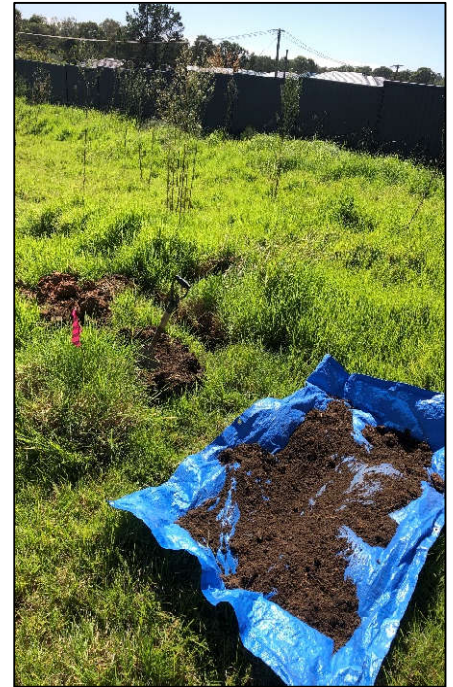
Plate 9 – Tilled soil/fill from TP5 inspected for ACM.

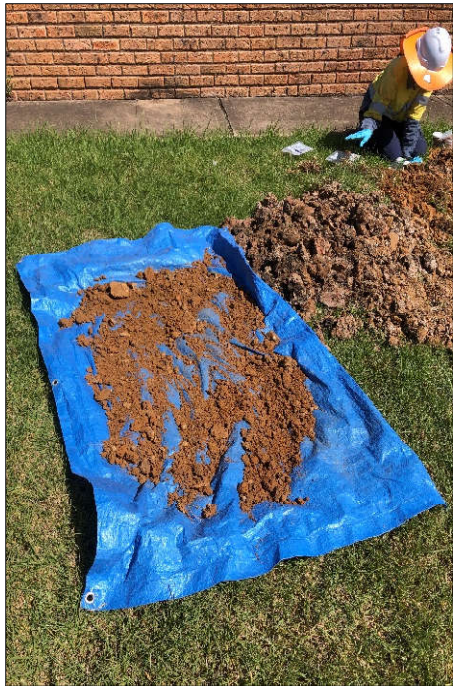
Plate 10 – Fill excavated from TP57 adjacent to eastern dwelling on northern portion of site.

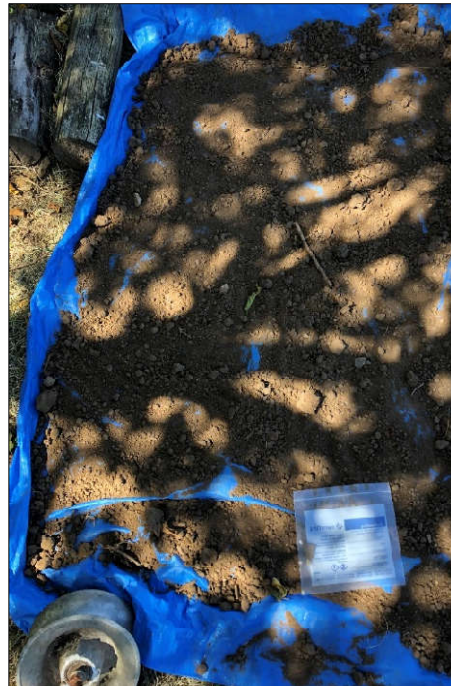
A fragment of ACM fibrous cement sheeting (8.28g) was observed in the 10L bulk sample of fill at location TP15. The fragment was sent for analysis at the laboratory for identification of asbestos (TP15/A1) and laboratory results identified asbestos within the fragment. The w/w % in soil was calculated at 0.008% at this location which is less than the site assessment criteria of 0.05% for ACM. The field sheet for calculation of ACM concentration in fill at TP15 is presented as Attachment H. However, given the ACM was encountered in the top 0.1m, it exceeds the assessment criteria "No visible asbestos in the top 0.1 m".

ACM/FA/AF where identified at concentrations above landuse assessment criteria in shallow fill (~0.5m) at locations TP15 and TP50. Both locations are adjacent and are in the location of current and former sheds/structures. The majority of shed appears to comprise corrugated metal sheeting and a non-fibrous plaster cement sheeting. At least one shed (former toilet) in this location comprised a fibrous cement sheeting, likely ACM, which was broken in some areas. A substantial number of plaster cement fragments on the site surface in and around this location. Many were observed to be the non-fibrous plaster cement sheet that was considered not likely to be ACM, however, it was not possible to differentiate non-fibrous from fibrous due to the volume of fragments. It is likely there is some ACM cement fragments on the ground surface in this location, and potentially near the adjacent central dwelling.

Plate 11 – Fill excavated from TP15 inspected for ACM, adjacent to sheds in central portion of north half of site.

It is recommended site demolition be conducted prior to remediation in the event the demolition works results in localised residual hazardous building material contamination to shallow soils.

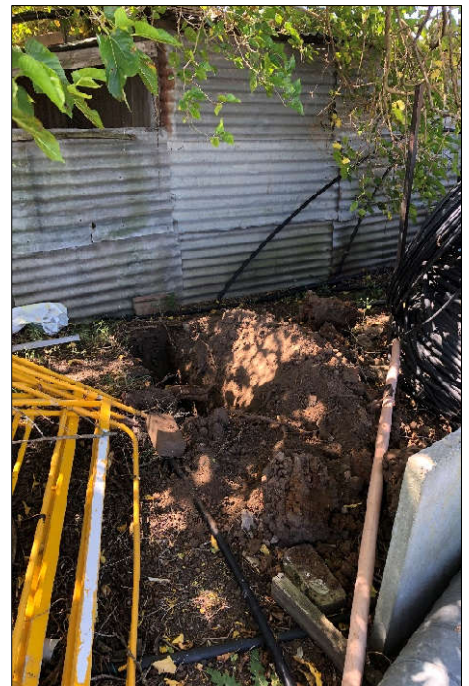
Plate 12 – Test pit excavated near the shed (TP15) in the north half of the site.

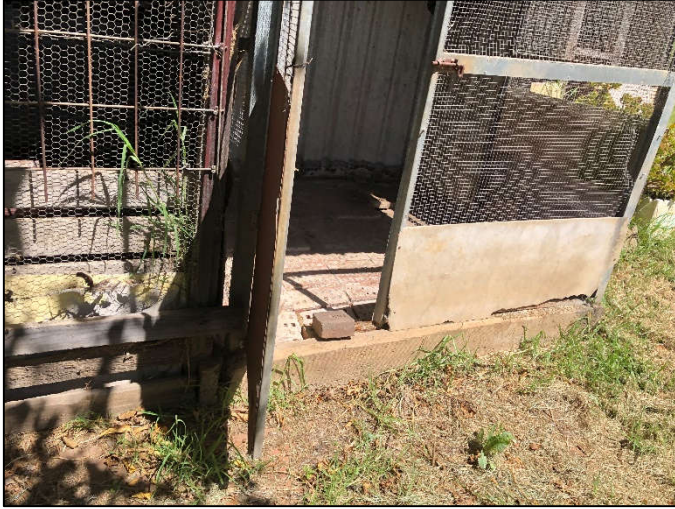
Plate 13 – One of the sheds comprising plaster cement sheeting that does not appear fibrous, on central portion of northern half of site.

It is recommended site demolition be conducted prior to remediation in the event the demolition works results in localised residual hazardous building material contamination to shallow soils.

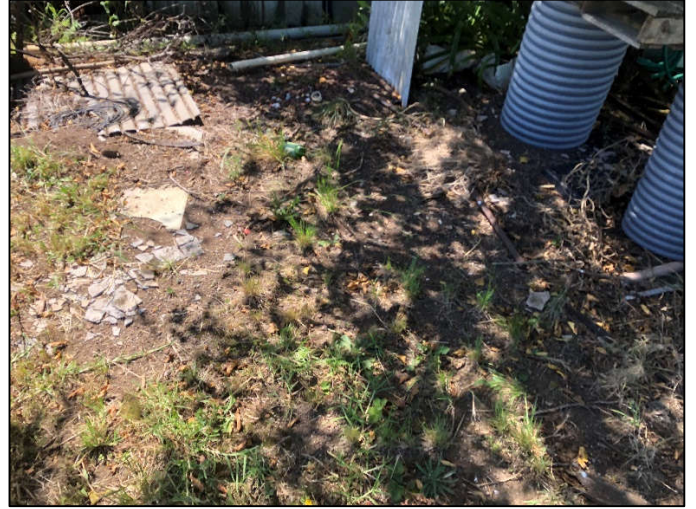
Plate 14 – Area of potential ACM fragments on the ground surface near location TP15, majority observed to be non-fibrous and not ACM .
