# GEOTECHNICAL REPORT

330 – 350 Eighth Avenue, Austral NSW

Woolworths Ltd – June 2023

**Report reference:** 2301008GTRpt01FinalV02\_16Jun23

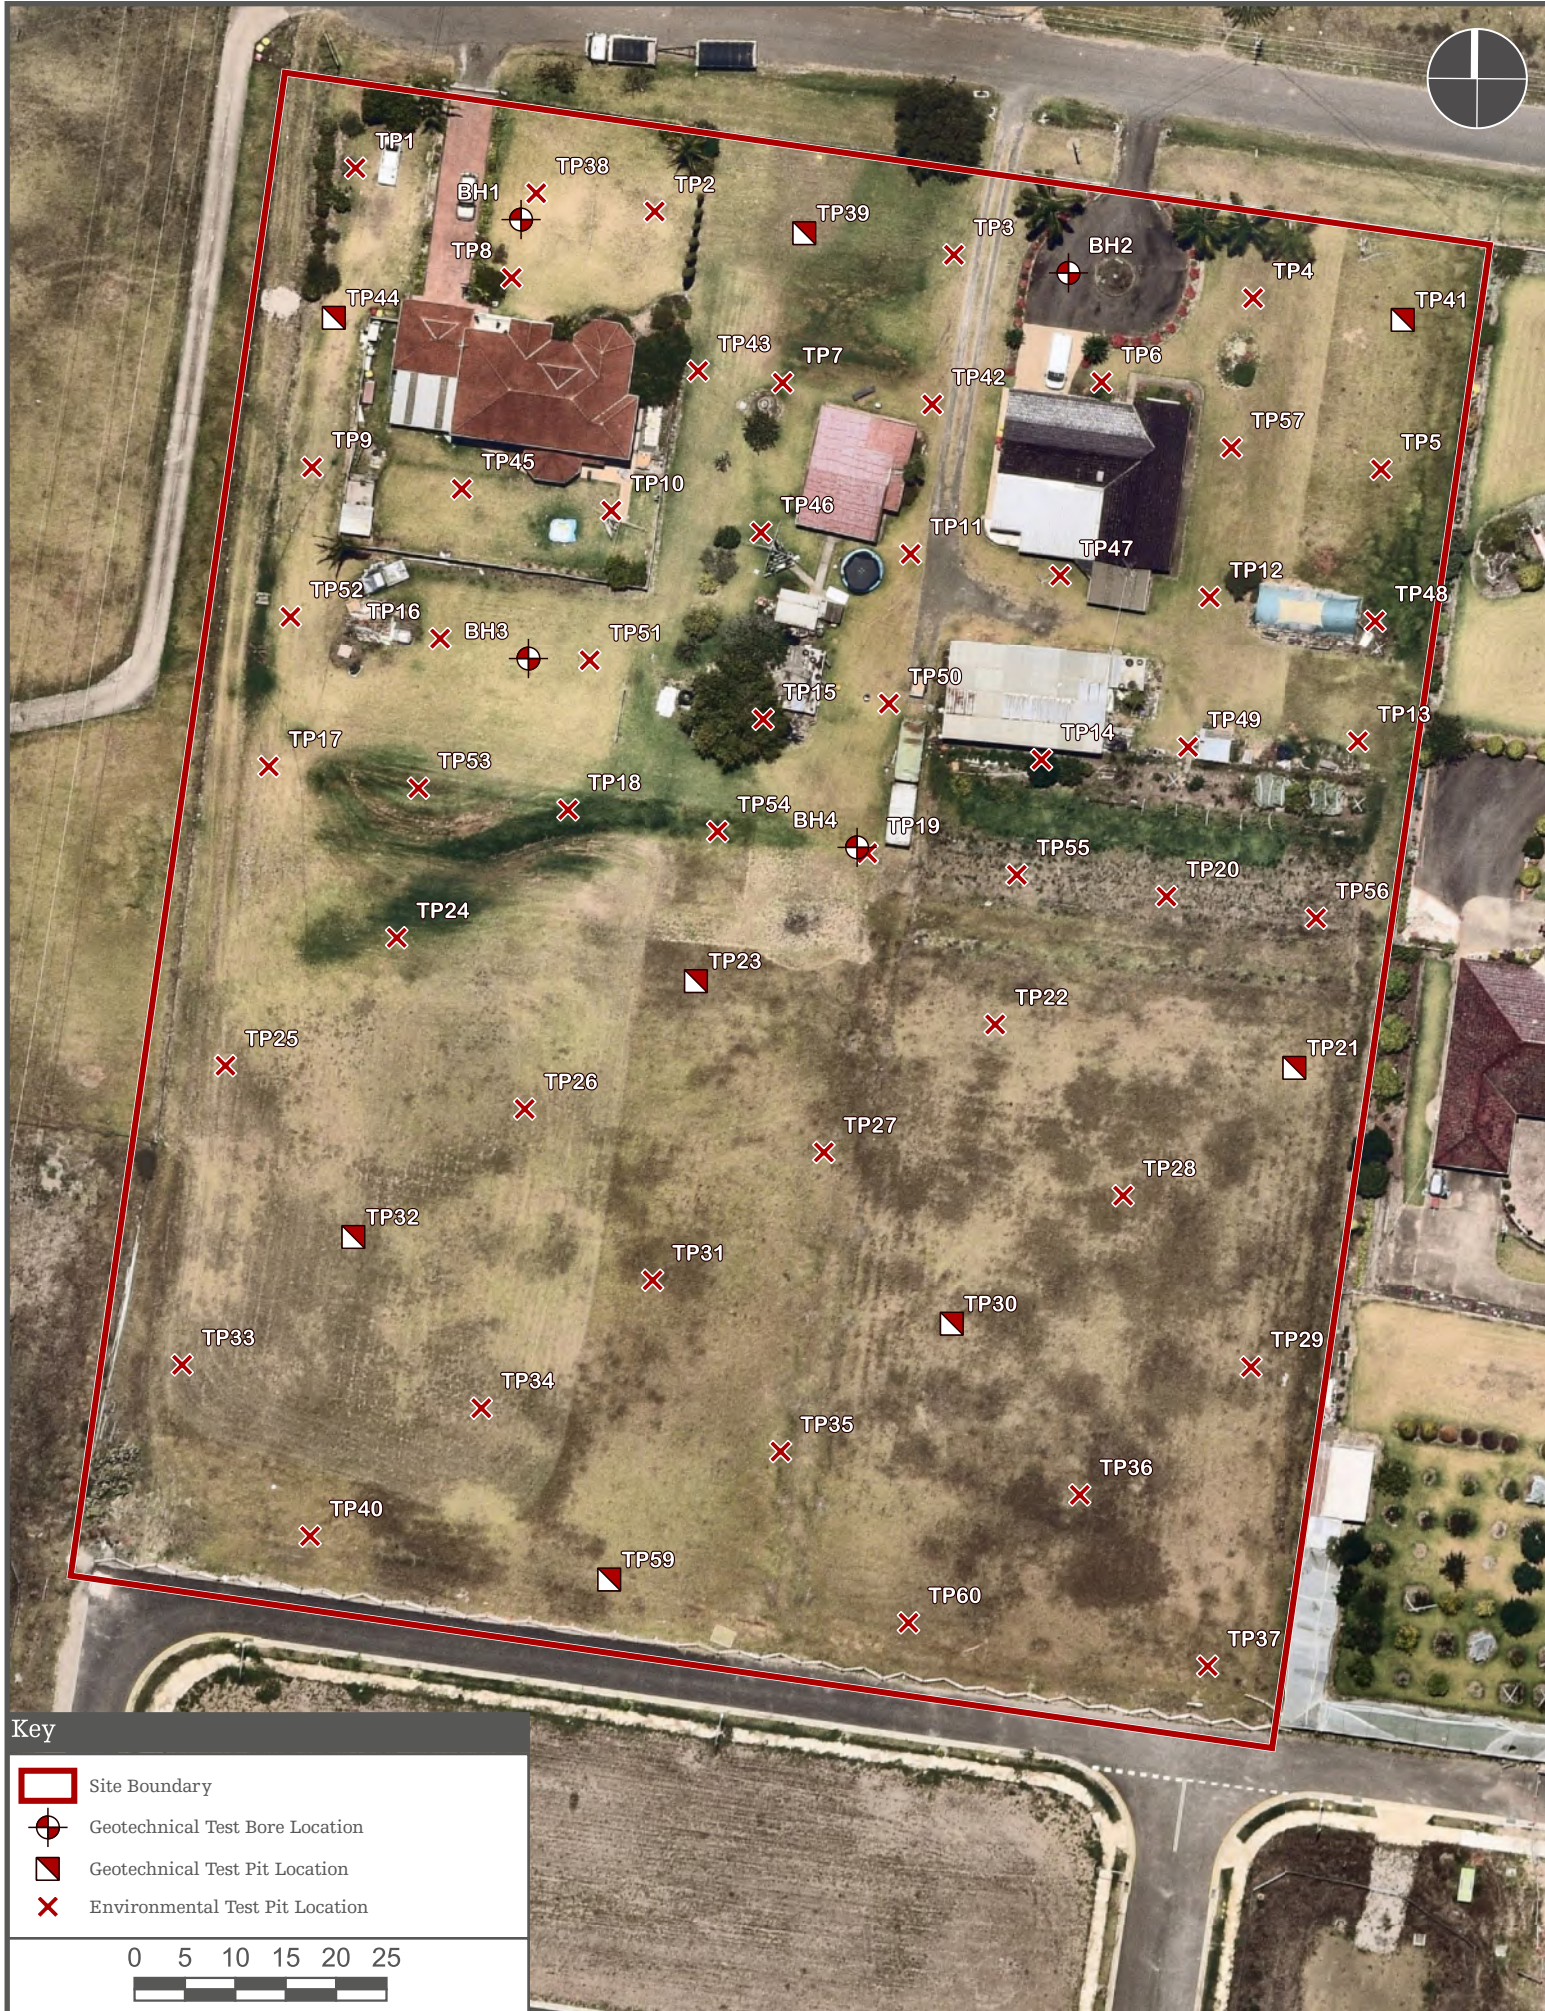
**Key**

- Site Boundary
- Geotechnical Test Bore Location
- Geotechnical Test Pit Location
- X Environmental Test Pit Location
