Preliminary Site Investigation

15-17 Lupin Avenue and 82 Belmore Street Fairfield East, NSW, 2165

Prepared for: BlueCHP Ltd

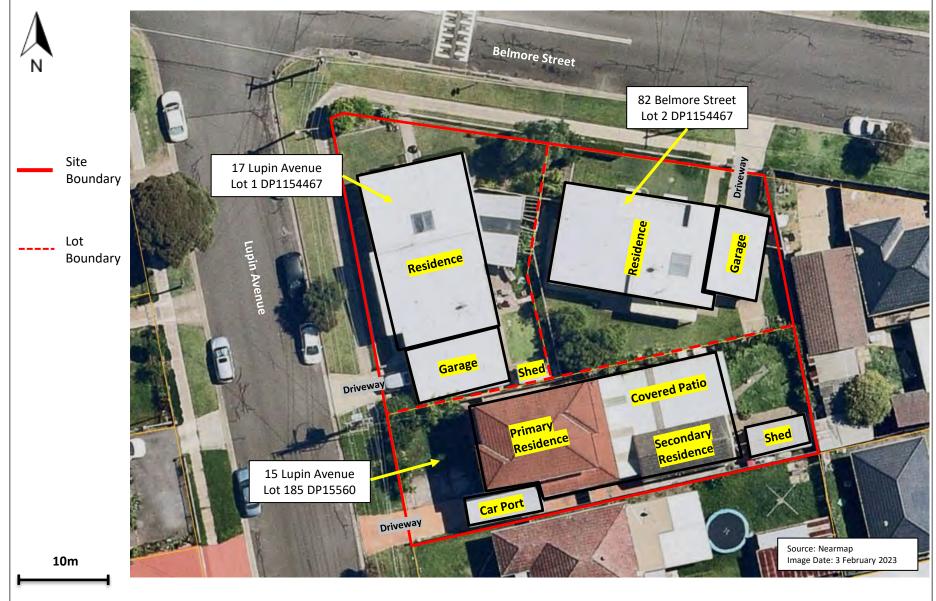
Project:	99.125	Title:	Site Plan and Features
	Figure:	2	Address:	15-17 Lupin Avenue and 82 Belmore Street, Fairfield East, NSW

A site inspection was completed by TRACE Environmental personnel on 5 April 2023. Photographs taken during the site visit are included in **Appendix B** and the general site layout is presented in **Figure 2**. Details of the site, as observed during the inspection and gathered from other sources detailed in this report, are outlined in **Table 2-2**, below.

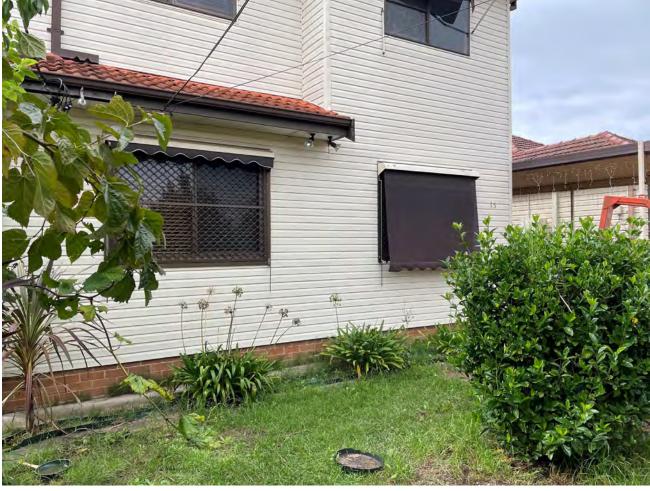
Photograph 1: View of the front yard of the residence at the 15 Lupin Avenue site parcel (facing east).

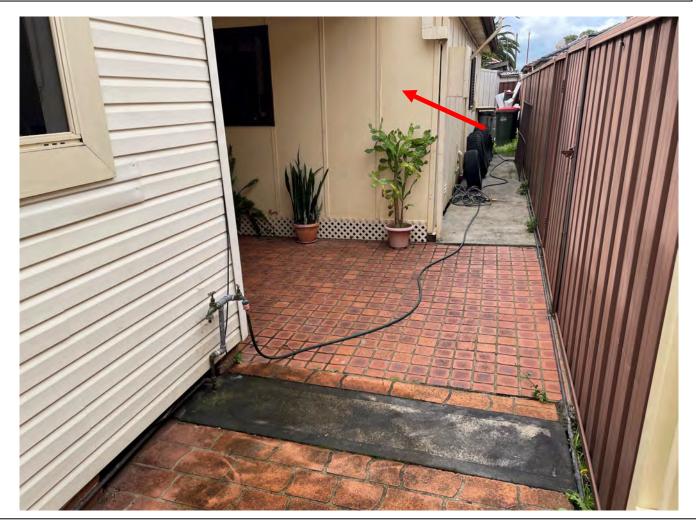
Photograph 2: View of the secondary residence (denoted by the red arrow) at the 15 Lupin Avenue site parcel (facing east), with the southern site boundary to the right of the photograph.

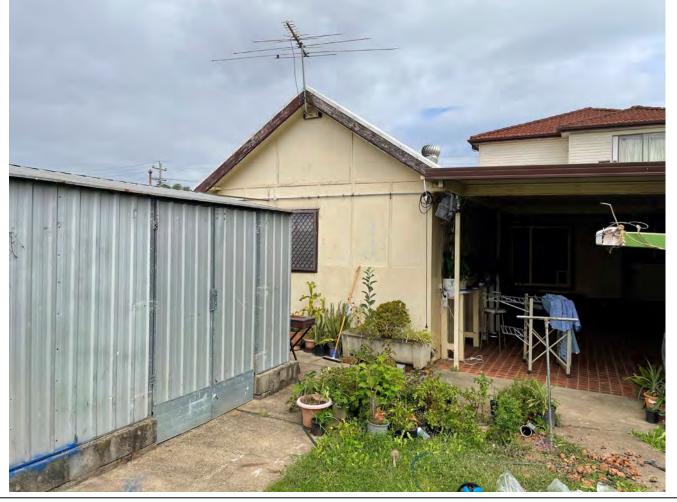
Photograph 3: View of the back yard of the residence at the 15 Lupin Avenue site parcel (facing west) showing a metal shed (to the left of the photograph), the secondary residence, a covered patio area and the primary residence (in the background).

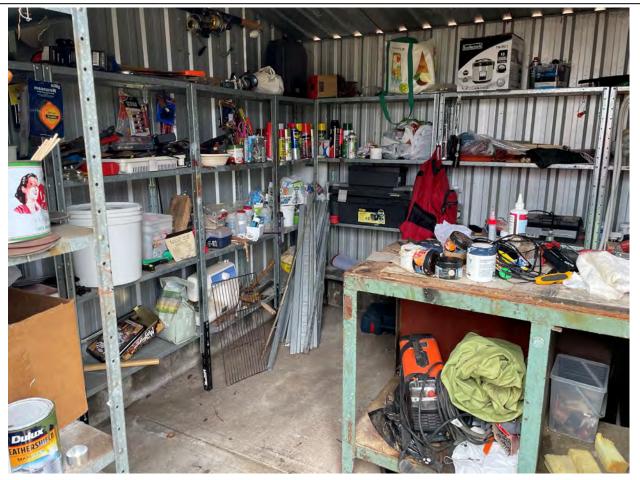
Photograph 4: View of interior of the shed at the 15 Lupin Avenue site parcel containing household items and chemicals.

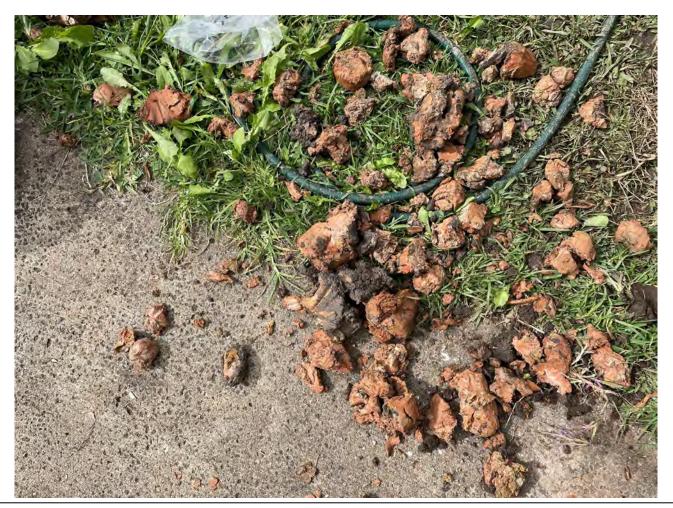
Photograph 6: View of soil cuttings from geotechnical augering works being conducted at the 15 Lupin Avenue site parcel during the site inspection.

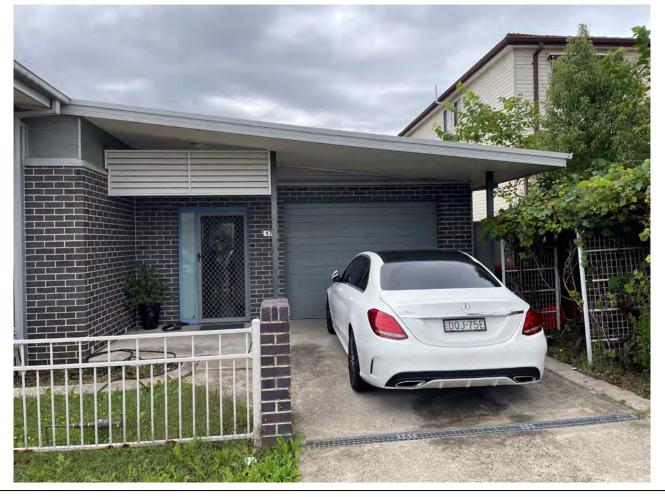
Photograph 7: View of the garage of the residence at 17 Lupin Avenue (facing east) with the 15 Lupin Avenue site parcel residence visible at the right of the photograph.

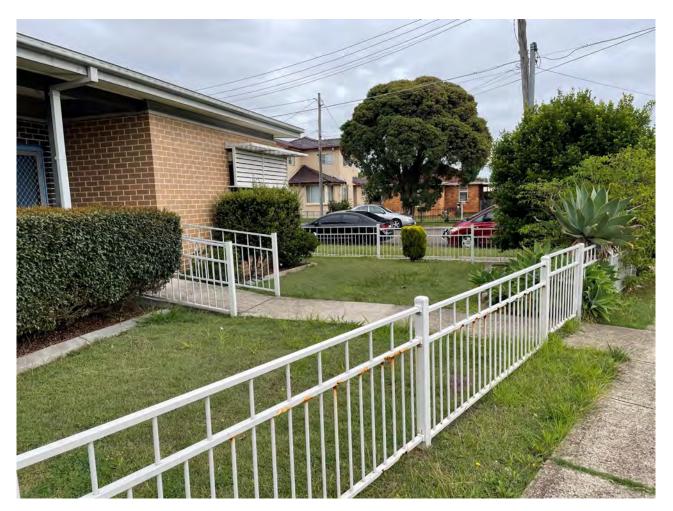
Photograph 8: View of the front yard of the residence at 17 Lupin Avenue site parcel as visible from Belmore Street (facing west).

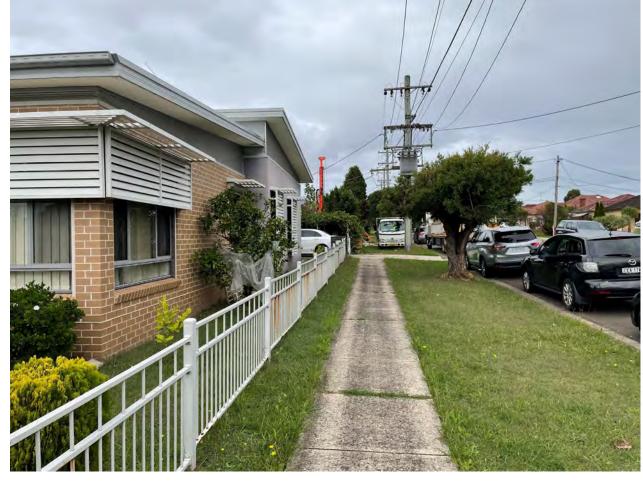
Photograph 9: View of the western portion of the 17 Lupin Avenue site parcel (facing south) and Lupin Avenue to the right of the photograph.

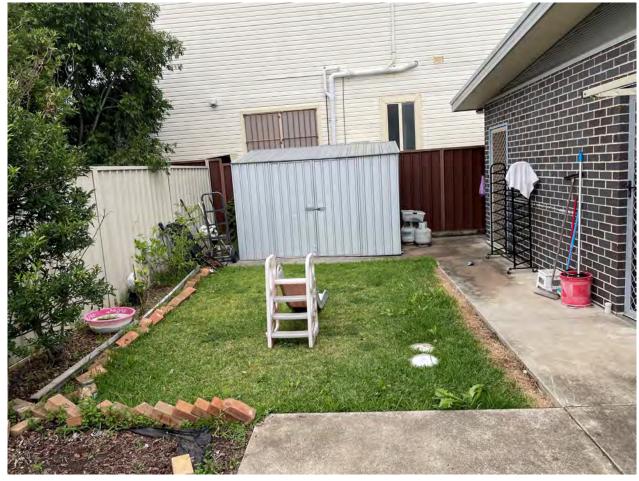
Photograph 11: View of the back yard of the 17 Lupin Avenue site parcel (facing south) showing a metal shed and the 15 Lupin Avenue site parcel residence visible at the rear of the photograph.

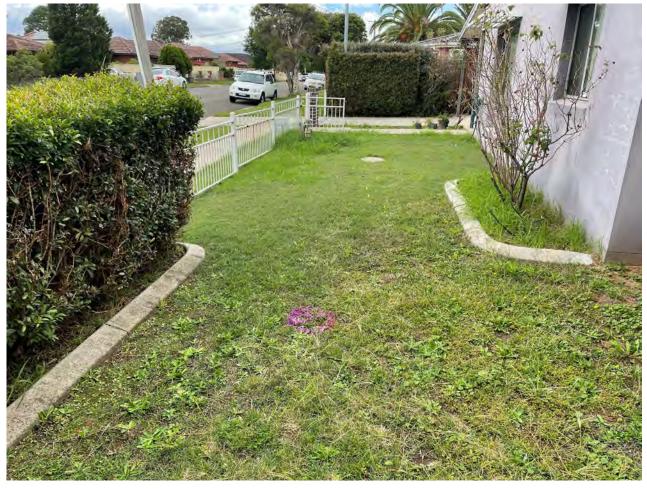
Photograph 13: View of the front yard of the 82 Belmore Street parcel (facing east).

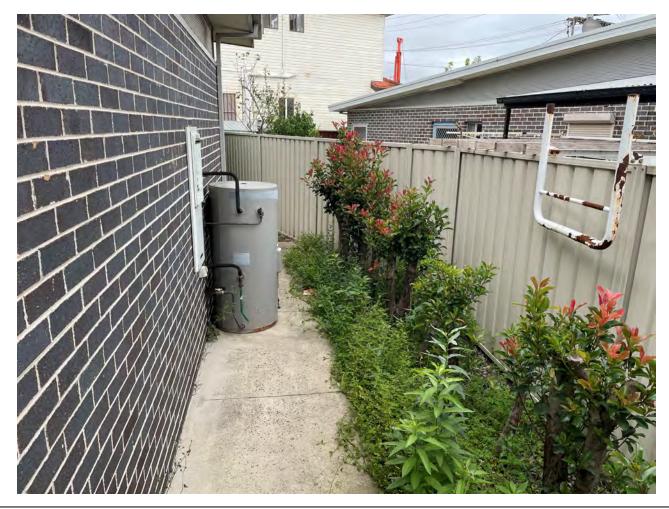
Photograph 14: View of western yard of the 82 Belmore Street site parcel (facing south) with the 17 Lupin Avenue parcel to the right of the photograph.

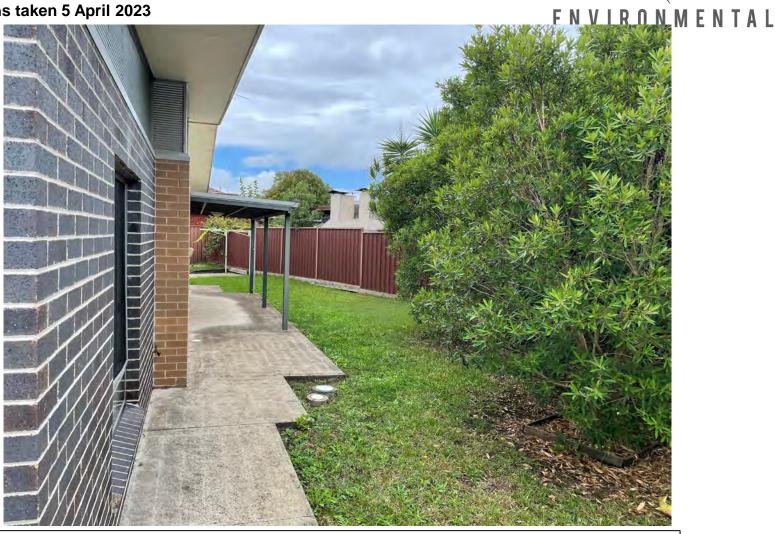
Photograph 15: View of the back yard of the 82 Belmore Street parcel (facing south-east).

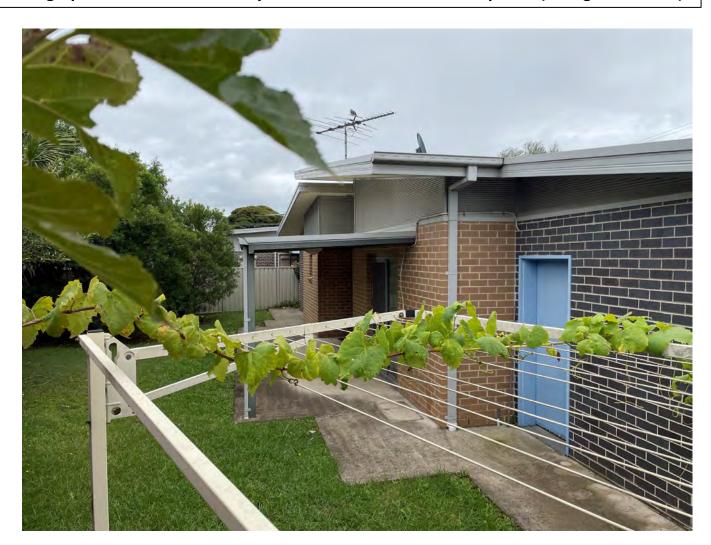
Photograph 16: View of the back yard of the 82 Belmore Street parcel (facing west).
