**Arboricultural Impact
Assessment &**

**Tree Protection Management
Plan**

45 Orth St,
Kingswood NSW 2747

Project Name:	Axis Trust Medical Consulting Rooms Development
Reference #:	E-001663-22
Client:	Jodie Ellis-Clark
Site:	45 Orth St, Kingswood NSW 2747
Prepared by:	Kane Hollstein Senior Consulting Arborist Dip. Arb., AQF Level 5 ISA TRAQ QTRA VALID IACA Accredited Member
Contact Details:	Canopy Consulting Ph: 0432 633 402 E: info@canopyconsulting.com.au

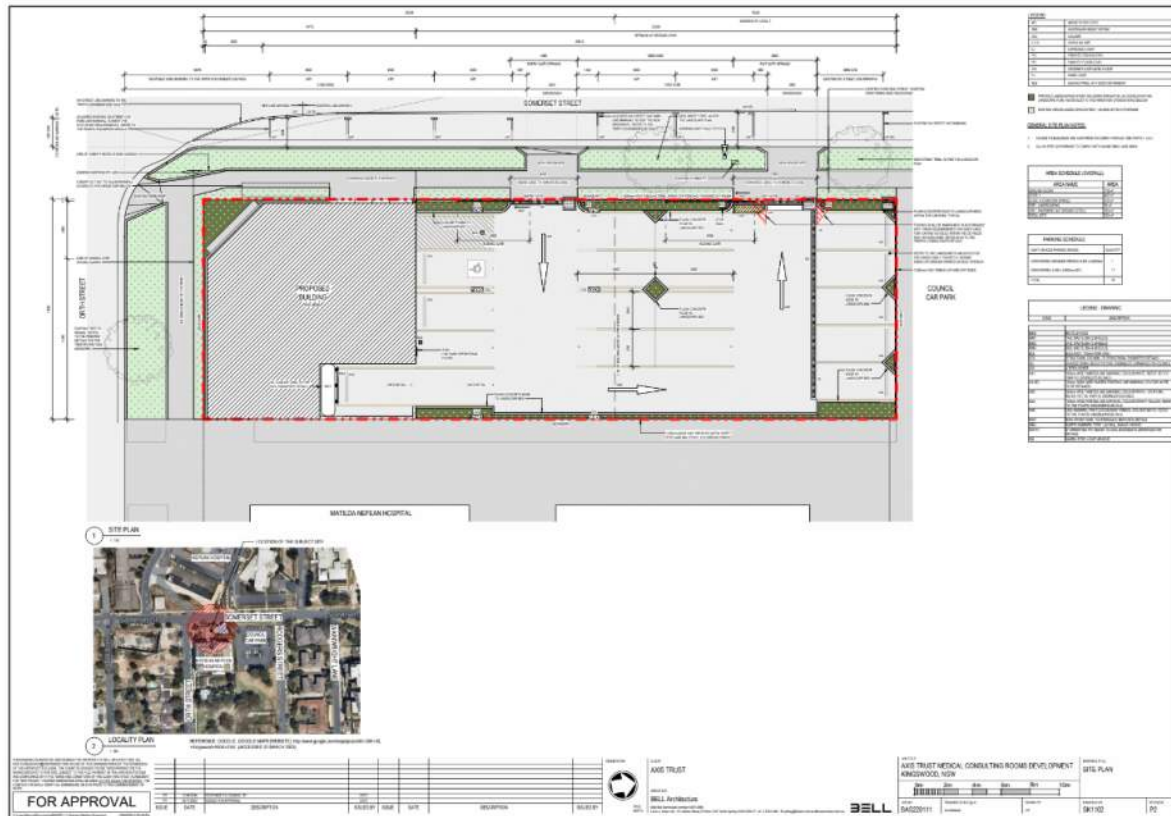
Figure 1: Proposed site layout. (Bell Architecture, 2024)
