Report on  
Geotechnical Investigation

Proposed Thornton Central Village High-Rise Development  
184, 192 and 41 Lord Sheffield Circuit, Penrith

Prepared for  
Thornton Operations Limited

Project 85715.00  
November 2021

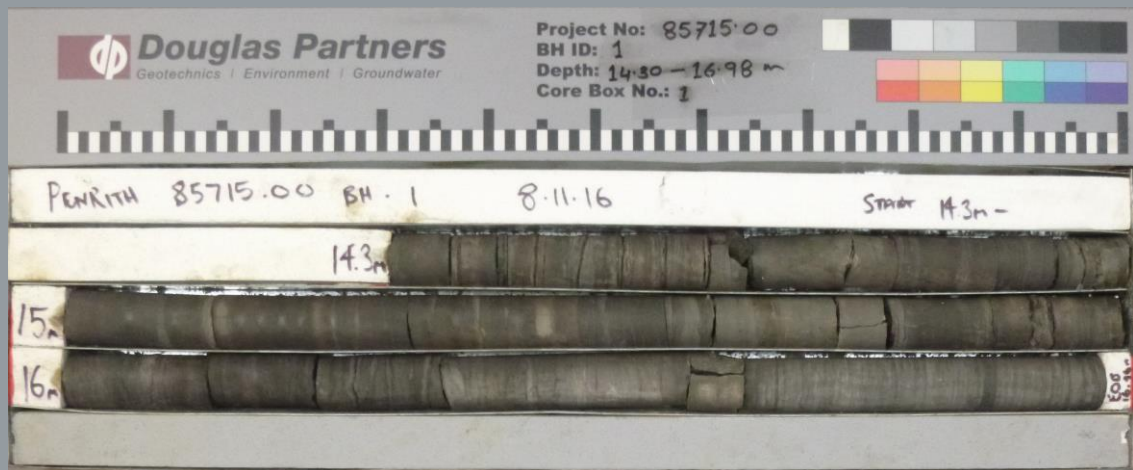
14.3 - 16.98m

13.8	LAMINITE - very low strength, light grey laminite																			
	14																				
	14.3	LAMINITE - high strength, fresh, slightly fractured then unbroken, light grey fine grained sandstone (60%) interlaminated and bedded with siltstone (40%)																			
	15																				
	16																				
	17

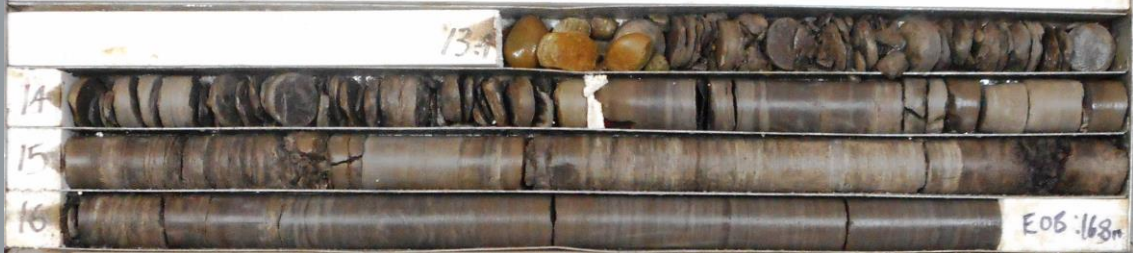
13.4 - 16.8m

PENRITH 85715.0 BH-2 31.10.16 START: 13.4m

12.6	LAMINITE - extremely low to very low strength, grey laminite																									
	13																										
	13.55	INTERLAMINATE/BEDDED SANDSTONE & SILTSTONE - medium and high strength, slightly weathered, fragmented and slightly fractured, light grey to grey, fine grained sandstone (60%) interlaminated and bedded with siltstone (40%)																									
	14																										
	15	LAMINITE - low to medium strength, slightly weathered, slightly fractured, light grey, laminite with approx 25% fine sandstone lamination

15.0	15.22-15.4m: high strength sandstone bed																									
	16	LAMINITE - high strength, fresh, slightly fractured, light grey fine grained sandstone (60%) interlaminated with siltstone (40%)

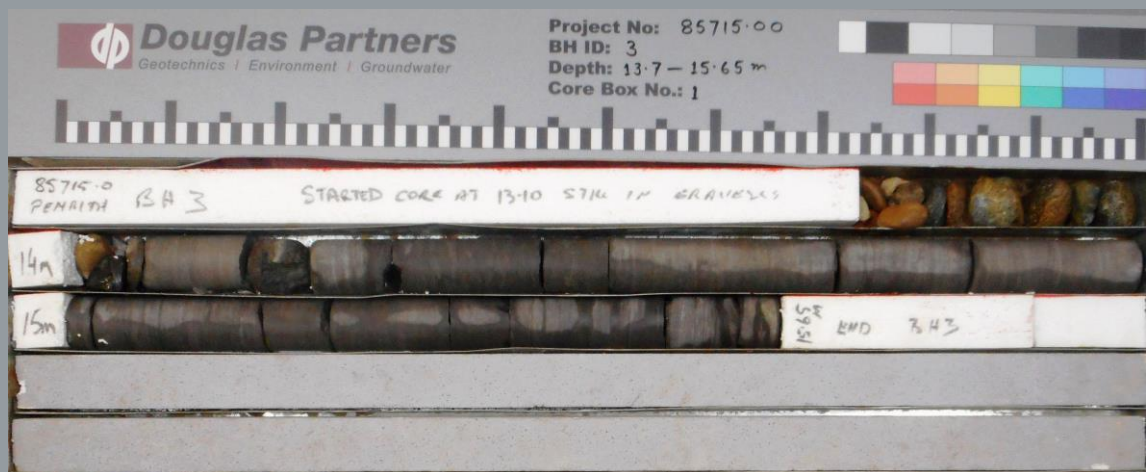
13.75 – 15.65m

RL	Depth (m)	Description of Strata	Degree of Weathering					Graphic Log	Rock Strength					Water	Fracture Spacing (m)	Discontinuities		Sampling & In Situ Testing				
			EW	HW	MW	SW	FS		FR	Ex Low	Very Low	Low	Medium			High	Very High	Ex High	B - Bedding S - Shear	J - Joint F - Fault	Type	Core Rec. %
17		SANDY GRAVEL - apparently dense, light grey-brown, rounded and subrounded gravel/cobble with coarse sand, moist <i>(continued)</i>																				
16	11																					
15	12																					
14	13																					
14	14																					
14	14.05	LAMINITE - very high then high strength, fresh, unbroken, light grey fine grained sandstone (40%) interlaminated with siltstone (60%)																C	0	0		PL(A) = 3.8
13	15																	C	100	0		
12	15																	C	100	100		PL(A) = 2.21

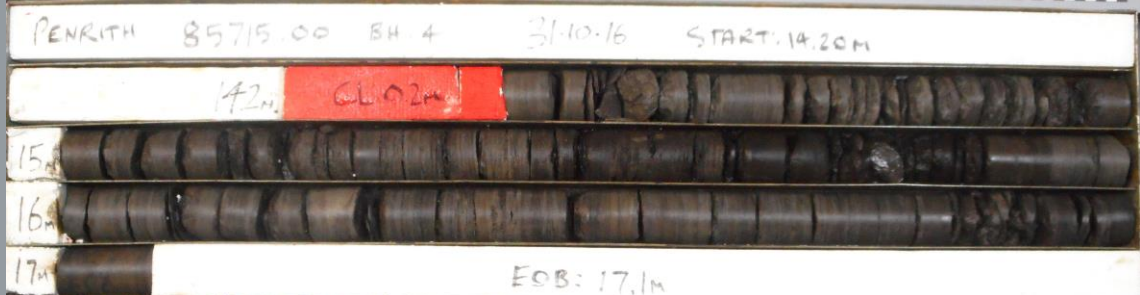
14.2 - 17.1m

Project No: 85715.00  
BH ID: 4  
Depth: 14.20 - 17.10 m  
Core Box No.: 1

EOB: 17.1m

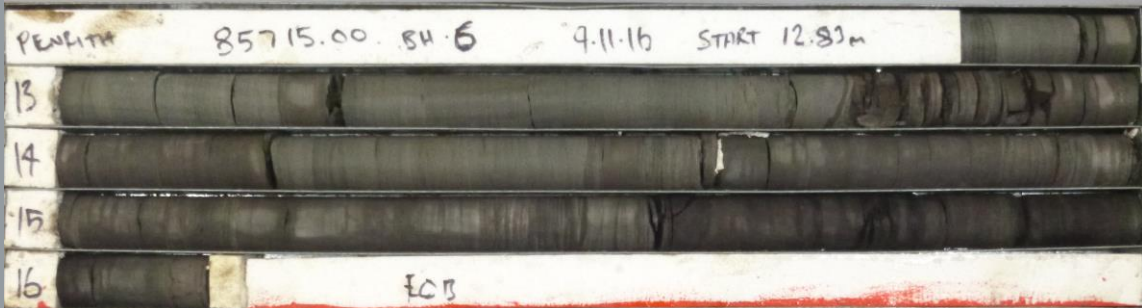
12.83 - 16.15m

Project No: 85715.00  
BH ID: 6  
Depth: 12.83 - 16.10 m  
Core Box No.: 1

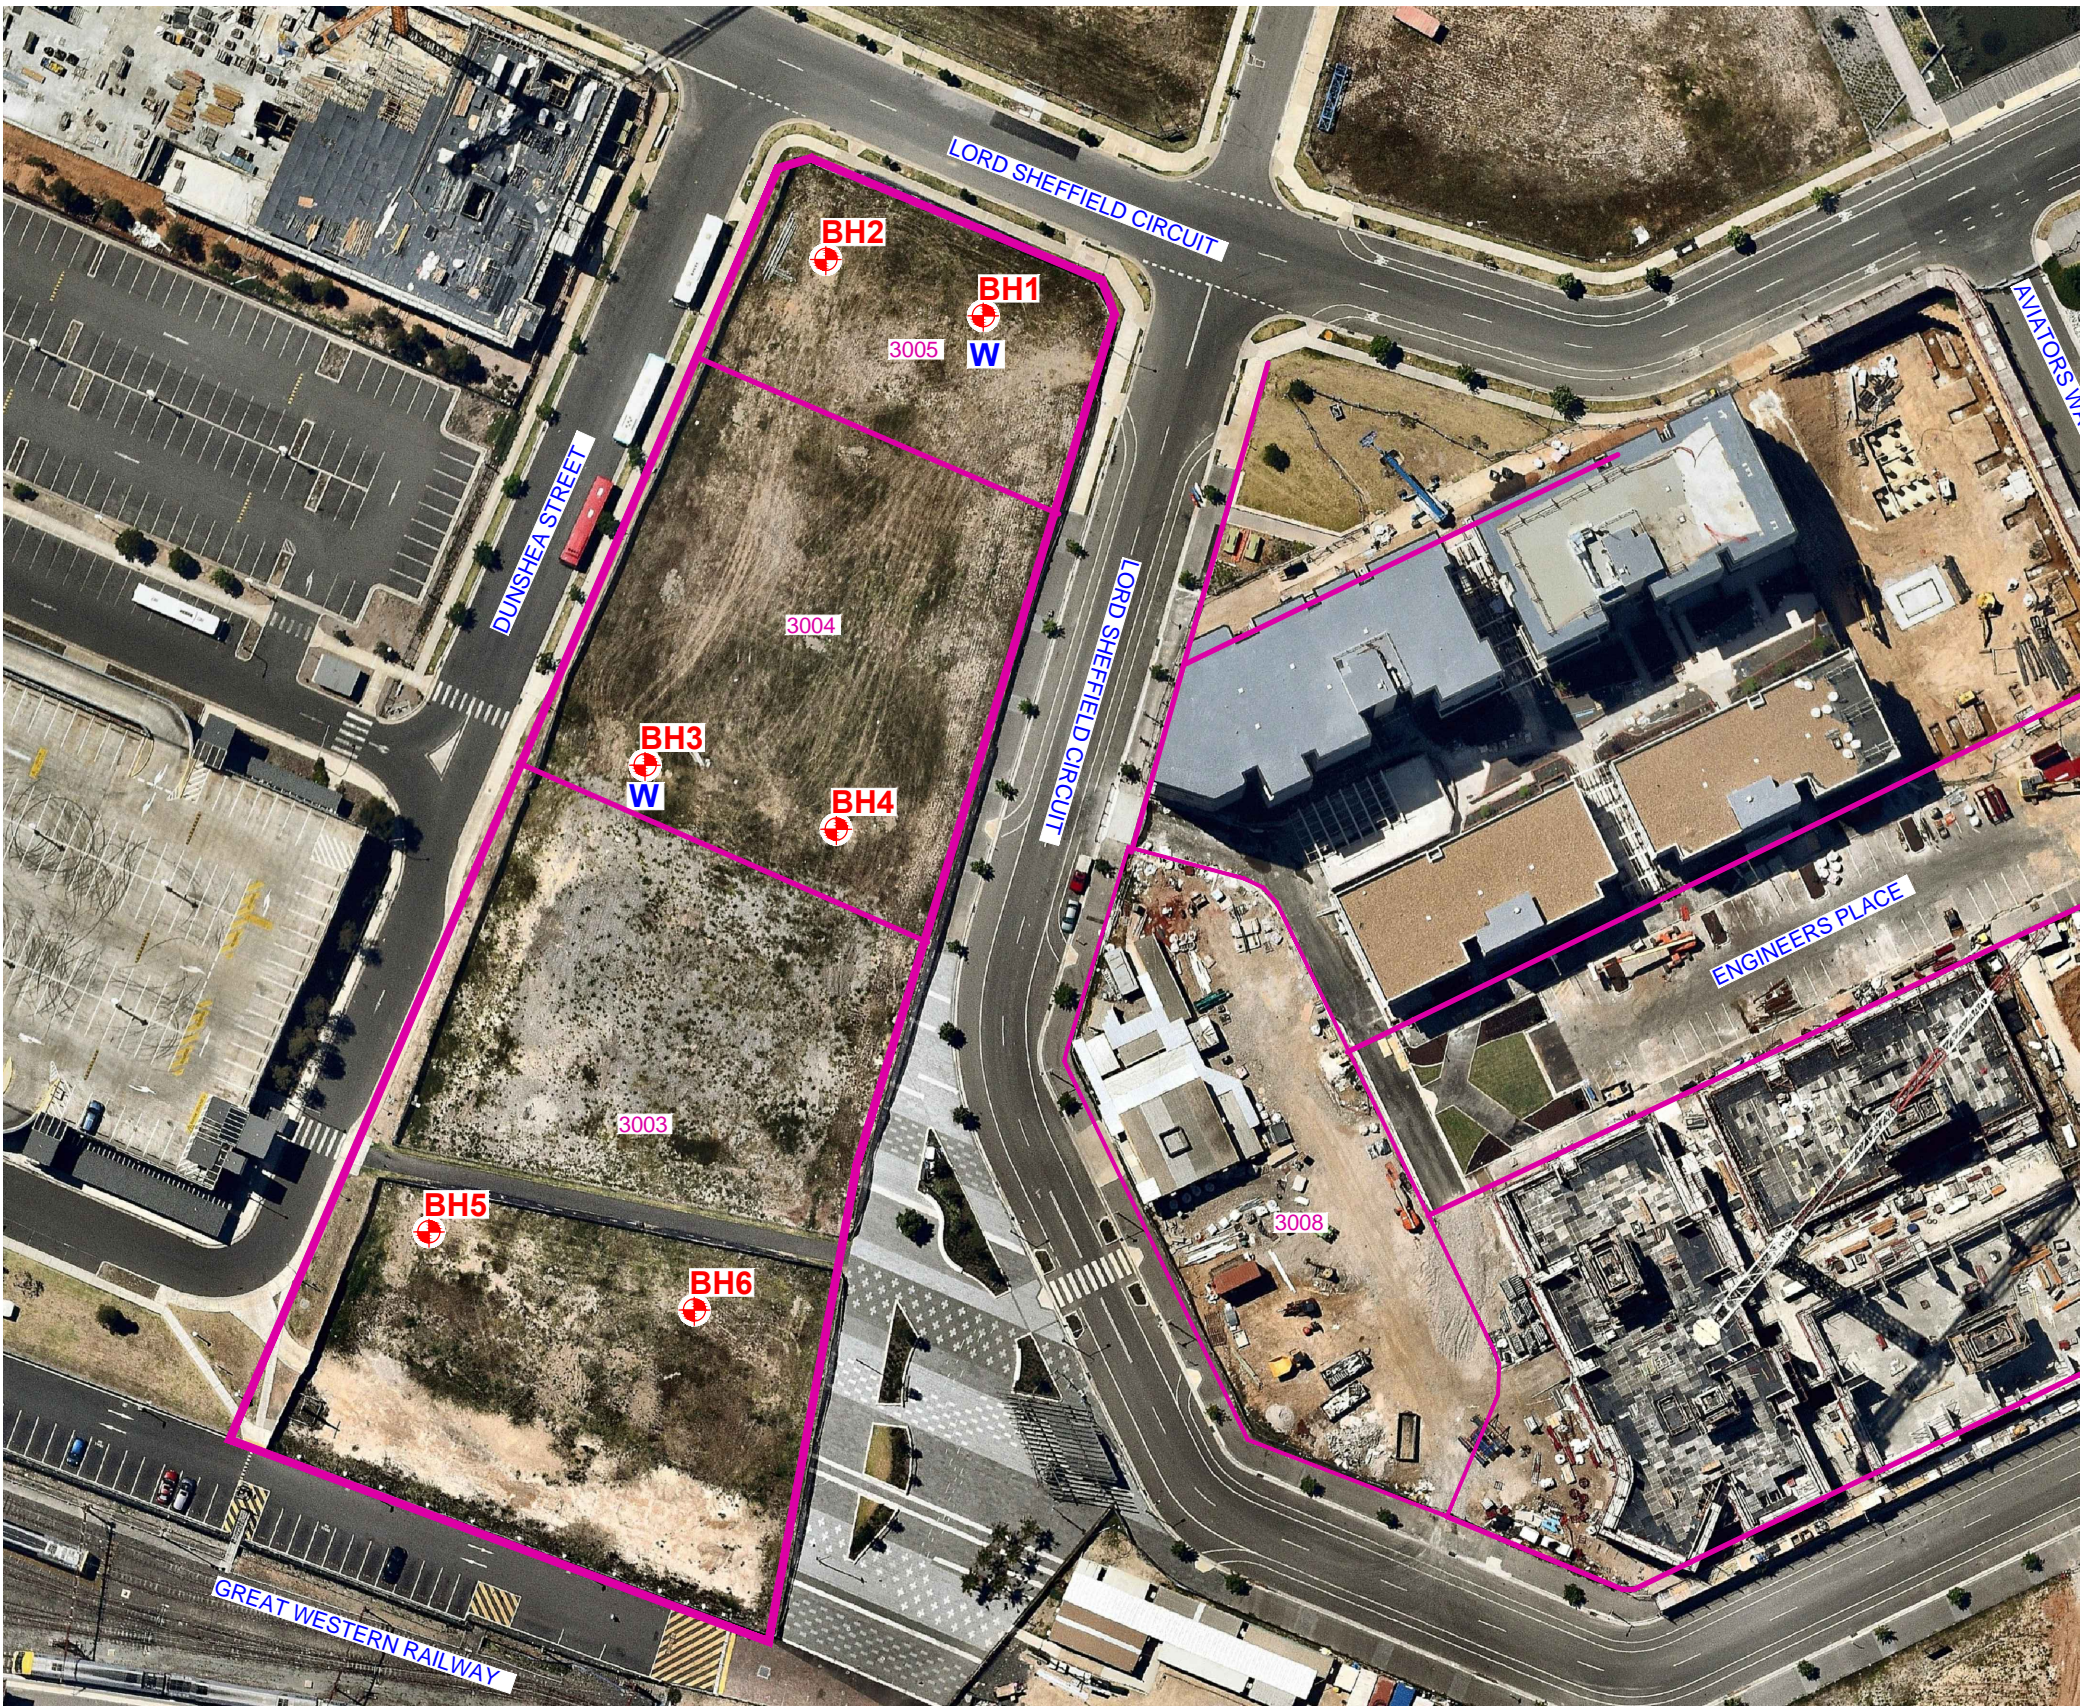
NOTE:  
1: Base image from Nearmap.com  
(Dated November 2016)  
2: Test locations are approximate only and are shown  
with reference to existing features.
