GEOTECHNICAL INVESTIGATION

FLOOD STORAGE BASINS AT ALSPEC INDUSTRIAL PARK 221-227 AND 289-311 LUDDENHAM ROAD, ORCHARD HILLS NSW

24 April 2024

Ref: DRM P23.1039-R07

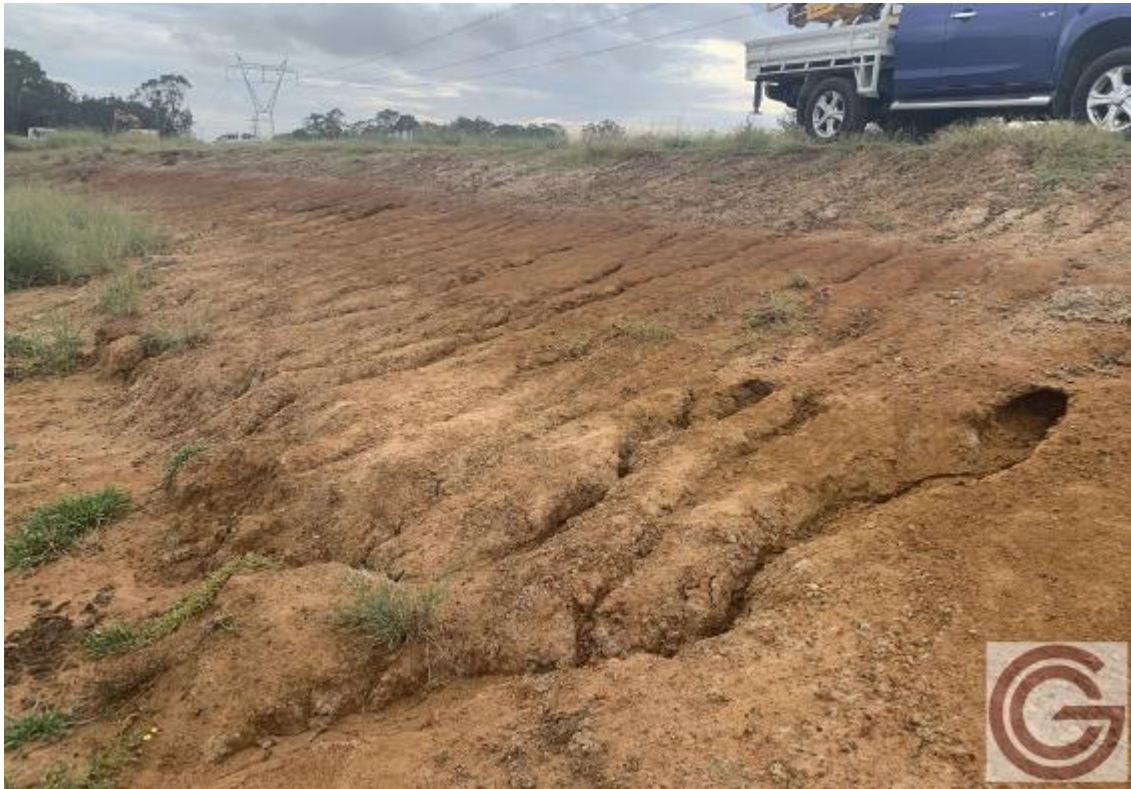
Photo 3: Site view showing signs of soil erosion on the existing dam wall within basin 1

The soils to be excavated for the basins are generally susceptible to erosion and it could be a main concern for the area where such soils to be placed. About 56% of tested samples were moderately saline soils. Therefore, we recommend that the soil management plan should minimise impacts of erosion and possible soil salinity.

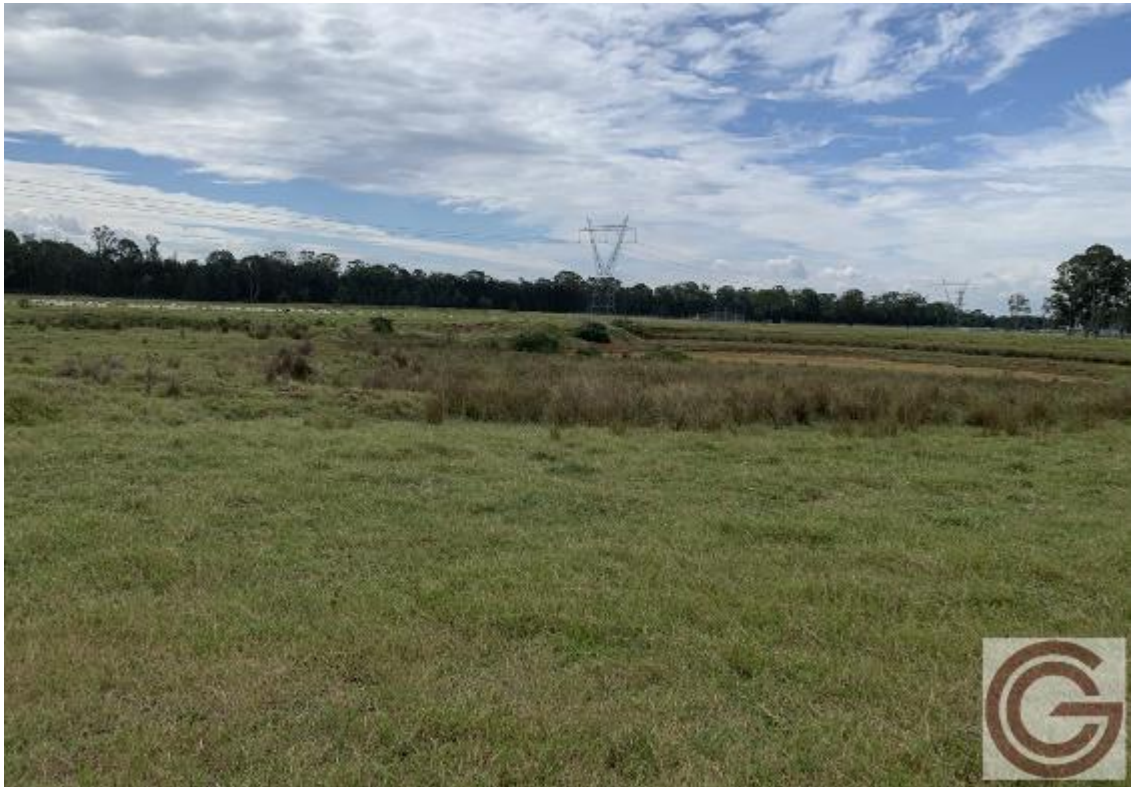
Photo 5: Site view showing a dam within the area of basin 2

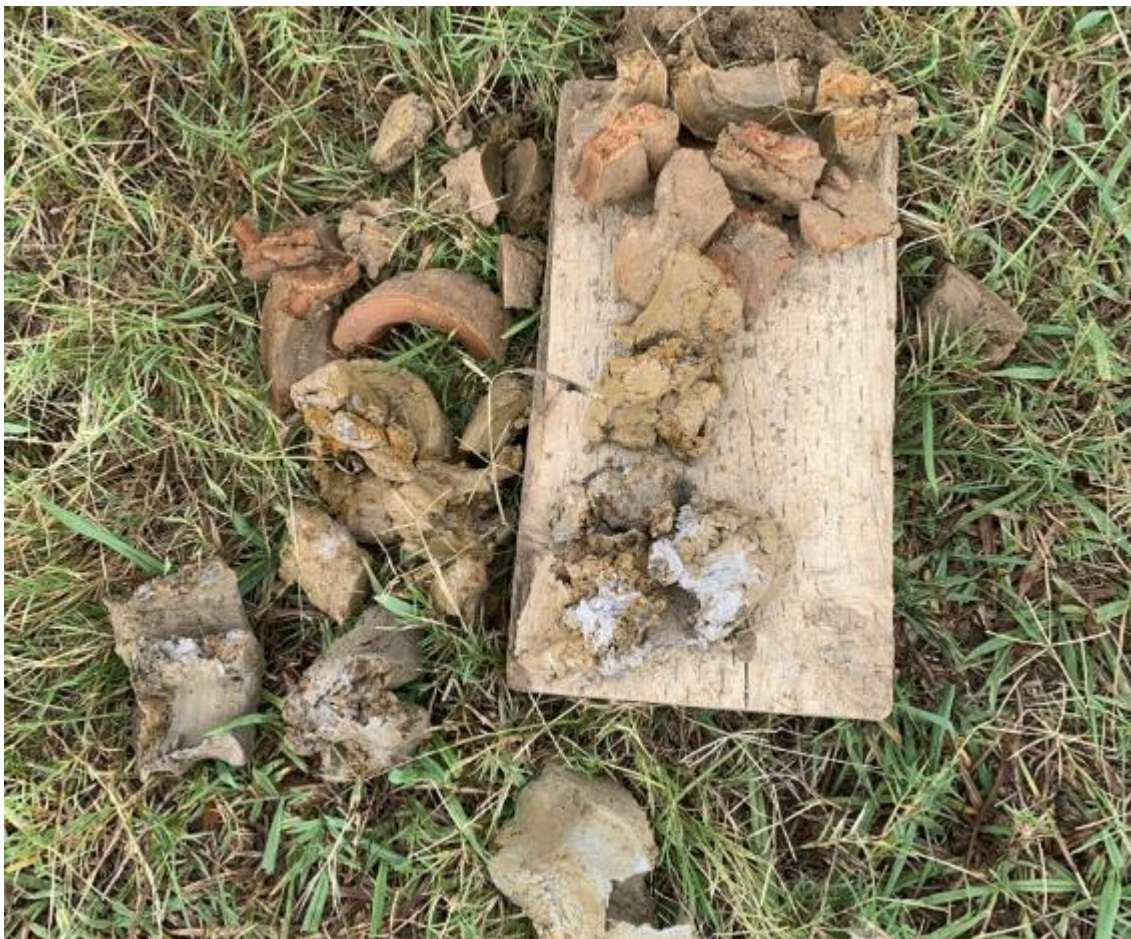
Photo 6: Site view showing subsurface encountered during borehole drilling
