REMEDIAL ACTION PLAN

CENTRAL & NW PORTIONS OF OUTER SYDNEY ORBITAL
221-227 AND 289-311 LUDDENHAM ROAD, ORCHARD HILLS, NSW

Prepared for **Co-ordinated Infrastructure**

Ref: DRM P23.1039.V12-R02r1

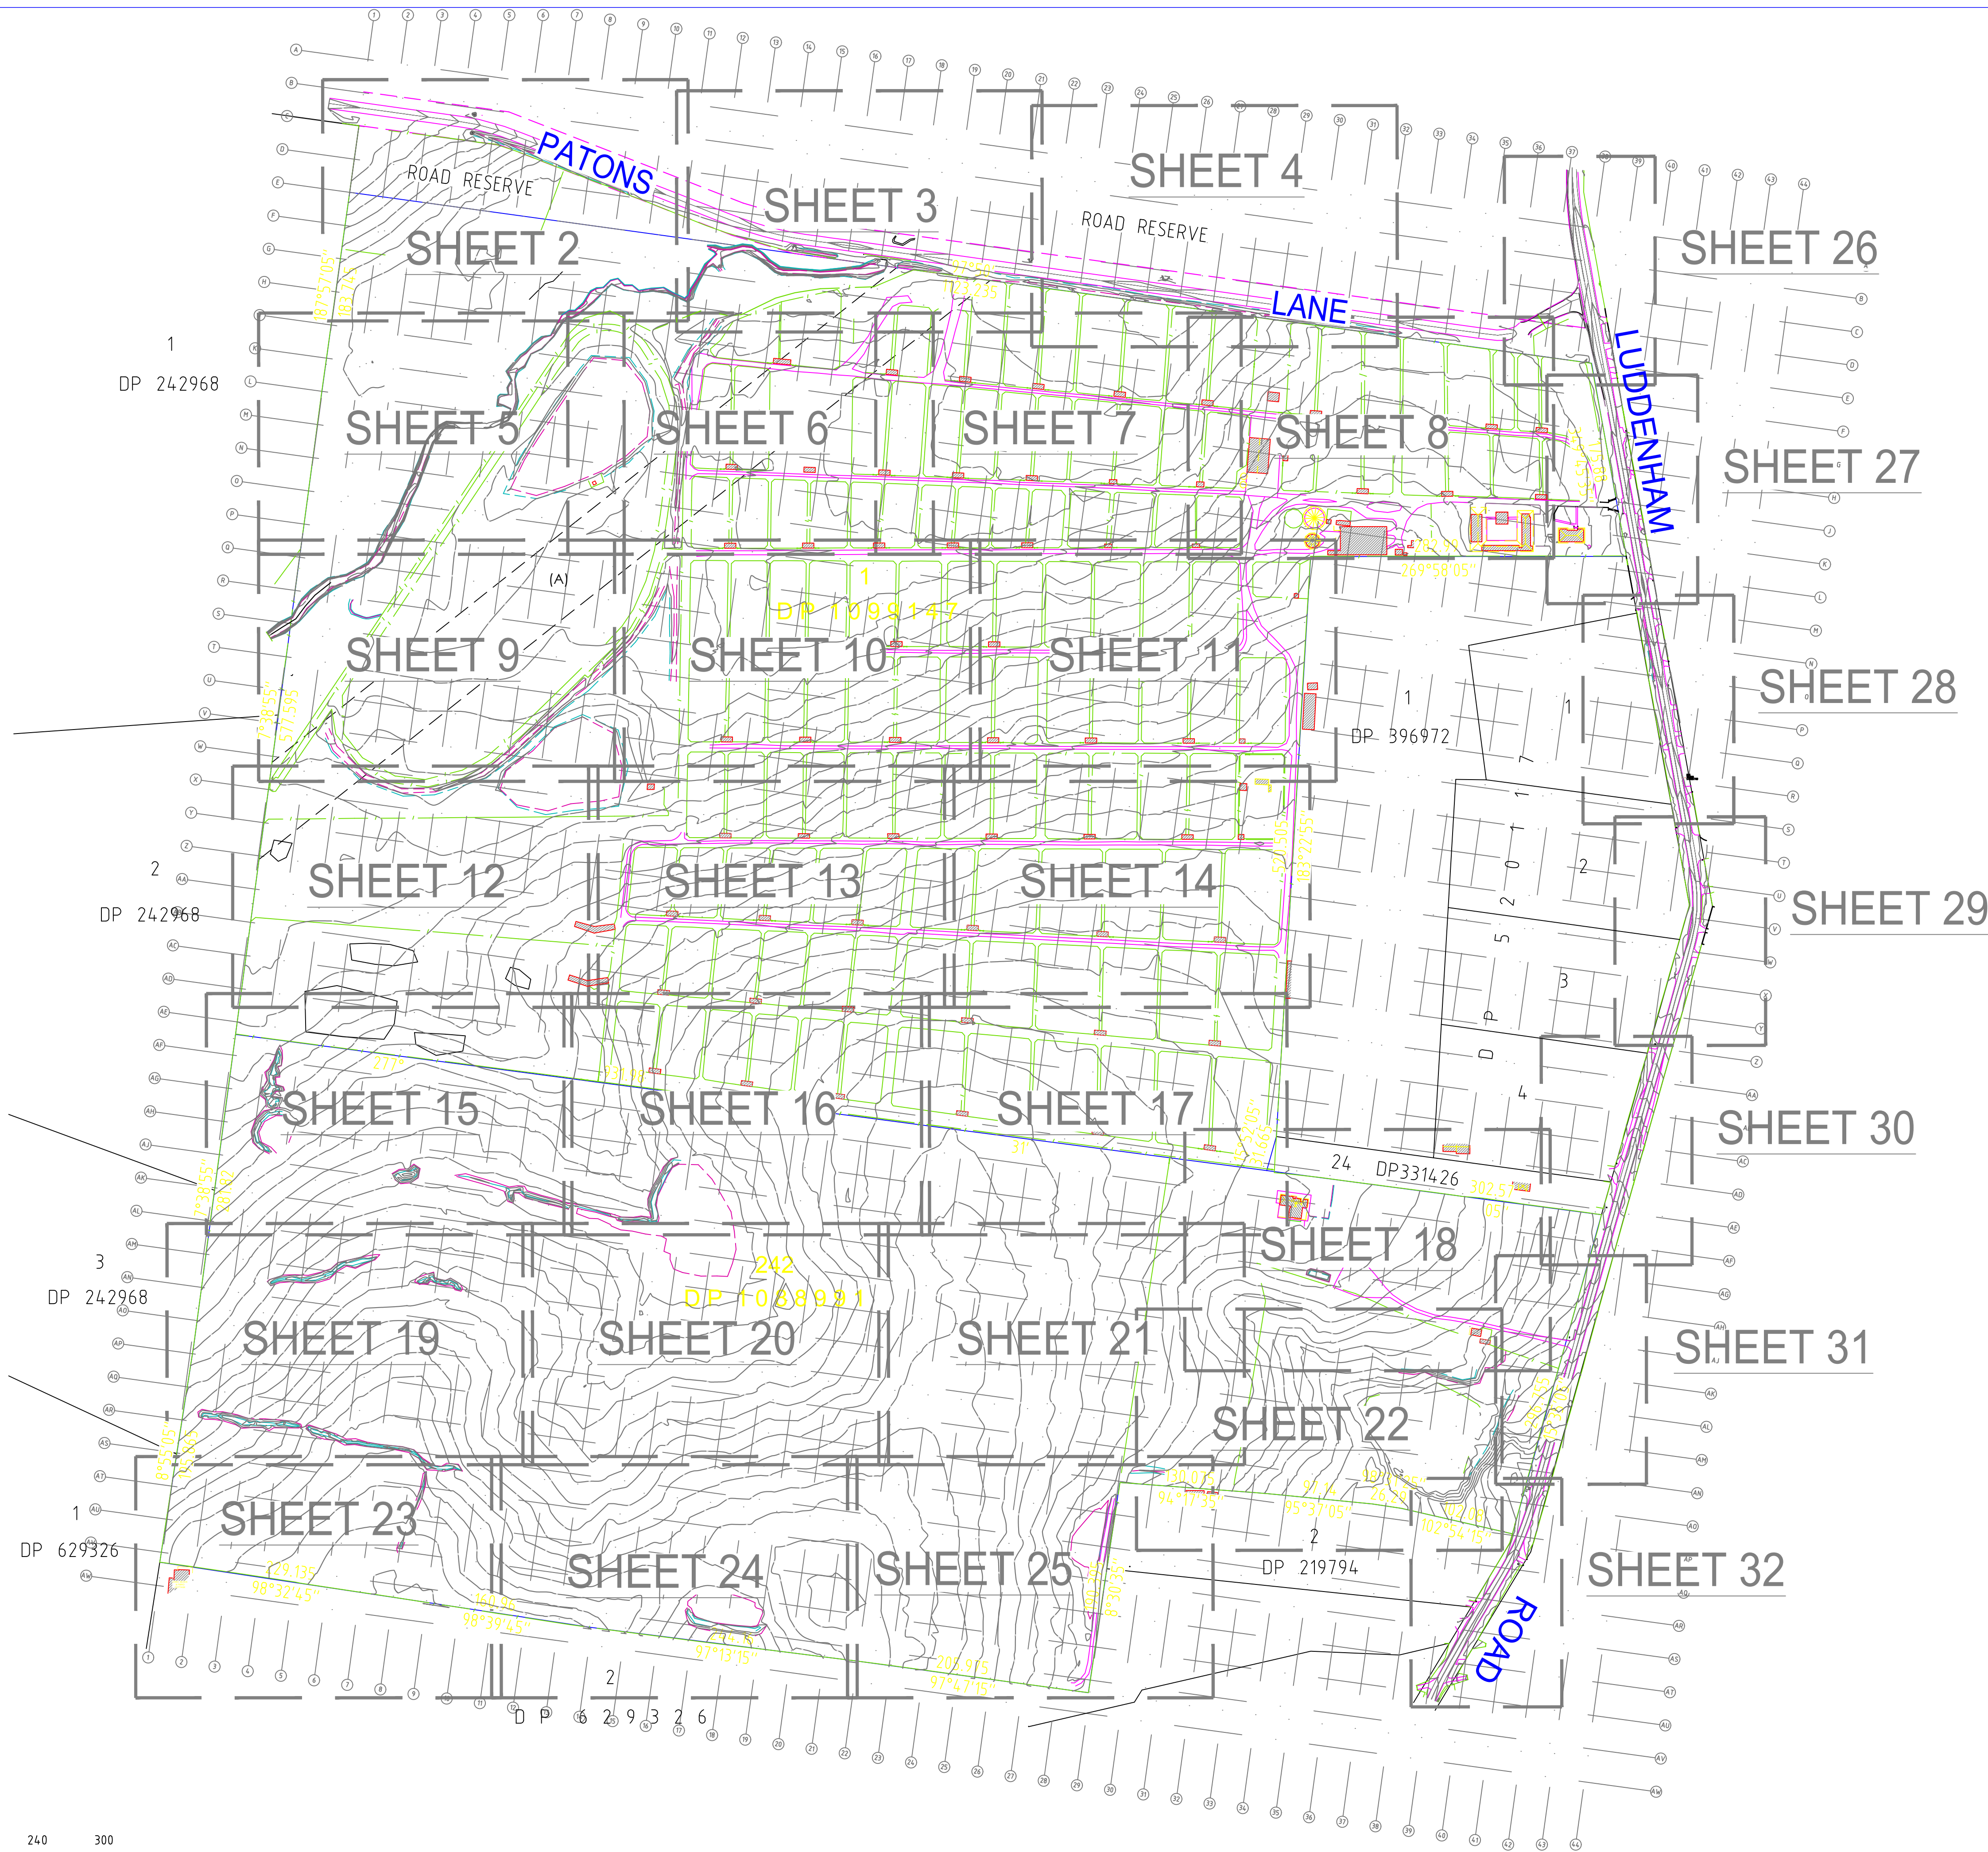
datum: AHD
site Area: 125.3 ha
LGA: PENRITH
reference number: 51007 001DT
scale: 1:3000 @A1
date of survey: 29-04-2020
SHEET 1 OF 32

Client: HB & B PROPERTY PTY LTD
Drawing title: PLAN OF DETAIL AND LEVELS OVER LOT 242 DP 1088991 AND LOT 1 DP 1099147 KNOWN AS No 221-227 & No 289-317 LUDDENHAM ROAD, ORCHARD HILLS

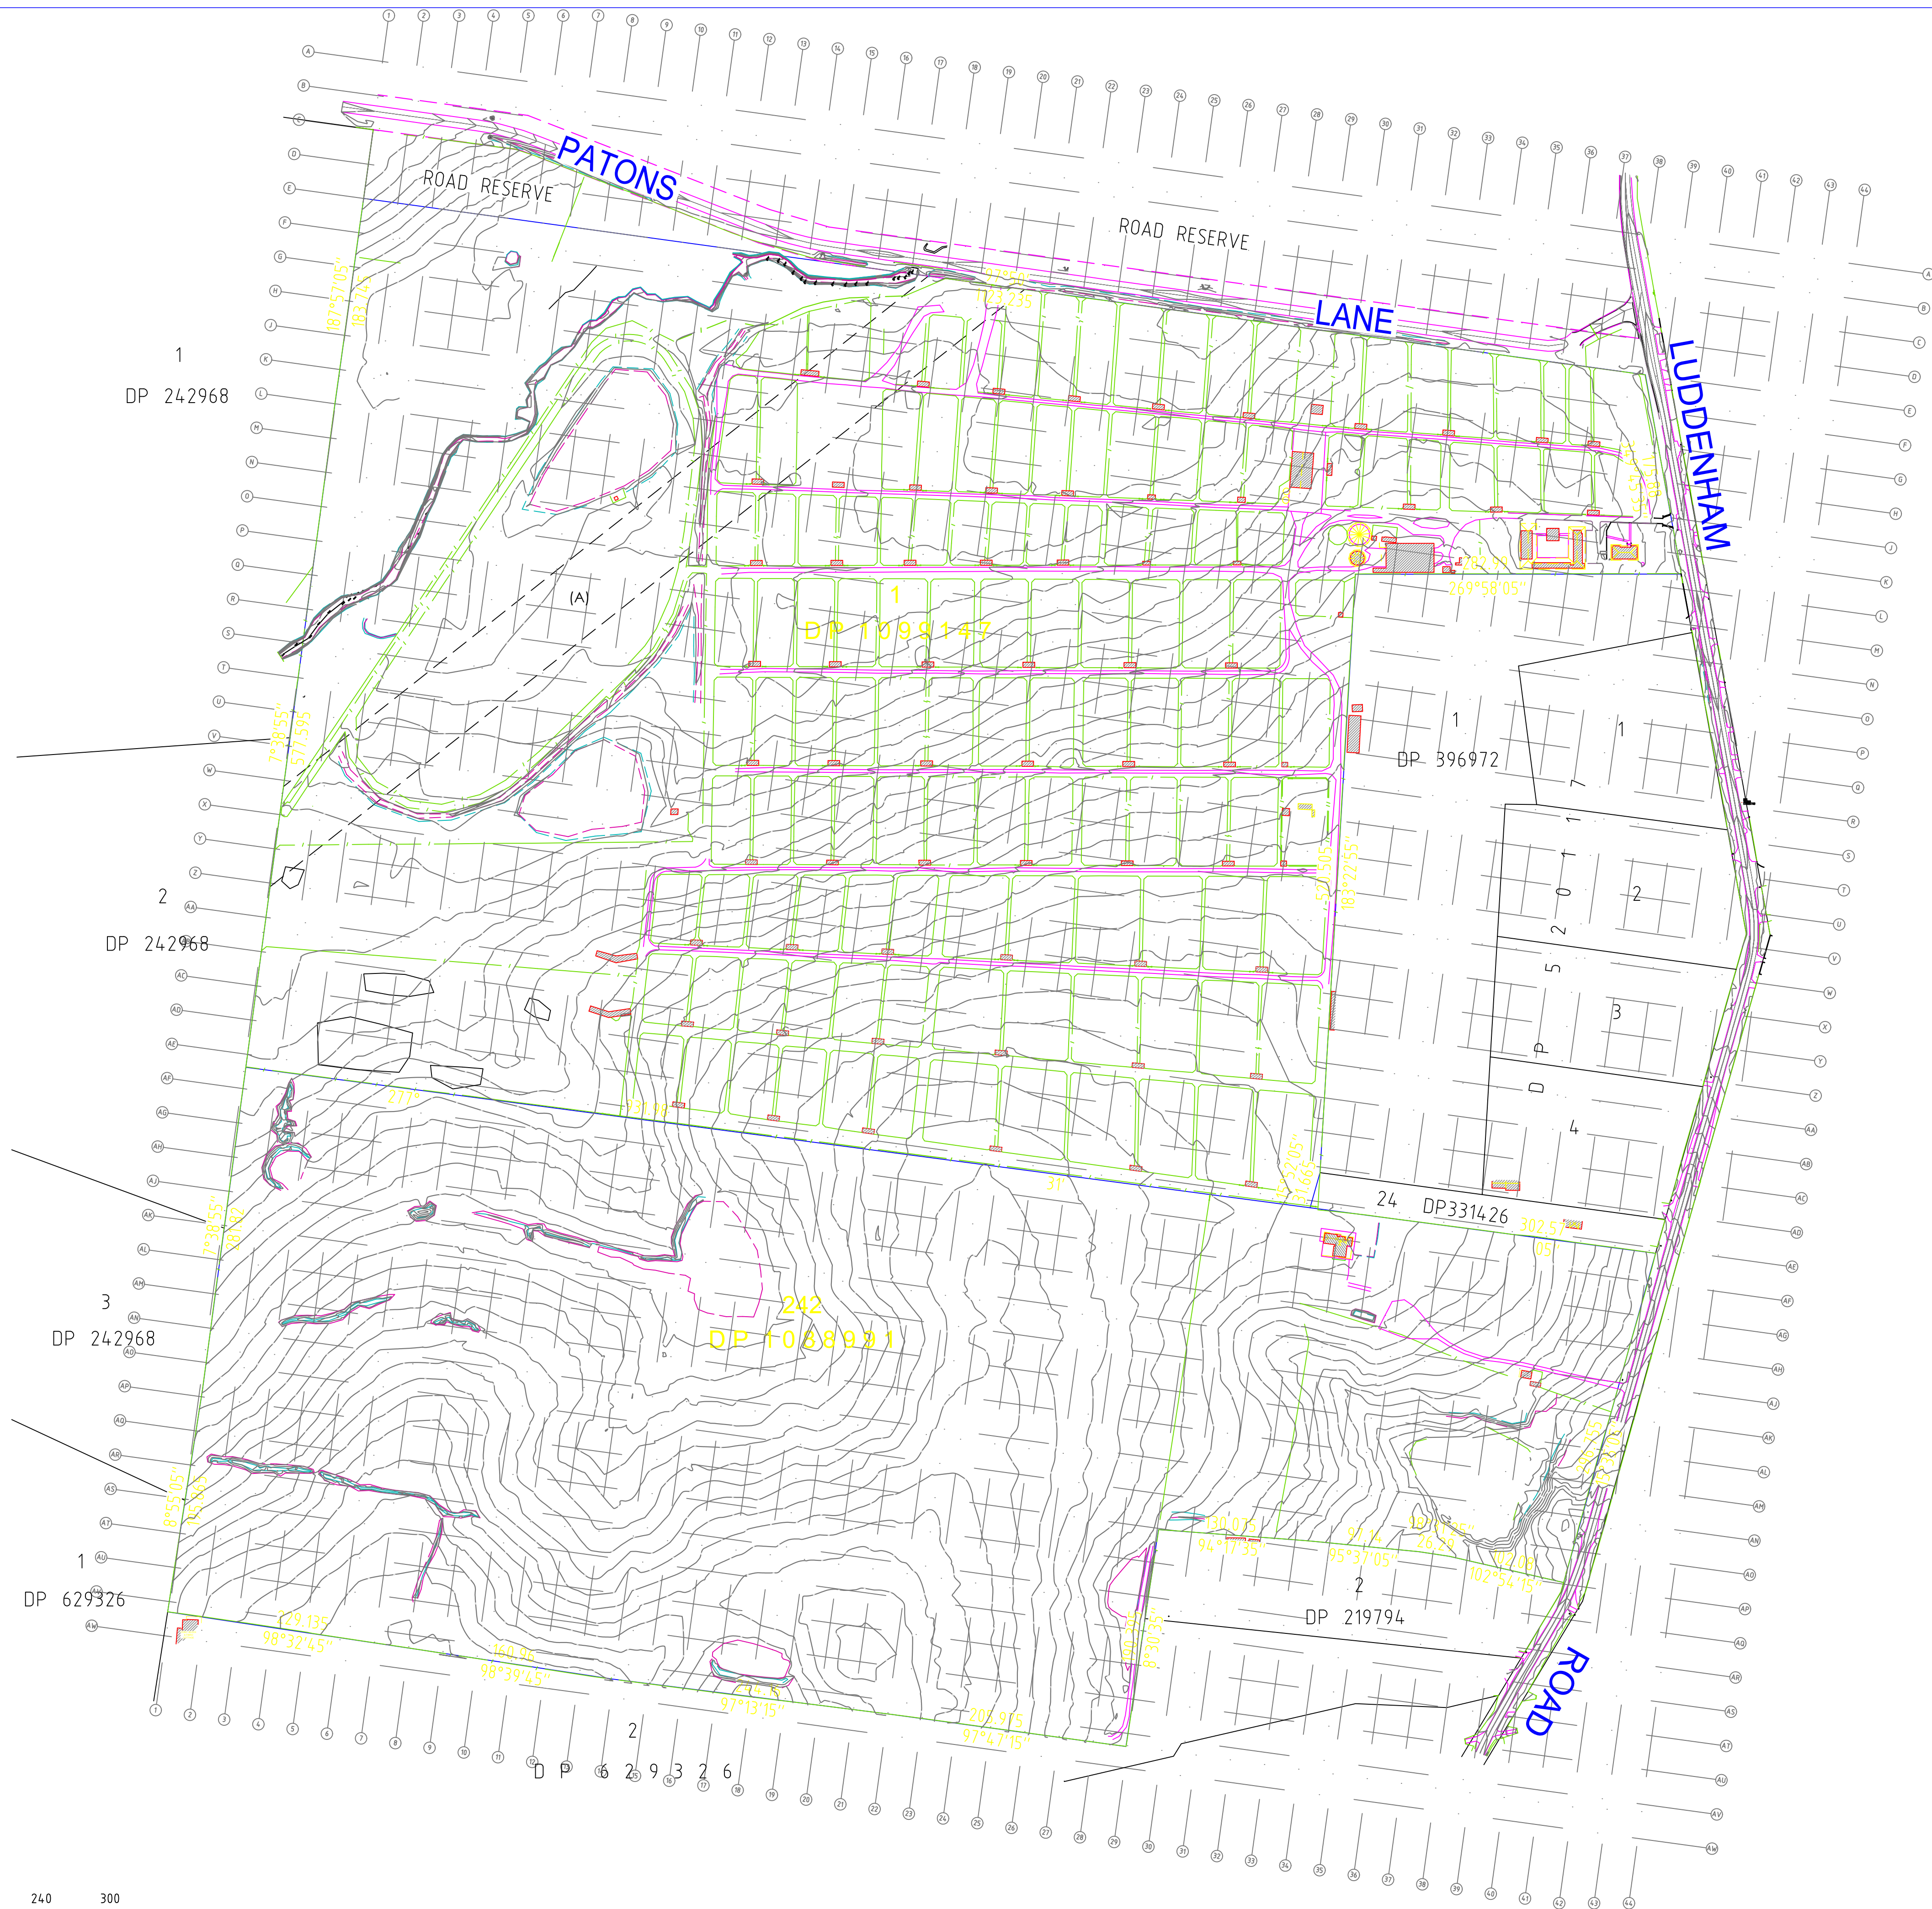
datum
AHD
site Area
125.3 ha
LGA
PENRITH
reference
number
51007 001DT
scale
1:3000 @A1
date of survey
29-04-2020
SHEET
OF
32
1A

Client: HB & B PROPERTY PTY LTD
Drawing title
PLAN OF DETAIL AND LEVELS OVER LOT 242 DP 1088991 AND LOT 1 DP 1099147 KNOWN AS No 221-227 & No 289-317 LUDDENHAM ROAD, ORCHARD HILLS
