Celestino Developments SSP Pty Ltd Unexpected Finds Protocol

> Proposed LUD3 Intersection SSP Luddenham Road, Luddenham, NSW

64659-150773 (Rev 1)

JBS&G Australia Pty Ltd

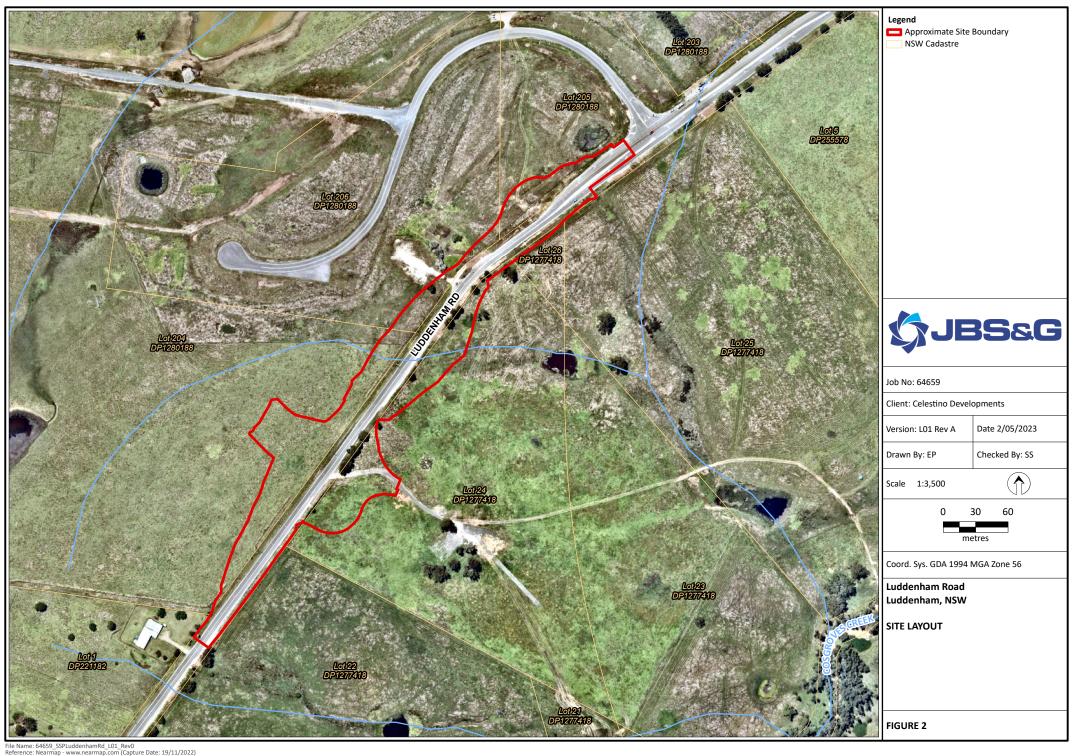
The location of the site current layout is shown in **Figure 1** and **Figure 2**, respectively. The site details are summarised in **Table 1.1** below.

JBS&G Australia Pty Ltd (JBS&G) was engaged by Celestino Developments SSP Pty Limited (Celestino, the client) to prepare an Unexpected Finds Protocol (UFP) to manage unexpected contamination during ground disturbance works associated with the proposed interim signalised intersection (LUD3) on Luddenham Road, Luddenham, NSW (the site). The site is inclusive of an approximate 650 m length of Luddenham Road, and portions of the surrounding lots. The lots are legally defined as Part of Lots 204 to 206 in Deposited Plan (DP) 1280188 which are located within the Sydney Science Park (SSP) development site, and Lots 24 and 26 in DP1277418 on the southern side of Luddenham Road. The site location and layout are presented on **Figures 1** and **2**, **Attachment 2**.

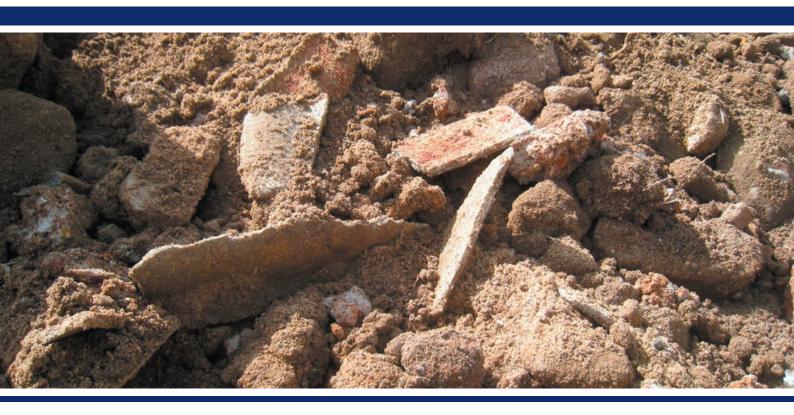
Appendix D SafeWork Asbestos Flowchart

Minor asbestos unexpected finds should be assessed in accordance with *Managing Asbestos in or on soil* (SafeWork NSW 2014), specifically, the flow chart provided on page 9 of SafeWork (2014) document, which is presented in **Appendix D**.
