## Remedial Action Plan

Lot 1 in DP875804 & Lot 2 in DP817692

Pleasure Point, NSW

Hodge Developments Pty  
Ltd

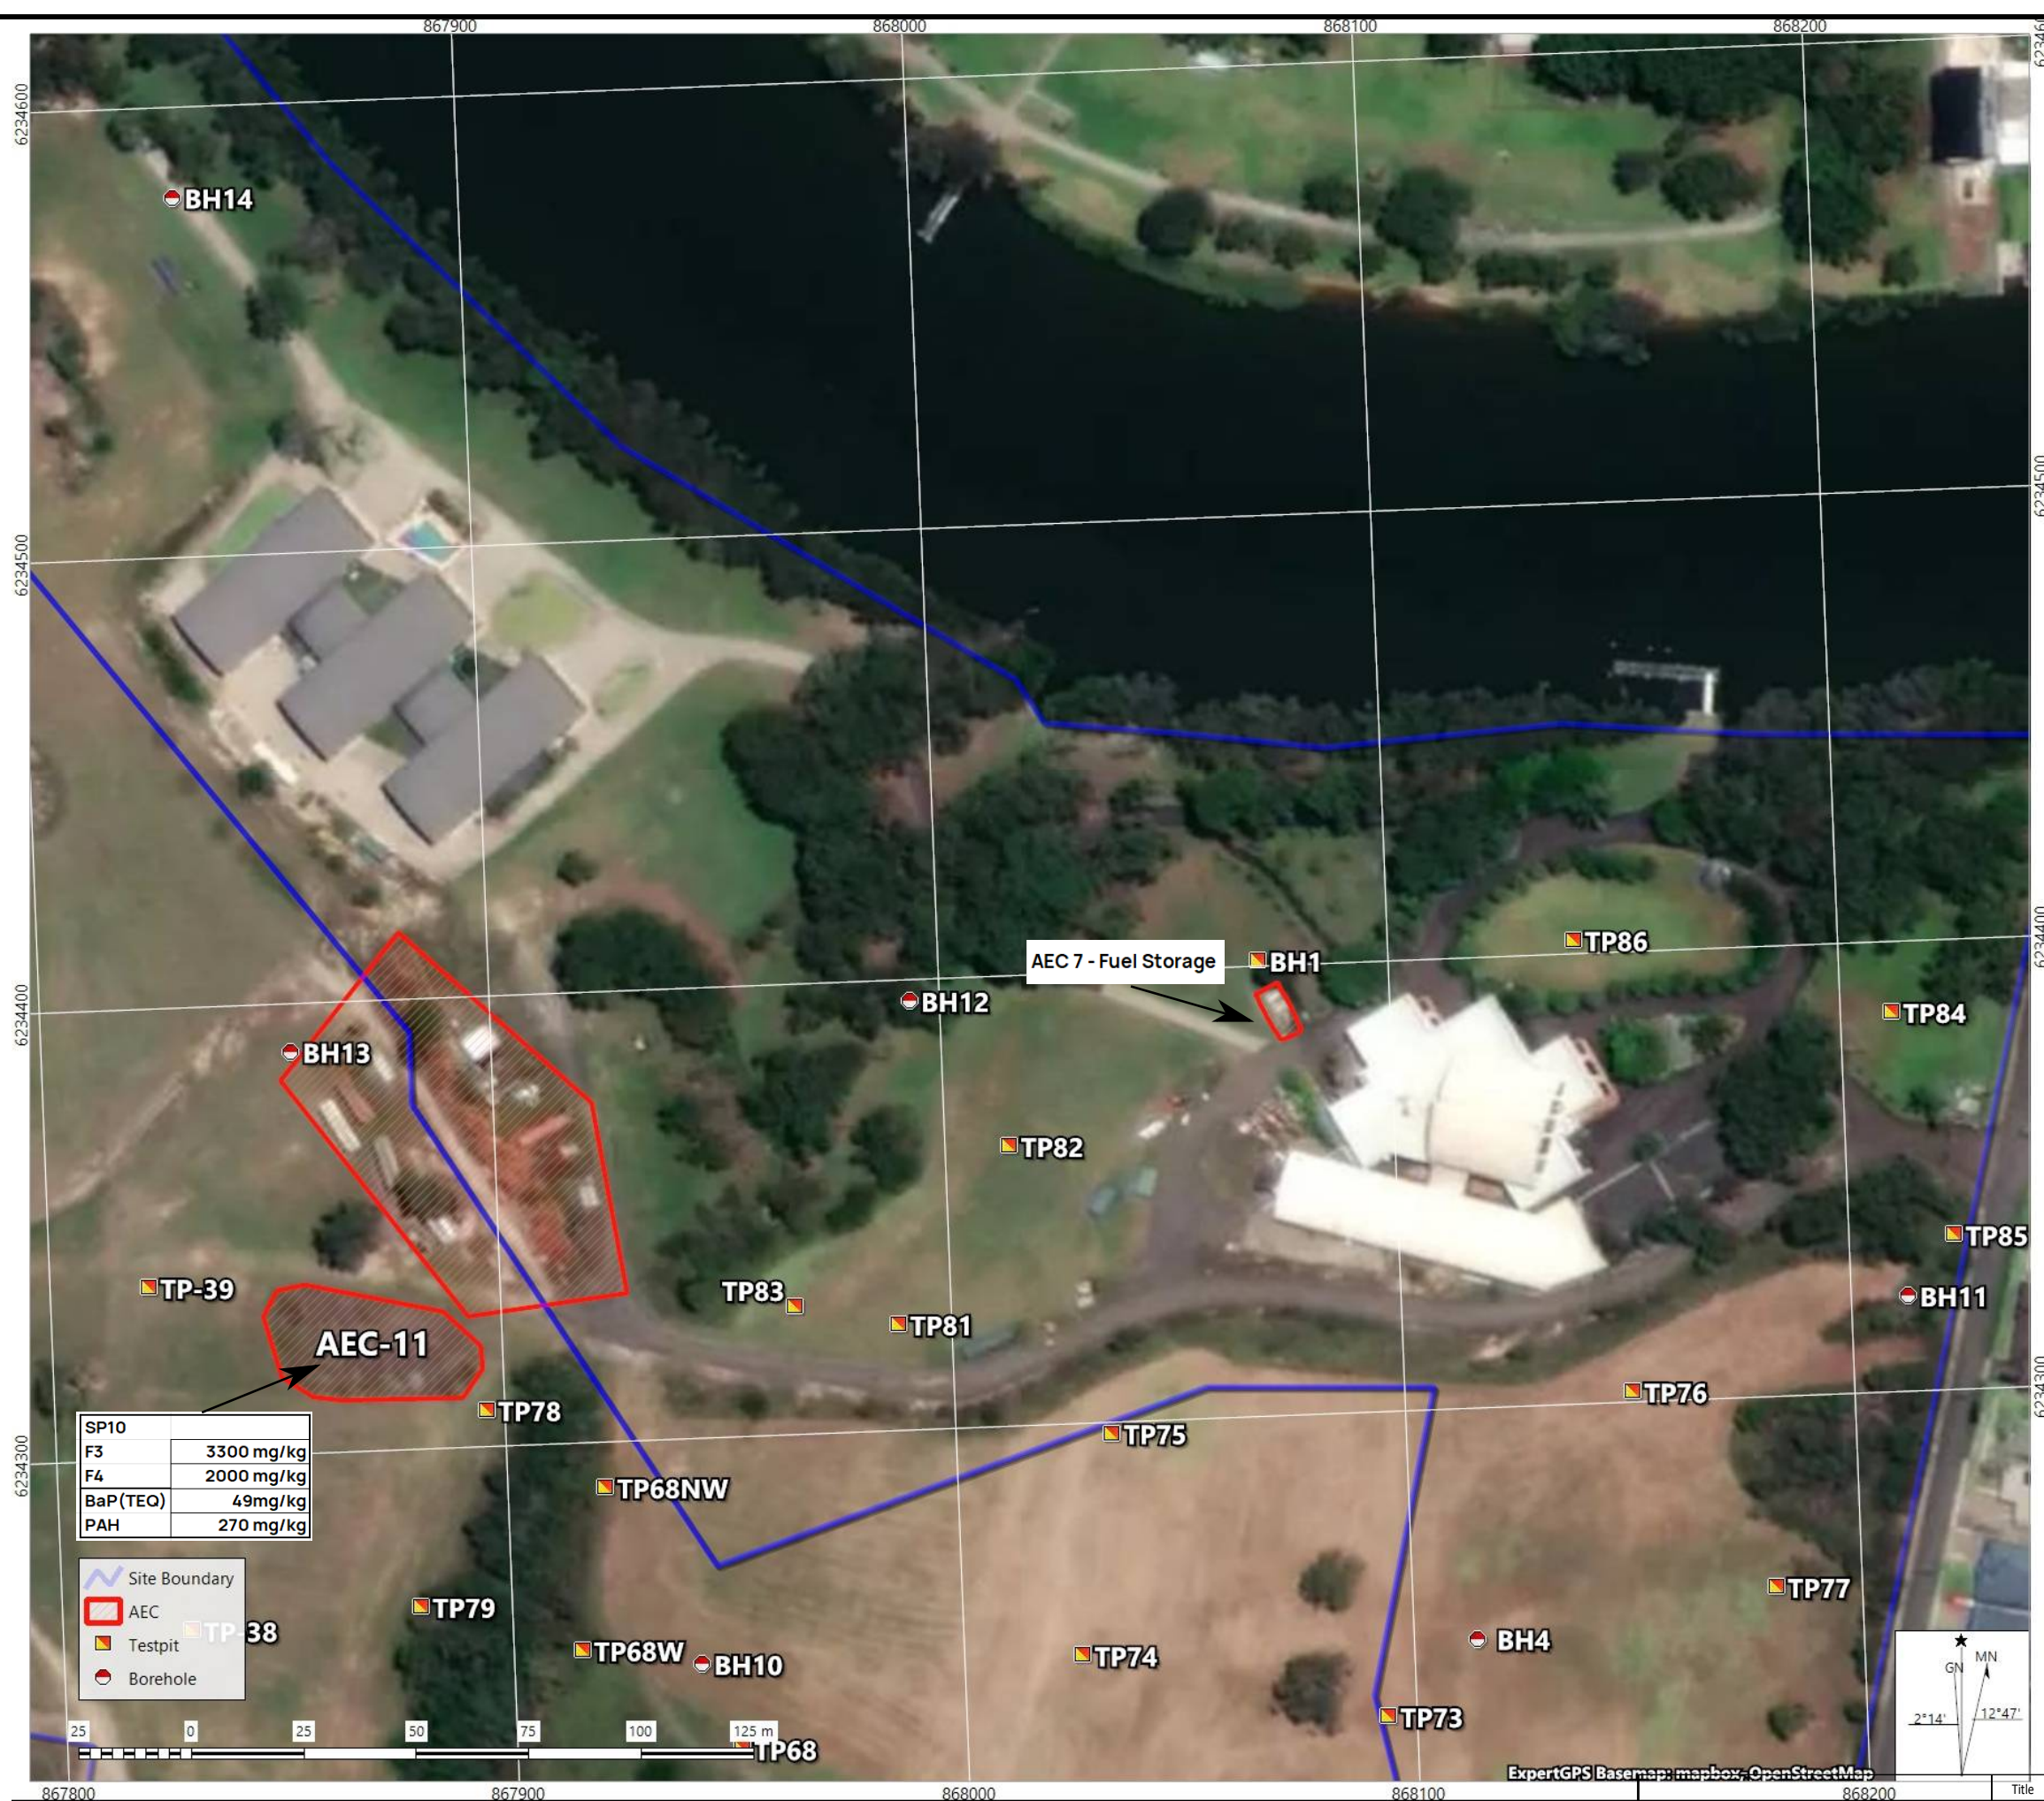
Figure 5 - Sample Layout -Lot 2

| SP10 | |
| F3 | 3300 mg/kg |
